Geohazards Associated with Dispersive-Soil Voids

Chris Grapel, M.Eng., P.Eng.

GRMP 2018

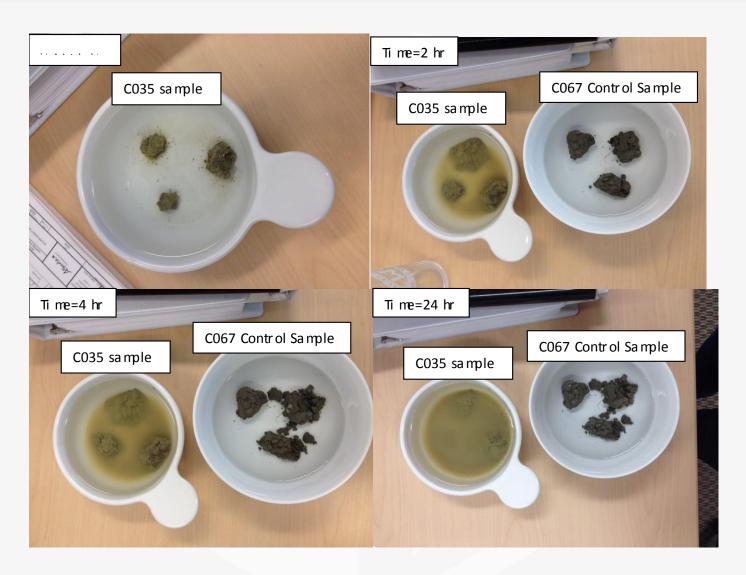
C035 Simplified Crumb Testing (Immersion)

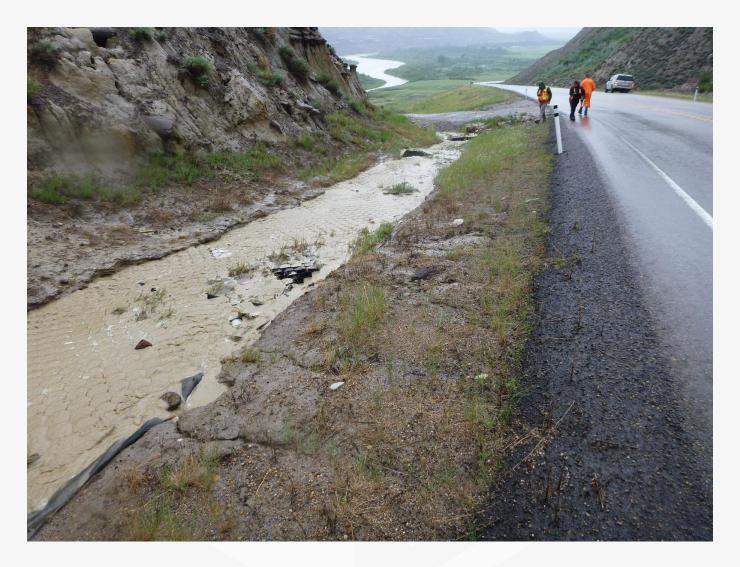
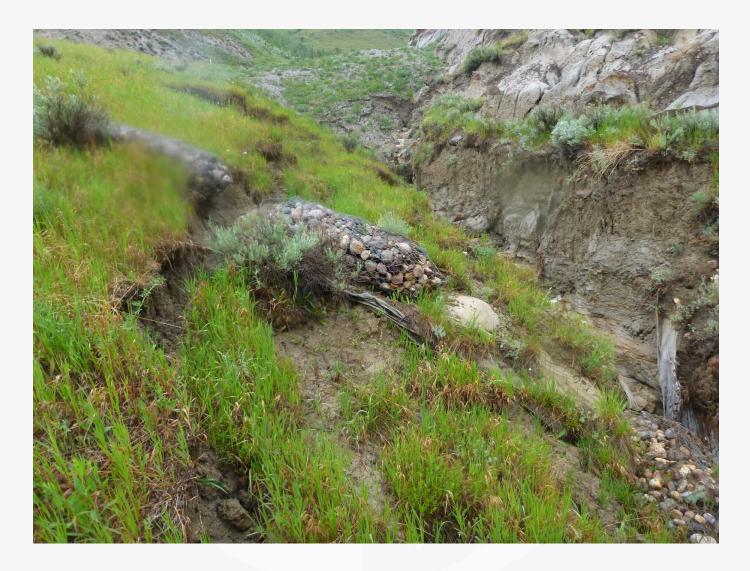
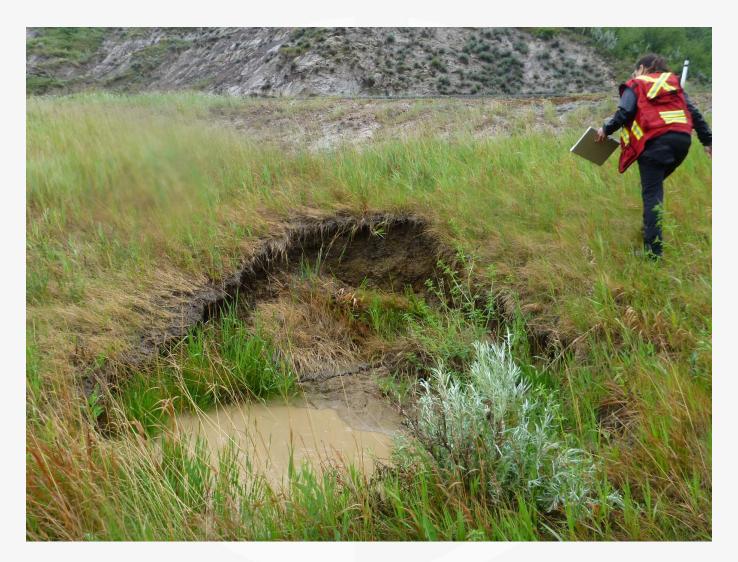
C011 Ditch Erosion and Sinkholes

Hwy 837:02, km 5.637

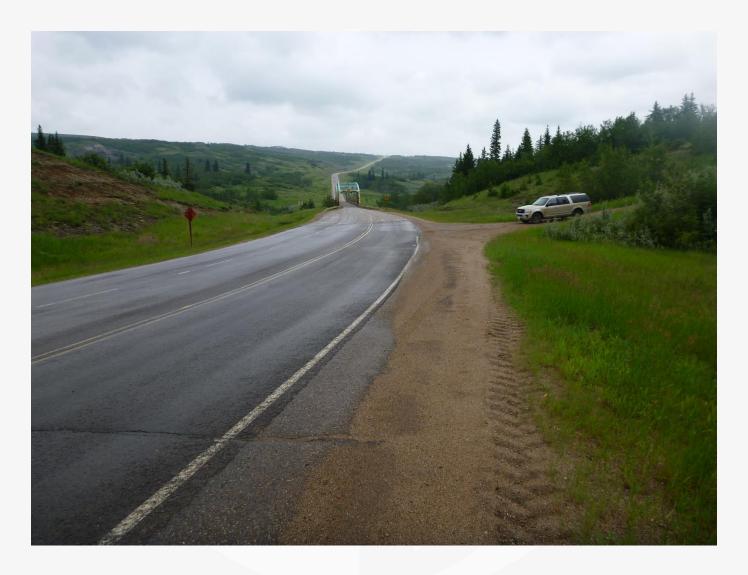
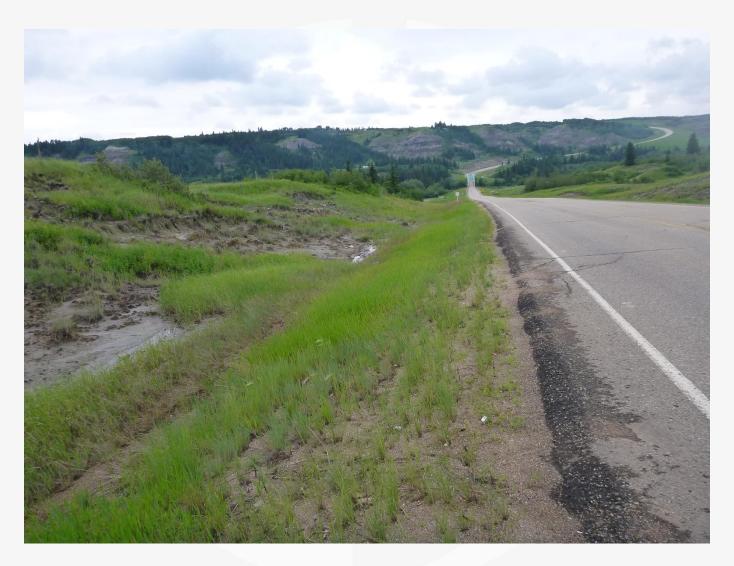
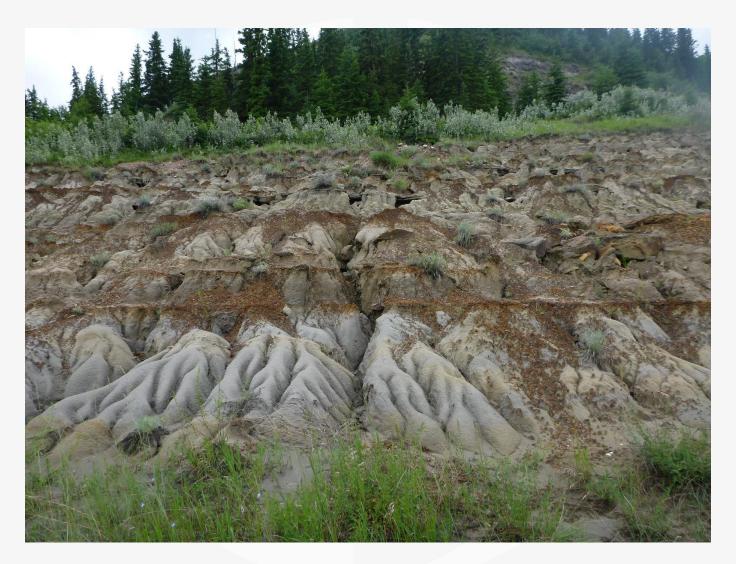
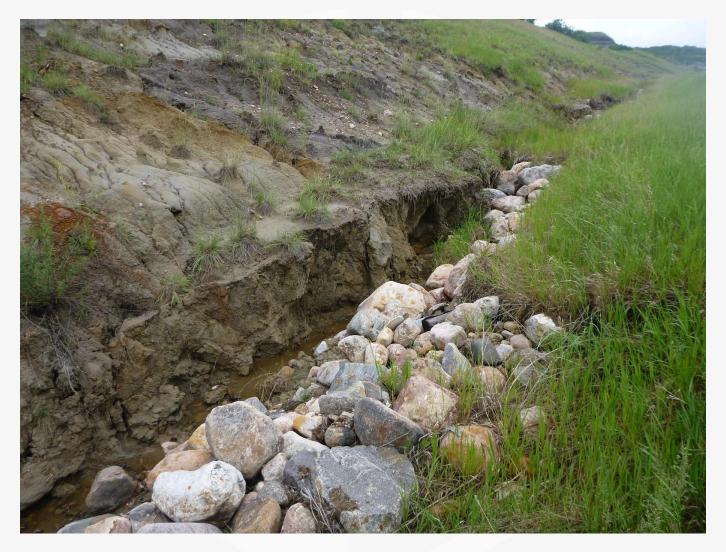
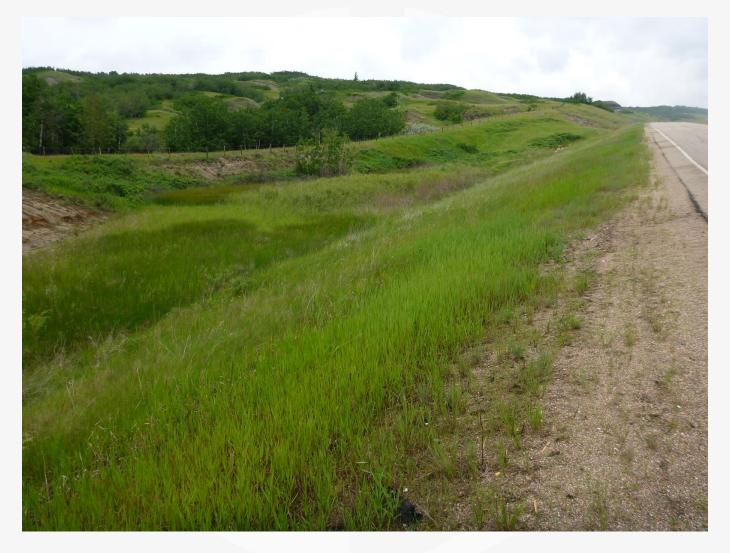
C035 Ditch Erosion

Hwy 590:04, km 20.104

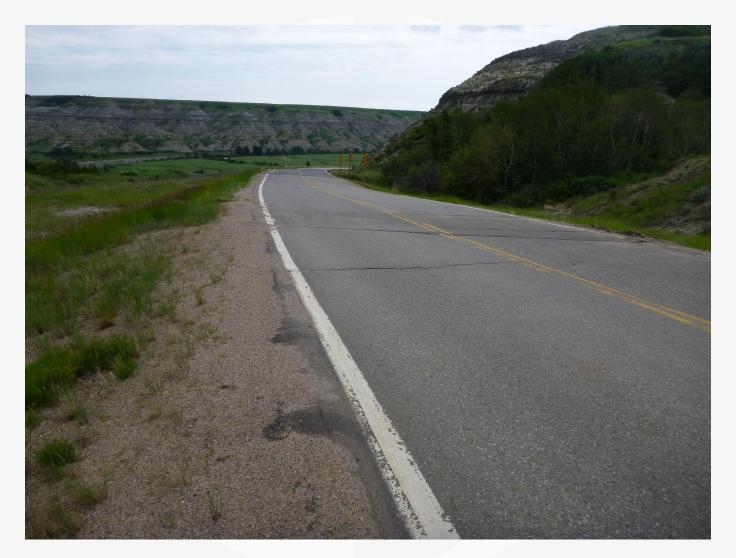
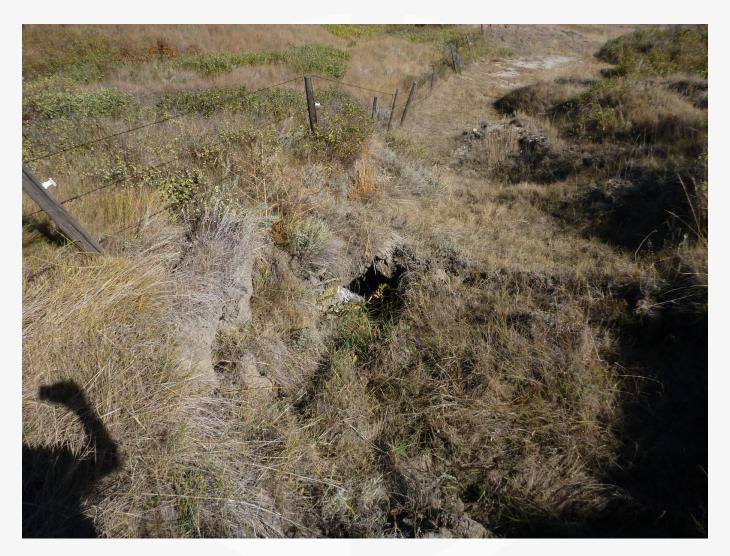
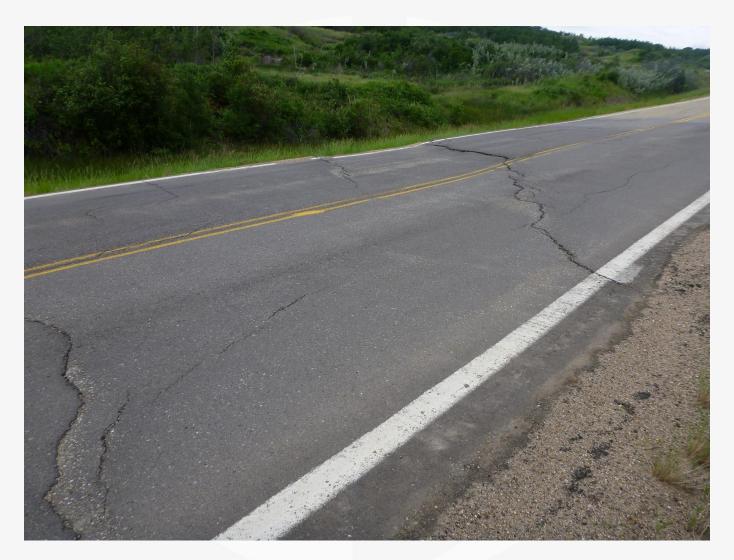
C065-I and -II East of Trochu

Hwy 585:02, km 16.136

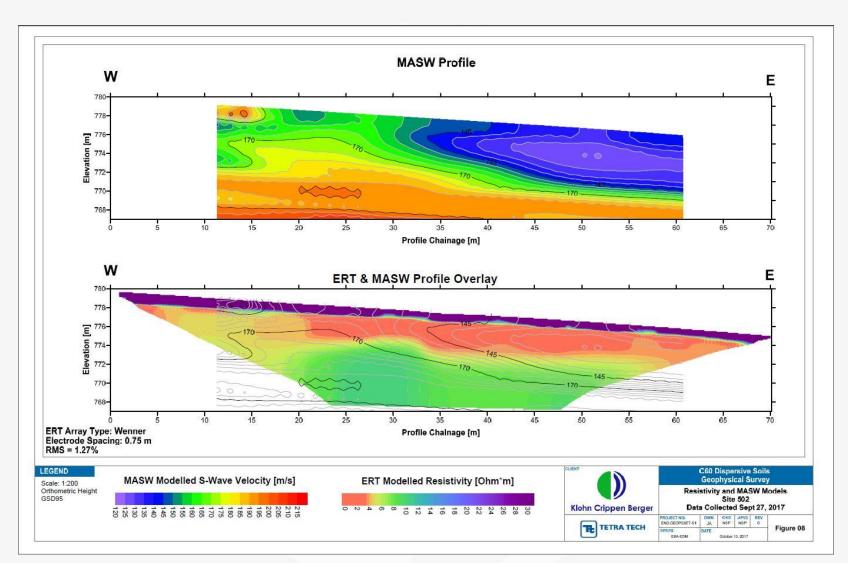
C065 Geophysics

- goal was to assess if voids were present below the two dip areas
- Drilled a borehole at one dip (no void) but soils below highway were quite soft and wet compared to the soils encountered in a borehole drilled on adjacent higher ground
- started at S040 to assess if voids could be detected (success)
- Conducted electrical-resistive tomography (ERT), ohm-mapper, multi-channel analysis of surface waves (MASW), and electromagnetic (EM) conductivity surveys at C065
- The ERT and MASW gave the best results
- Conclusion no void detected below highway, but ongoing dissolution at a preferential seepage path could be causing the settlement

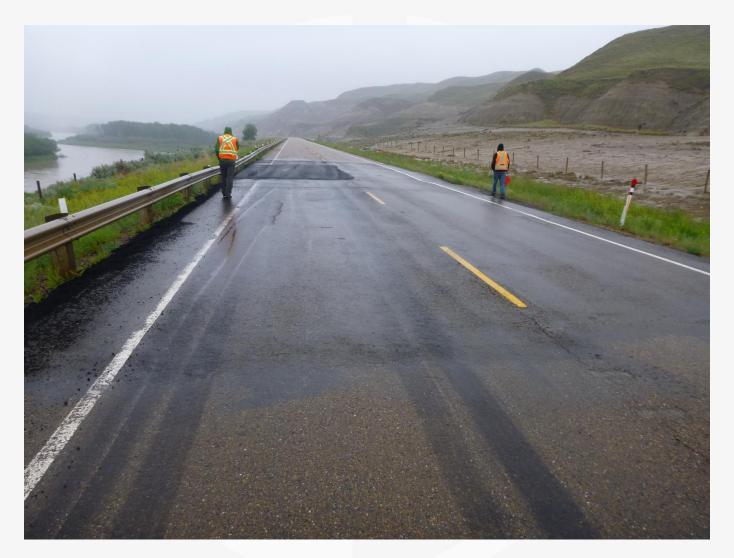
C058 Sinkholes

Hwy 570:02, km 12.000

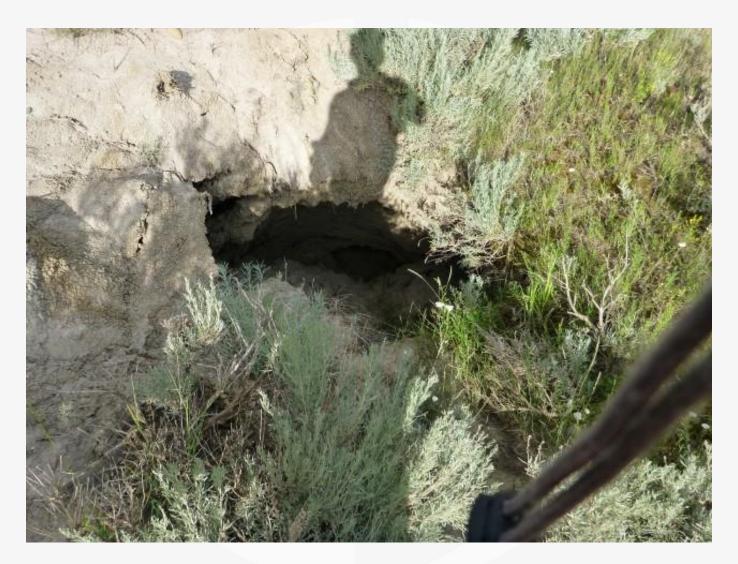
S040 – Sinkhole near culvert inlet

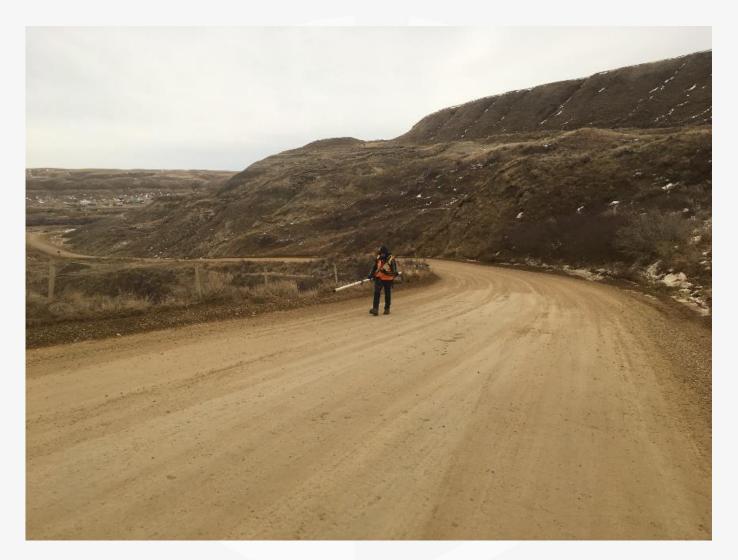
S040 – Geophysics (EM Conductivity)

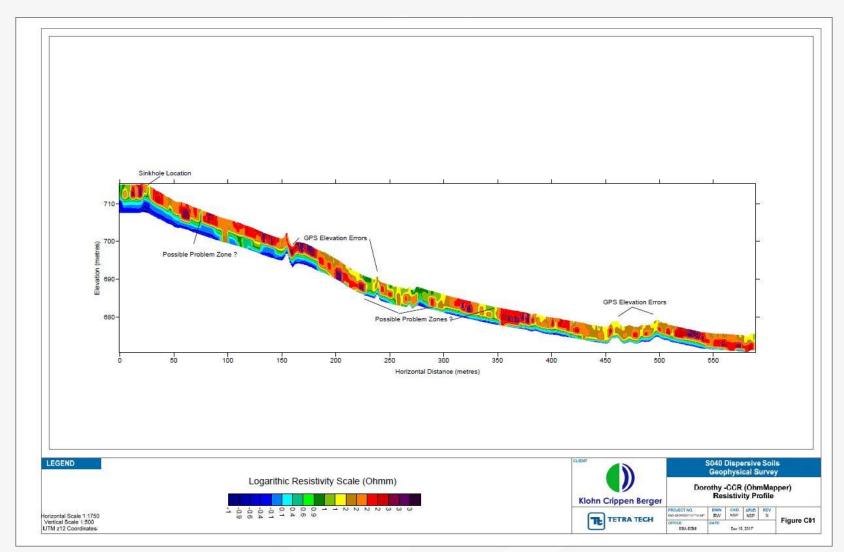
S040 – Geophysics (EM Conductivity)

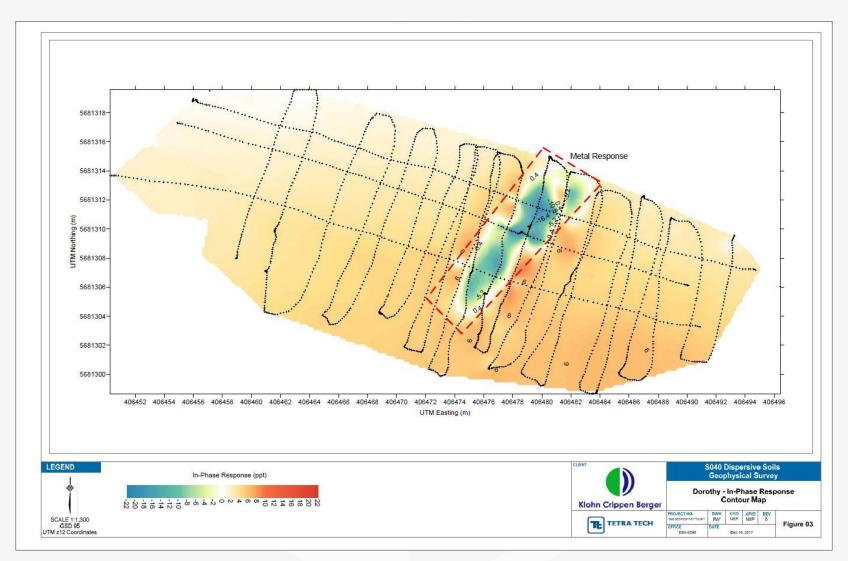
S040 – Geophysics (EM Conductivity)
