Alberta Transportation
Bi-Annual GRMP
Meeting

North Central
Region – NC76,
NC82, and
NC57 Overview

NC76 – Blue Ridge Slide

NC57 – HWY 624 Embankment Failure

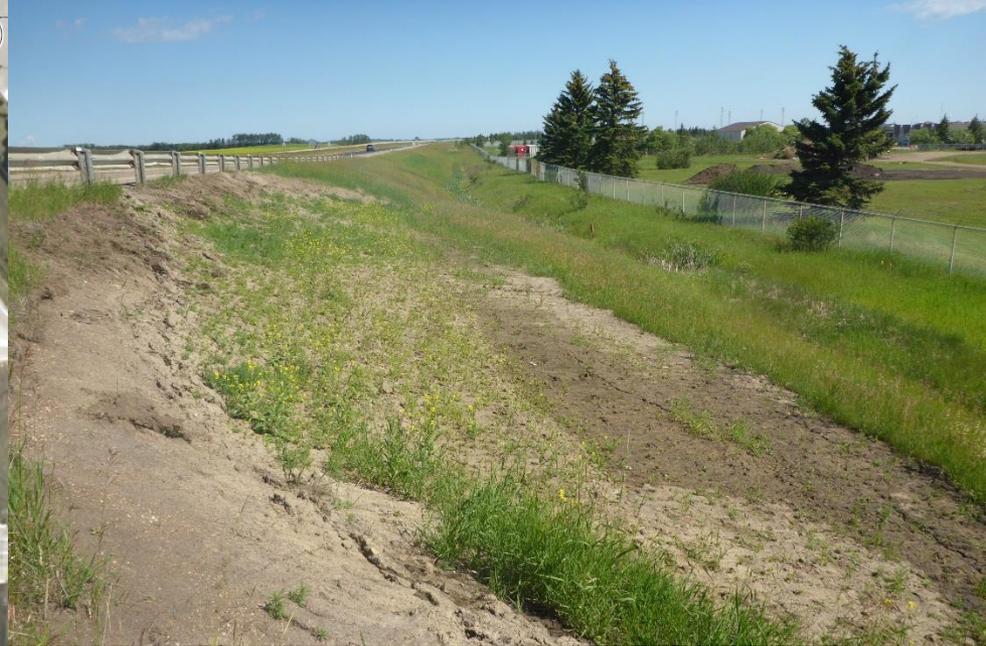
- Two slides
 - North 55 m x 20 m
 - South 30 m x 15 m
- 4 m to 5 m high embankment, 3H:1V
- Standing water in east ditch – No grade
- Test pits showed soft soils, possible high water table, and uncontrolled fill
- No instrumentation

Photo 1 – Looking north at north slide

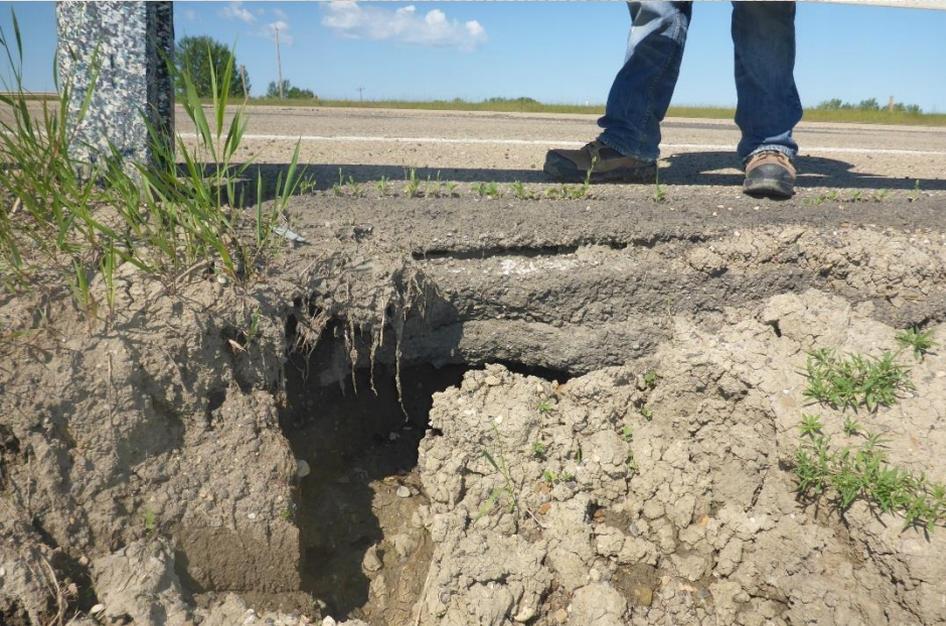
Photo 2 – Looking west from north slide

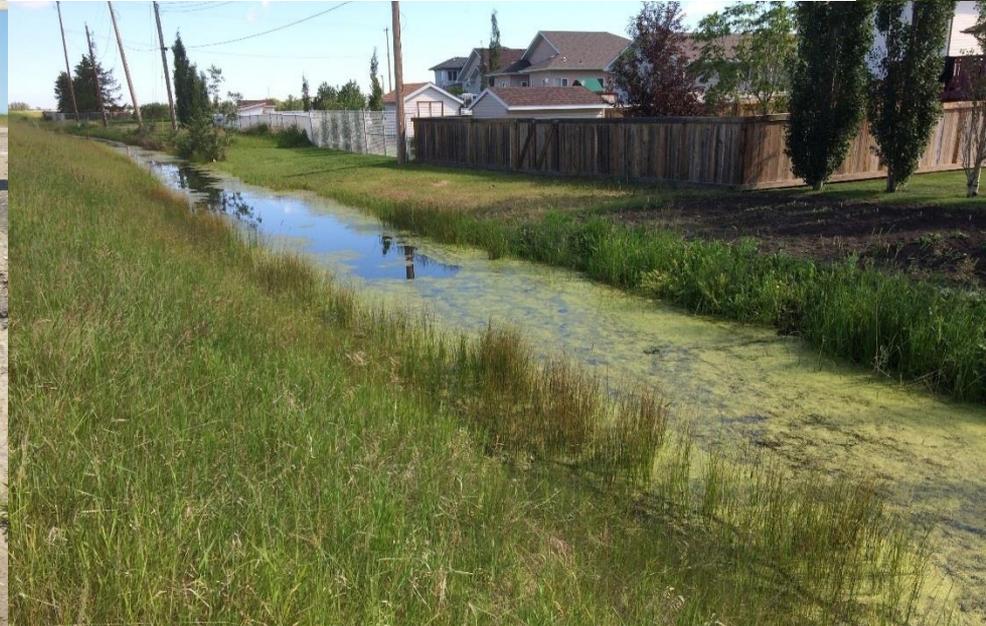
Photo 3 – Looking north at drainage ditch

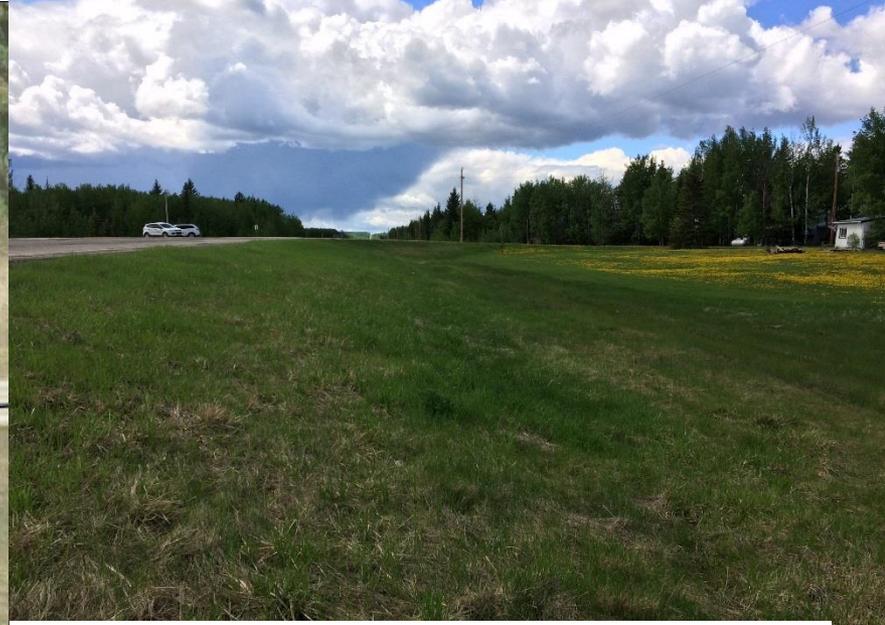
Photo 1 – Looking west gentle slope

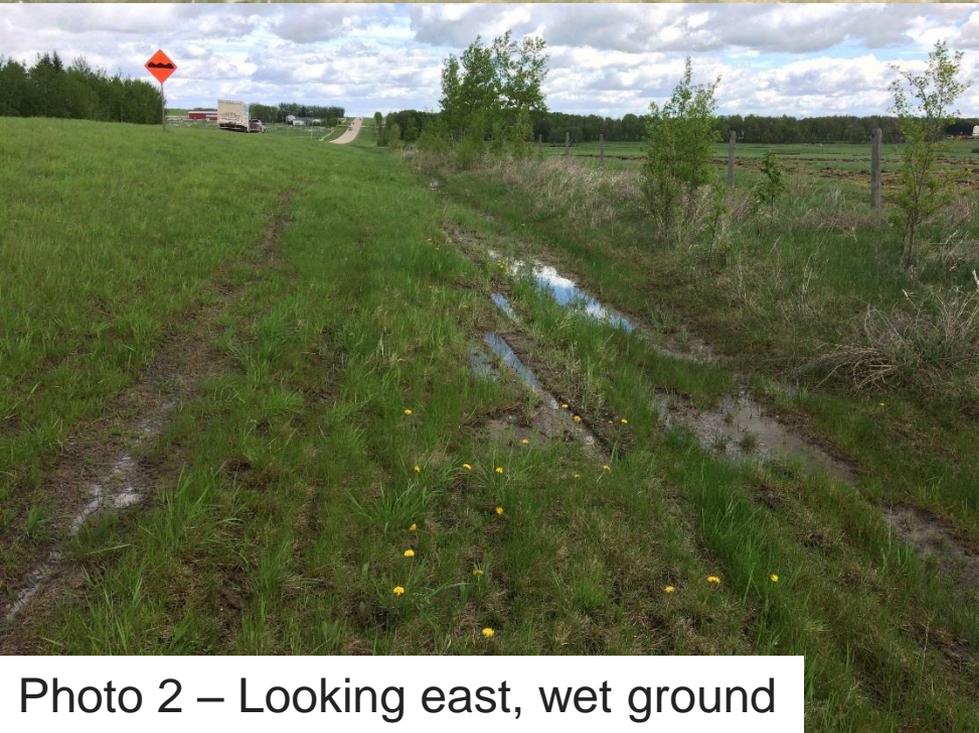
Photo 2 – Looking east, wet ground

- Very soft to soft clay
 - Need to improve strength. Remove and replace. Cematrix?
- High Groundwater Table
 - Boreholes drilled showed piezometric levels 1 m above highway surface
 - Need free draining material. Not Cematrix.
 - Gravel available nearby
 - Tire derived aggregate (TDA) also available from Alberta recycling

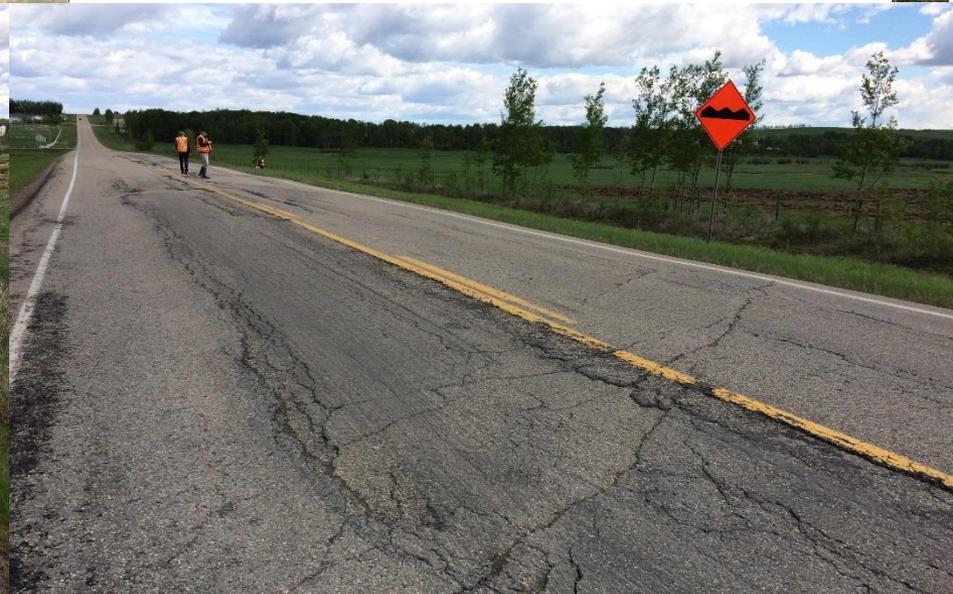
- 2 m embankment with 6H:1V to 7H:1V side slopes
- Settlement and lateral spreading of highway
- First embankment failure in 2006
- Repaired in 2007 with granular sub-drains installed.
- Highway 624 performed well until 2014

Photo 3 – Looking southeast, pavement distress
