Erosion Ditch Repair
H614:02 and H894:04
Using ArmorMax System (an anchored reinforced vegetation system)
Fred Cheng - Geotechnical and Materials Section
Tom Somerville, FST – Vermilion District - Central Region
May 2012

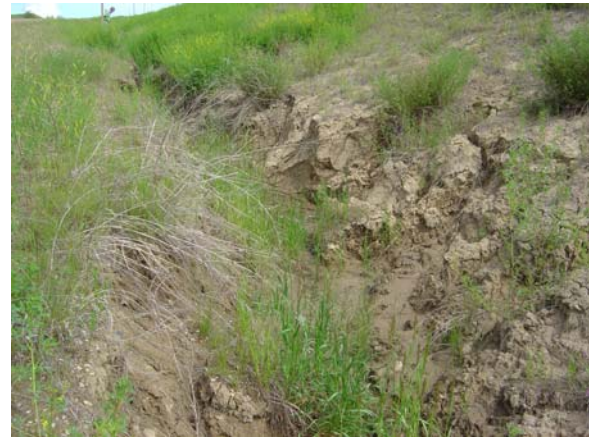
H894:04 - 2006

H894:04 east ditch – the eroded ditch is 114m in length with a 5.4% grade. In 2006 the ditch displayed widespread erosion gulying and by 2009 the scoured area had doubled in size.

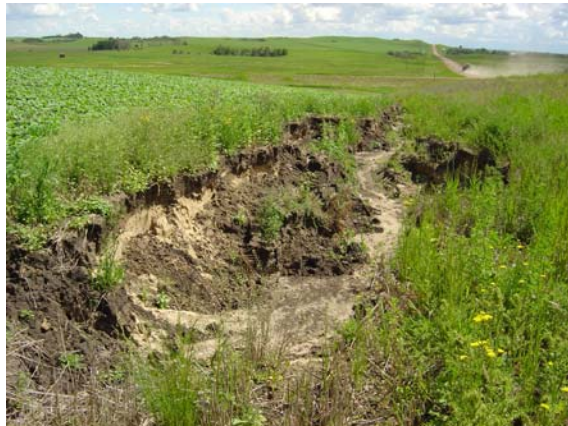
H614:02 – 2006

H614:02 north ditch – the eroded ditch was 91m long with a 7.2% grade. In 2006, ditch scour was in the order of 1m to 1.5m; in 2009 erosion had doubled the scour size to more than 2m in some areas. The existence of sand intrusions within a mainly silty soil profile produces a highly erodible soil profile. Furthermore, this ditch borders the south edge of a farmer's canola field and would be a liability to the department should farm equipment roll into the erosion gully. Public safety would also be jeopardized should a vehicle or snowmobile drive along the ditch. With the steep 7% slope and the large ditch void there is potential danger of losing the roadway during large storm events. Added to the risk is the existence of a gas pipe line running across the ditch at the east end of the site.

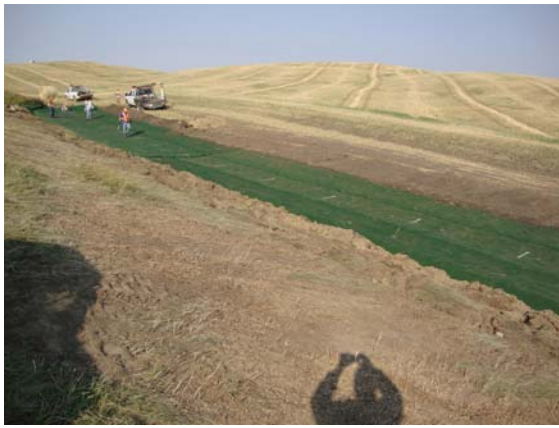
H614:02 – 2009 During construction

Organic material was removed before back filling and compaction with imported competent material. This was native non-organic soil extracted from a local farmer's property adjacent to the job site. The ditches were graded to a trapezoidal cross-section with 4:1 side slopes. A 300mm x 300mm trench was dug at all 4 sides of the ditch to allow for edge embedding and anchoring of the matting. Properly burying the edge in the trench will prevent unraveling of the matting due to runoff. Seed and fertilizer was applied after grading was complete. Starter rolls were keyed in at the bottom of the ditch and worked uphill in order to minimize runoff erosion to the lower ditch due to flash storms. Roll overlap was 300mm. The matting was anchored with 2 types of pins: deep duck-bill anchors at overlap and edge locations and 500mm x 5mm steel rods also at manufacturer prescribed grid locations. A backhoe was used to "knuckle" the trenched keys to compaction. At the H894 site, riprap was placed at the culvert to form a stilling basin.

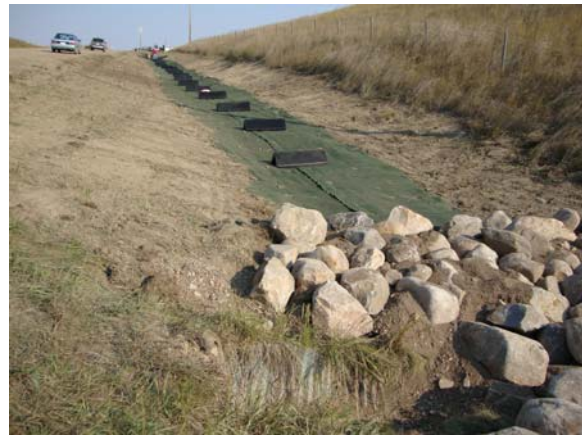
H894:04 – 2009 During construction

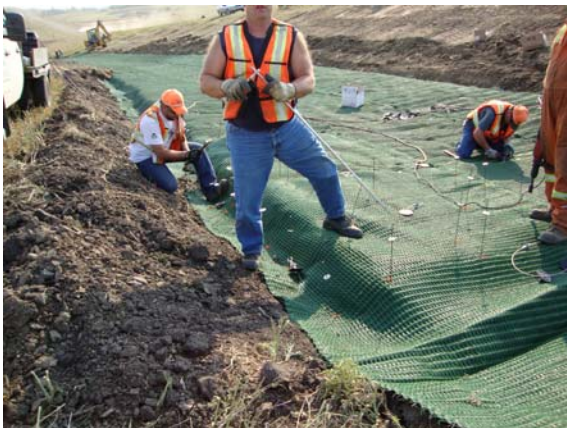
H614:02 - Placement of anchor pins

The ArmorMax system comprises of a high performance Turf Reinforcement Mat (TRM) and percussion driven anchors. The matting is a 3-dimensional woven polypropylene geosynthetic and it exhibits high interlocking and reinforcement capacity with both soil and root systems. Percussion duck-billed anchors, connected by stainless steel cable and an end-lock device, are driven up to 700mm into the soil by using a Hilti percussion hammer which makes the installation easy and fast.

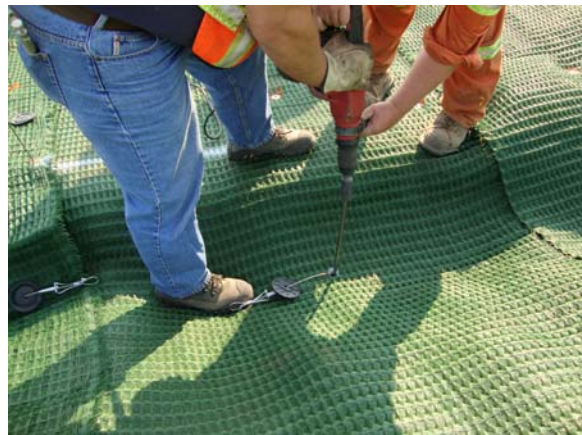
Hilti hammering the duckbill anchors

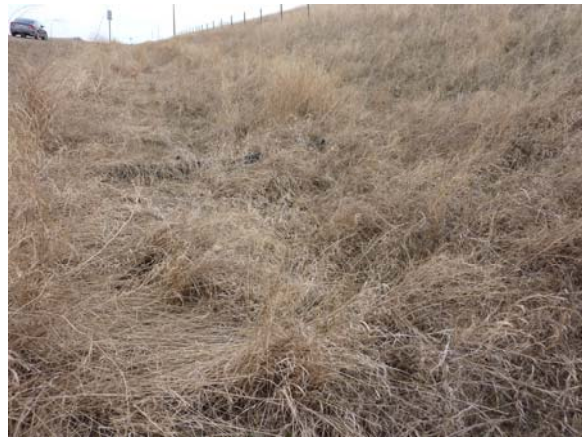
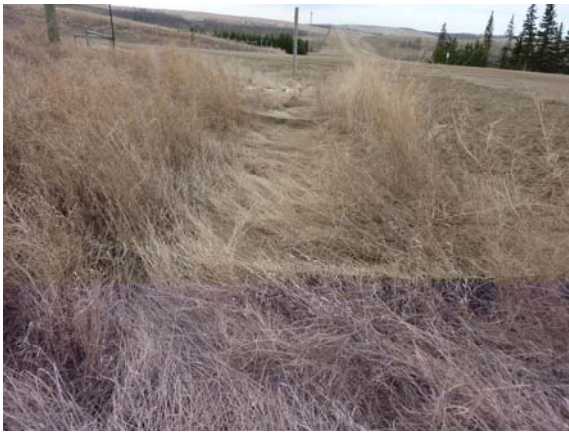
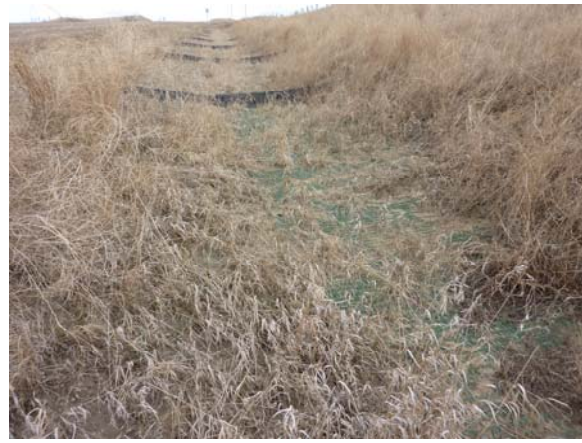
H894 - May 2012

All in all, the project went without a hitch. The sites have been monitored regularly by Carillion and district staff since installation. ArmorMax was found to perform very well on this 7% ditch. No ditch erosion has been noticed and grass catch is full. GeoRidge barriers will be removed in coming months.
