Note to Bridge File 81939 - Waldo Creek

Aluminum Structural Plate Pipe inspection

location: Hwy 58 (165 km east of High Level)

Date of inspection: September 26, 2017

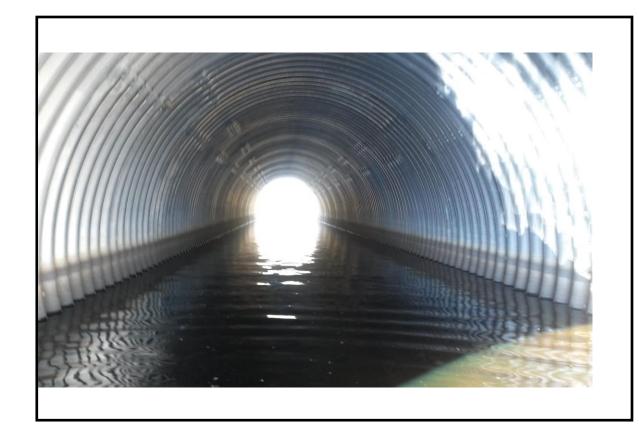
Looking upstream from the end of the barrel

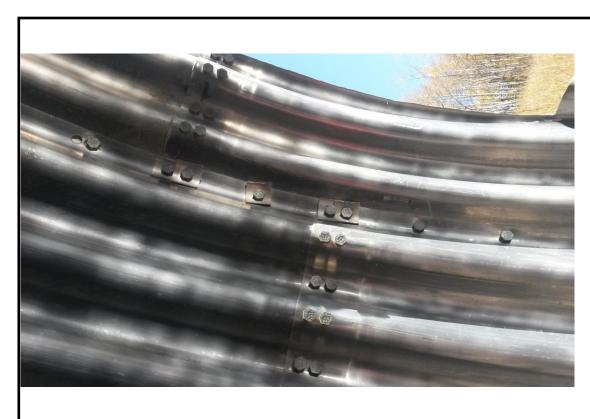
Close up of the east wall near the downstream (south) end.

Looks good.

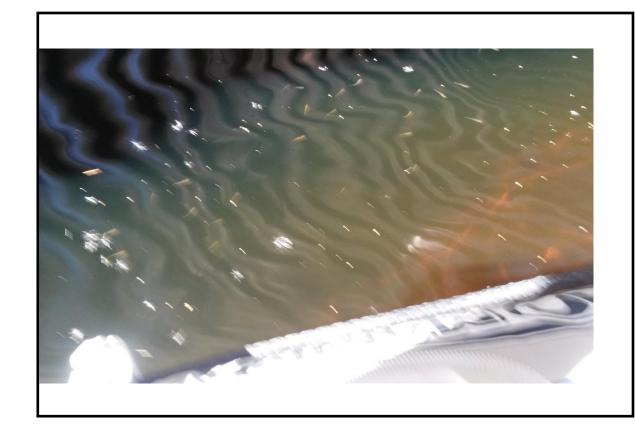
looking at the bottom. lots of minnows at this site.

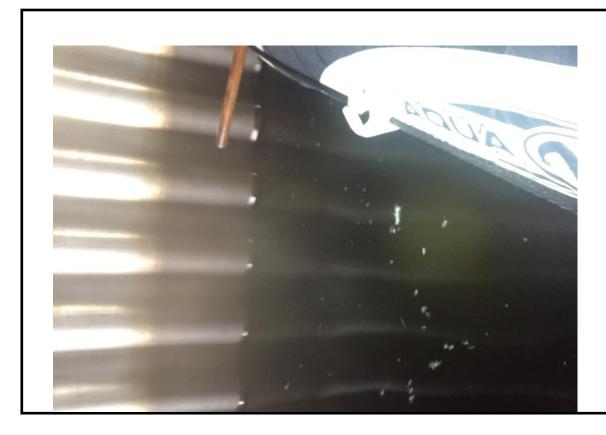
Water staining on the side of the pipe.

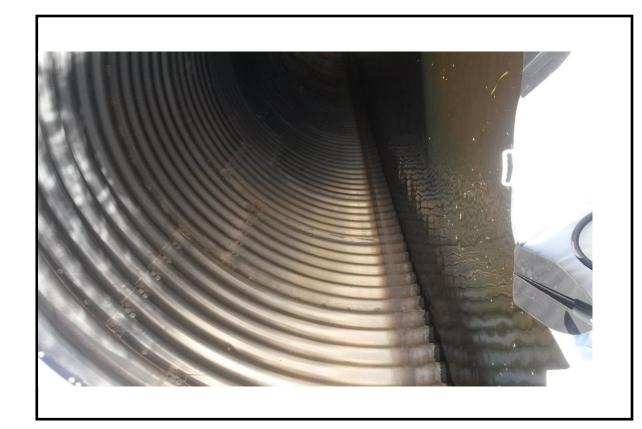
Looking u/s at the west wall of the pipe.

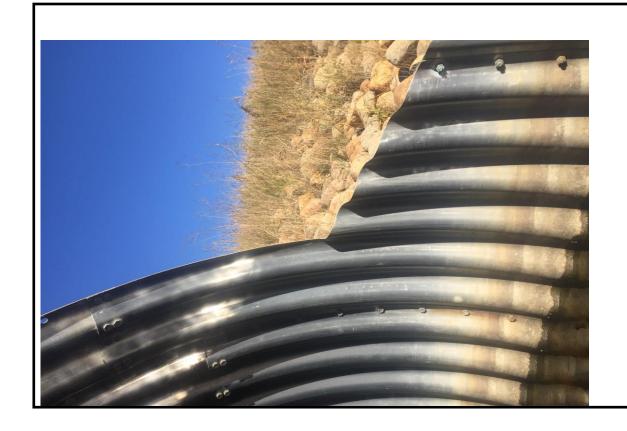
looking at the east wall of pipe at the d/s step bevel end
