Evaluation of HD-21A Durable Waterborne, Regular Waterborne & Alkyd Traffic Paint

Location: Hwy. 43:12, 43:10, 43:08, 43:06 and 49:12
Applied: June, August and October 2007
Inspected: February 20, 2008

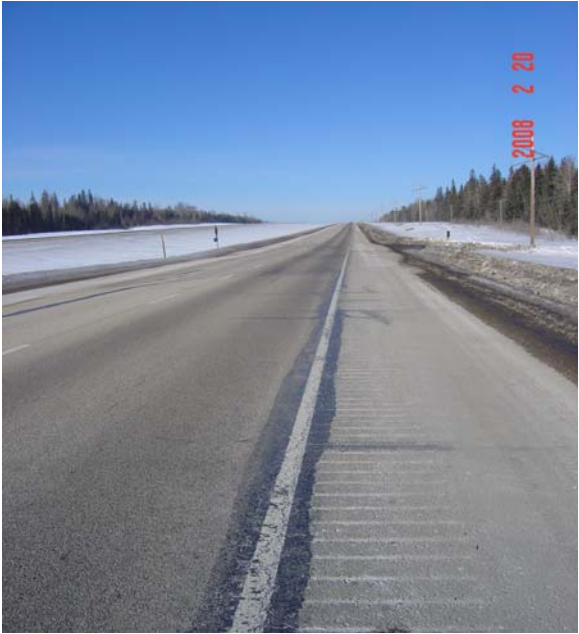
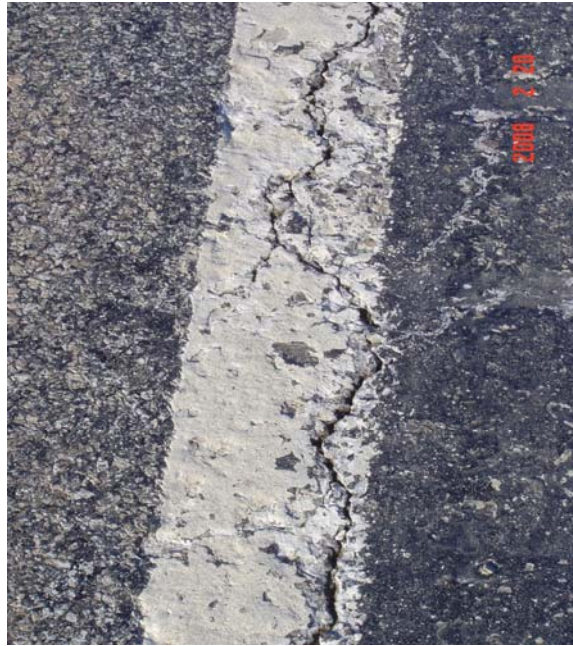
Highway 43:12, NBL, Km 12

White edge line: looks fair at this location, good bead retention. Paint is starting to chip away.
Retro readings: 84, 110, 77, 79, 100, 105, 96, 122, – **Average: 97 Mcd**

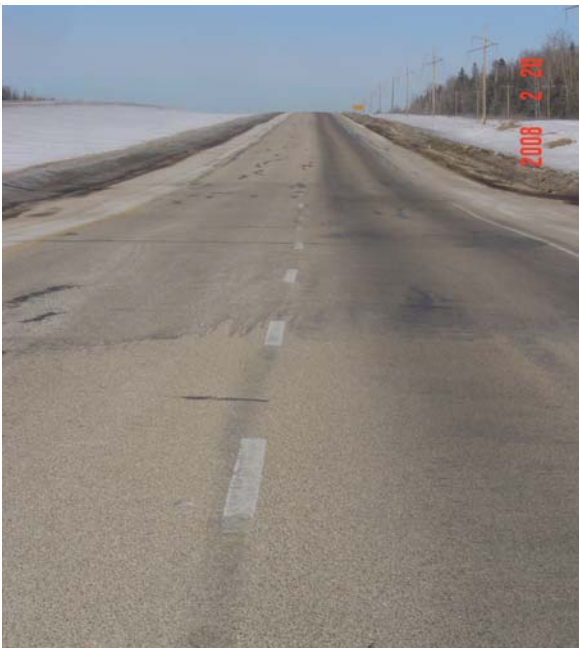
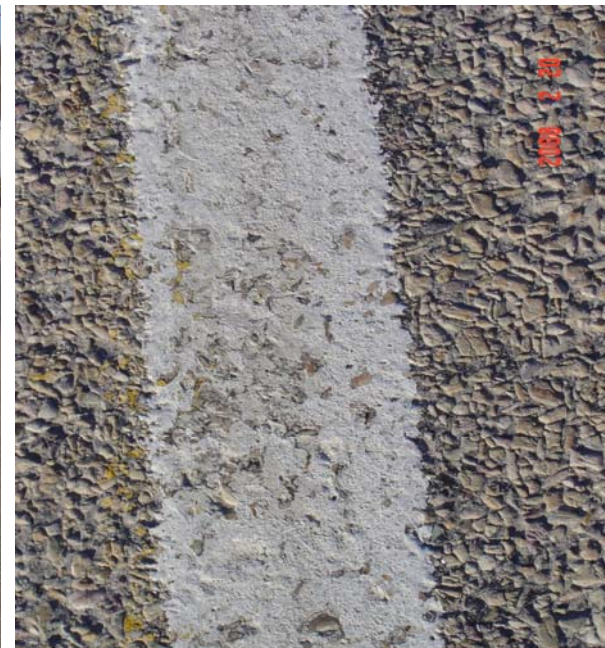
White skip line: appearance and reflectivity look good. Some snowplow scragging.
Skip line Retro readings: 117, 119, 98, 83, 102, 106, 110, 111, 93, 108 – **Average: 105 Mcd**

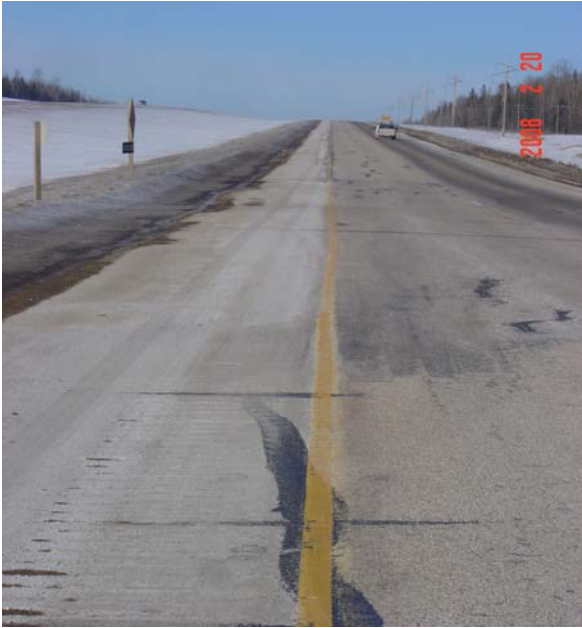
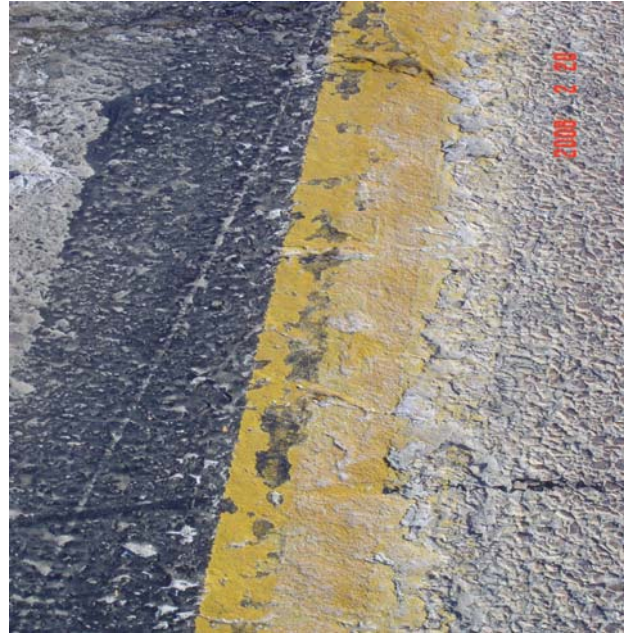
Yellow edge line: more snowplow scapping was evident on the yellow line.
Retro readings: 79, 86, 84, 80, 90, 90, 90, 77, 59, 80, 72 – **Average: 81 Mcd**

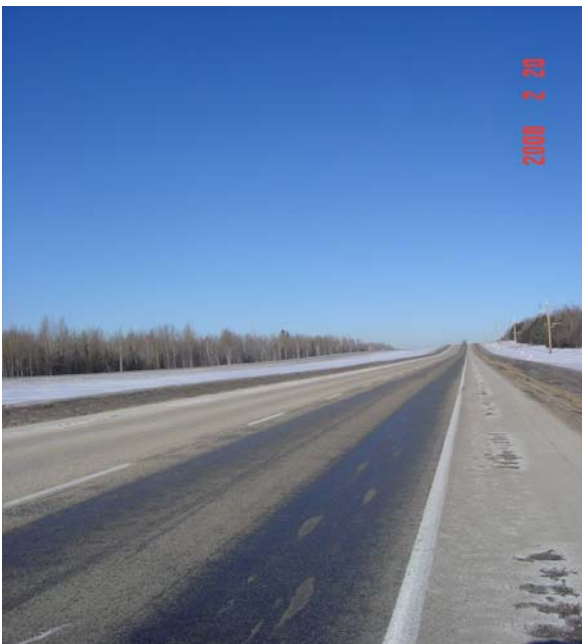
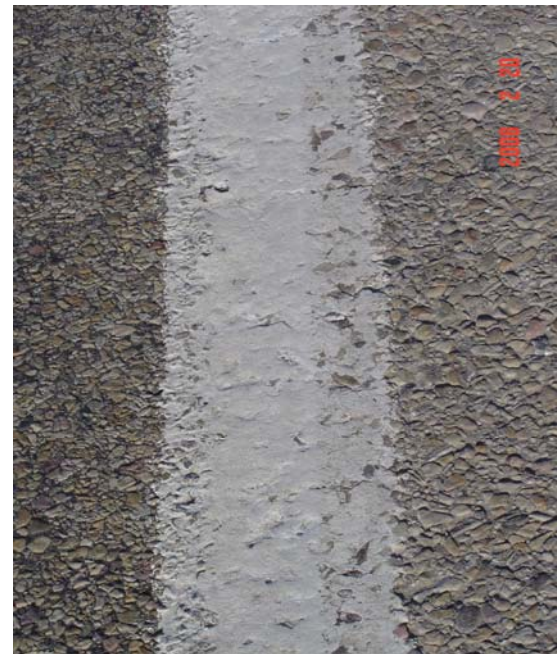
Highway 43:10, NBL, Km 39

White edge line: edge line looks good at this location, good durability.
Retro readings: 92, 95, 89, 82, 83, 84, 86, 92, 94, 77 – **Average: 87 Mcd**

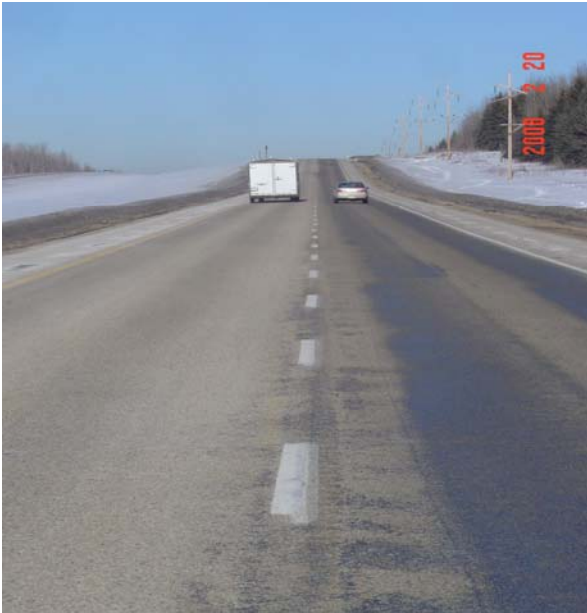
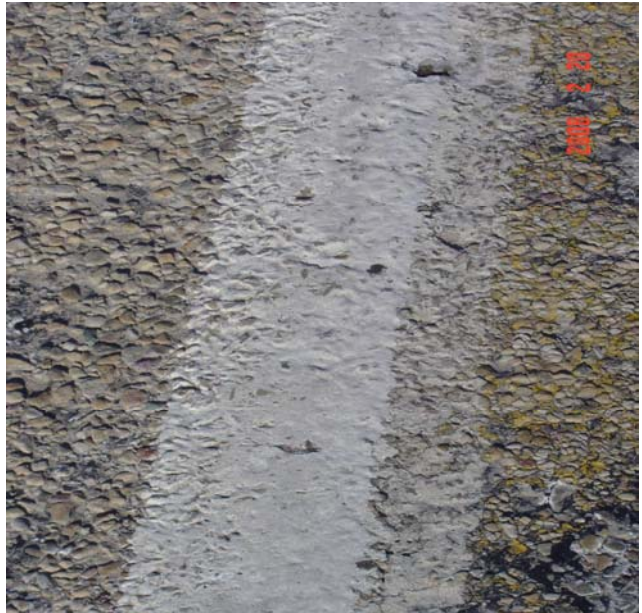
White Skip line: line is performing fairly well at this location.
Retro readings: 76, 81, 81, 92, 92, 79, 88, 76, 104, 89, 86, 104

Average: 80 Mcd

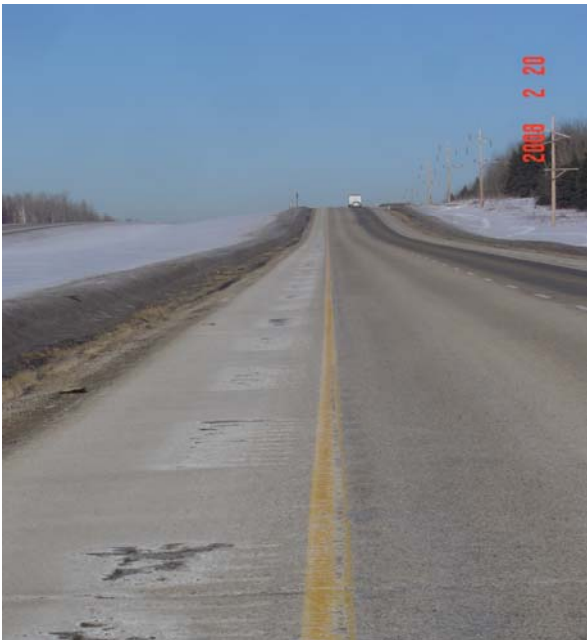
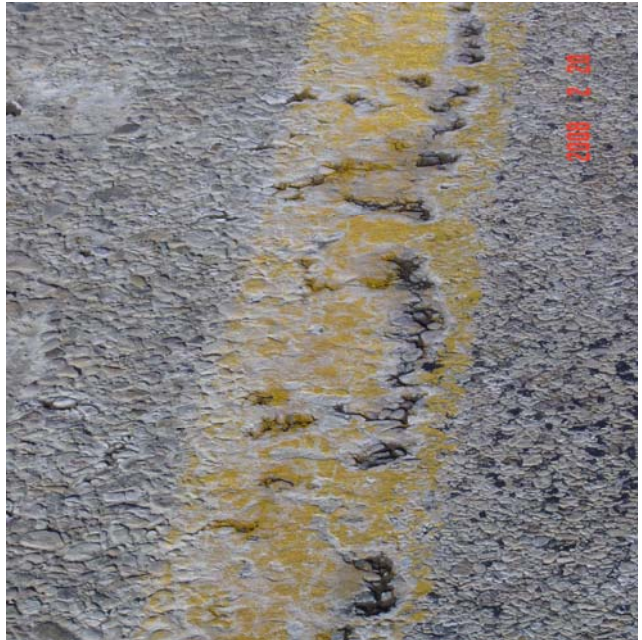
Yellow edge line: more snowplow scapping at this location, however good bead retention.
Retro readings: 107, 124, 109, 103, 97, 93, 105, 122, 122, 93 –

Average: 108 Mcd

Note: The good retro-reflectivity may be due to the yellow line over the original white line which adds to the brightness.

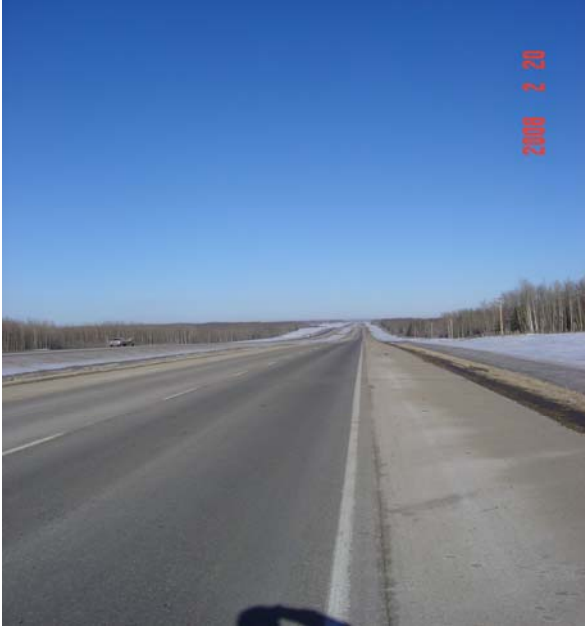
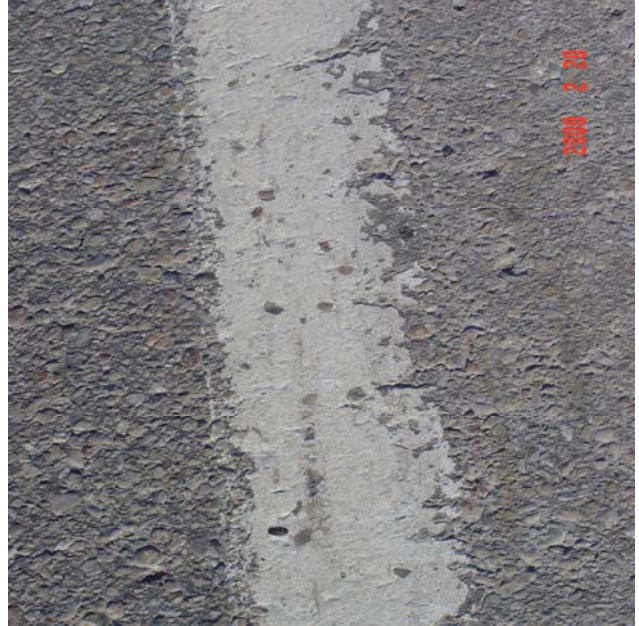
Highway 43:08, NBL, Km 28

White edge line: more wear at this location, bead retention is less as can be seen from the retro's.
Retro readings: 75, 63, 57, 60, 72, 61, 62, 59, 58, 75, 70, 72 – **Average: 65 Mcd**

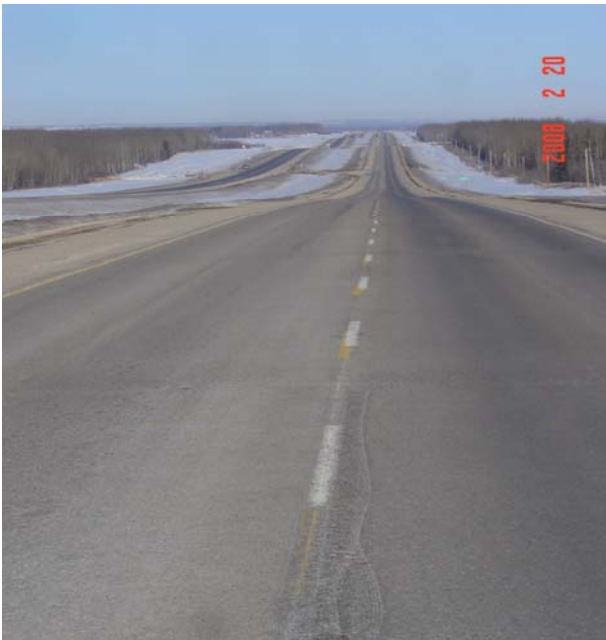
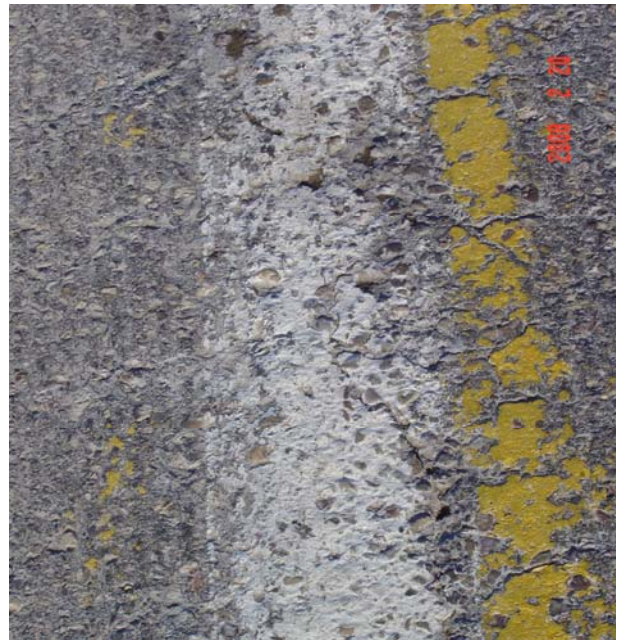
White skip line: poor durability and bead retention, retro-reflectivity has dropped in this area.
Retro readings: 59, 64, 53, 76, 59, 73, 54, 56, 57, 60, 64 – **Average: 61 Mcd**

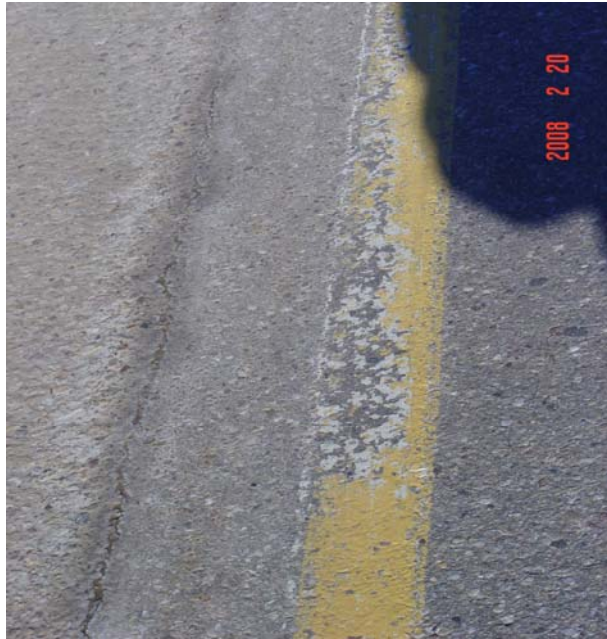
Yellow edge line: poor durability and loss of glass beads.

Retro readings: 56, 47, 50, 68, 57, 54, 51, 50, 44, 50, 48, 59 – **Average: 53 Mcd**

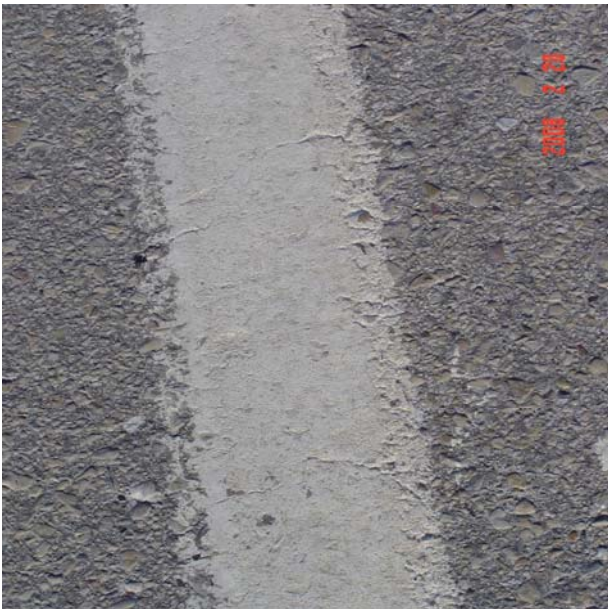
Highway 49:12, Km 6

White edge line(E): durability is good, poor bead retention.

Retro readings: 47, 43, 47, 47, 43, 40, 45, 40, 45, 48, 45

Average: 45 Mcd

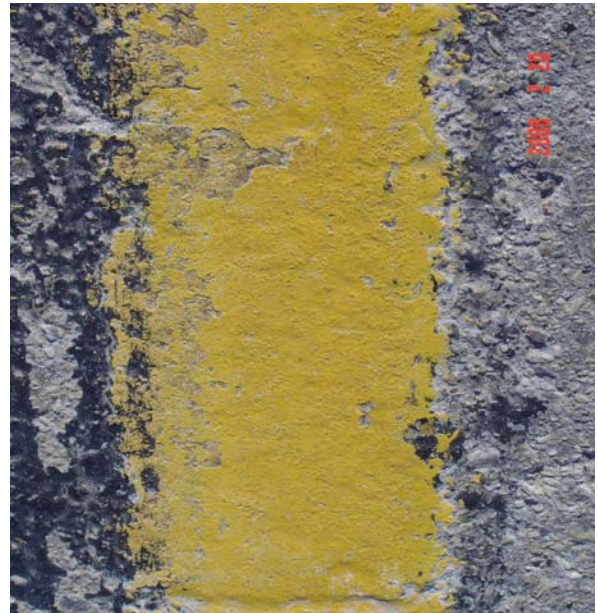
Yellow skip line: same as white line

Retro readings: 36, 43, 39, 43, 36, 44, 38, 43, 37, 43, 39, 42

Average: 40 Mcd

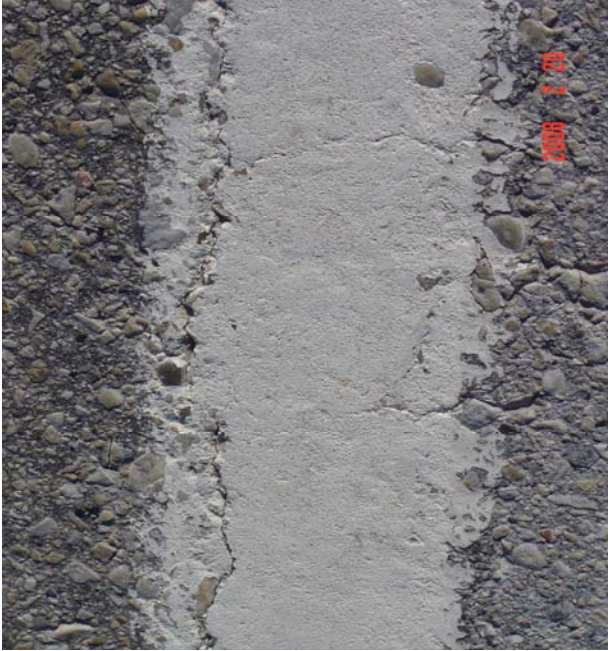
White edge line(W): good durability, poor bead retention
Retro readings: 54, 56, 43, 52, 46, 58, 48, 58, 54, 58, 50, 49
Average: 52 Mcd

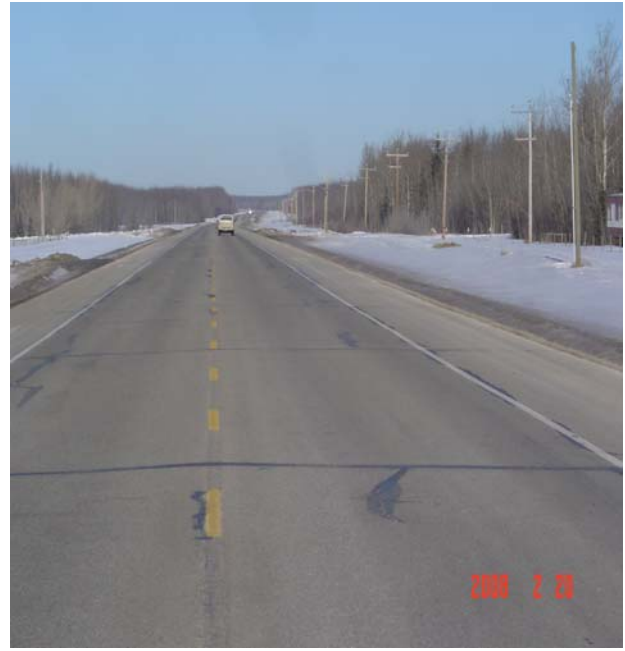
Overall look of alkyd paint system
Alkyd appearance is good.

The alkyd system on highway 49:12 and 43:06 was observed to have good durability; however the bead retention is poor resulting in low retro-reflectivity. This paint system will require re-painting in the coming season.

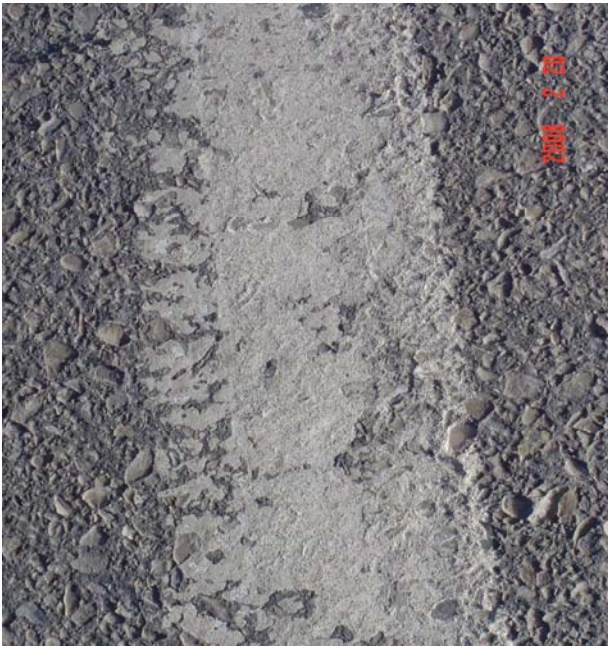
Highway 43:06, WBL, Km 48

White edge line: fair durability, poor bead retention
Retro readings: 33, 47, 42, 37, 39, 39, 42, 37, 38, 36, 38, 43
Average: 39 Mcd

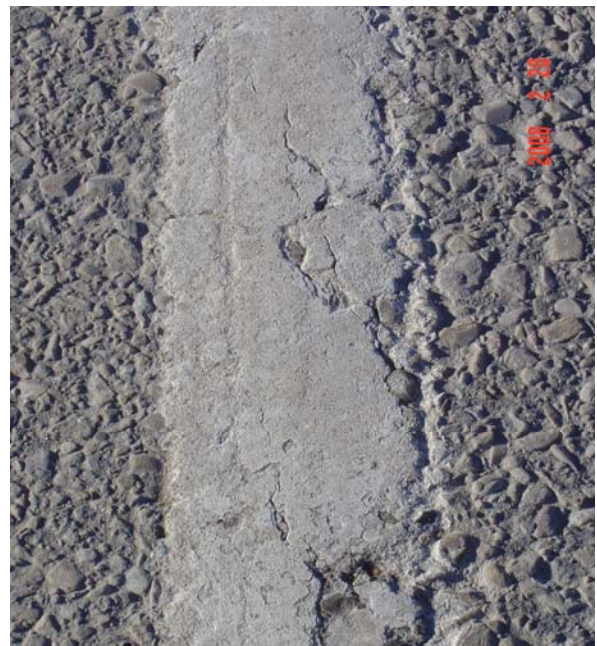
White skip line: good durability, poor bead retention
Retro readings: 38, 50, 49, 54, 48, 47, 55, 50, 49, 41, 42, 42
Average: 47 Mcd

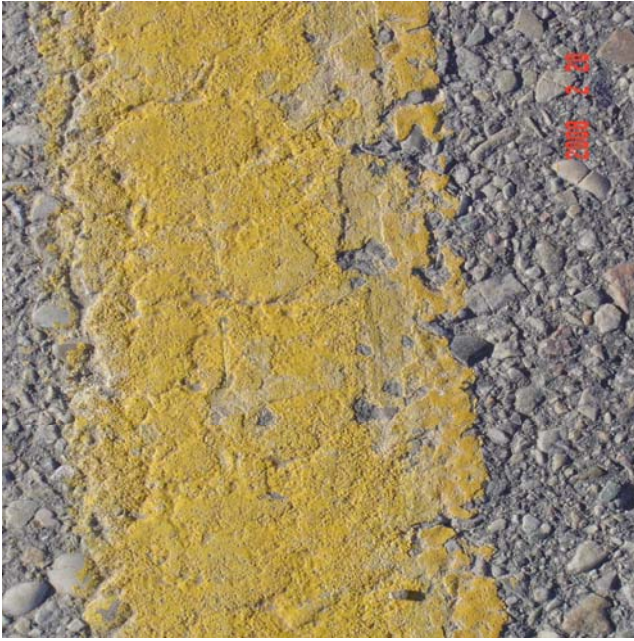
Yellow edge line: good durability, poor bead retention.
 Retro readings: 49, 46, 43, 52, 49, 49, 51, 45, 52, 43, 47, 47
 Average: 44 Mcd

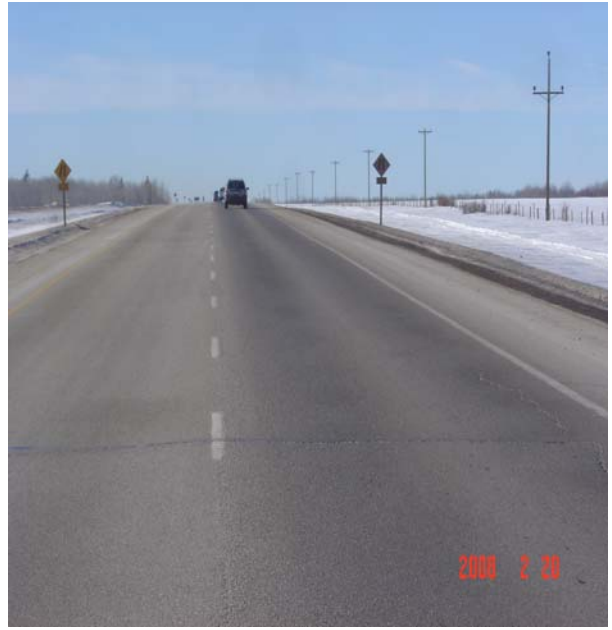
Alkyd paint system, Overall looking west

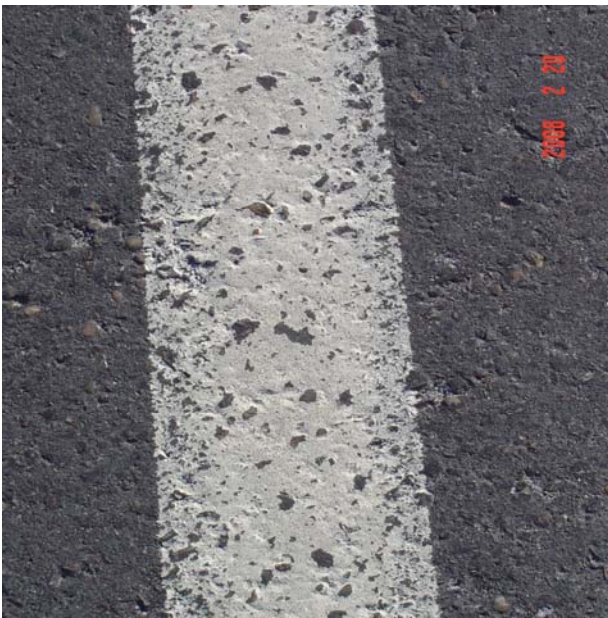
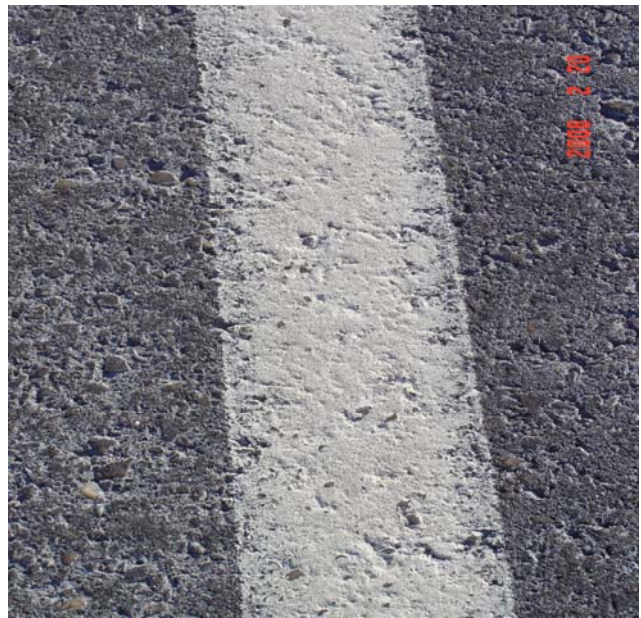
Highway 43:08, SBL, Km 31.5

White edge line: paint chipping, loss of bead
 Retro readings: 65, 71, 62, 66, 76, 72, 64, 77, 67, 64, 72, 74
 Average: 92 Mcd

White skip line: good appearance and bead retention
 Retro readings: 93, 86, 105, 92, 112, 102, 102, 112, 111, 94, 111
 Average: 93

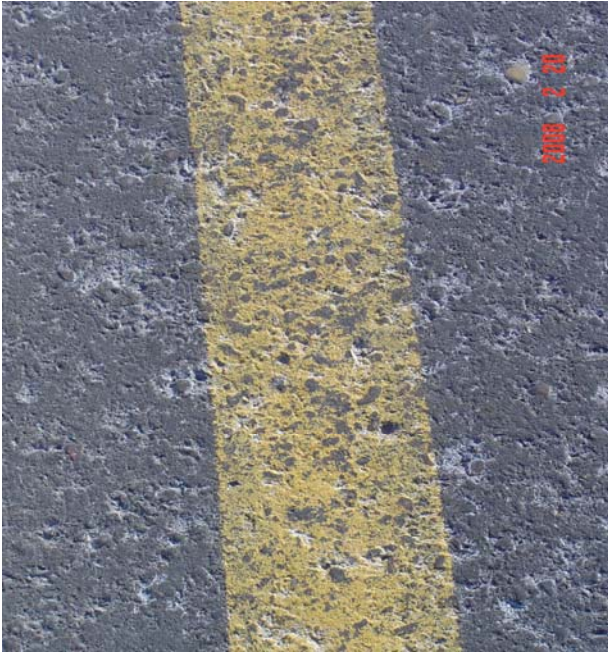
Yellow edge line: paint is faded and chipped.
Retro readings: 59, 49, 46, 51, 54, 51, 48, 55, 57, 49, 59
Average: 52 Mcd

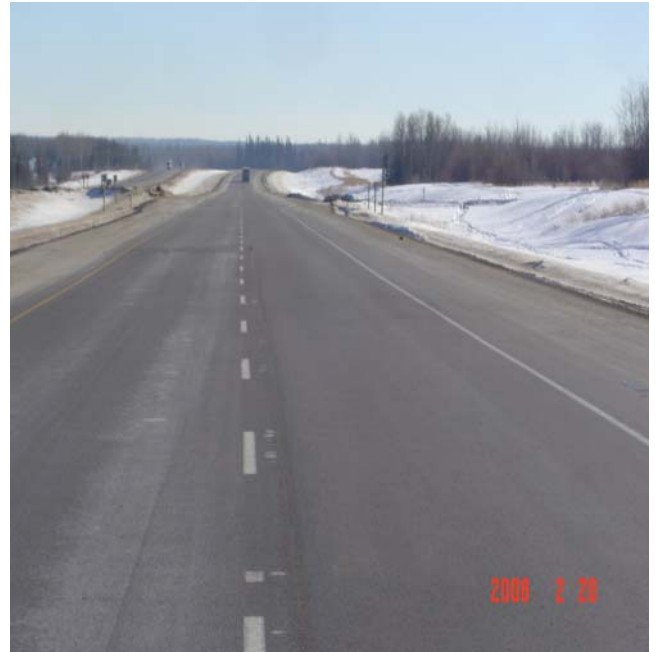
Normal waterborne paint system on newer pavement, durability is poor.

The normal waterborne paint on highway 43:08 and 43:10 SBL has good glass bead retention (good retro-reflectivity), however the durability is poor, paint is chipping away. This area will require re-painting in the upcoming season.

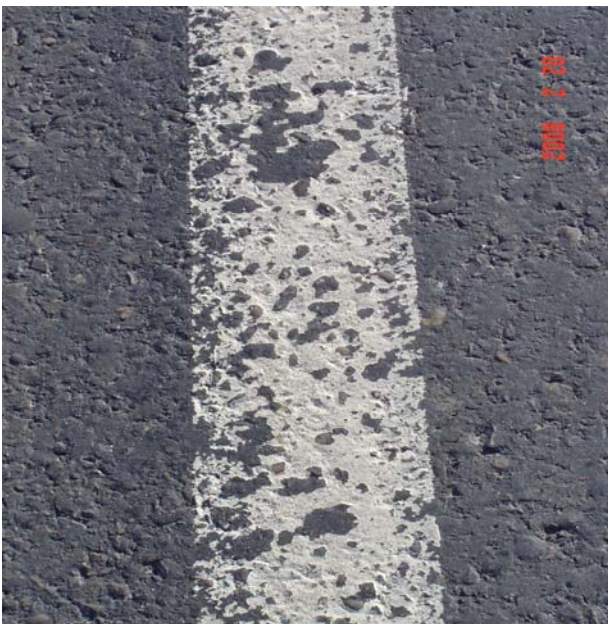
Highway 43:10, SBL, Km 13.5

White edge line: paint is chipped, loss of glass beads.
Retro readings: 90, 75, 40, 50, 71, 97, 84, 74, 87, 86, 97, 72
Average: 77 Mcd

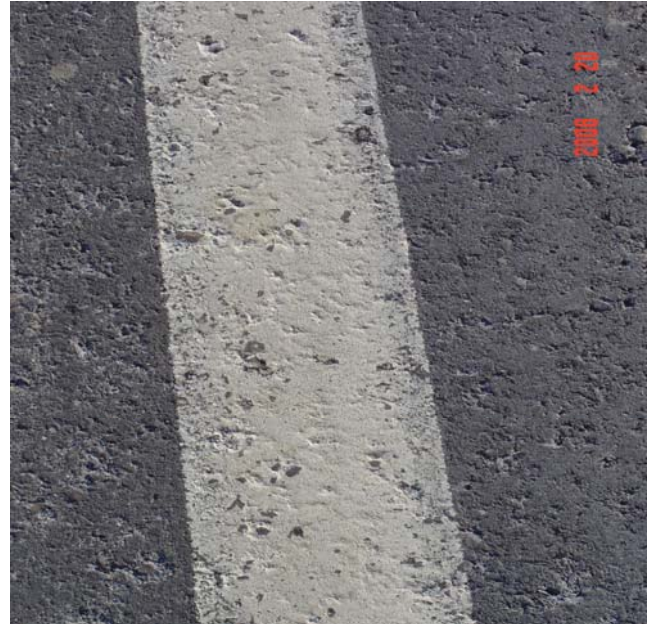
White skip line: good durability and bead retention.
Retro readings: 119, 98, 94, 113, 100, 101, 105, 91, 101, 99
Average: 101 Mcd

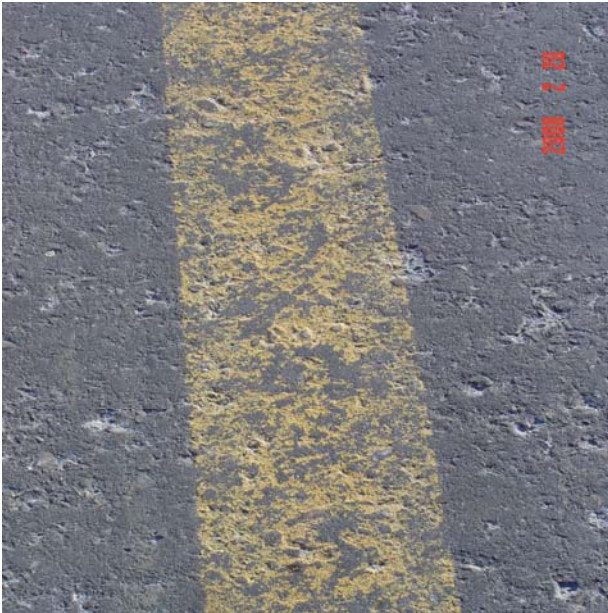
Yellow edge line: poor durability and bead retention.
 Retro readings: 59, 51, 46, 46, 42, 39, 43, 40, 34, 33, 39, 48
 Average: 43 Mcd

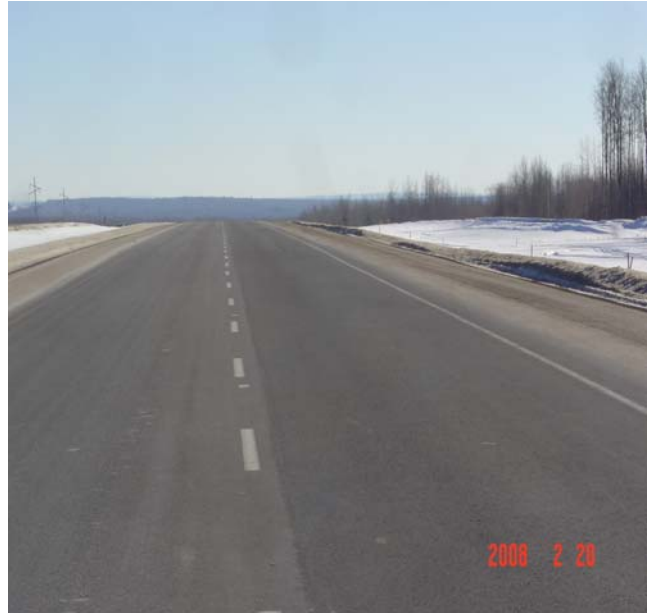
Normal waterborne paint system on newer pavement,
 edge lines are poor, skip line is good.

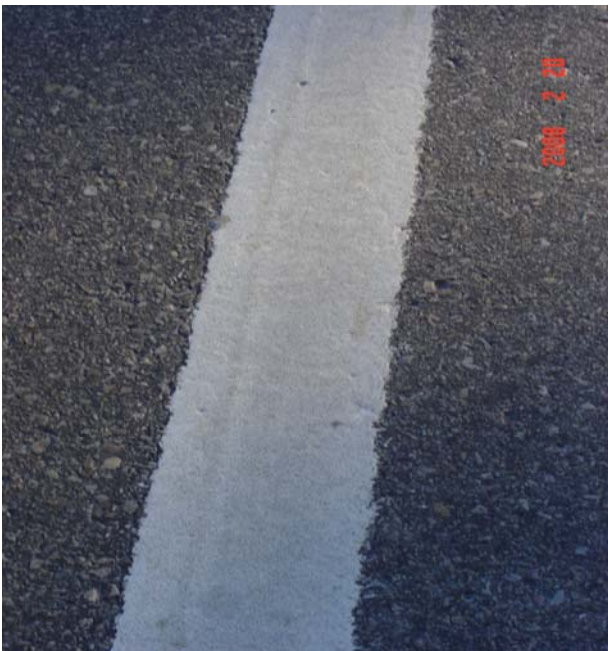
Highway 43:10, SBL, Km 24

White edge line: paint is in excellent shape
 Retro readings: 101, 113, 94, 98, 93, 90, 97, 100, 104
 Average: 99 Mcd

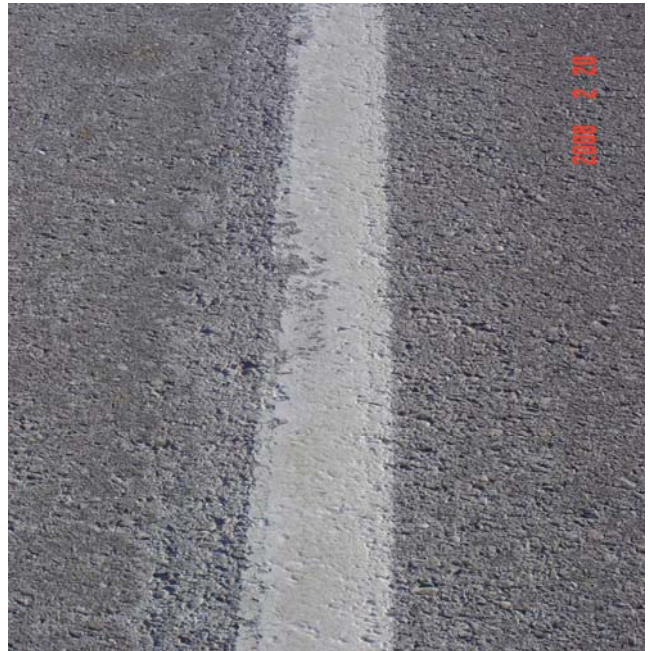
White skip line: some minor scraping, otherwise good condition
 Retro readings: 122, 110, 98, 86, 84, 118, 107, 108, 90, 107, 114, 98
 Average: 104 Mcd

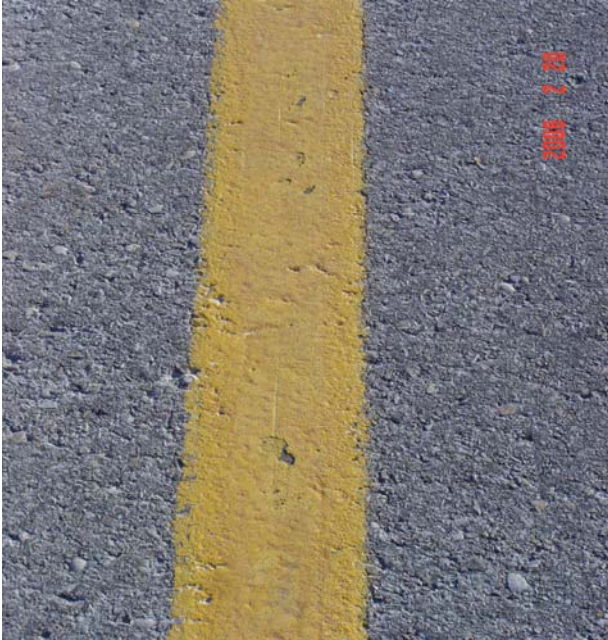
Yellow edge line: very good condition
Retro readings: 75, 68, 70, 79, 66, 87, 91, 73, 82, 72, 76
Average: 77 Mcd

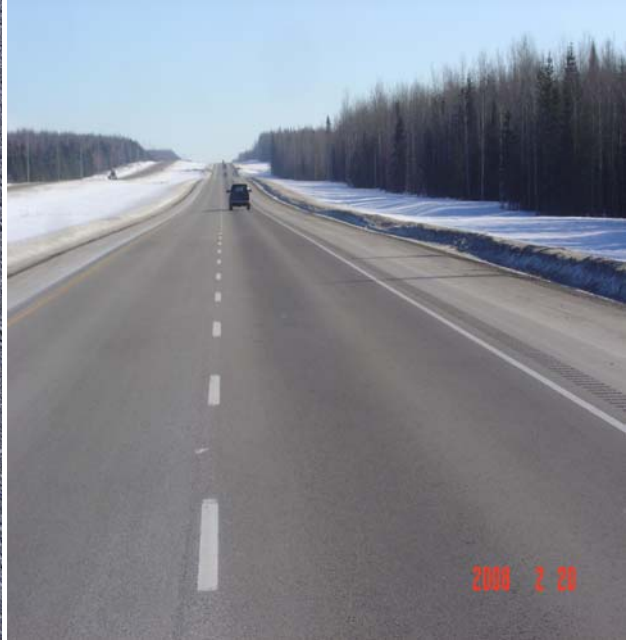
Looking south, paint in good condition. It appears that there is no need to repaint this section in 2008.

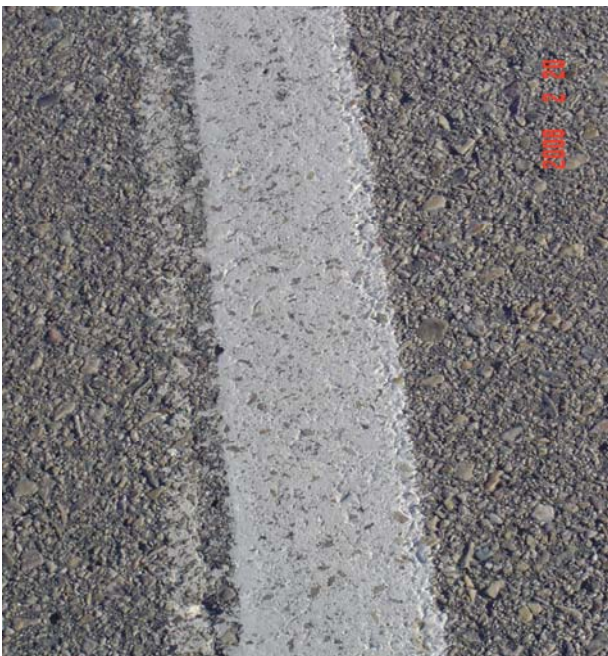
Highway 43:12, SBL, Km 12

White edge line: good condition

Retro readings: 86, 70, 84, 73, 65, 62, 59, 79, 82, 62, 71
Average: 72 Mcd

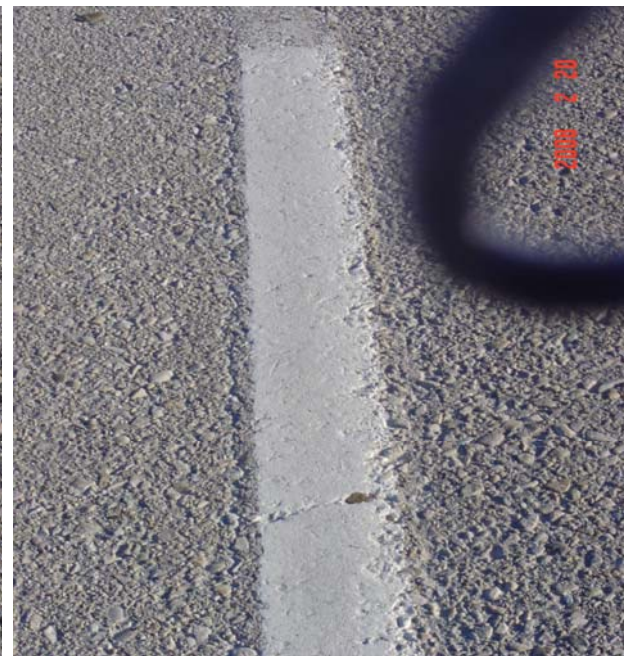
White skip line: very good condition.

Retro readings: 114, 108, 103, 98, 103, 103, 95, 99, 91, 92, 98
Average: 101 Mcd

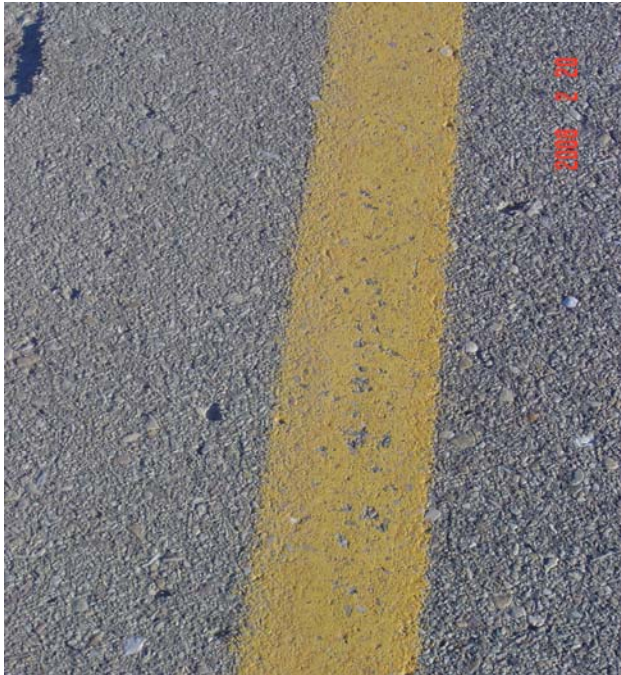
Yellow edge line: some loss of paint and chipping
Retro readings: 42, 44, 45, 44, 47, 46, 47, 51, 46, 46, 56
Average: 47 Mcd

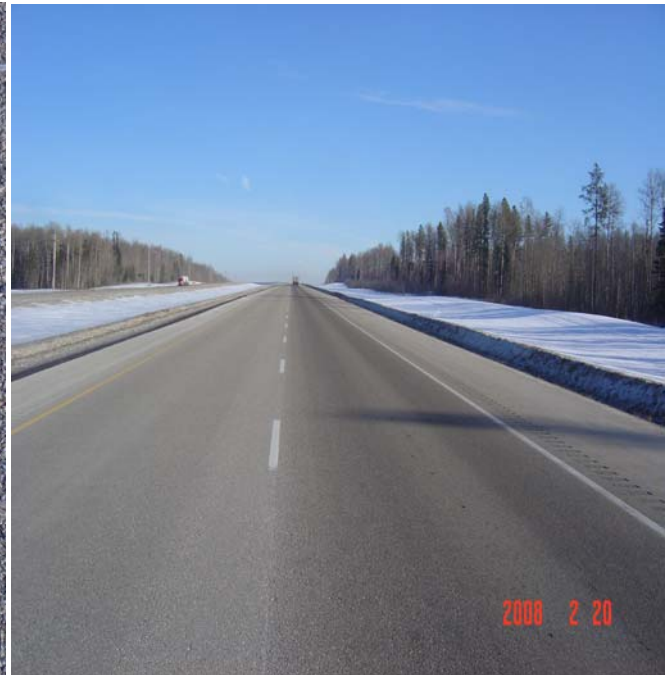
Looking south, HD-21A paint looks good, however not as good as the last section. There is more bead loss on white & yellow edge lines, however durability is fine. The HD-21A May provide one more year of service.
