Note To File

File: 8085-4-20

Subject: Crack Sealant Trial Performance
Location: Highway 64A and Hwy 682 Fairview
Placed: July 2012
Inspected: September 2014

NUVO 6690 Type IV Hot Applied, Polymer Modified Crack & Joint Sealant

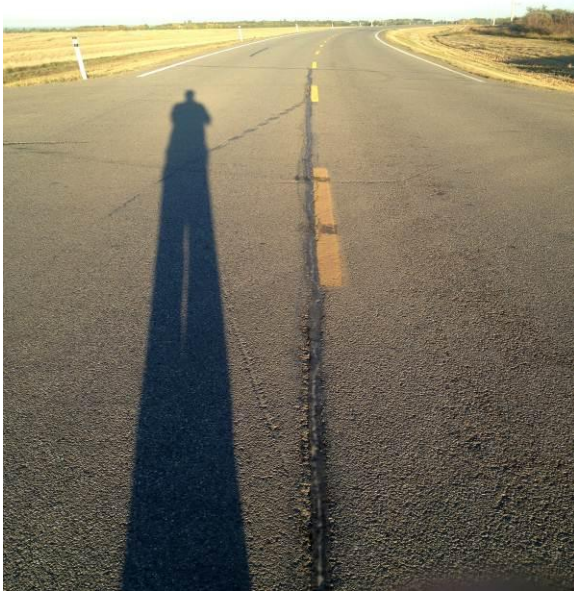
Longitudinal crack, performing well, no adhesion failures were noticed

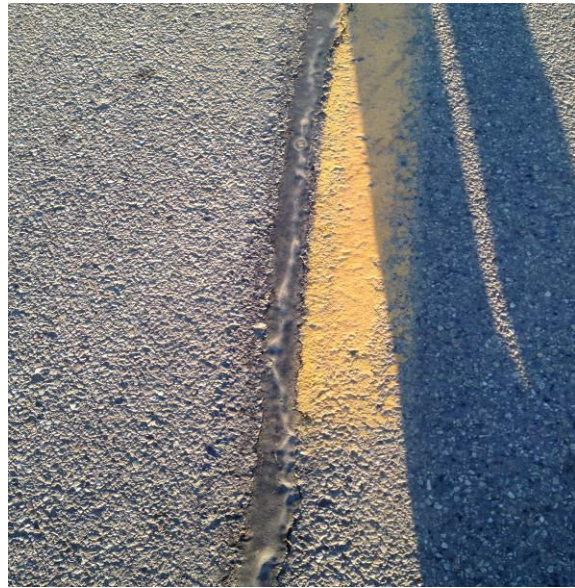
Sealant is still present longitudinally

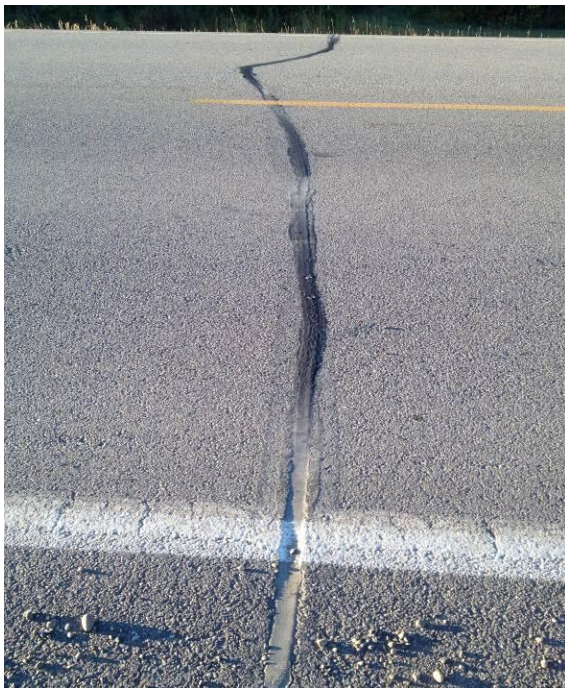
Sidewall adhesion is good

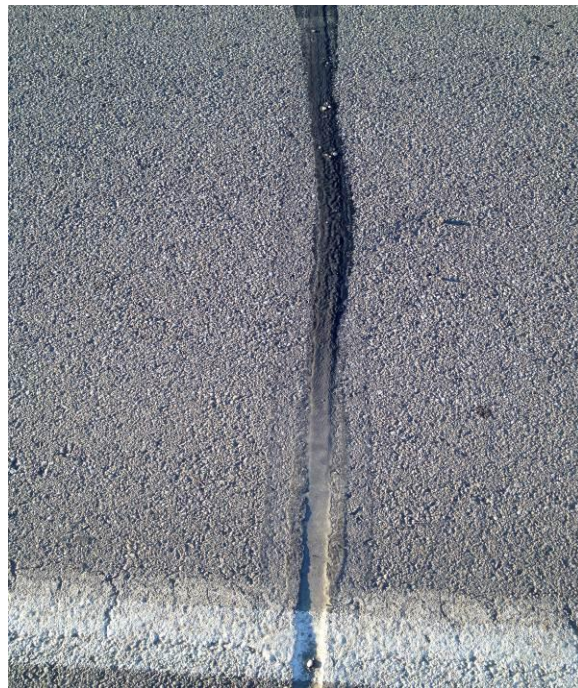
Sealant is performing very well in the transverse cracks, good cohesion and adhesion.
