RainLine

File: 8190-3-10
Date: May 6, 2003

RainLine Durable Pavement Markings

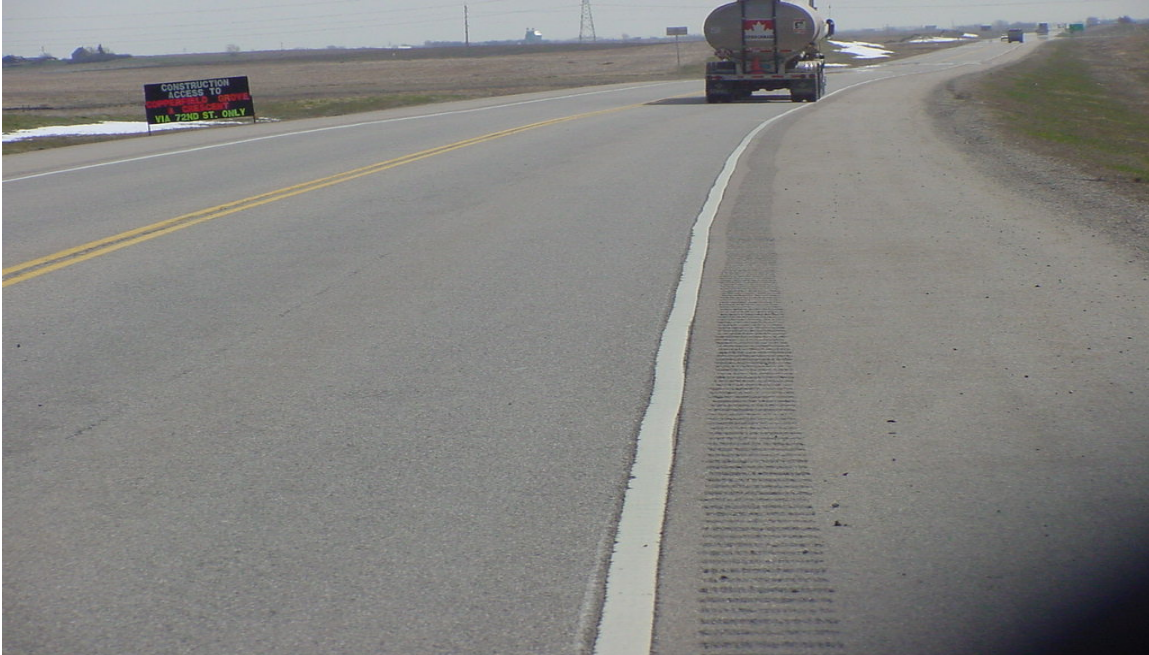
Rainline right edge line providing very good delineation.

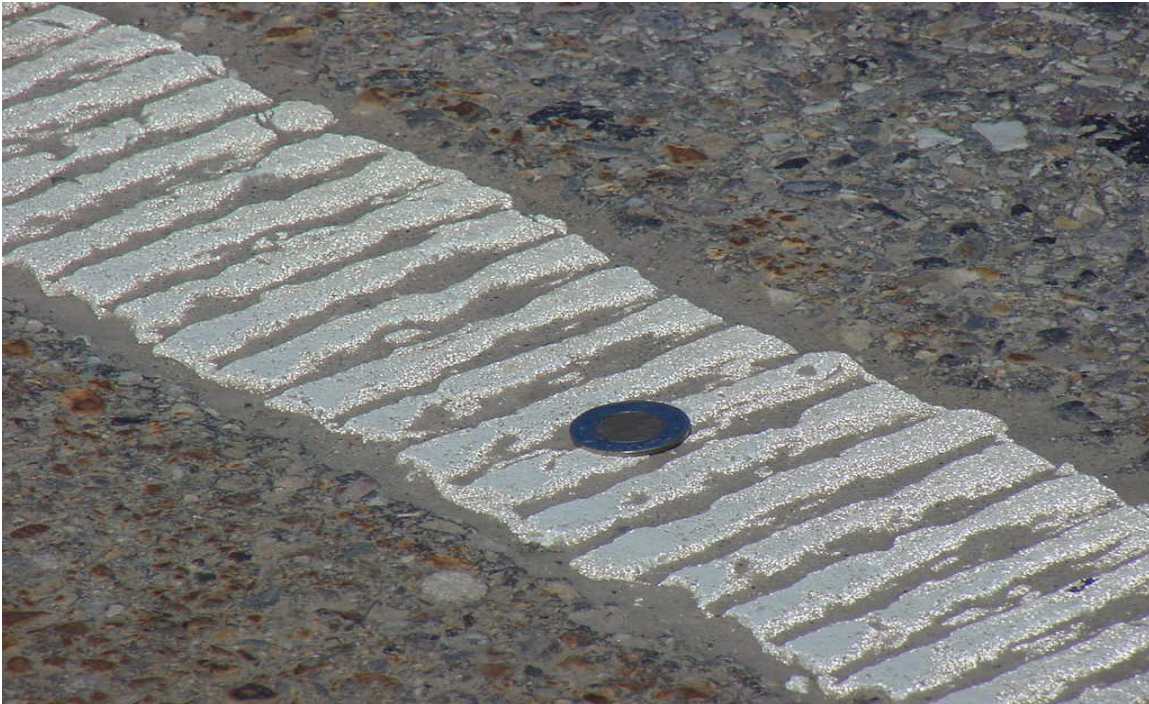
Close up look at the Rainline marker notice the excellent glass bead retention.

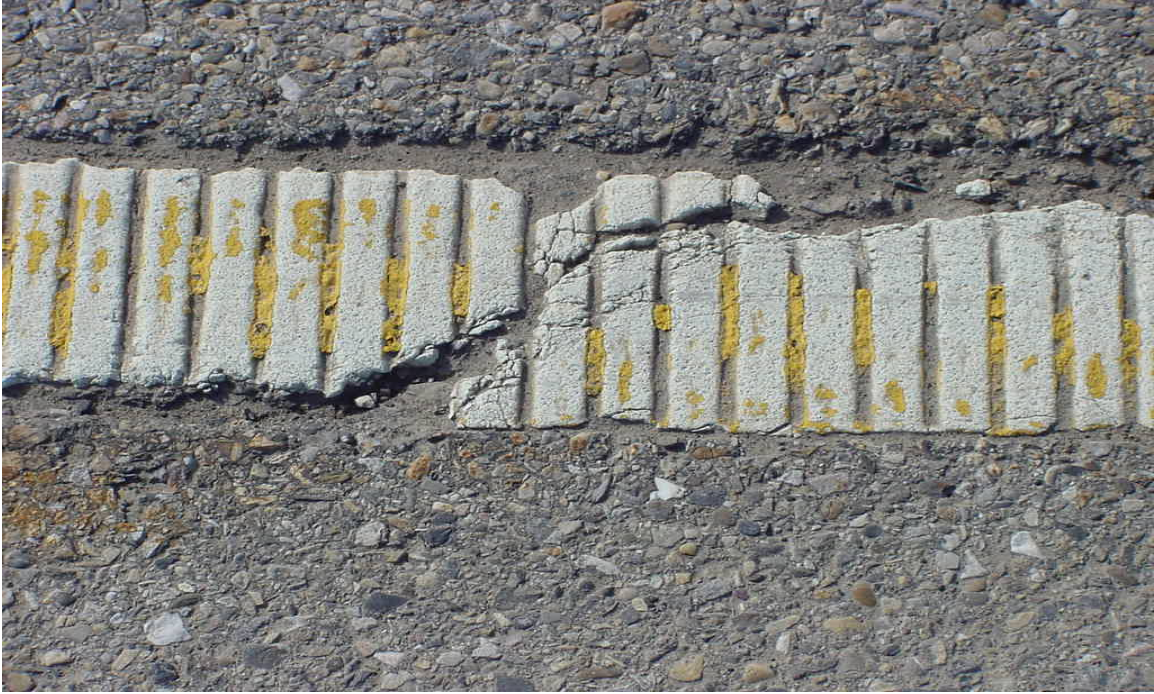
A section of Rainline that is damaged. This section appears to have been painted with yellow paint.

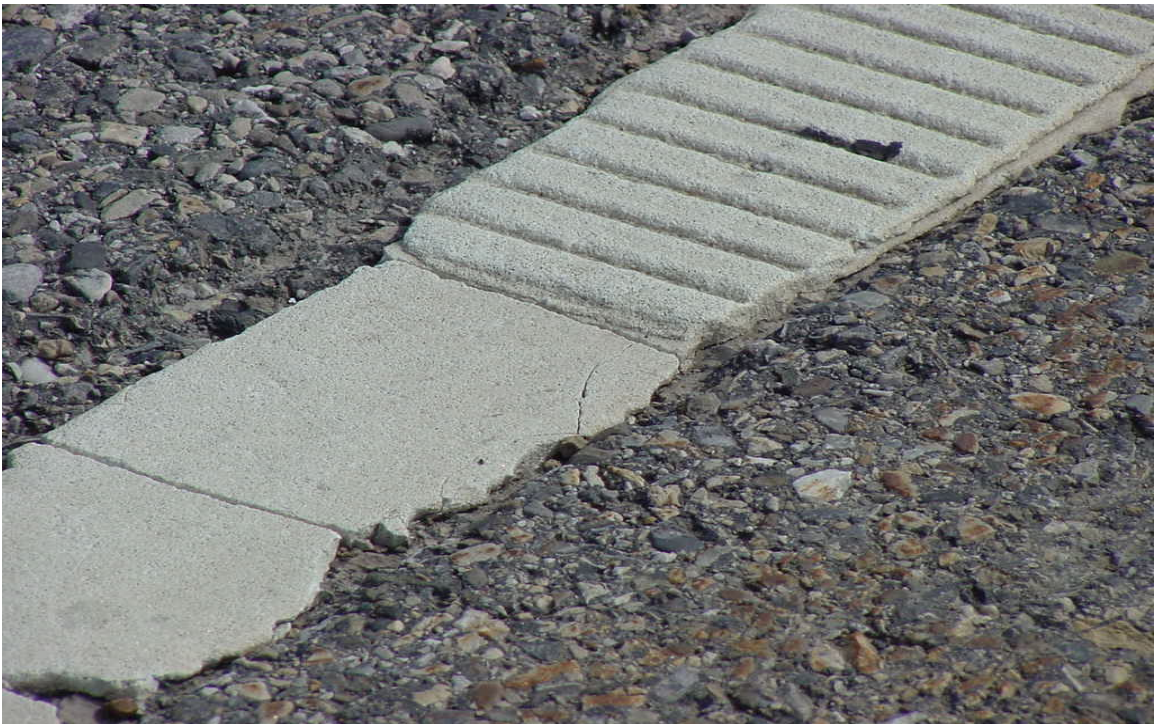
There is a section of Rainline that transitions to a thin layer of thermoplastic without the grooves. I assume this was done to compare the performance of each one.

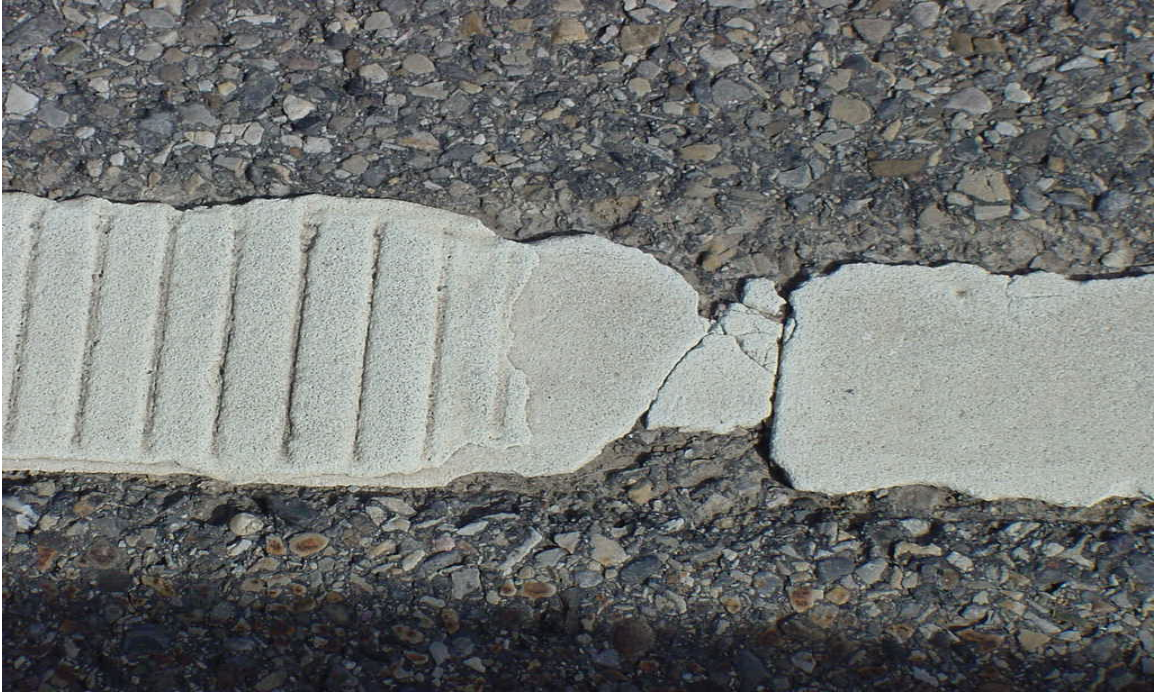
The thinner (un-grooved) layer is not performing very well (Line marking supplied by other manufacturer). The majority of this section is in poor condition with no bead retention.

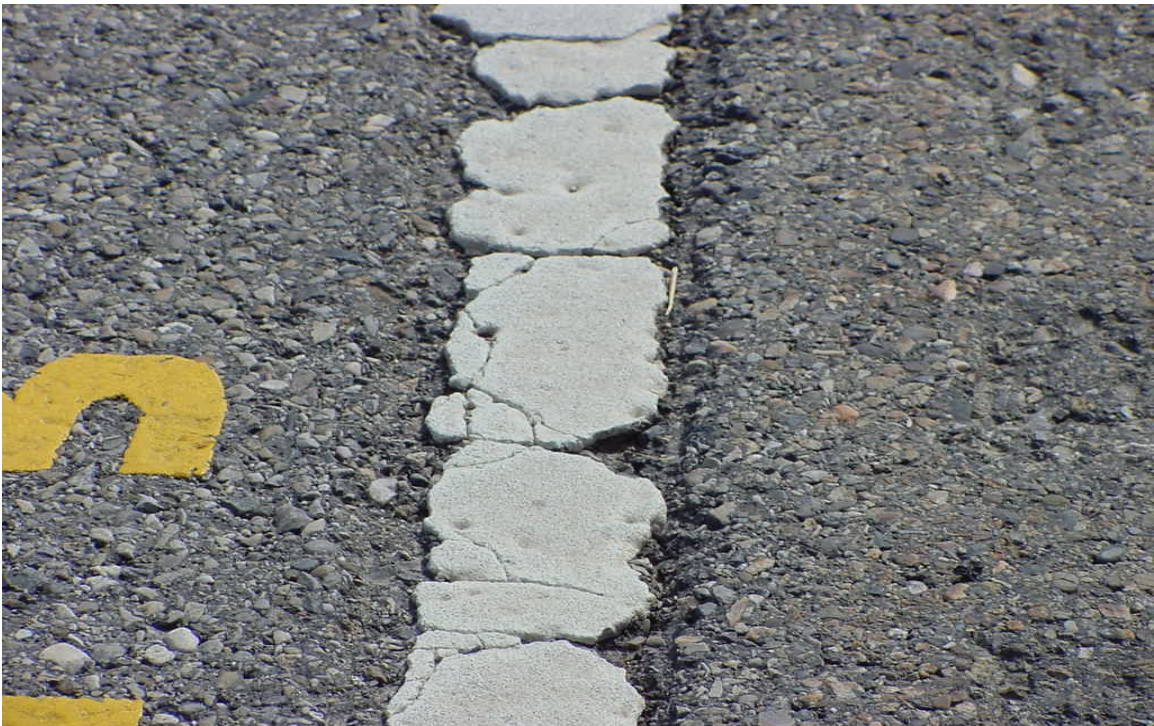
Line marking is in poor condition with some sections debonding.
