## **Note to File**

### **Rainline Pavement Marking**

Highway 2:60 & 2:62 (Peace River)  
Evaluated on September 5 & 6, 2007

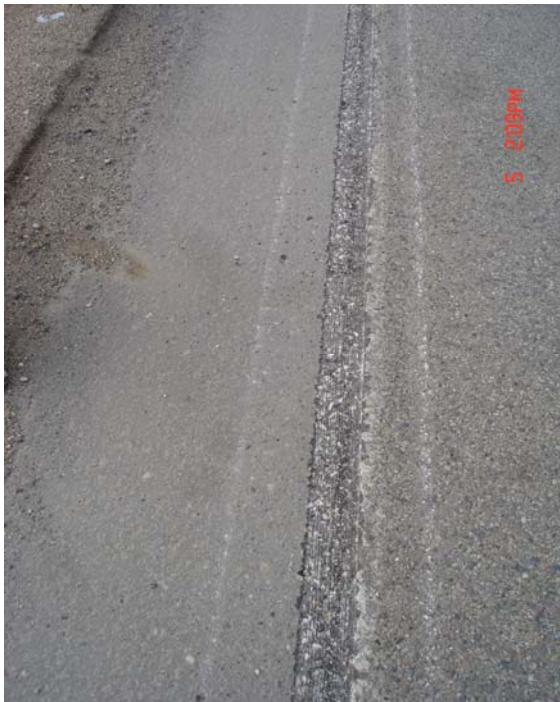
Overall the pavement edge of the milled out line appears to be smooth with only a few jagged areas. The majority of the milled out line has some emulsion remaining. The adhesion of the Rainline product may be a problem at some locations, time will tell.

Milled edge line

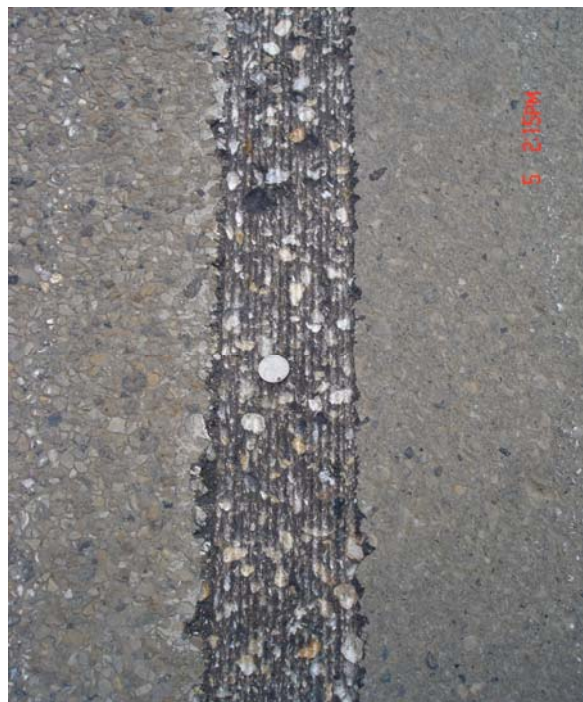
Close-up, jagged edge of seal coat

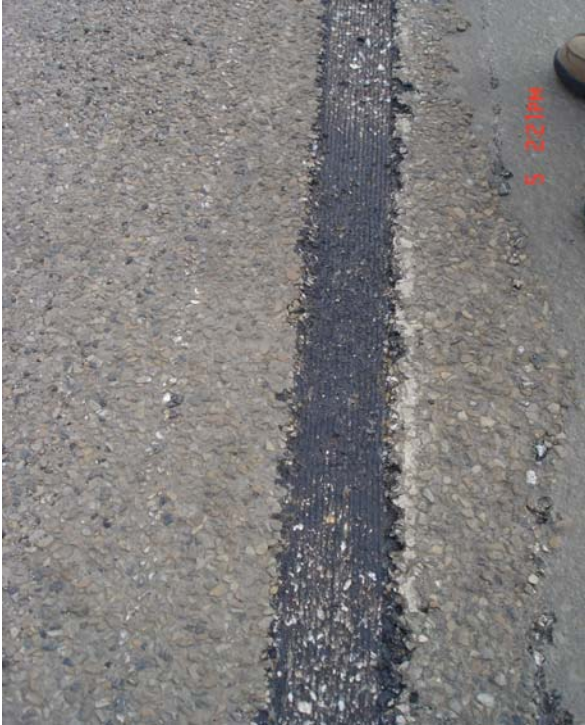
For a proper bond of the Rainline product it is important to mill through the seal coat emulsion (CRS-2). As can be seen by the following photographs not all of the emulsion is removed during the milling process. This may cause a bonding problem with the Rainline product. At the Pats Creek overpass a double seal coat was used, this will create a definite bonding problem with the Rainline marking (see photographs). Another common problem for seal coat pavements is that the rock chips become dislodged over time; this could create a bonding problem of the marking to the substrate which could affect its performance over time.

Emulsion present, may create a poor bond

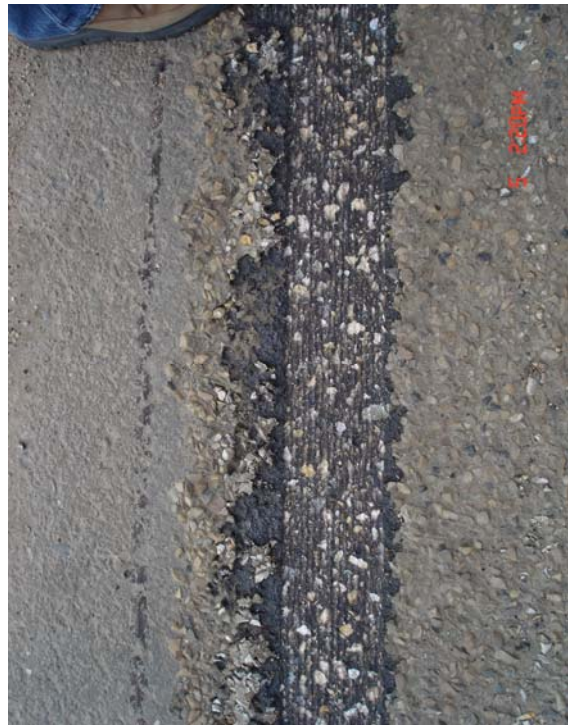
The milling of the double seal coat at Pats Creek overpass was not very smooth; there is a lot of emulsion remaining which will not bond very well to the Rainline marking (see photographs). The application of the Rainline product looks mostly smooth; some areas appeared wavy due to uneven pavement.

Double seal coat on bridge, edge failure

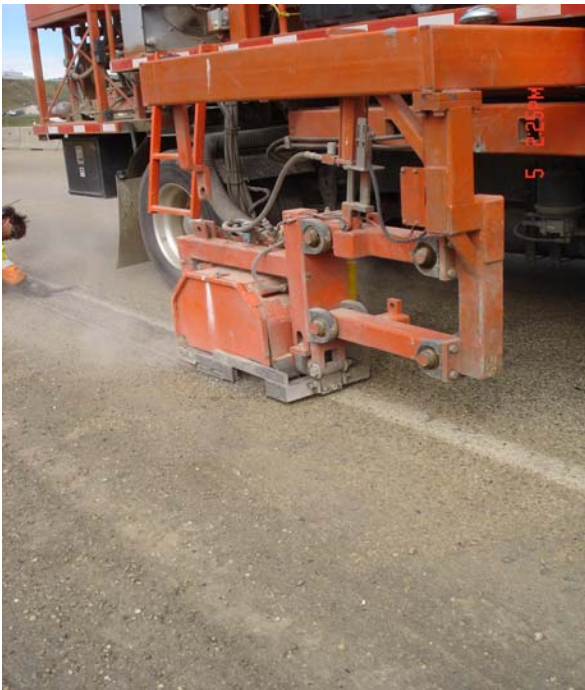
Milling equipment

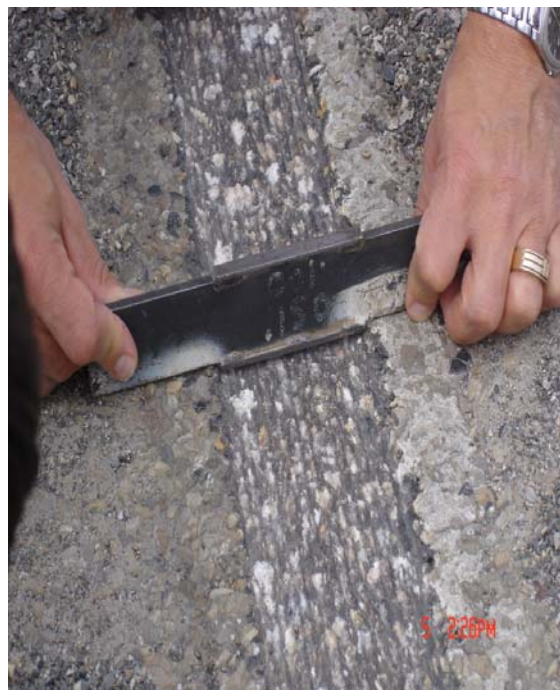
The pavement surface is seal coated which made milling more difficult and slower for the crew. The crew made several attempts at establishing the proper depth of milling on the seal coat surface. The depth of the milling on seal coat surface is greater than normal asphalt pavement; this will require more material than what was estimated for this project.

Measuring depth of mill

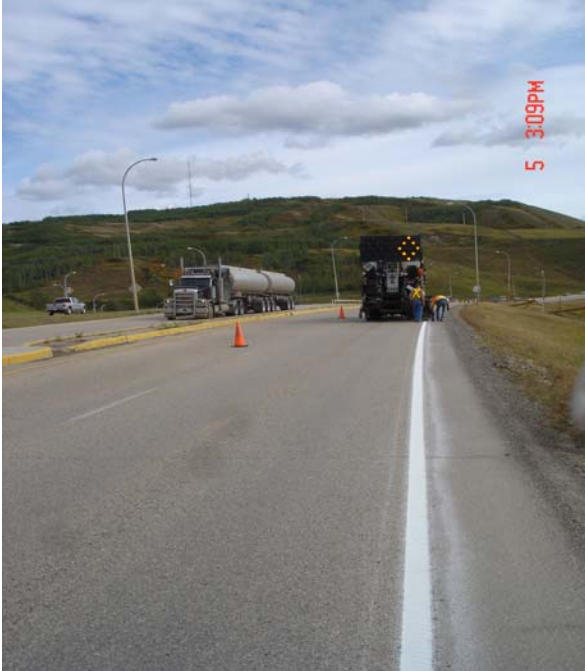
Application of Rainline

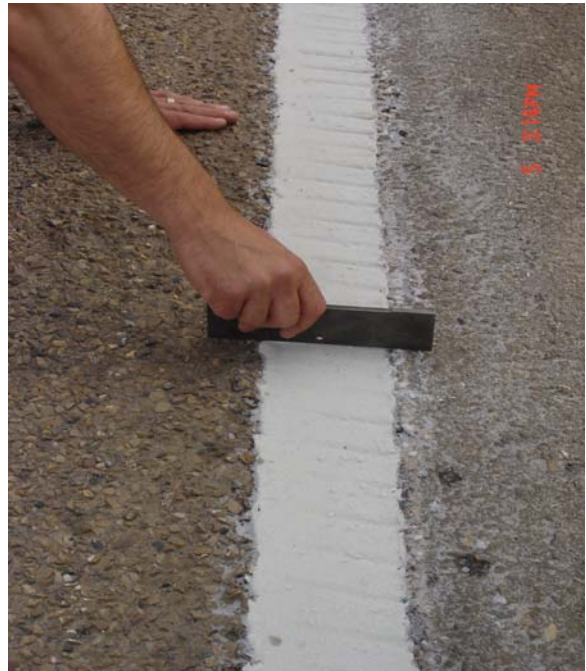
Measurement tool
