Location: Highway 2A:22/24 (Town of Hobbema)

Applied: June 2008

Evaluated: June 17, 2009

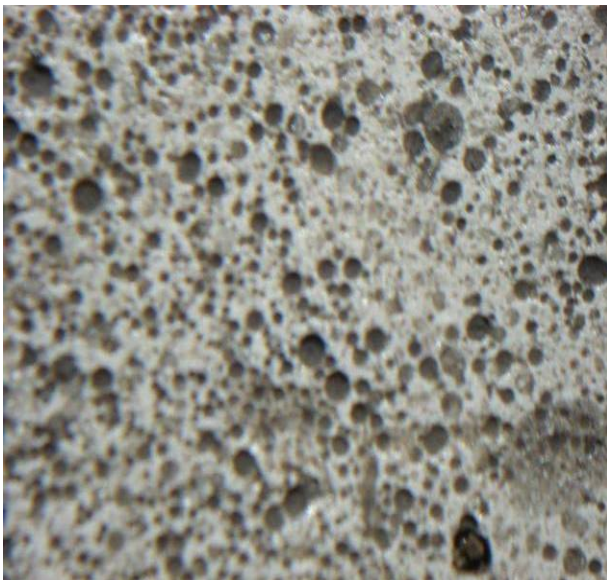
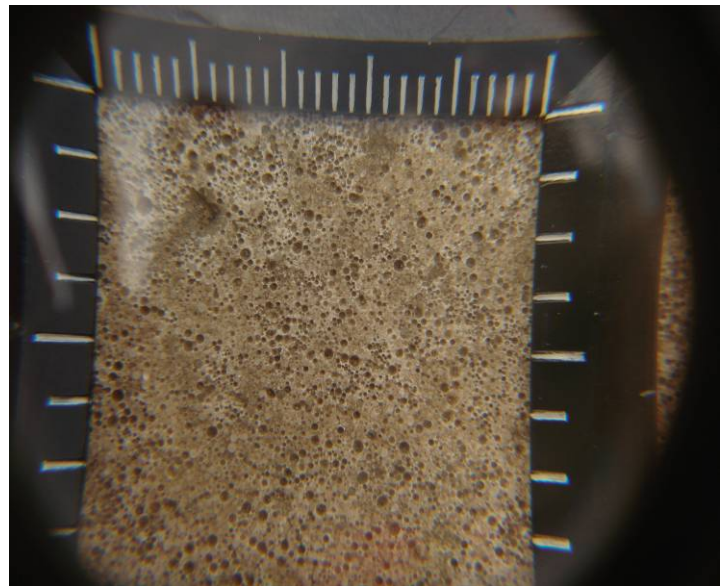
There appears to be a problem with the compatibility of the glass beads holding up in the durable material. Also Snowplows have sheared off many of the remaining glass beads that were embedded in the durable material. As can be seen in the magnification photograph (below), the majority of the glass beads have popped out or are sheared off..

There seems to be a glass bead compatibility problem with this material as can be seen by these two magnified photographs. The glass beads at this location have all popped out of the material, resulting in the very poor retro-reflectivity (non-existent). Of the glass beads that remain in the marking, the majority have sheared off from snowplows.

Contact Lafrentz the applicator of the System 400 Durable Marking System on providing a remedial action to restore the reflectivity of these markings to the warranty levels (I believe a 4 year warranty).

Durable pavement markings should only be considered in an inlaid application.

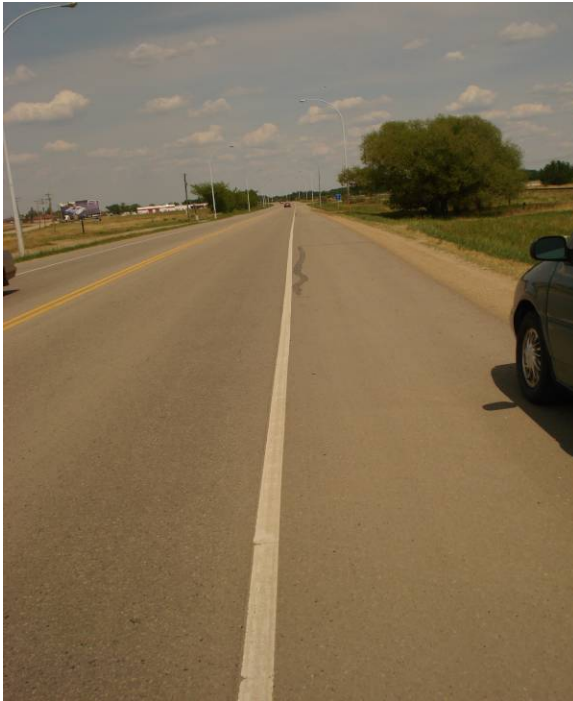
Looking N. along east edge line

Retro readings—75, 80, 56, 64, 61, 53, 76, 67, 45, 34 - **Average retro = 61Mcd**,

Retro-reflective readings are very low on the east edge line. The majority of the glass beads have popped out (see below for marking magnification).

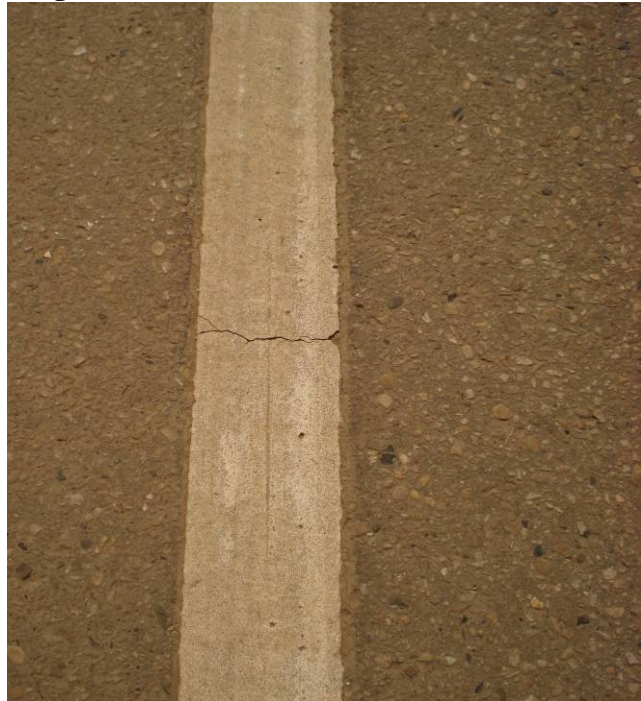
Close-up, lots of snow plow wear

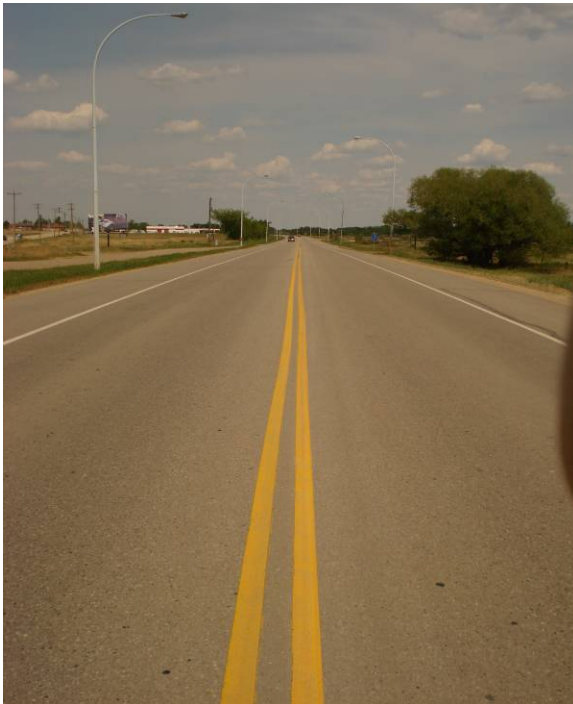
Centerline looking North

Retro readings— 24, 28, 40, 38, 41, 24, 25, 27, 50, 27, 53, 44, 42 – **Average retro = 39 Mcd**

Retro-reflectivity is very poor on the yellow centerline.

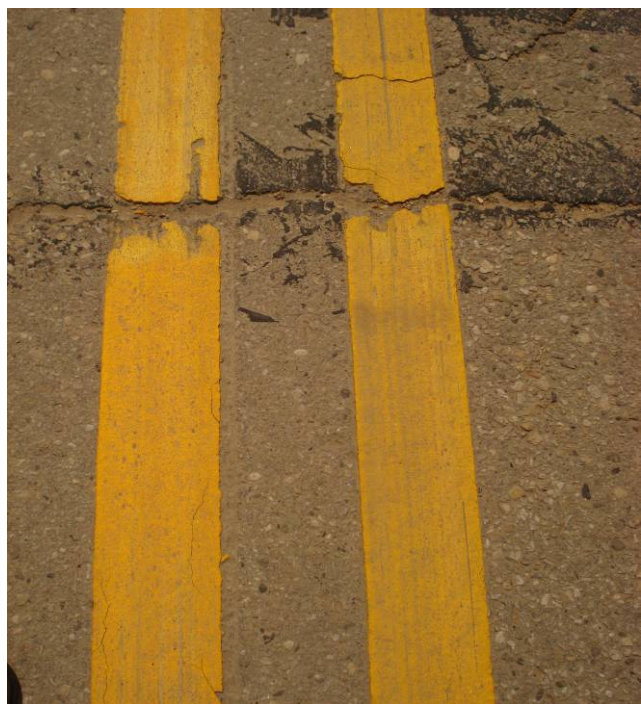
Close-up, snow plow damage

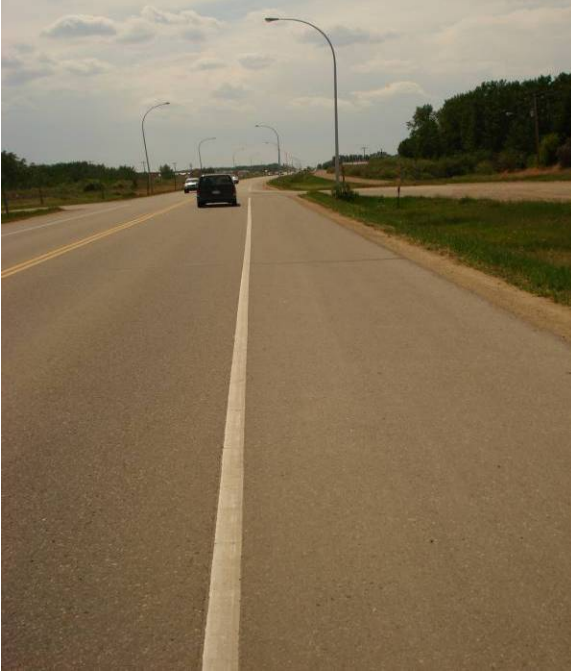
Looking south

W. white Retro readings– 49, 81, 96, 101, 82, 36, 52, 66, 63, 87 – **Average retro = 71 Mcd**  
Inconsistent retro-reflective readings along the west edge line. Glass beads have been sheared off by snowplows.

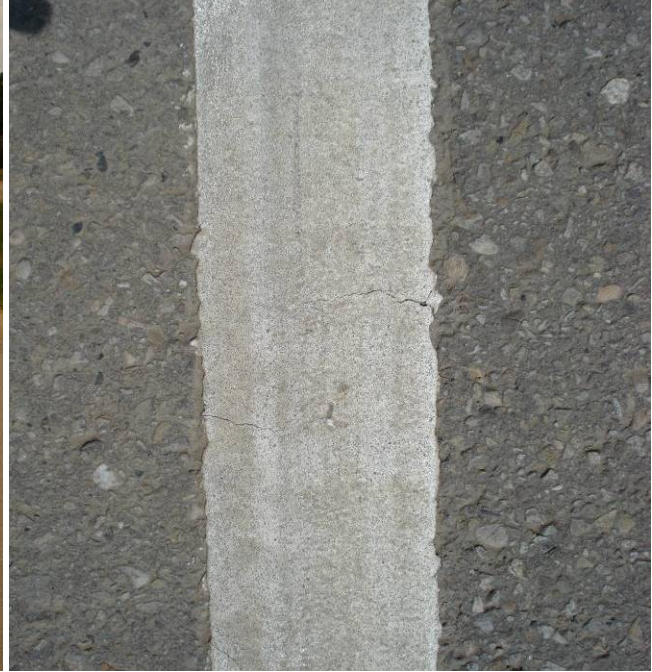
Close-up, snowplow damage
