File: 8190-3-2

Location: Highway 2A:22/24 (Town of Ponoka)

Applied: June 2008 Evaluated: June 18, 2008

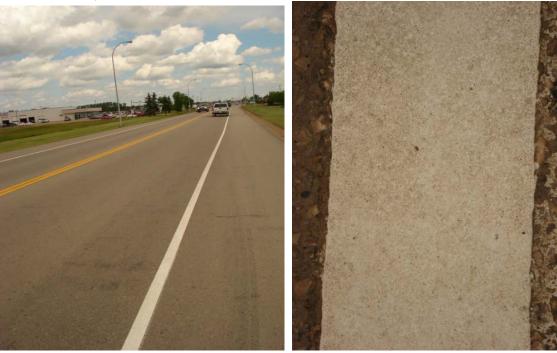
Location # 1, KFC site

Retro readings–326, 325, 304, 315, 328, 326, 334, 323, 325, 320, 296, 325, 320, 294- **Average retro = 319Mcd**, Initial retro-reflective readings are very good at this location, marking looks very good, lots of glass beads in the marking.

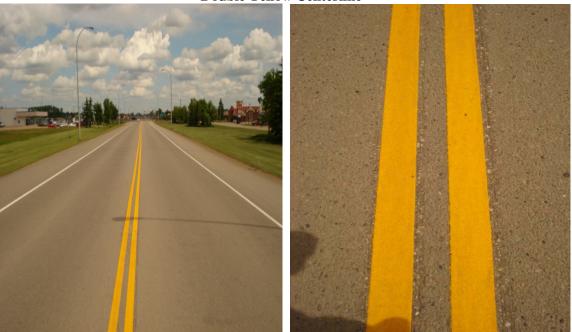
Double Yellow Centerline

Retro readings-206, 162, 179, 164, 170, 180, 155, 191, 171, 191, 194, 218,164, 188- Average retro = **181** Mcd The yellow line appeared to be have a bit of dirt on some sections which resulted in lower initial retro's., otherwise the yellow line looks very good.

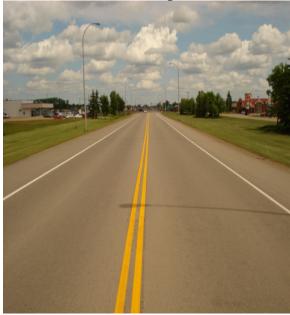
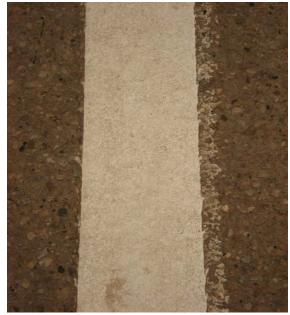
West White Edge Line

E. white Retro readings–298, 331, 302, 313, 353,336, 312, 294, 307, 303, 287, 292, 288, 286 – **Average retro** = **307 Mcd** Initial retro-reflective readings are also very good on the west edge line location, marking looks very good, lots of glass beads in the marking.

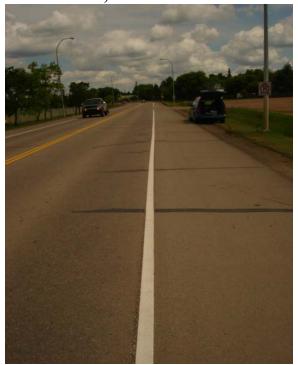
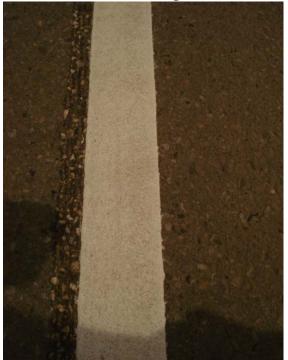
East White Edge Line

Retro readings–255, 287, 212, 179, 180, 250, 190, 182, 189, 190, 224, 208, 268, 228- **Average retro = 217Mcd,** Initial retro-reflective readings are considerable lower than location # 1. This could be attributed to dirt being tracked over the lines. Time will tell on the longer term performance.

I recommend that additional retro-reflective readings be taken some time in September, this would allow some time for wear on the lines which should expose more glass beads and provide increased reflective readings at location #2. .

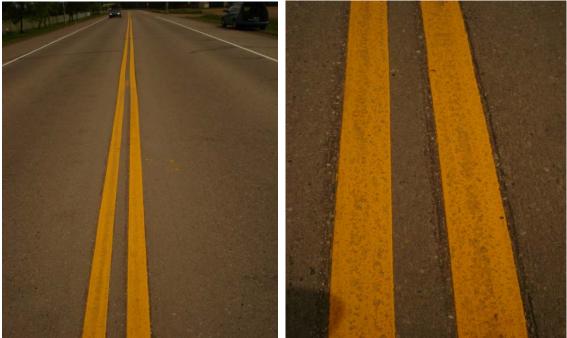
Double Yellow Centerline

Yellow centerline appears to be slightly dirty looking
Retro readings—71, 70, 70, 85, 75, 70, 75, 67, 66, 74, 69, 74, 112, 84— **Average retro** = **76 Mcd**The initial retro-reflective readings on the yellow line at this location are very low; this could be attributed to the appearance of dirt on the line. The lower retro readings could also be attributed to the glass beads sinking lower in the material. Therefore, I would recommend that additional readings be taken some time in September after more wear has exposed the glass beads on the yellow lines, this would validate the readings. **If the readings continue to be low then this line would not be acceptable.**

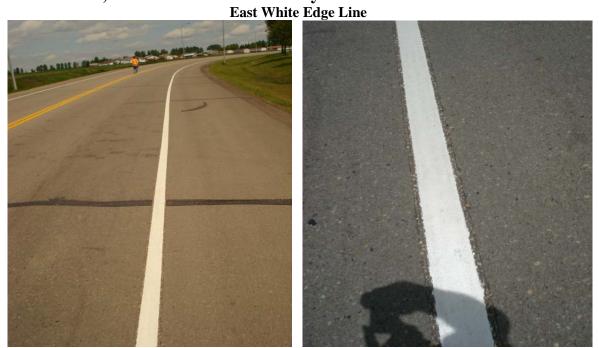
Location # 3, Curve North of the Husky Station

Retro readings–294, 287, 278, 301, 292, 286, 294, 270, 305, 321, 315, 301– **Average retro = 295 Mcd** Retro-reflective readings at this location are very good.

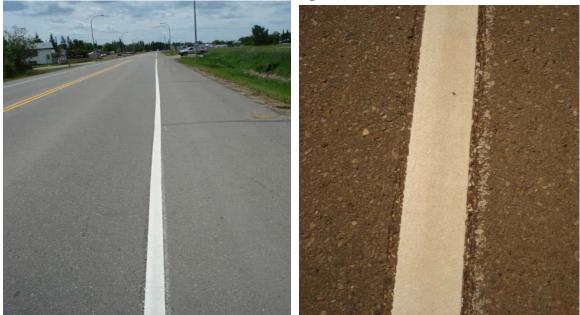
West White Edge Line

Retro readings—282, 271, 309, 302, 269, 276, 307, 301, 288, 306, 288, 287—**Average retro** = **291 Mcd** Retro-reflective readings at this location are very good.

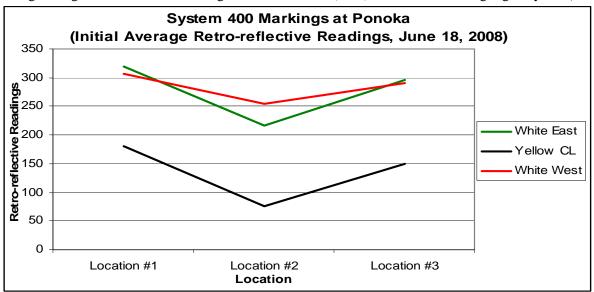
Chart showing average retro-reflective readings in Millicandelas (Mcd) at 3 locations along highway 2A (Ponoka):

The average retro-reflective readings (white edge) are above 300Mcd at location #1 and slightly below 300Mcd at location #3 as shown in the above chart. Location #2 is well below the readings taken at location #1 and #3 for both white and yellow lines. The lower readings could be attributed to some of the glass beads sinking lower into the material during the application at location #2. The other reason may be that the lines are covered in a thin film of dust/dirt which would reduce the reflectivity. I believe the reason for the low readings is that the beads have sunk into the marking material which will require some wear to expose the beads.
