July 5, 2022

**ALBERTA TRANSPORTATION GRMP (CON0022163)  
NORTH CENTRAL (ATHABASCA AND FORT McMURRAY DISTRICTS)  
INSTRUMENTATION MONITORING RESULTS – SPRING 2022**

**SITE NC102 (NC024-2): HWY 41:23 KEHIWIN LAKE (km 8.8)**

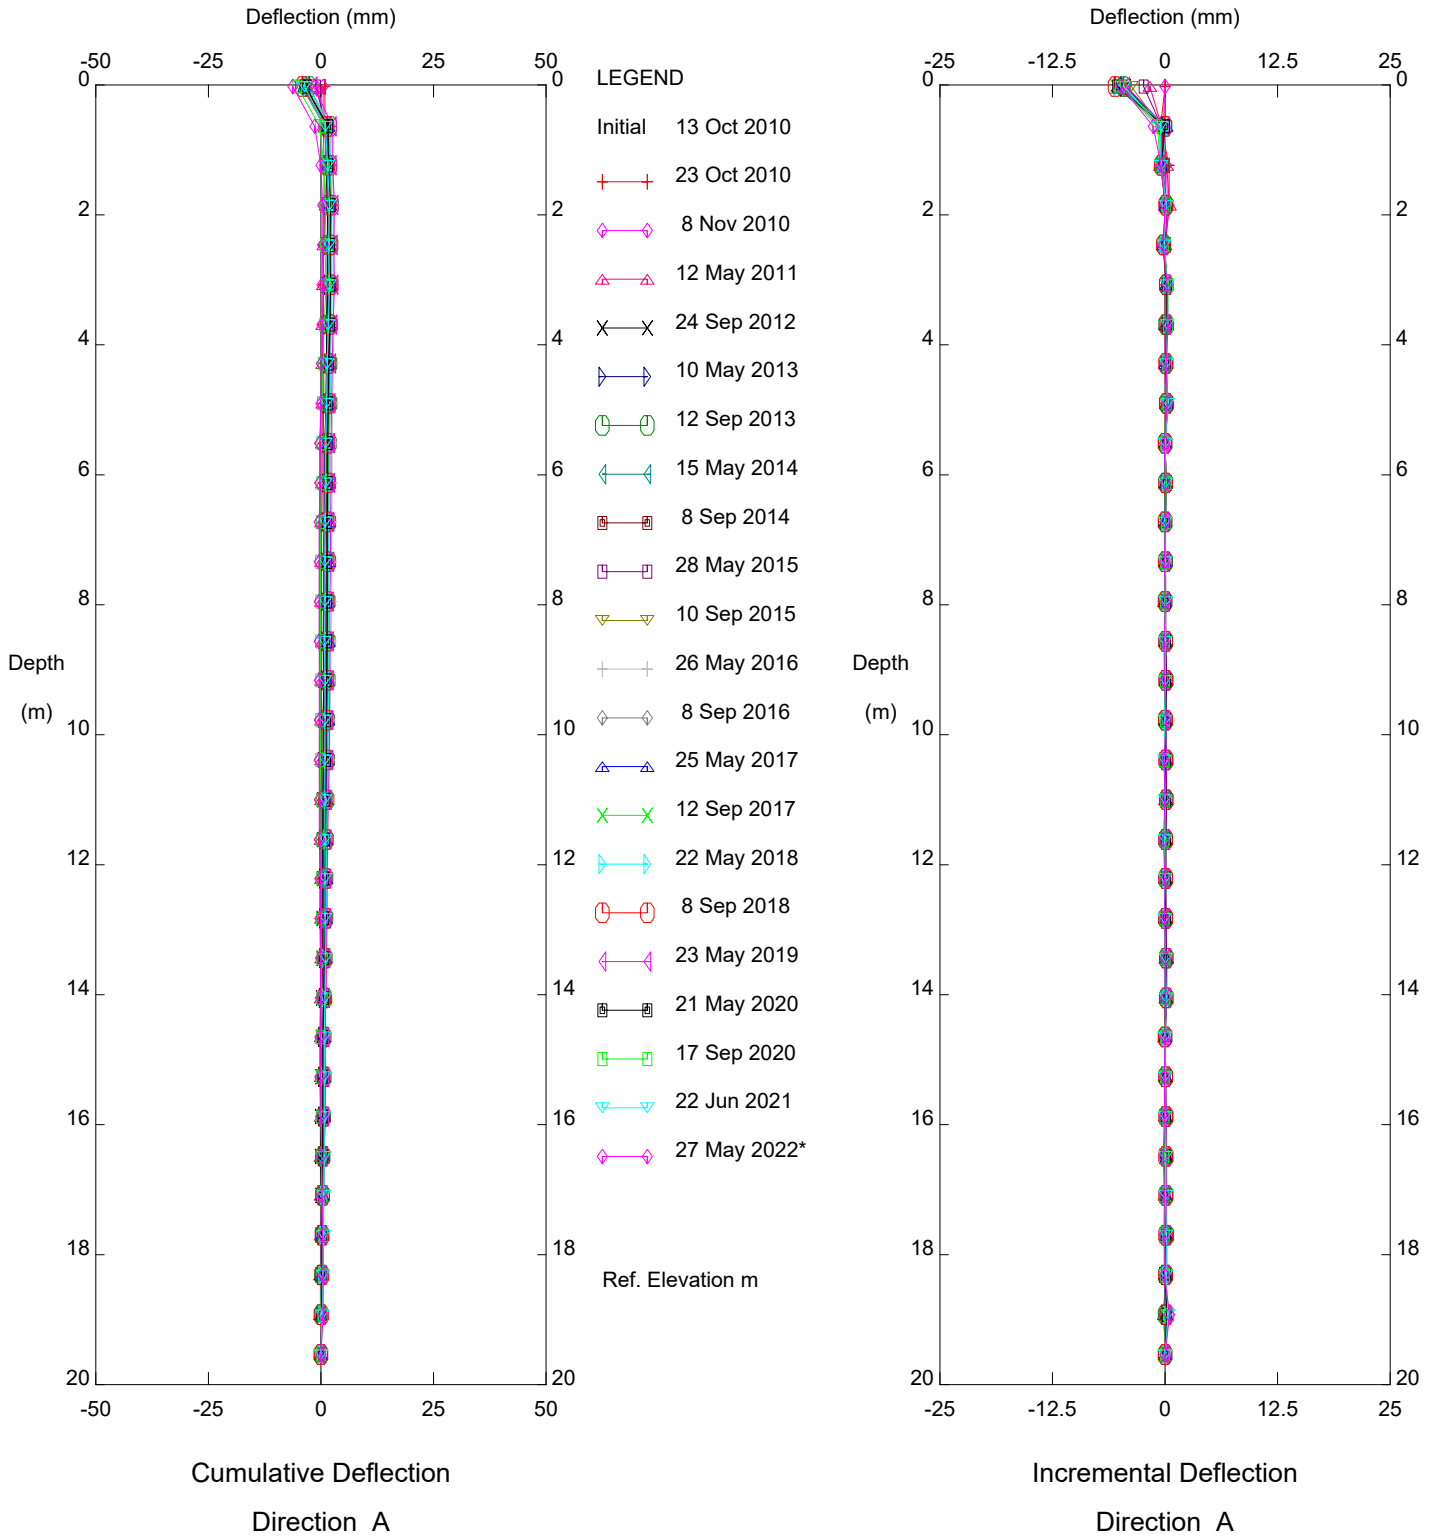
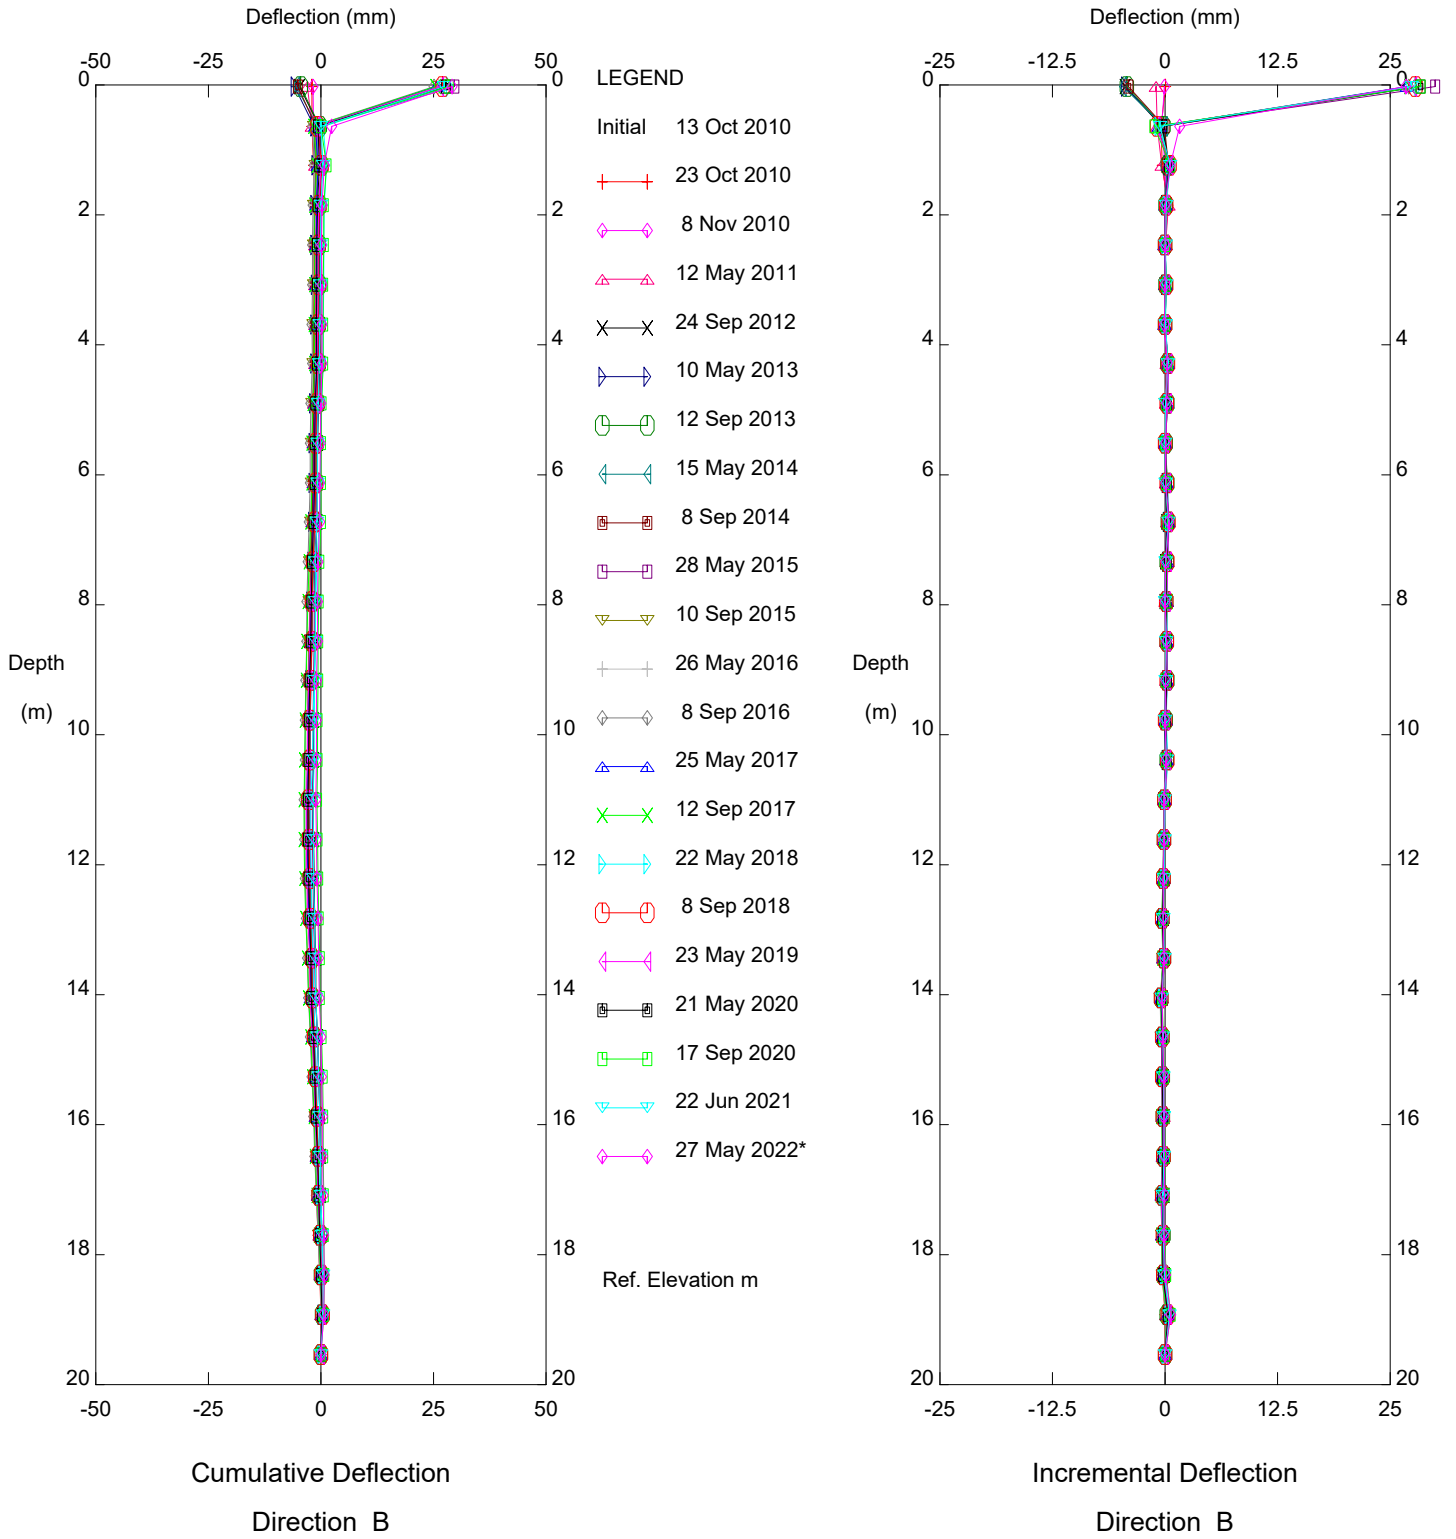
Hwy 41:23 Kehiwin Lake (NC102), Inclinometer SI10-1

Slope inclinometer SI10-1, installed in the highway east ditch upslope of the NC24B pile wall, continued to show no discernible movement. SI10-3 installed downslope of the NC24B pile wall, showed a rate of movement of 0.6 mm/yr over 0.0 m to 2.4 m of depth since the spring of 2021 readings.

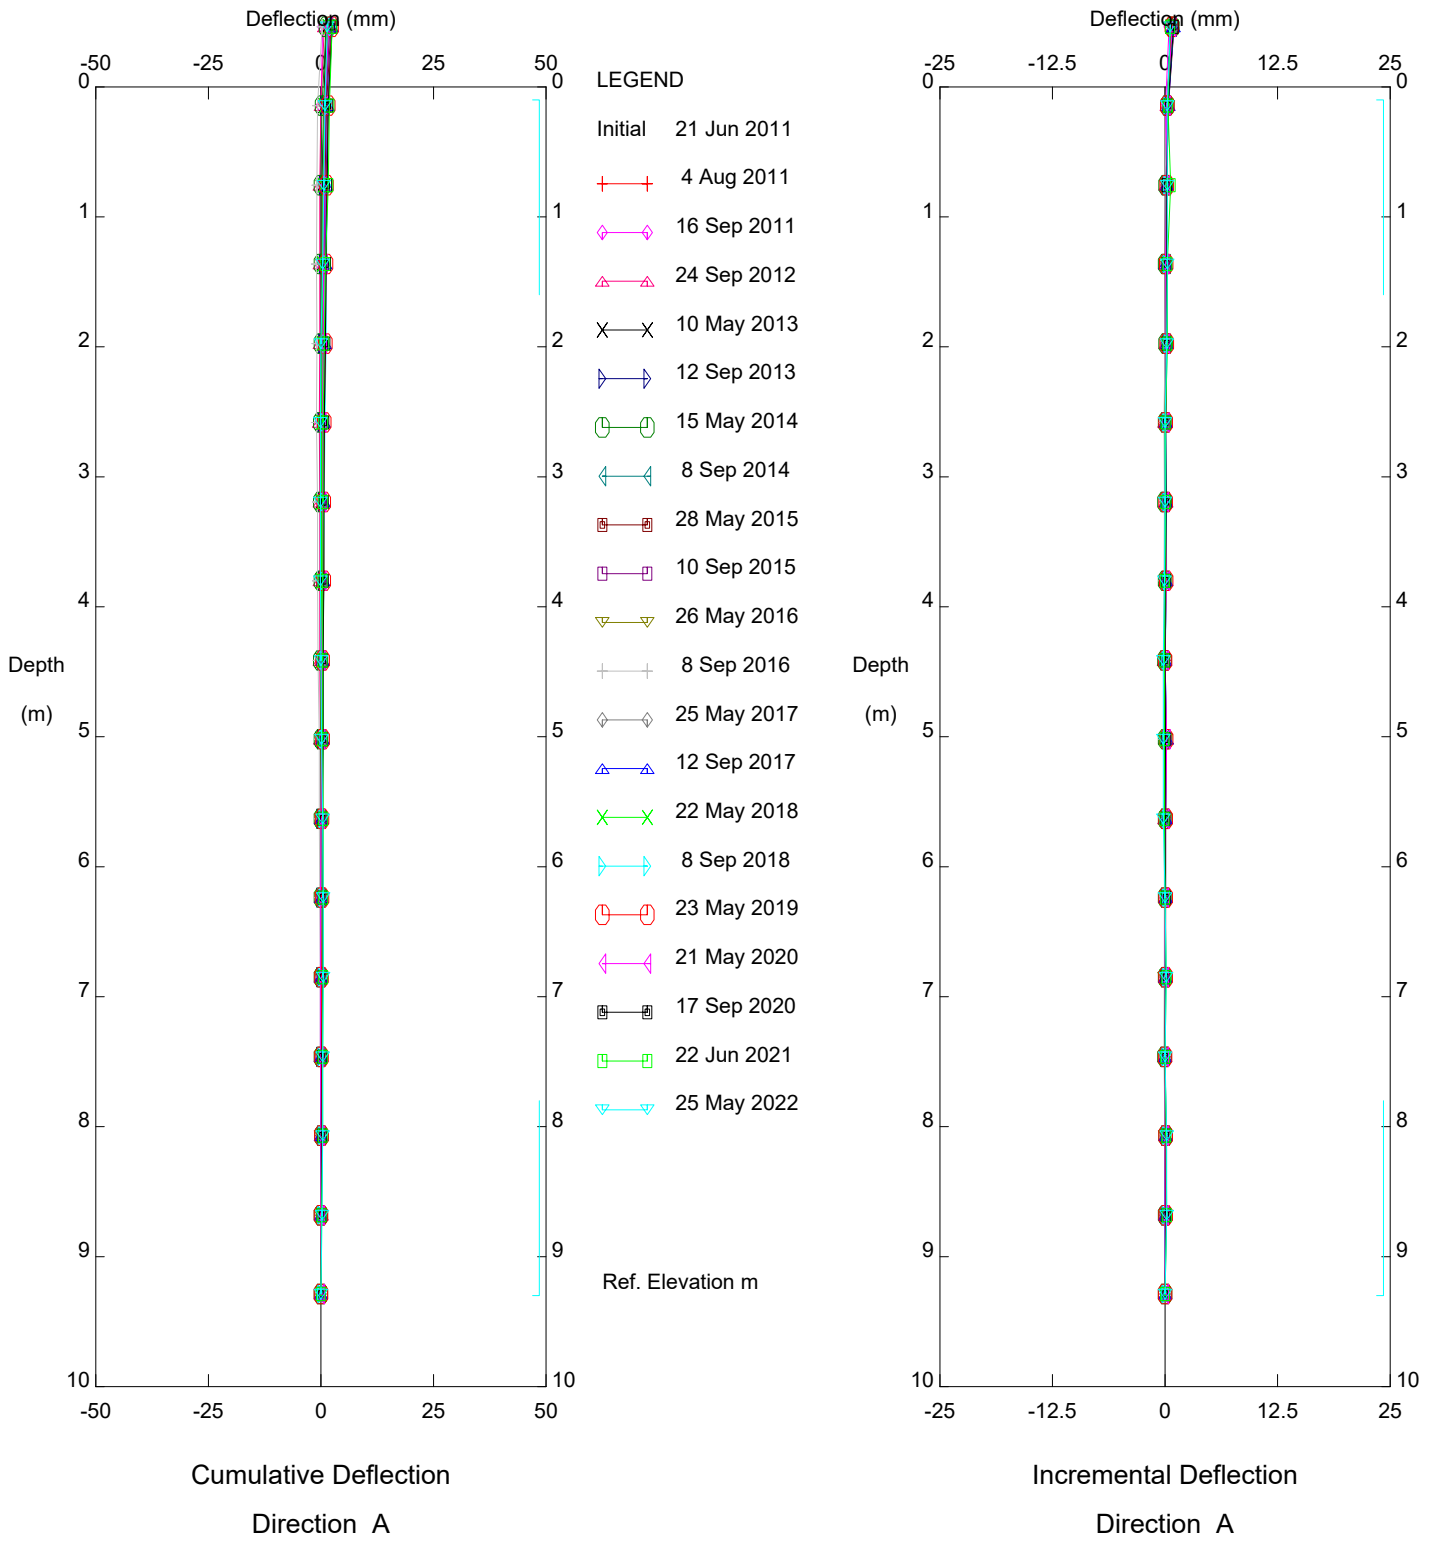
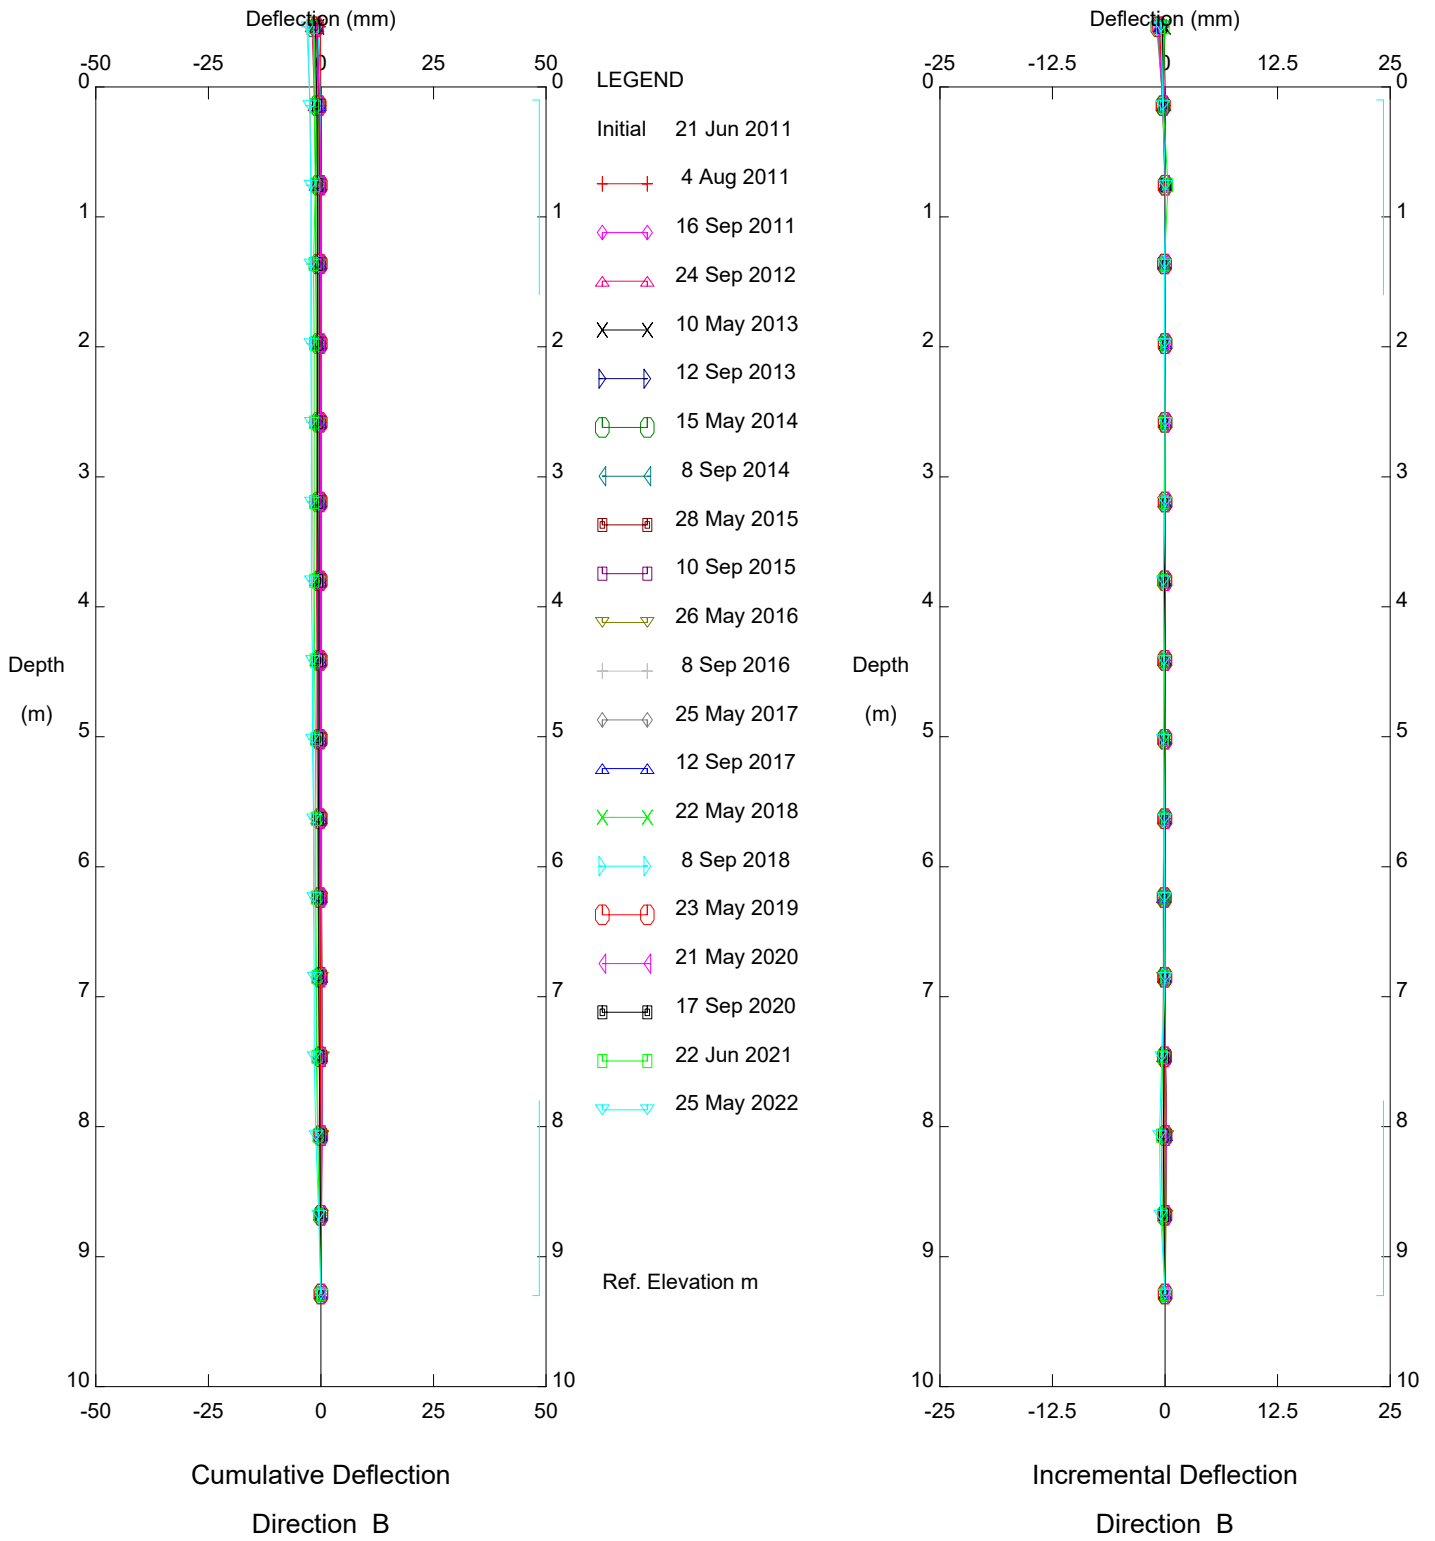
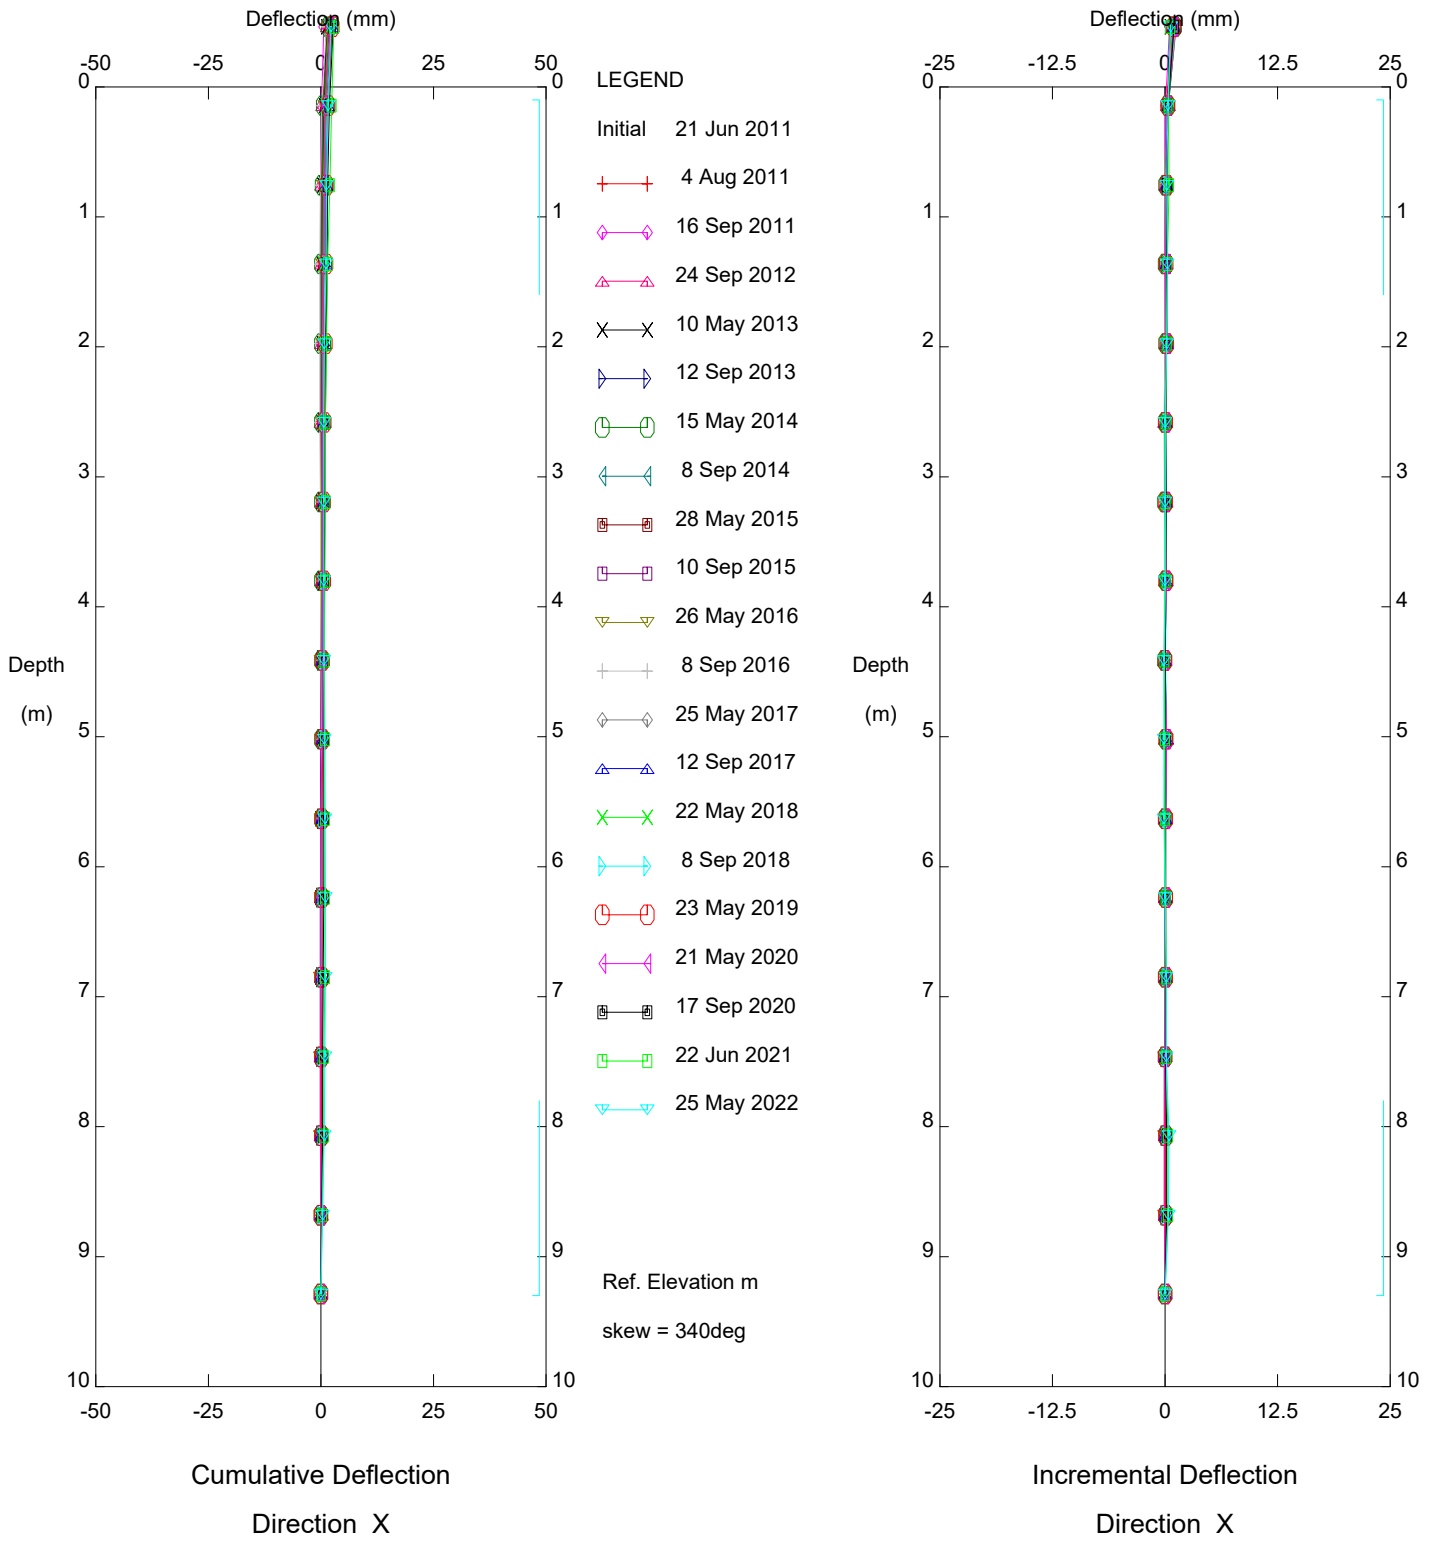
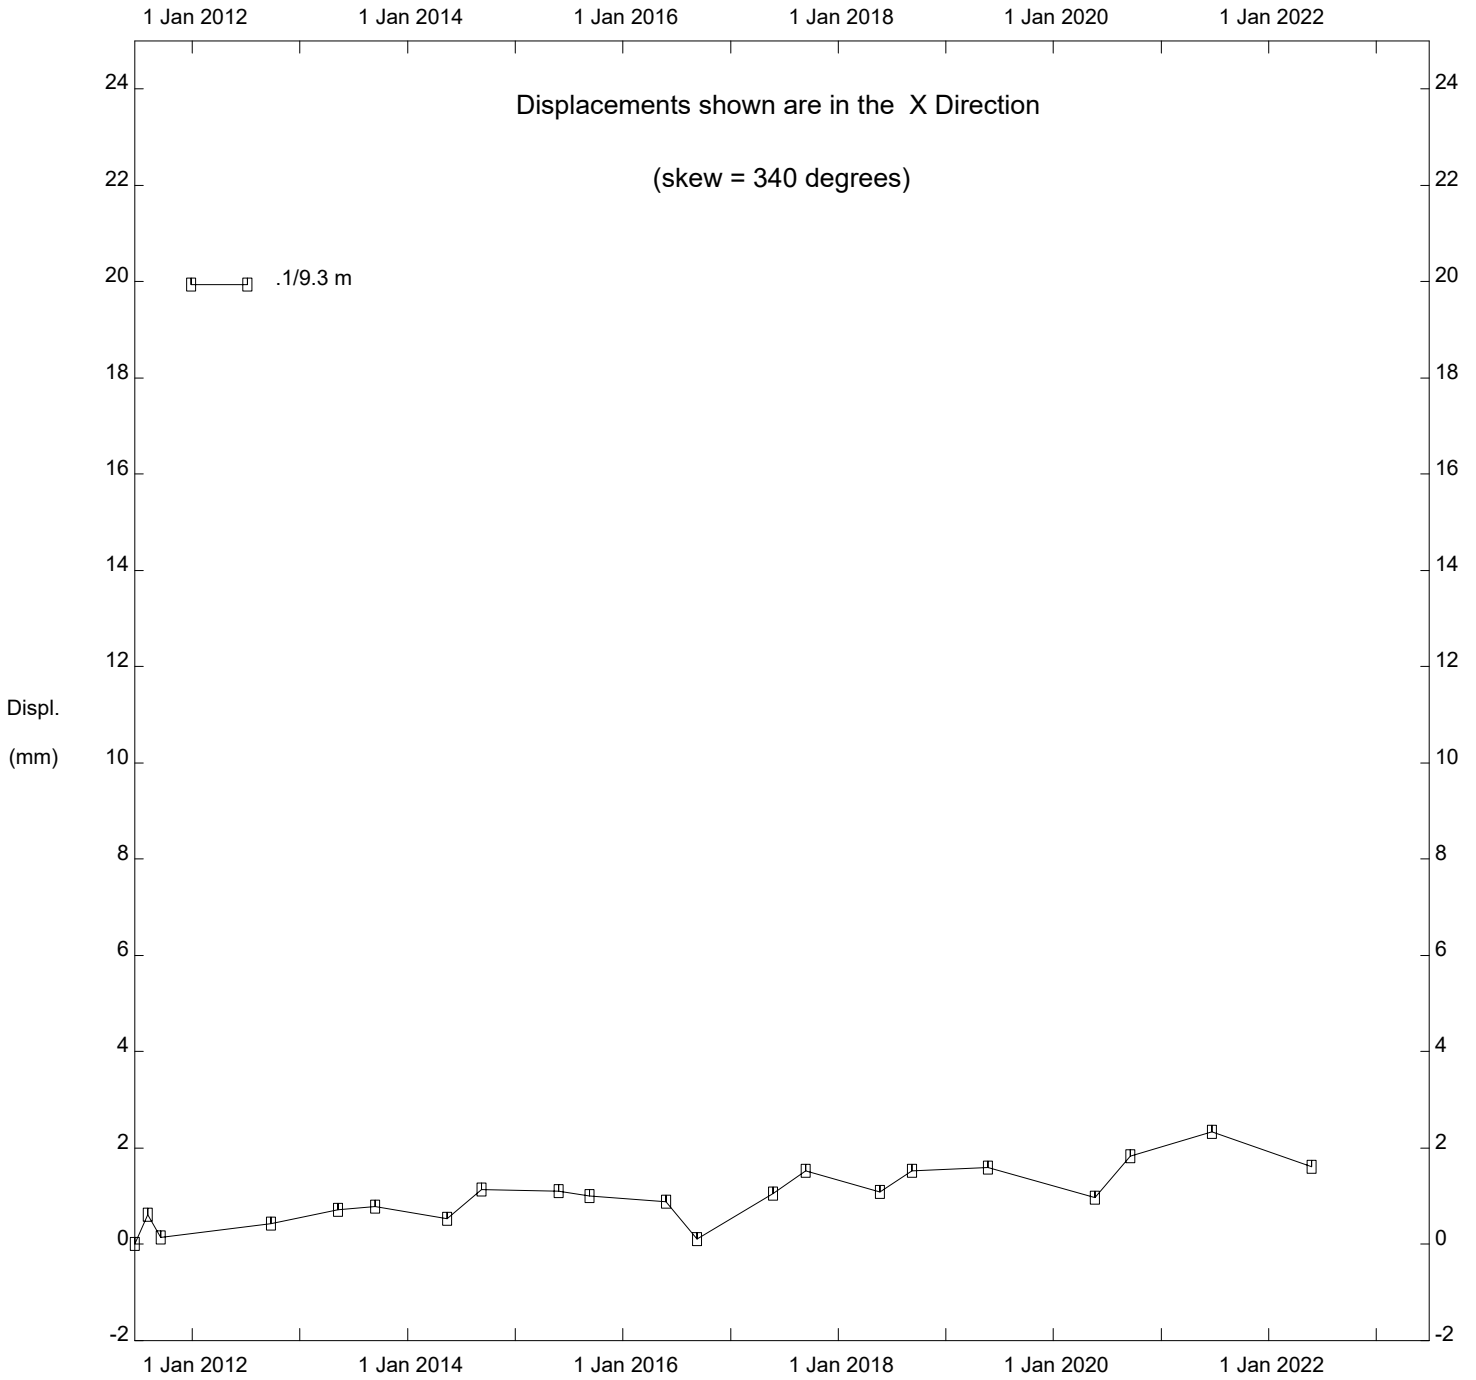
Hwy 41:23 Kehiwin Lake (NC102), Inclinometer SI11-1 (P7)

SI11-1 through SI11-3 were installed in piles P7, P16 and P24, respectively, of the 2011 pile wall. Slope inclinometers SI11-1 to SI11-3 all showed no discernible movement since the spring of 2021 readings. SI11-1, SI11-2 and SI11-3 have shown total pile head movements of 1.6 mm, 2.9 mm, and 0.0 mm, respectively, since installation.

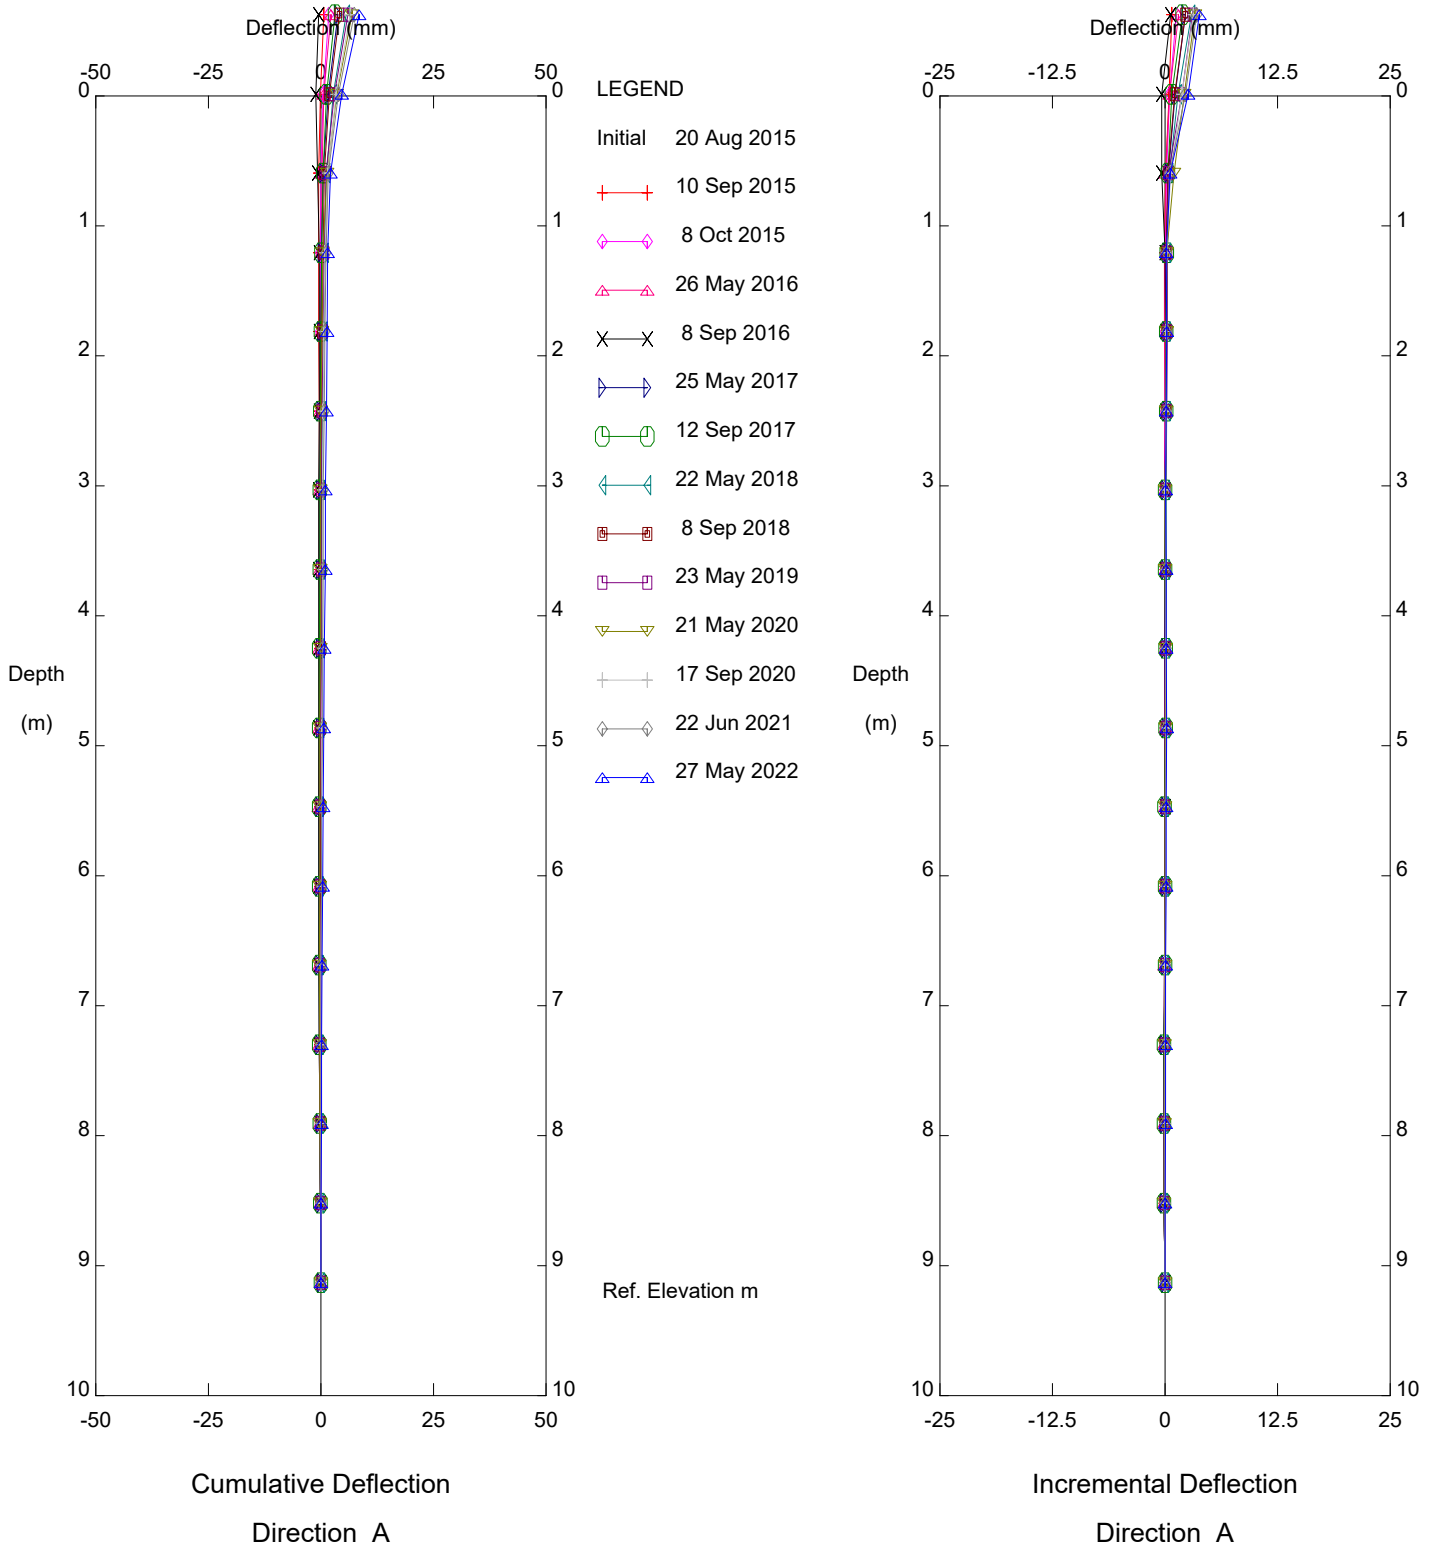
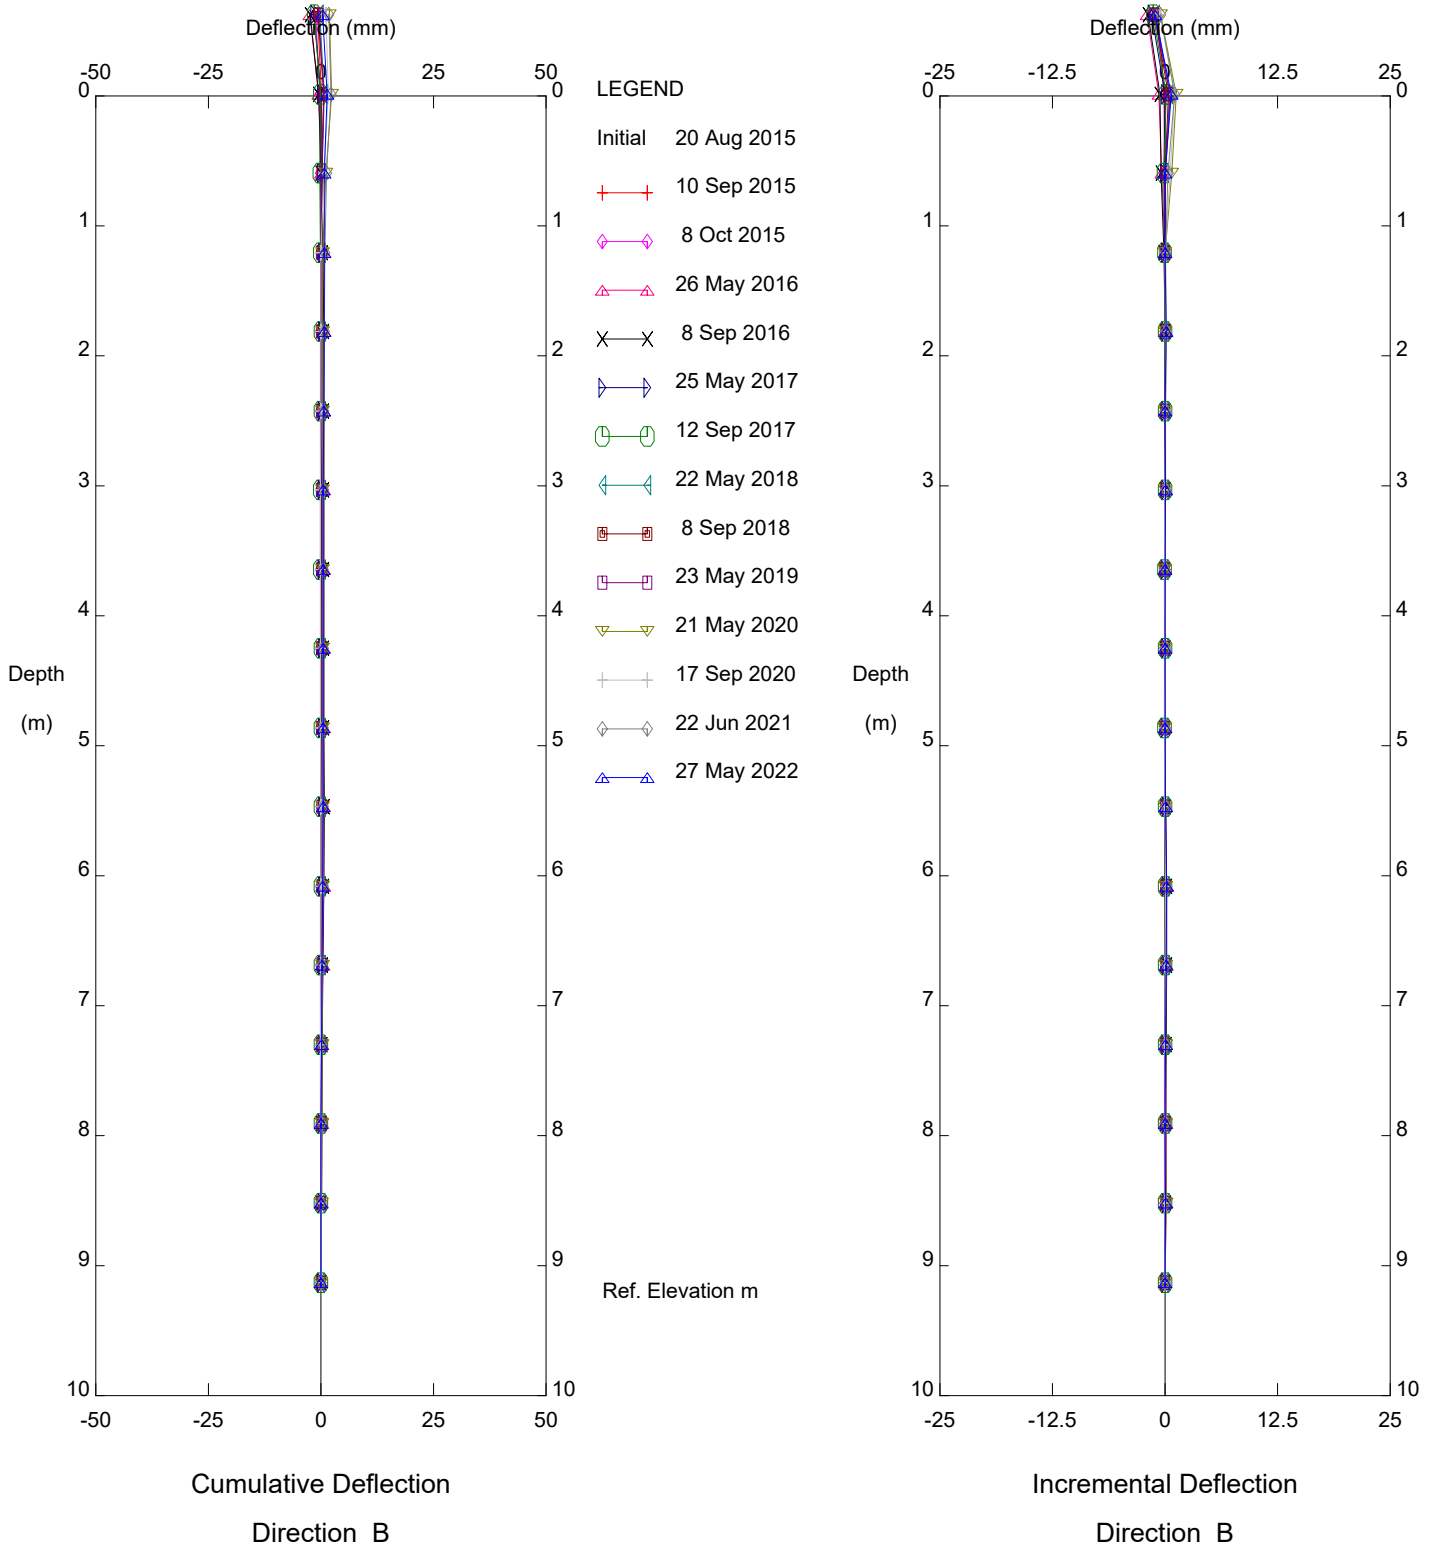
Hwy 41:23 Kehiwin Lake (NC102), Inclinometer SI15-1

Slope inclinometer SI15-1, installed in the highway east ditch upslope of the NC24D pile wall, has shown no discernible movement since initialization. SI15-2, installed immediately downslope of the NC24D pile wall, showed a no discernible movement over 3.0 m to 4.8 m depth since the spring of 2021. SI15-3, installed near the bottom of the slope downslope of the NC24D pile wall, showed a rate of movement of 0.3 mm/yr over 1.7 m to 3.5 m depth since the spring of 2021. SI15-4, installed near the west edge of the highway to the south of the NC24D pile wall, showed a rate of movement of 1.8 mm/yr over 1.6 m to 3.4 m depth and a rate of movement of 0.7 mm/yr over 3.4 m to 4.7 m depth since the spring of 2021.
