July 5, 2022

**ALBERTA TRANSPORTATION GRMP (CON0022163)  
NORTH CENTRAL (ATHABASCA AND FORT McMURRAY DISTRICTS)  
INSTRUMENTATION MONITORING RESULTS – SPRING 2022**

**SITE NC102 (NC024-2): HWY 41:23 KEHIWIN LAKE (km 8.8)**

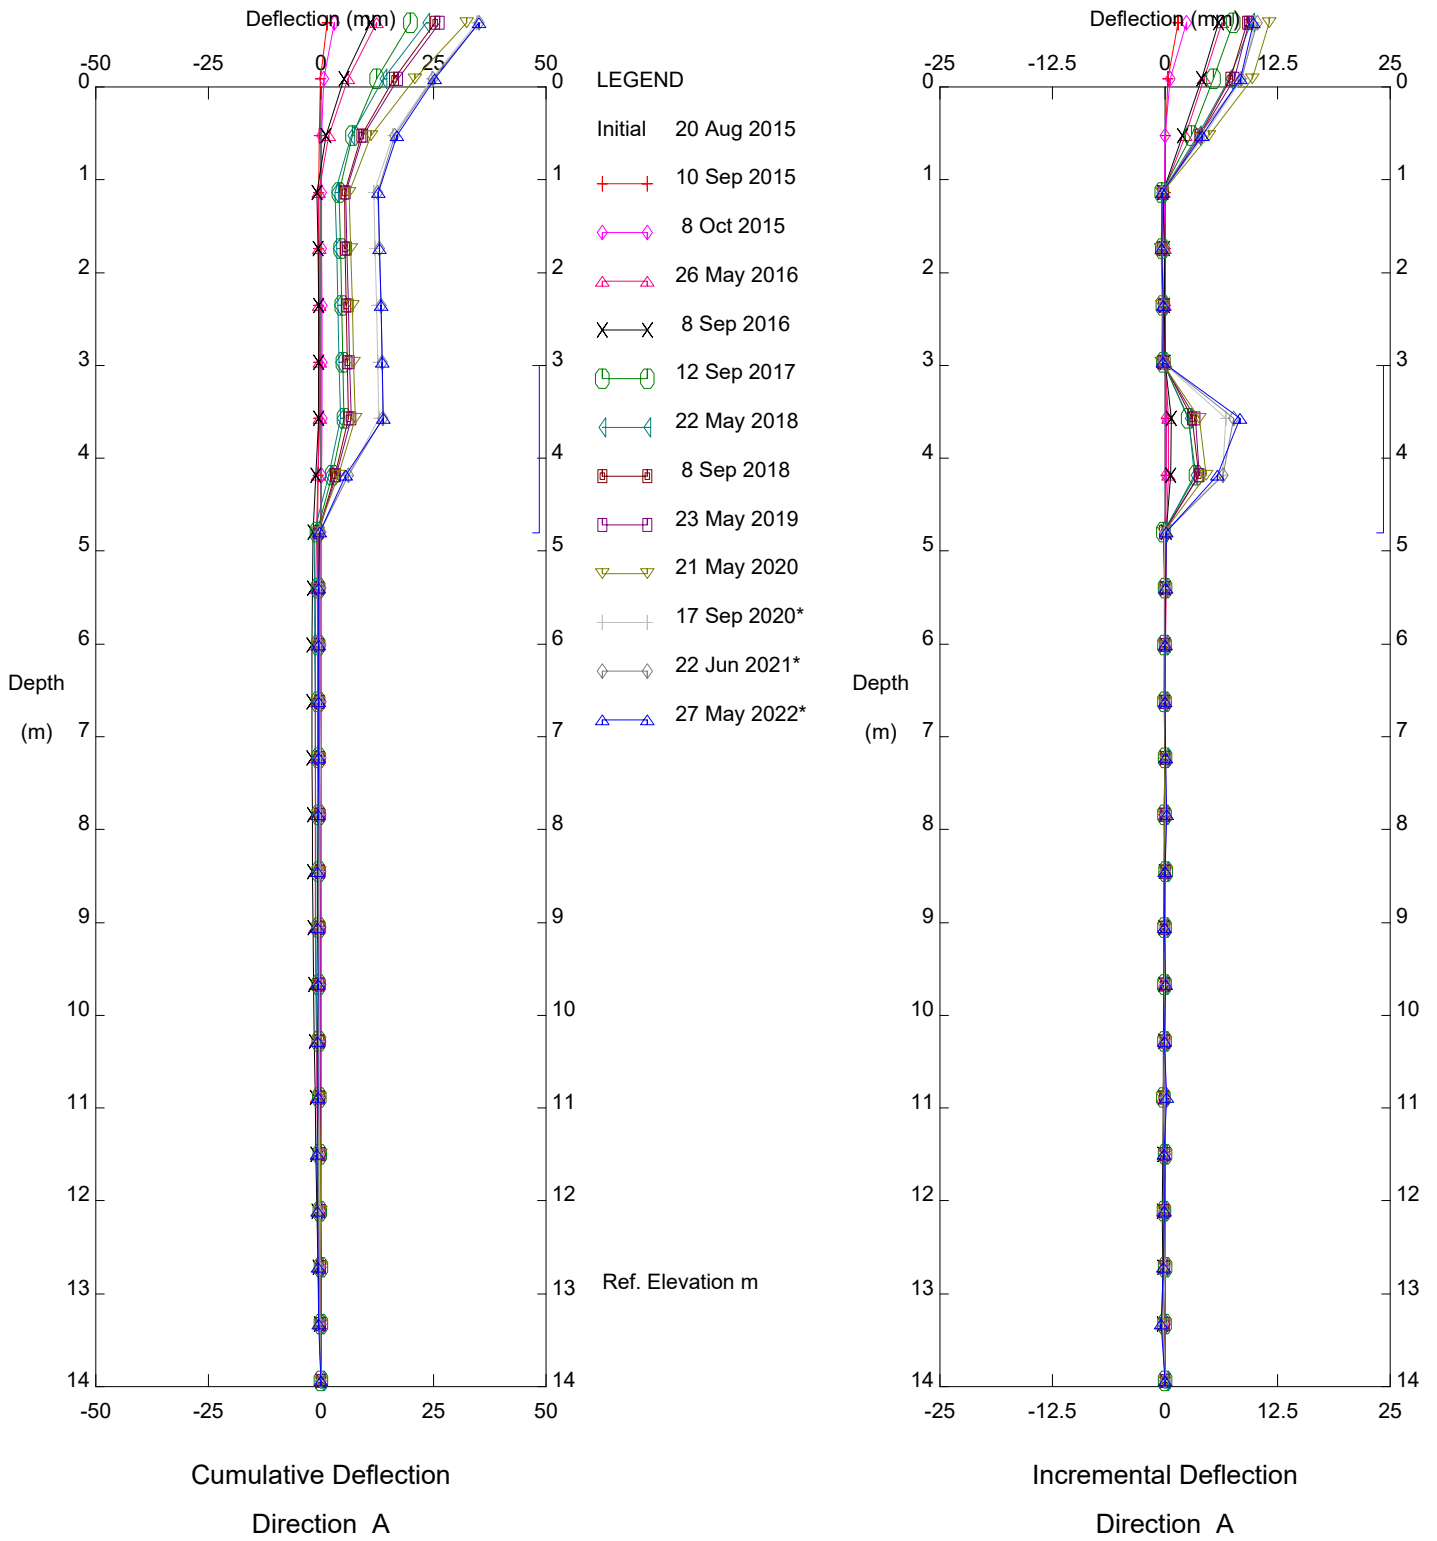
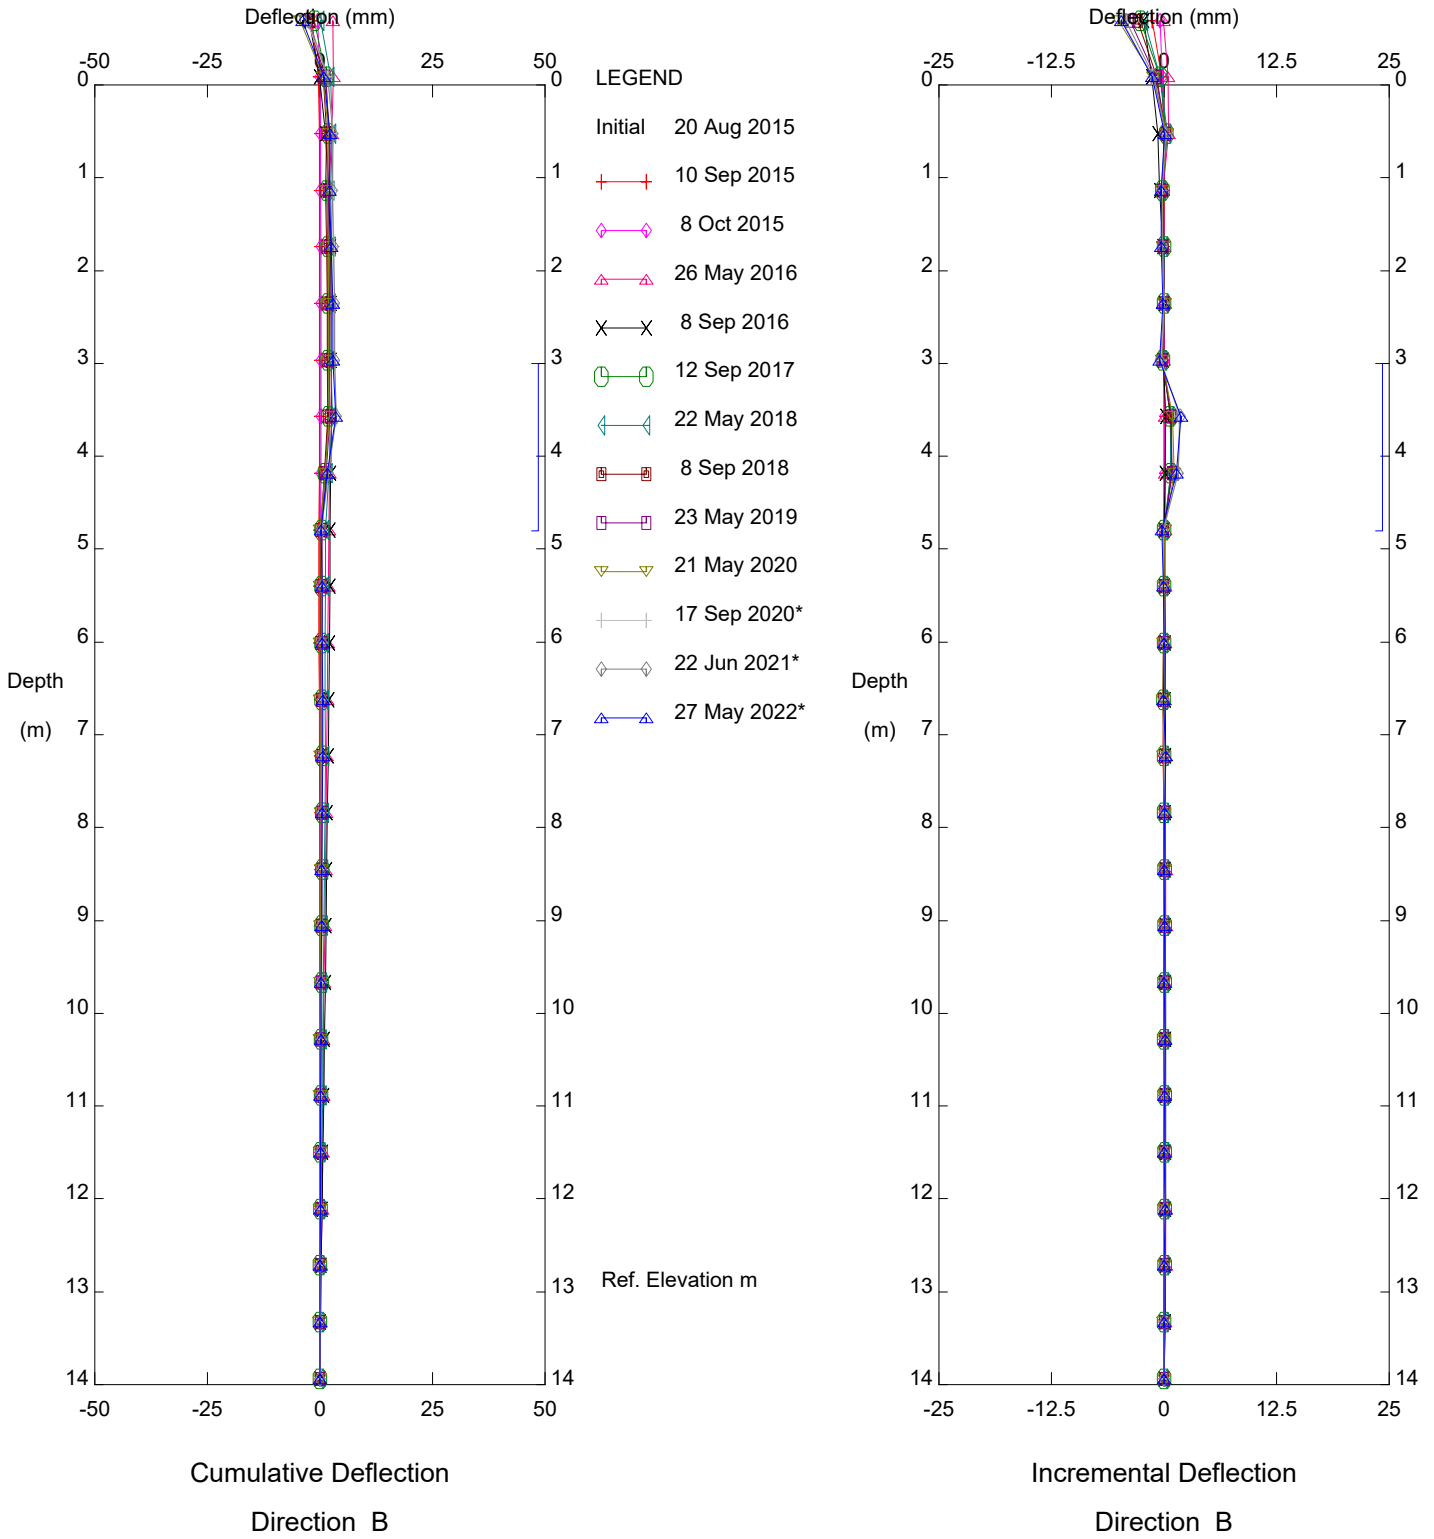
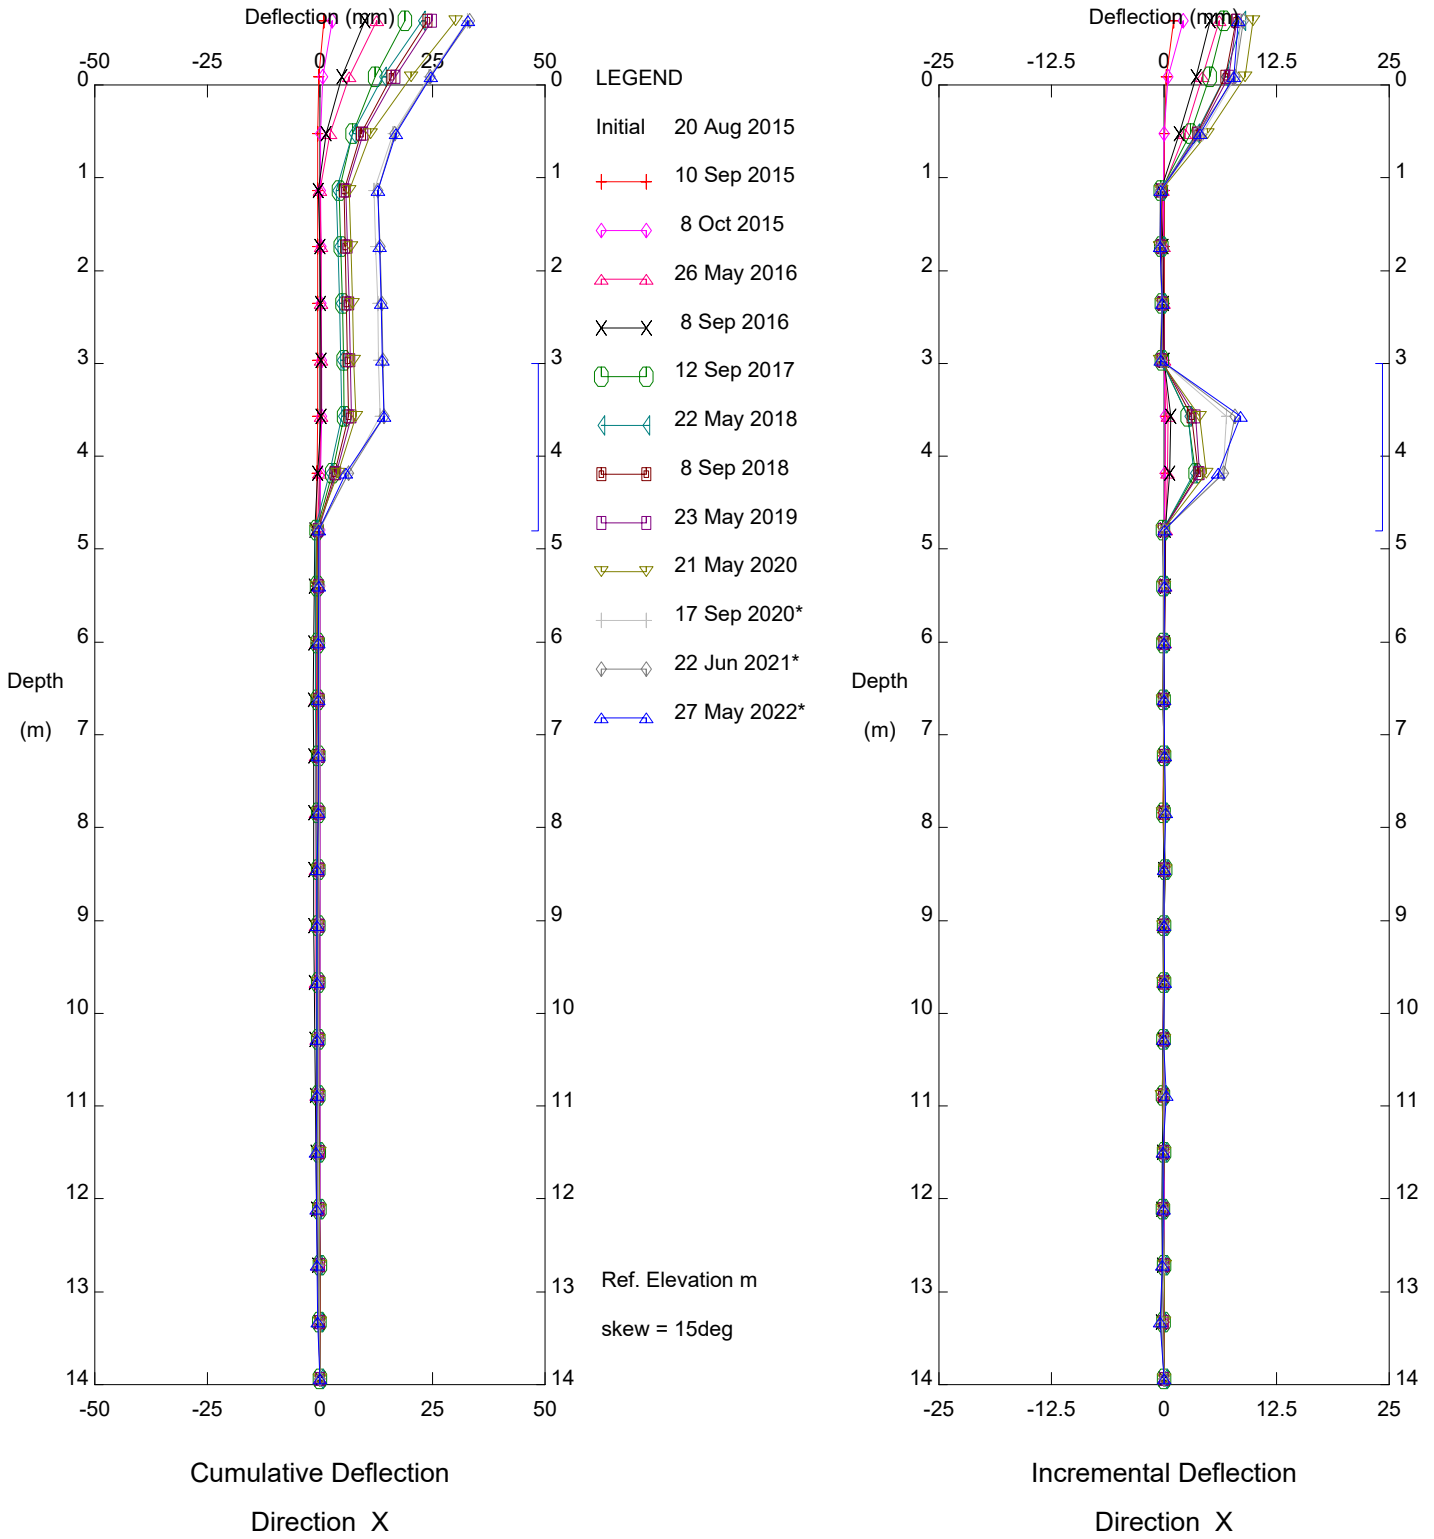
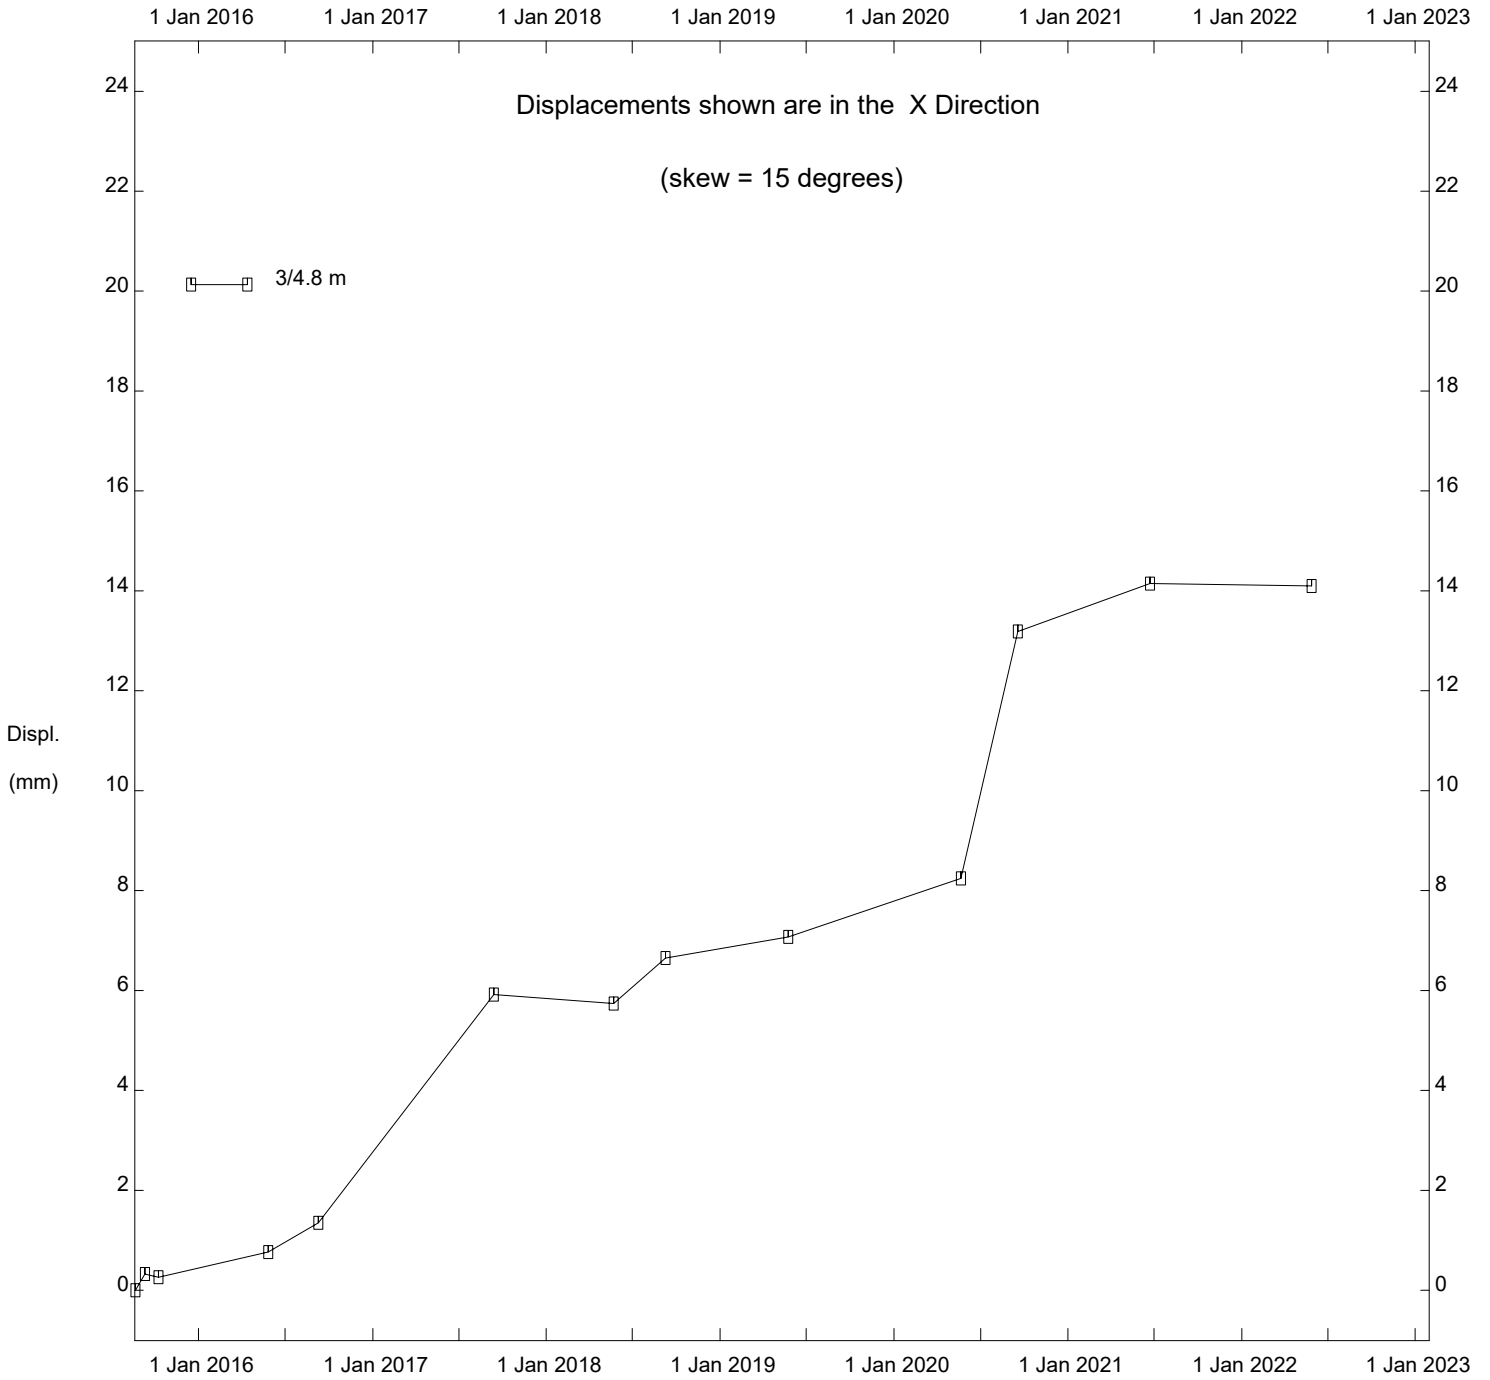
Hwy 41:23 Kehiwin Lake (NC102), Inclinometer SI15-2

Slope inclinometer SI15-1, installed in the highway east ditch upslope of the NC24D pile wall, has shown no discernible movement since initialization. SI15-2, installed immediately downslope of the NC24D pile wall, showed a no discernible movement over 3.0 m to 4.8 m depth since the spring of 2021. SI15-3, installed near the bottom of the slope downslope of the NC24D pile wall, showed a rate of movement of 0.3 mm/yr over 1.7 m to 3.5 m depth since the spring of 2021. SI15-4, installed near the west edge of the highway to the south of the NC24D pile wall, showed a rate of movement of 1.8 mm/yr over 1.6 m to 3.4 m depth and a rate of movement of 0.7 mm/yr over 3.4 m to 4.7 m depth since the spring of 2021.

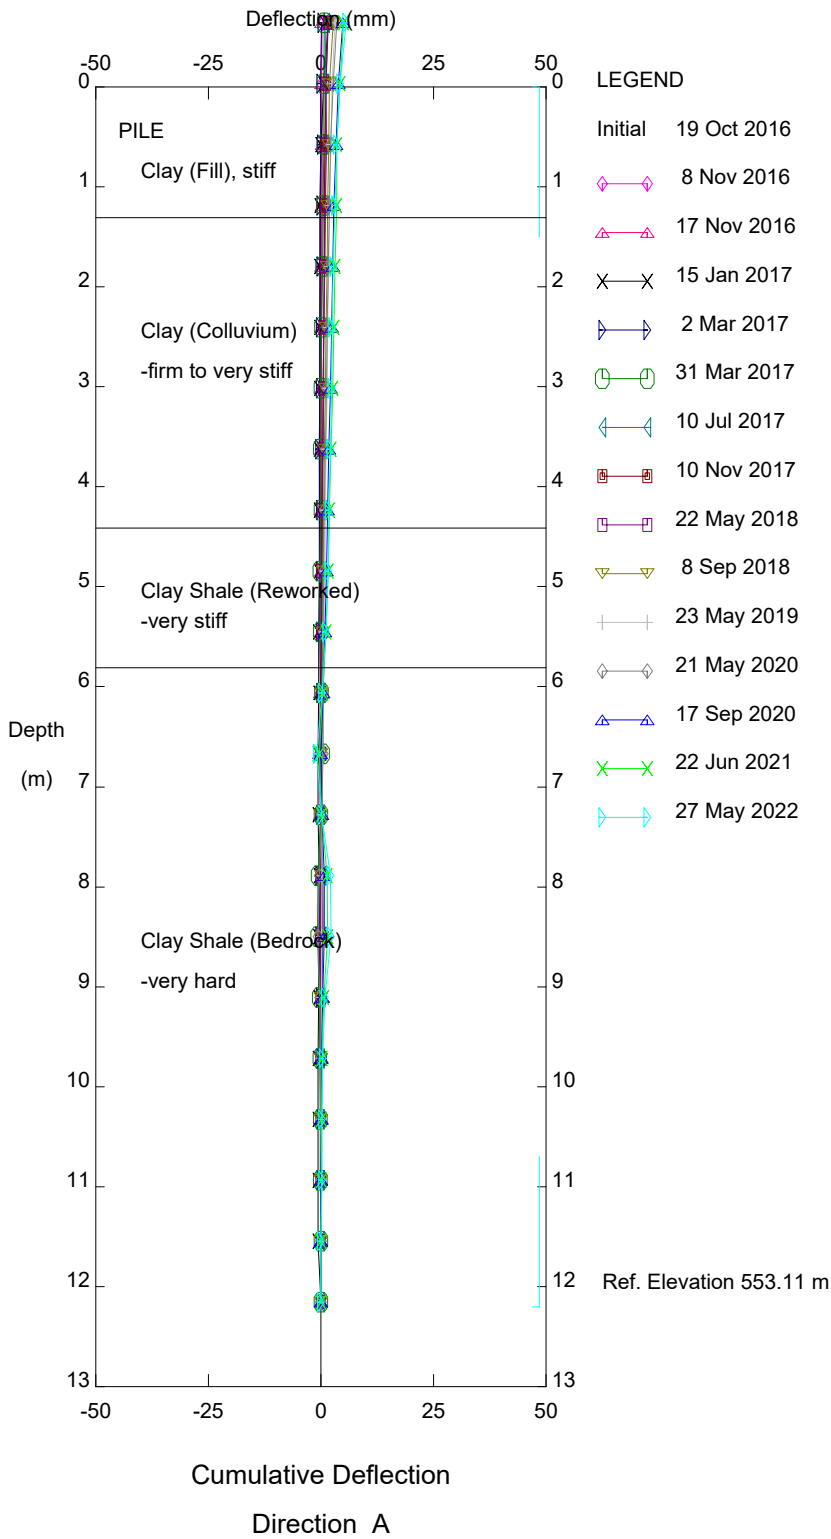
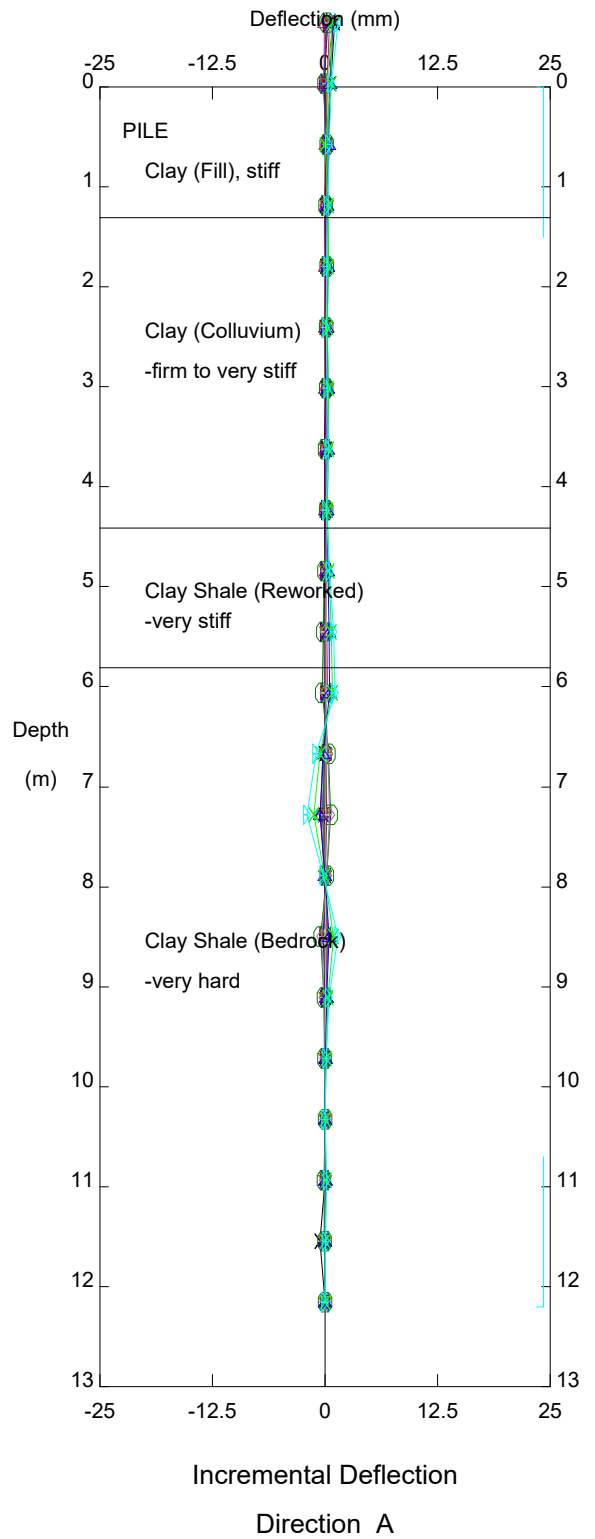
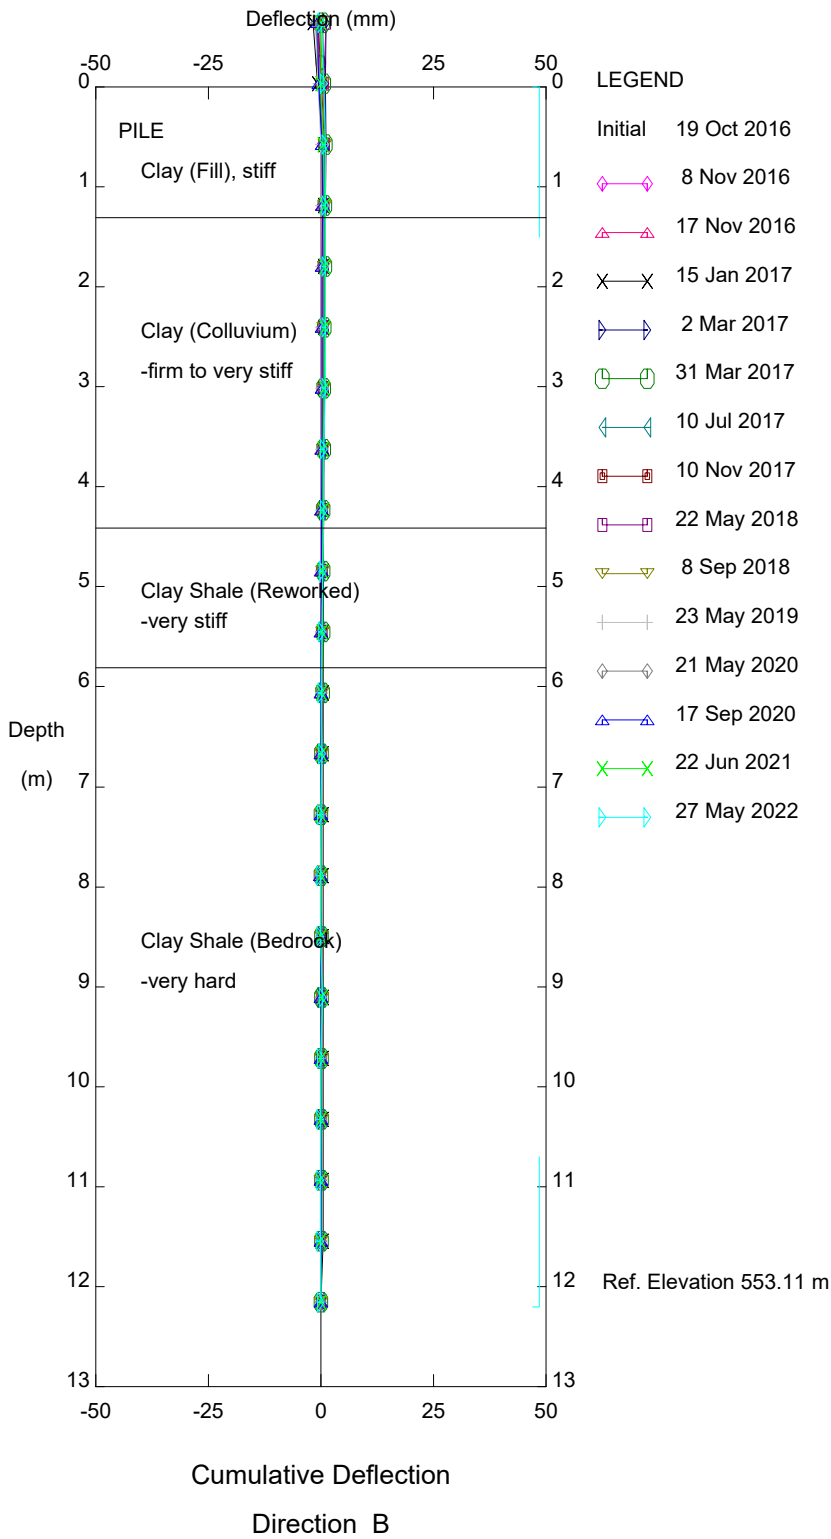
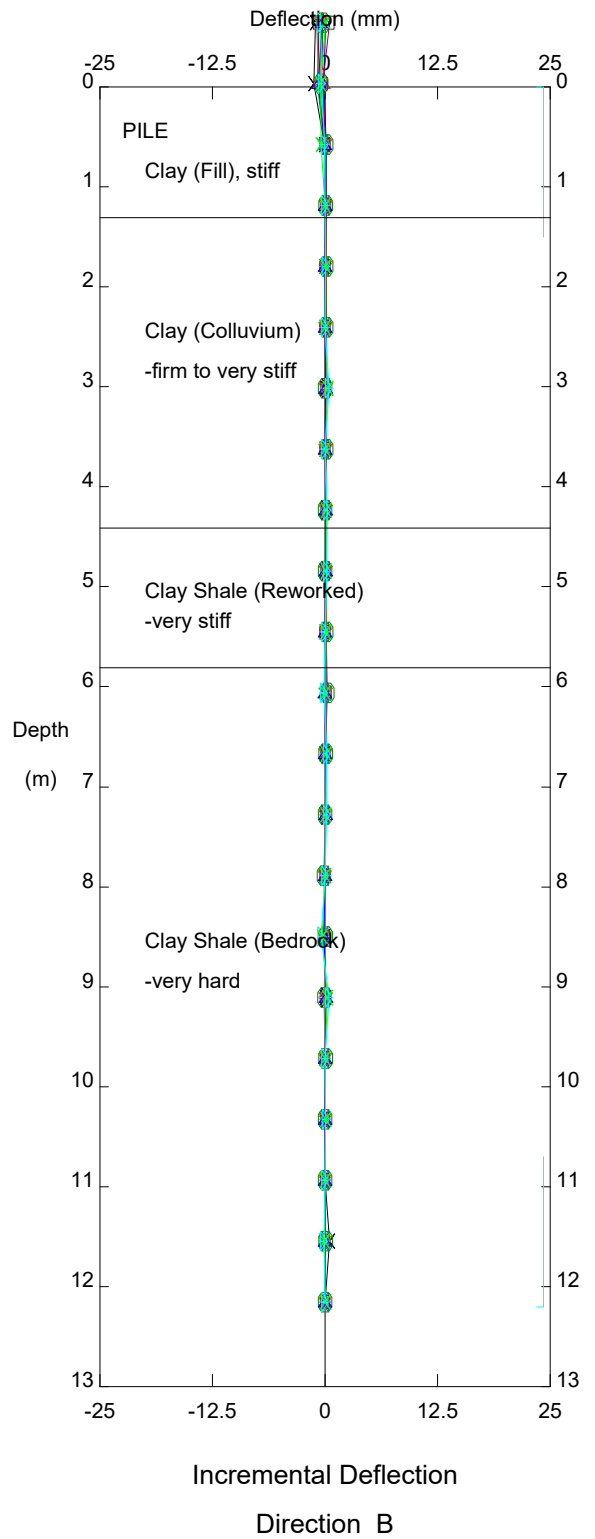
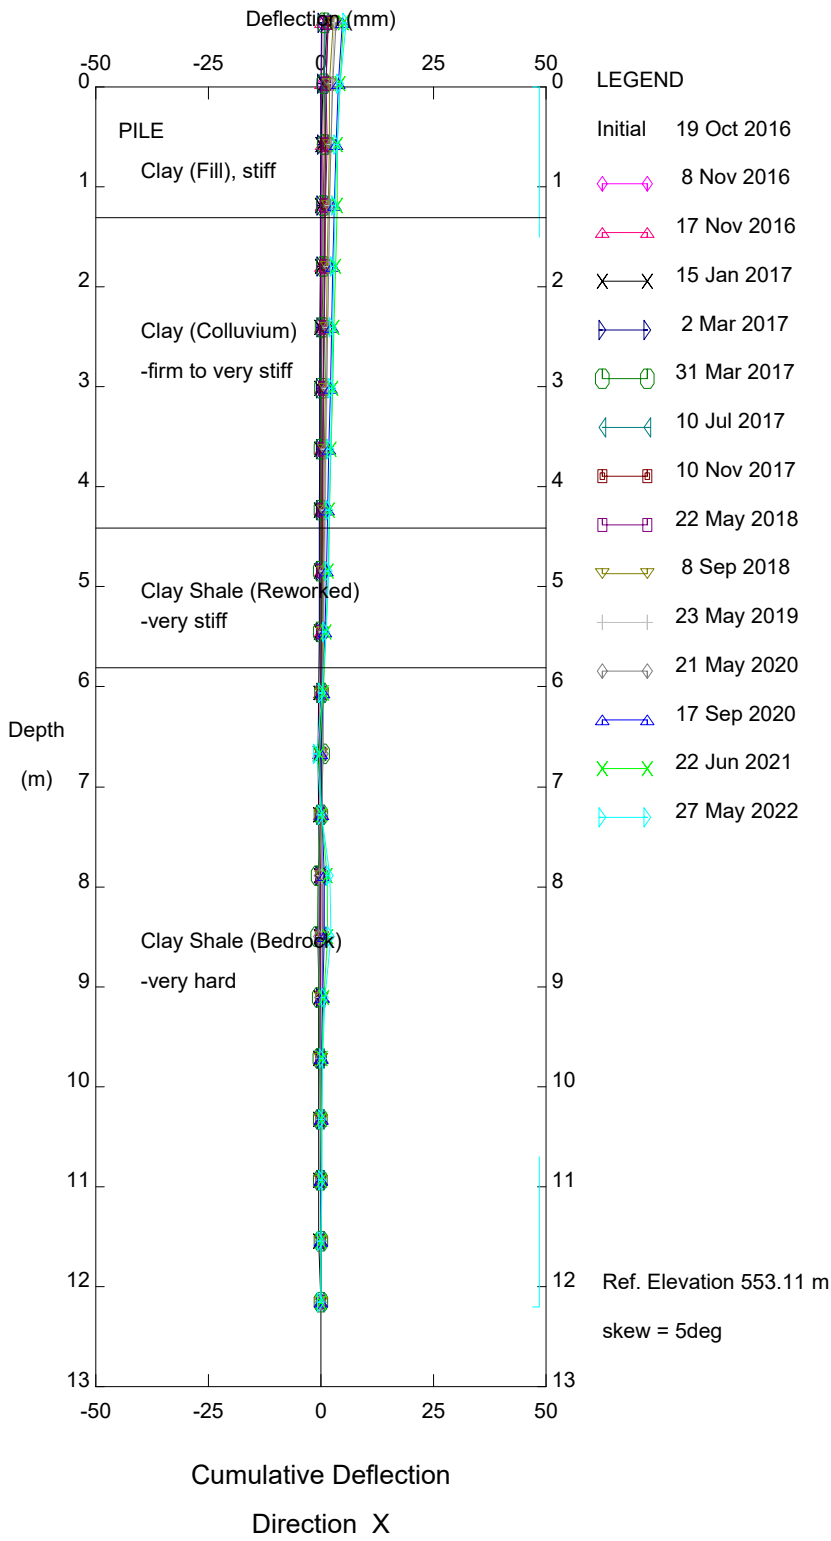
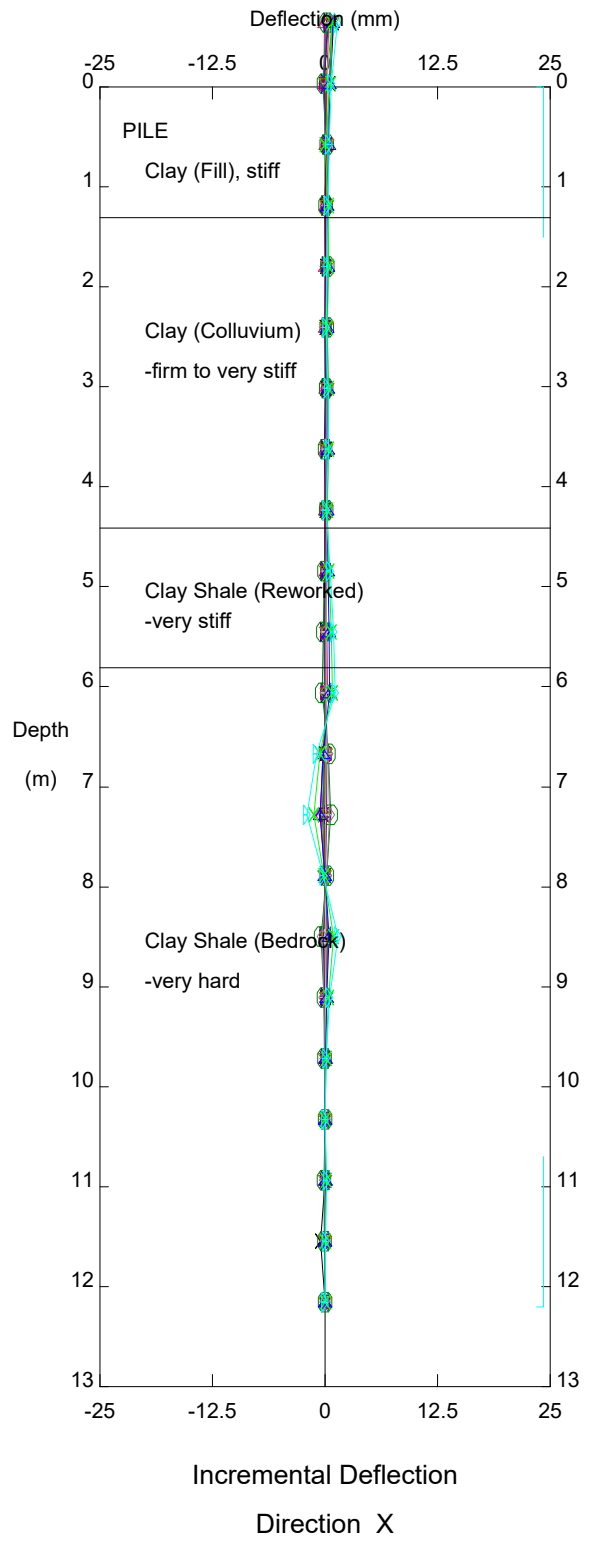
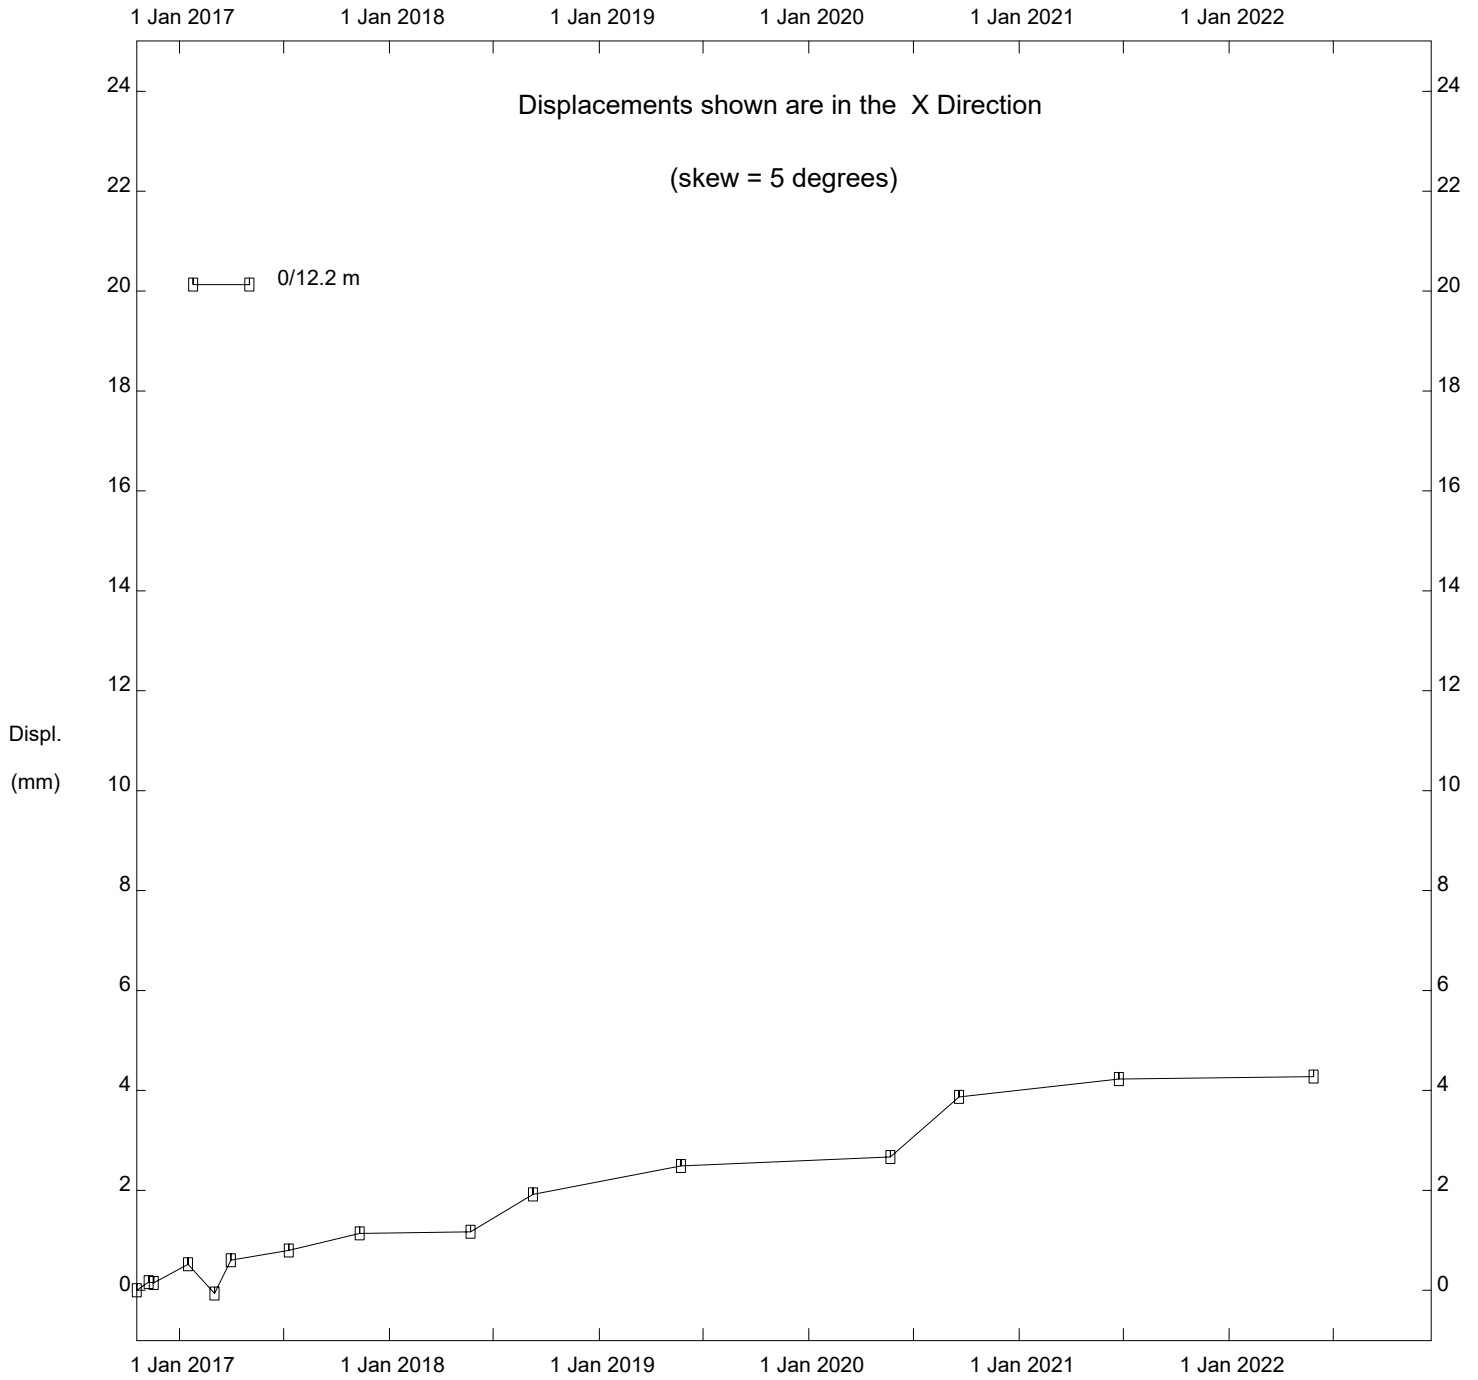
Hwy 41:23 Kehiwin Lake (NC102), Inclinometer SI16-1 (P04)

SI16-1, installed in the 2016 pile wall, showed a rate of movement of less than 0.1 mm/yr over the length of the pile from 0.0 m to 12.2 m depth since the spring of 2021 readings. SI16-1 has shown a total pile head movement of 4.3 mm to date. SI16-2, also installed in the 2016 pile wall, showed a rate of movement of 0.2 mm/yr over the length of the pile from 0.0 m to 12.2 m depth since the spring of 2021 readings. SI16-2 has shown a total pile head movement of 5.6 mm to date.
