July 5, 2022

**ALBERTA TRANSPORTATION GRMP (CON0022163)  
NORTH CENTRAL (ATHABASCA AND FORT McMURRAY DISTRICTS)  
INSTRUMENTATION MONITORING RESULTS – SPRING 2022**

**SITE NC102 (NC024-2): HWY 41:23 KEHIWIN LAKE (km 8.8)**

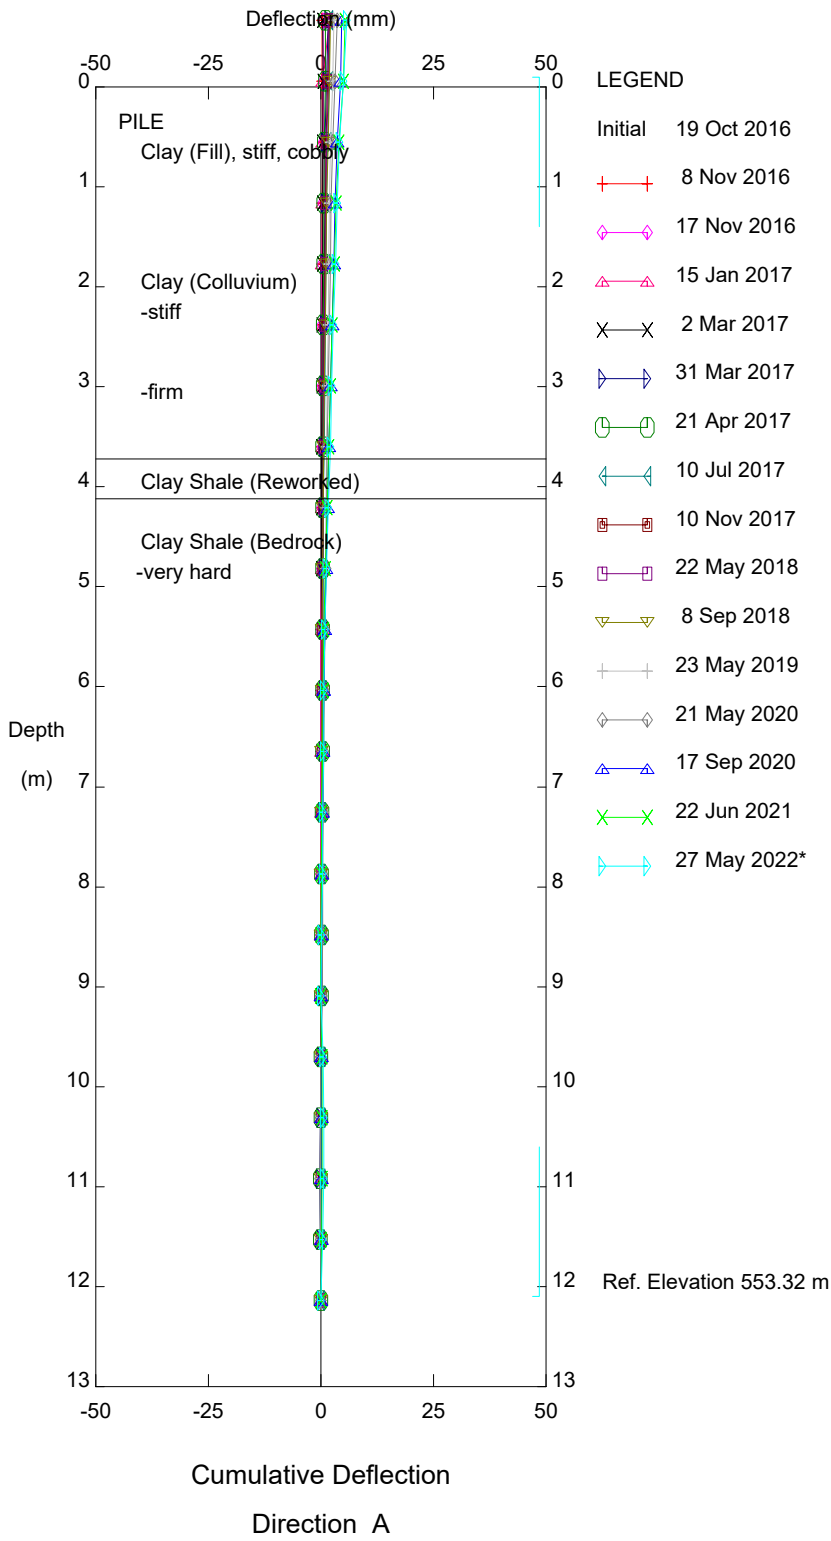
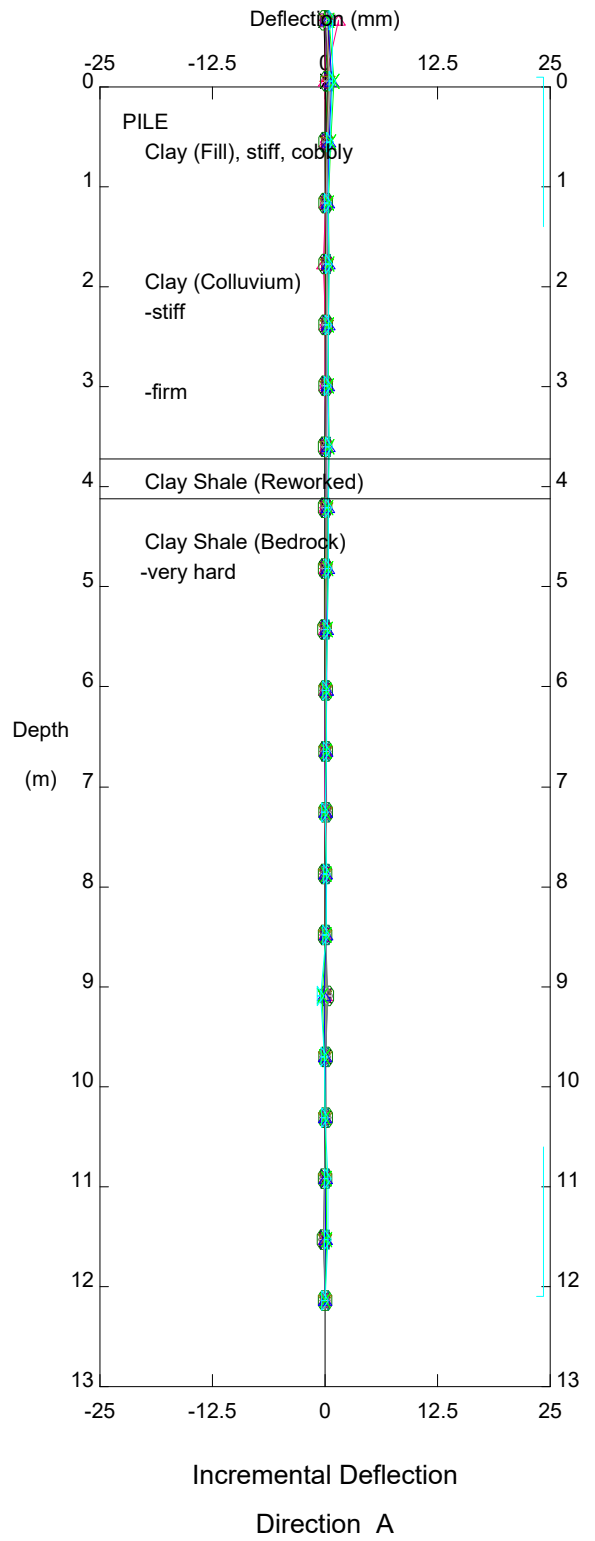
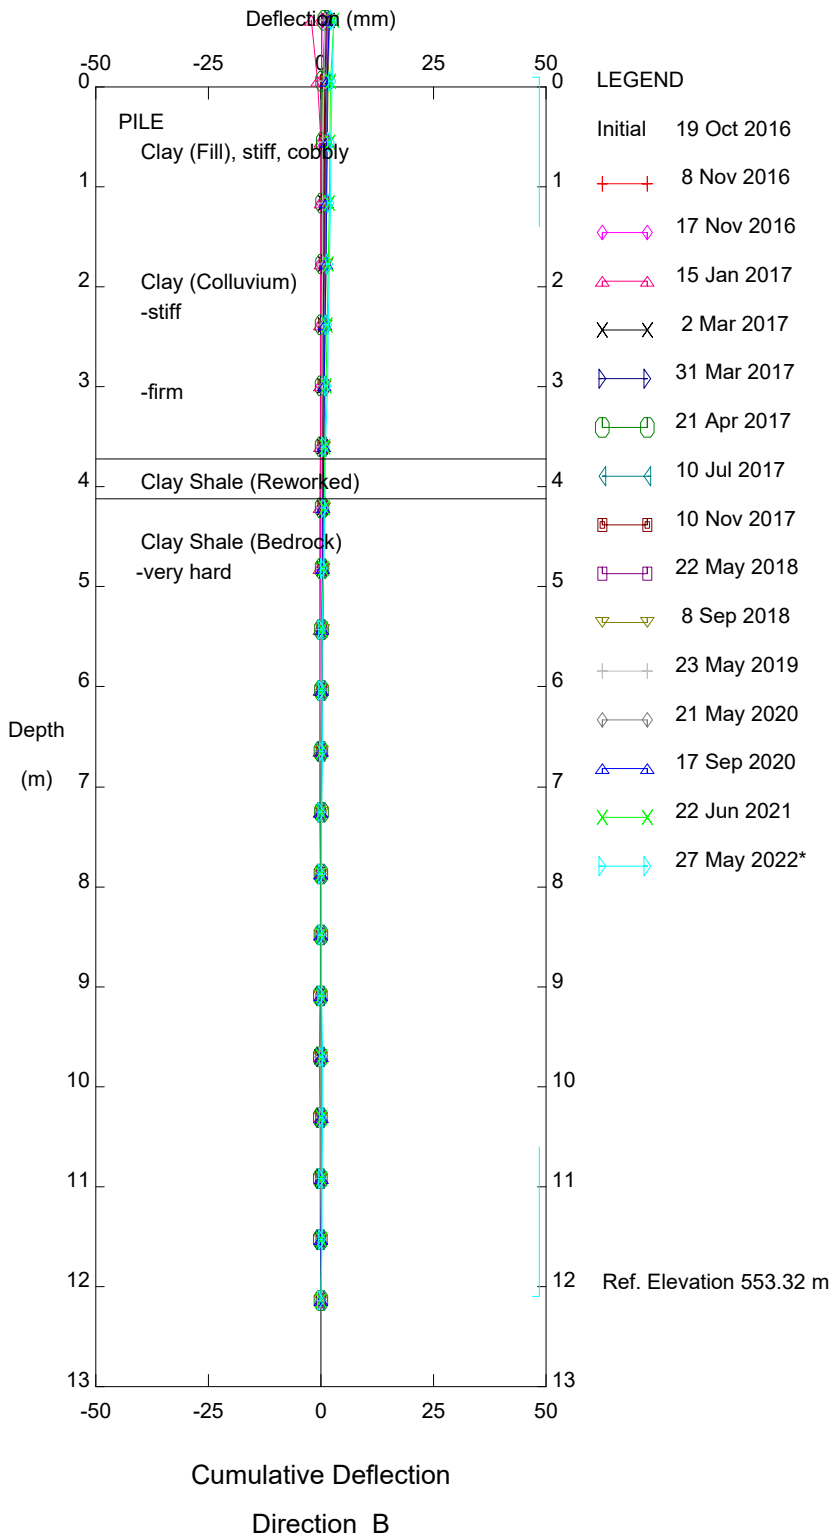
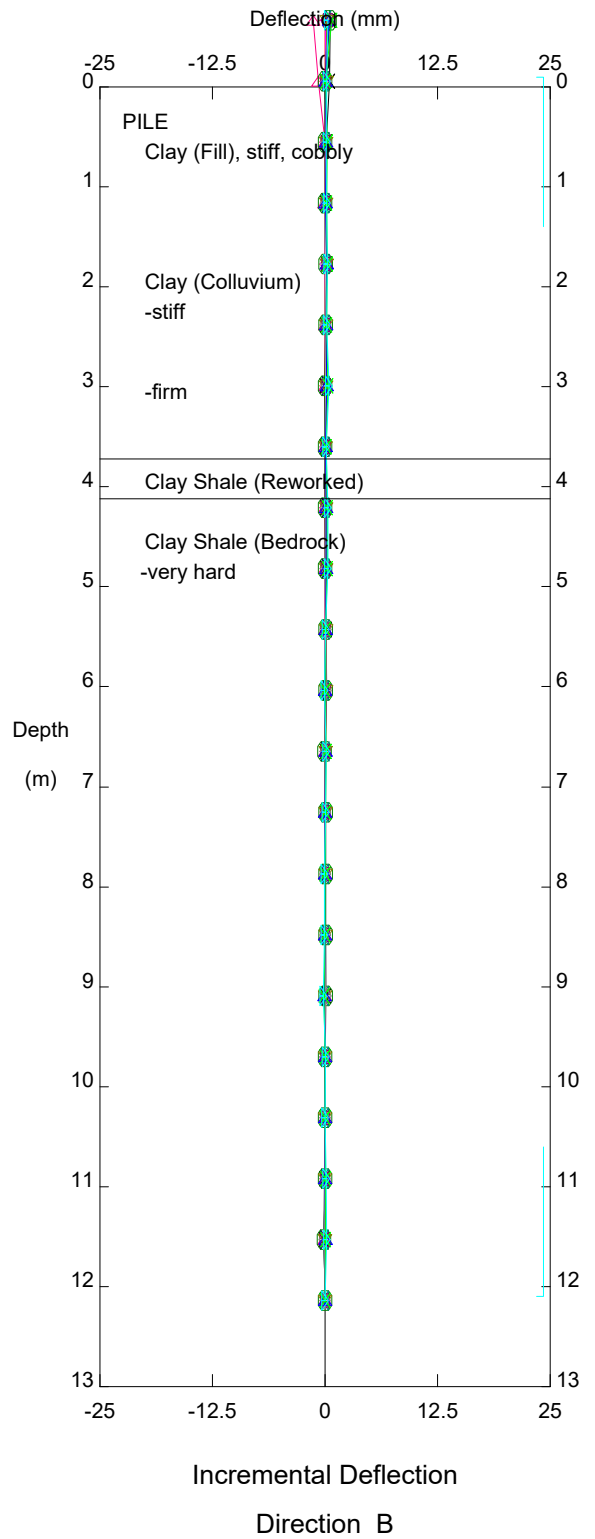
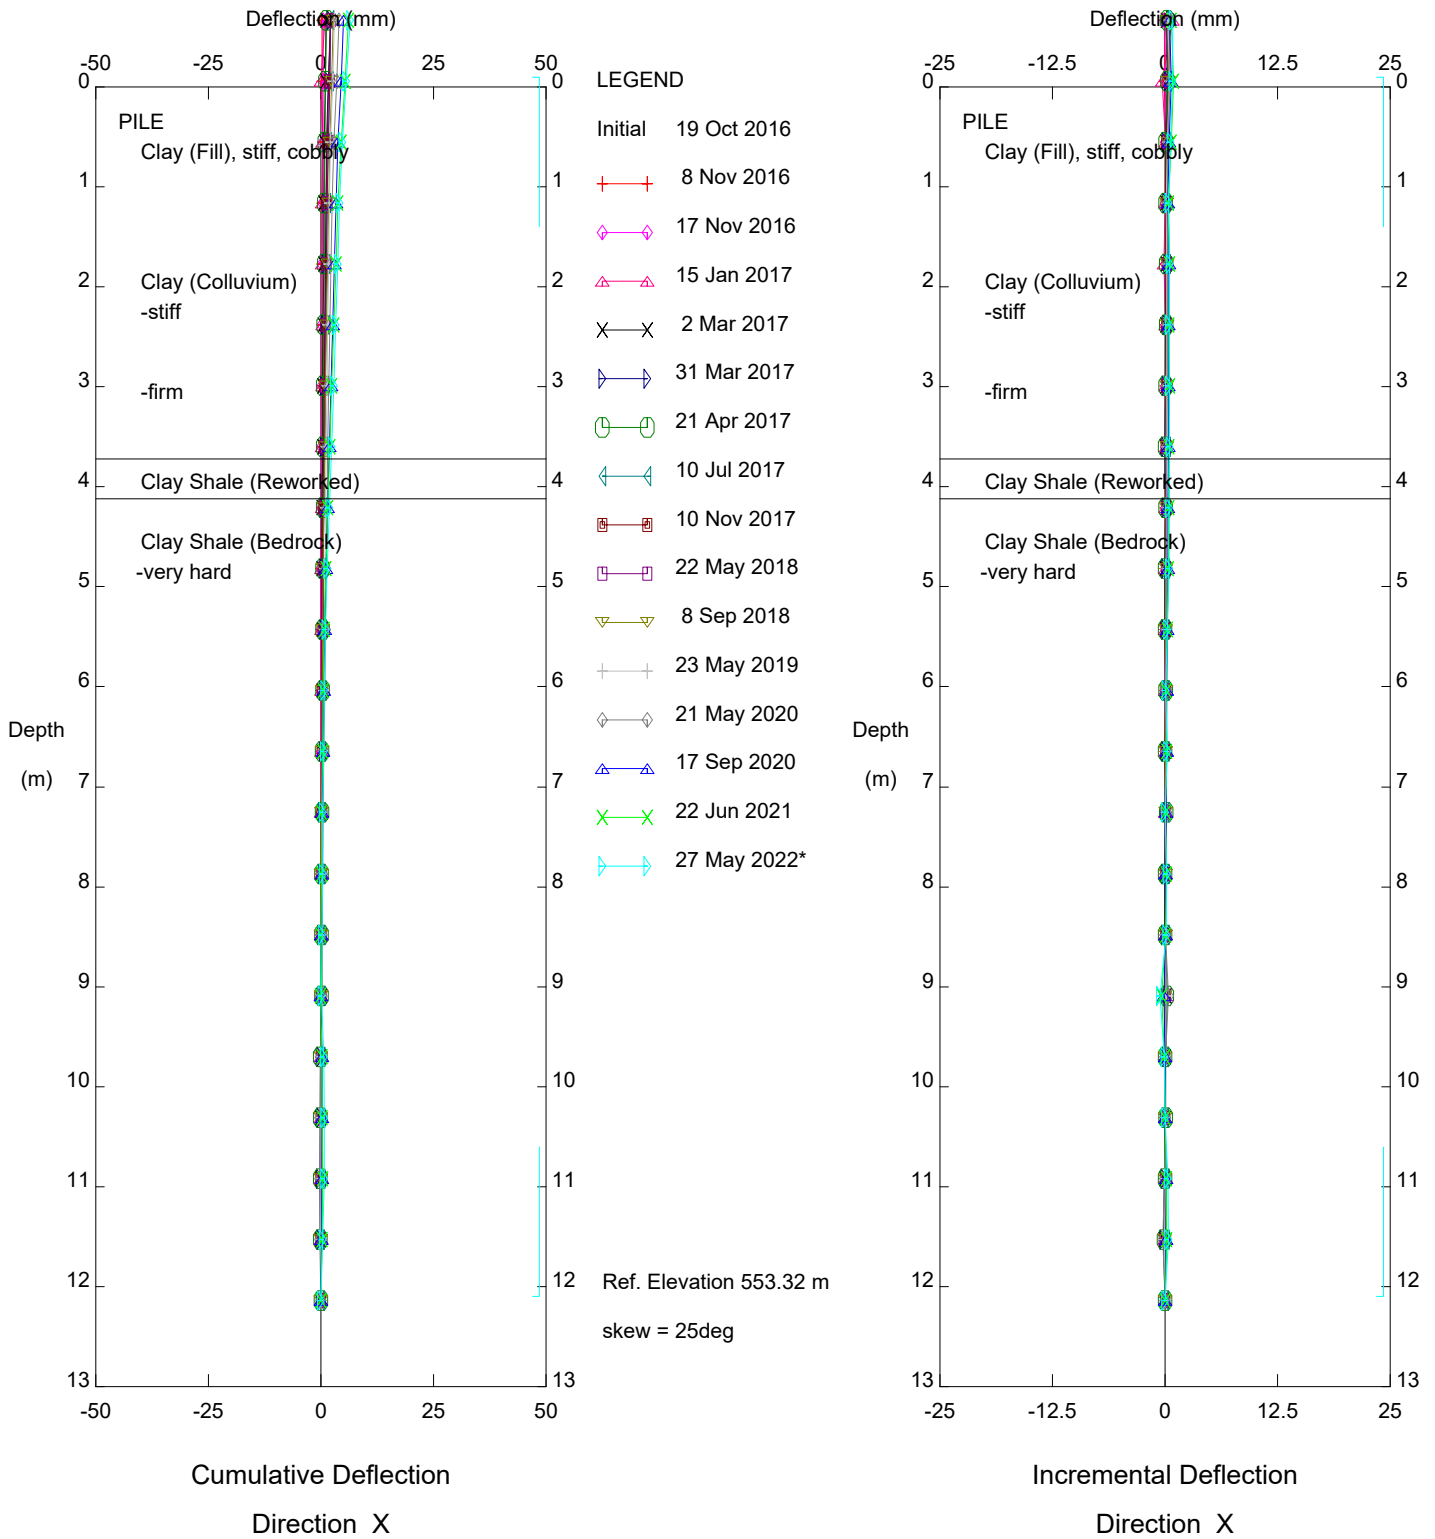
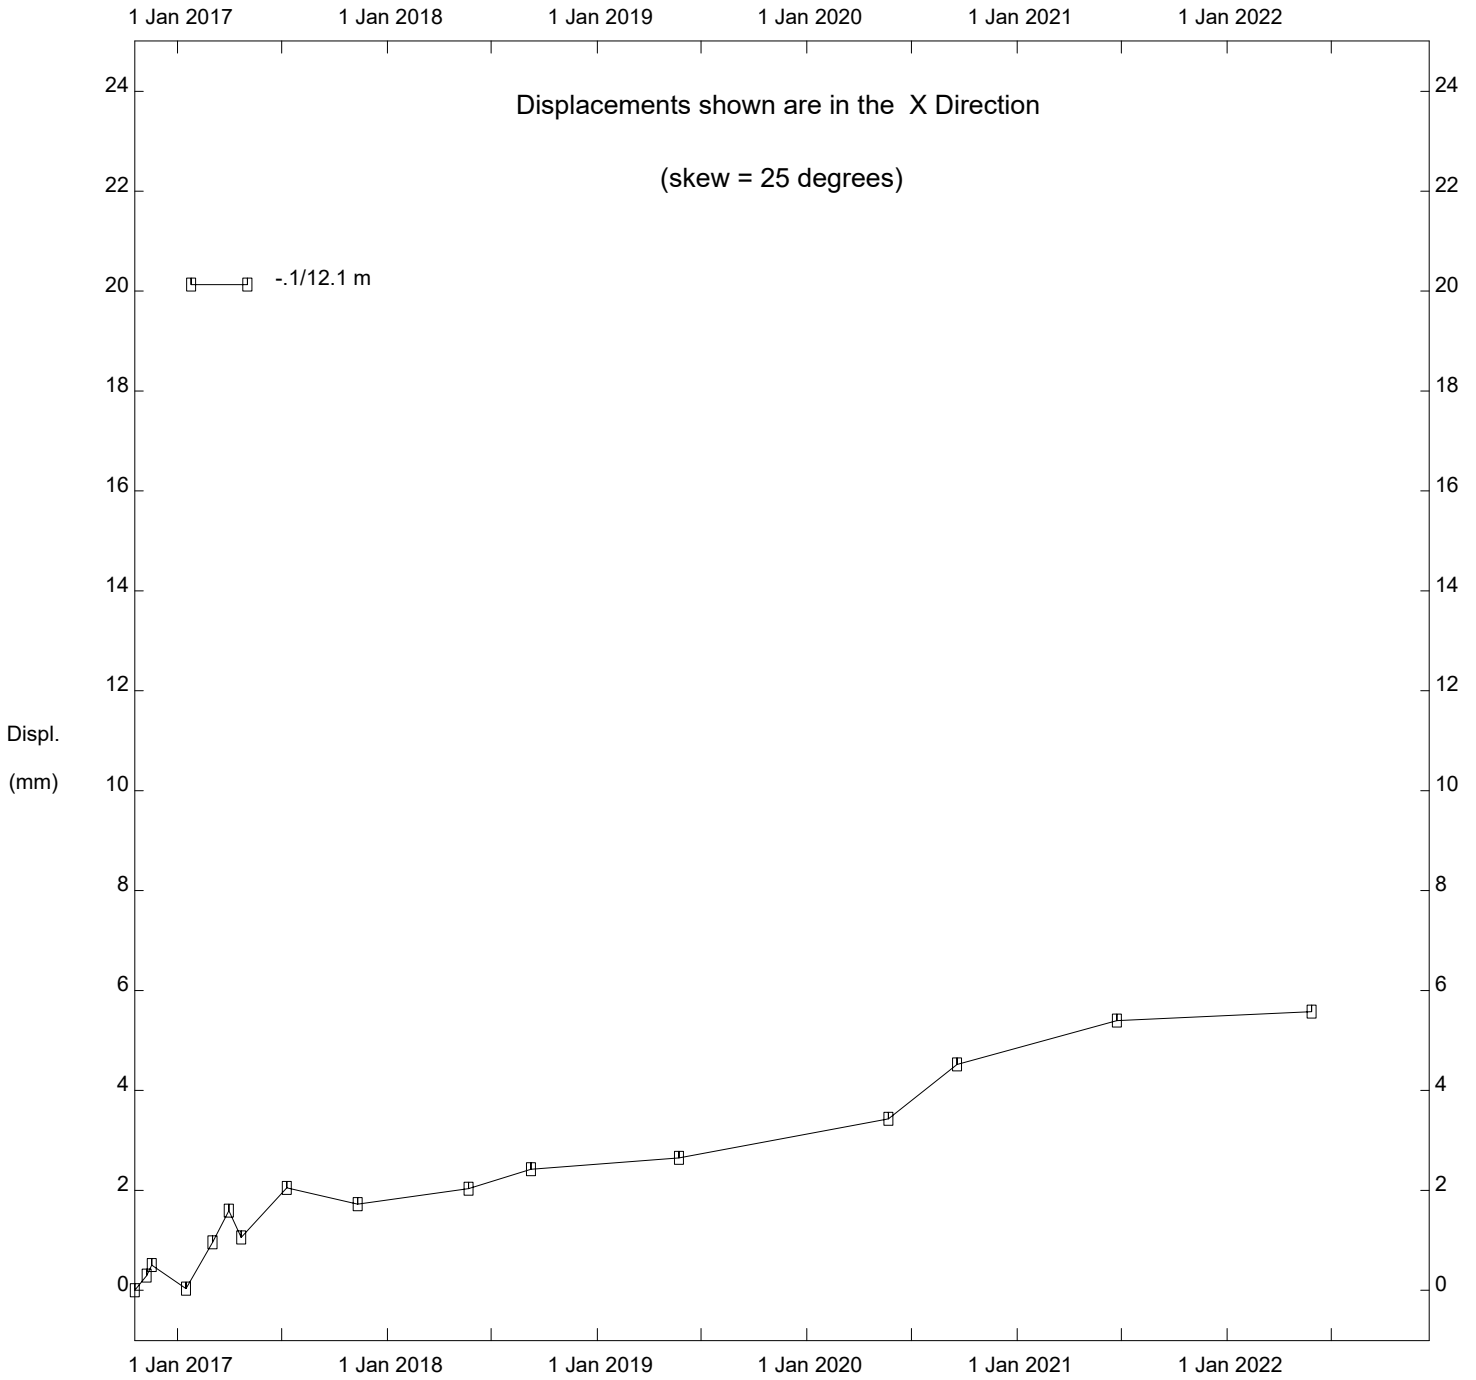
Hwy 41:23 Kehiwin Lake (NC102), Inclinator SI16-2 (P08)

SI16-1, installed in the 2016 pile wall, showed a rate of movement of less than 0.1 mm/yr over the length of the pile from 0.0 m to 12.2 m depth since the spring of 2021 readings. SI16-1 has shown a total pile head movement of 4.3 mm to date. SI16-2, also installed in the 2016 pile wall, showed a rate of movement of 0.2 mm/yr over the length of the pile from 0.0 m to 12.2 m depth since the spring of 2021 readings. SI16-2 has shown a total pile head movement of 5.6 mm to date.

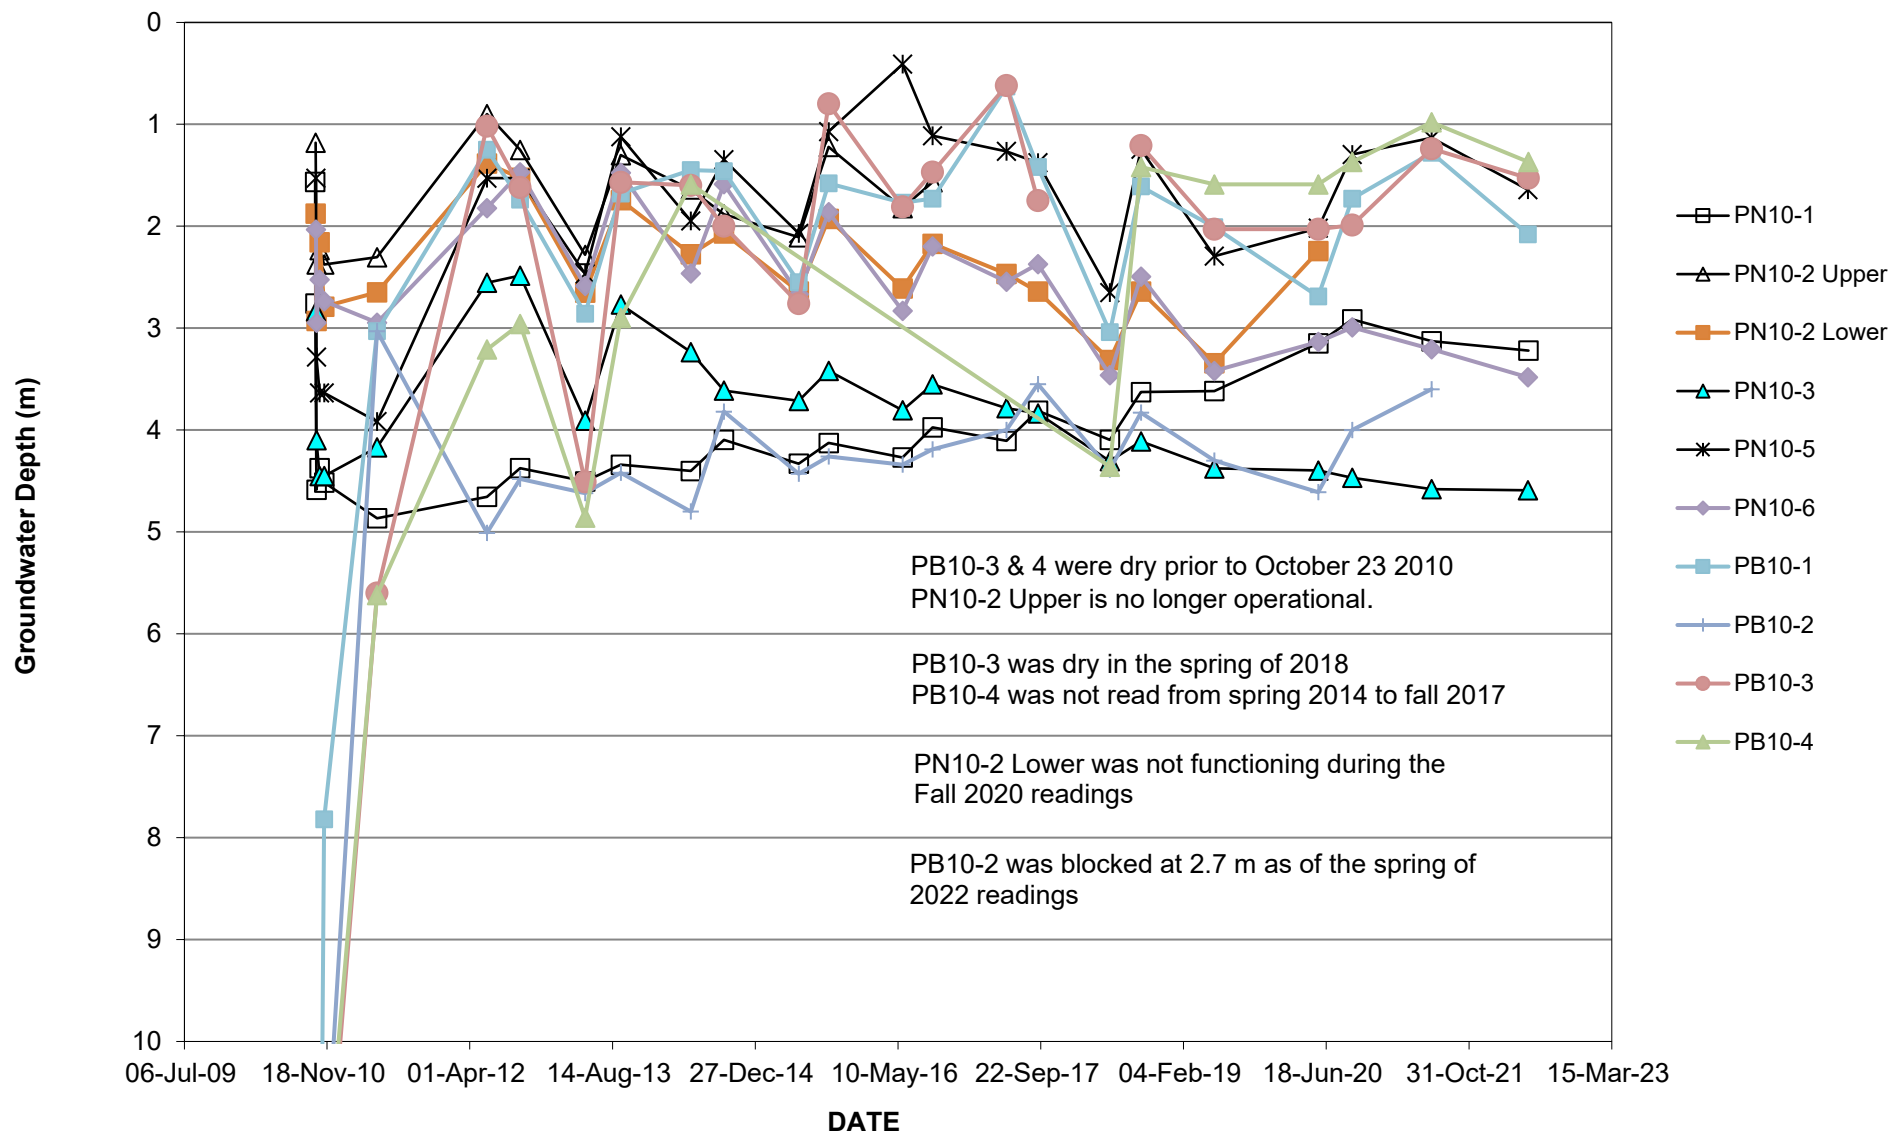
**FIGURE NC102-1  
PIEZOMETER DATA (2010 INSTRUMENTS) FOR NC024-2, KEHIWIN LAKE, km 8.89**

Most of the Pneumatic piezometers showed decreases in water levels, ranging from a decrease of 0.01 m in PN10-3, to a decrease of 0.51 m in PN10-5, since the spring of 2021 readings. The water level in PN15-3 increased by 0.02 m and was the highest recorded since initialization. The pneumatic piezometer readings are summarized in Table NC102-2.

Standpipe piezometers PB10-1, PB10-3, and PB10-4 showed decreases in groundwater level of 0.80 m, 0.29 m, and 0.39 m, respectively, since the spring of 2021 readings. The standpipe piezometer readings are summarized in Table NC102-3 .

The instruments should be read again in the spring of 2023. PB10-2 is blocked at 2.7 m below the top of pipe. When the instrument was read during the spring of 2021 readings, the dipmeter became stuck inside the pipe. It should therefore be removed from the readings program going forward.
