ALBERTA TRANSPORTATION AND  
ECONOMIC CORRIDORS GRMP  
NORTH CENTRAL (ATHABASCA AND FORT  
McMURRAY DISTRICTS)  
INSTRUMENTATION MONITORING- SPRING 2024

Site Number	Location	Name	Hwy	km
NC103 (NC024-3)	HWY 41:23 C1 7.89	Kehiwin Lake	41:23	Km 7.8
<b>Legal Description:</b> 9-25-58-7 W4		<b>UTM Co-ordinates</b>		
		12U E 506737.94	N	5988417.59

<b>Current Monitoring:</b>	7-June-2024	<b>Previous Monitoring</b>	06-Oct-2023
<b>Instruments Read By:</b>	Mr. Niraj Regmi, G.I.T and Mr. Nixson Mationg, of Thurber

**ALBERTA TRANSPORTATION AND ECONOMIC CORRIDORS GRMP (CON0022163)  
NORTH CENTRAL (ATHABASCA AND FORT McMURRAY DISTRICTS)  
INSTRUMENTATION MONITORING RESULTS**

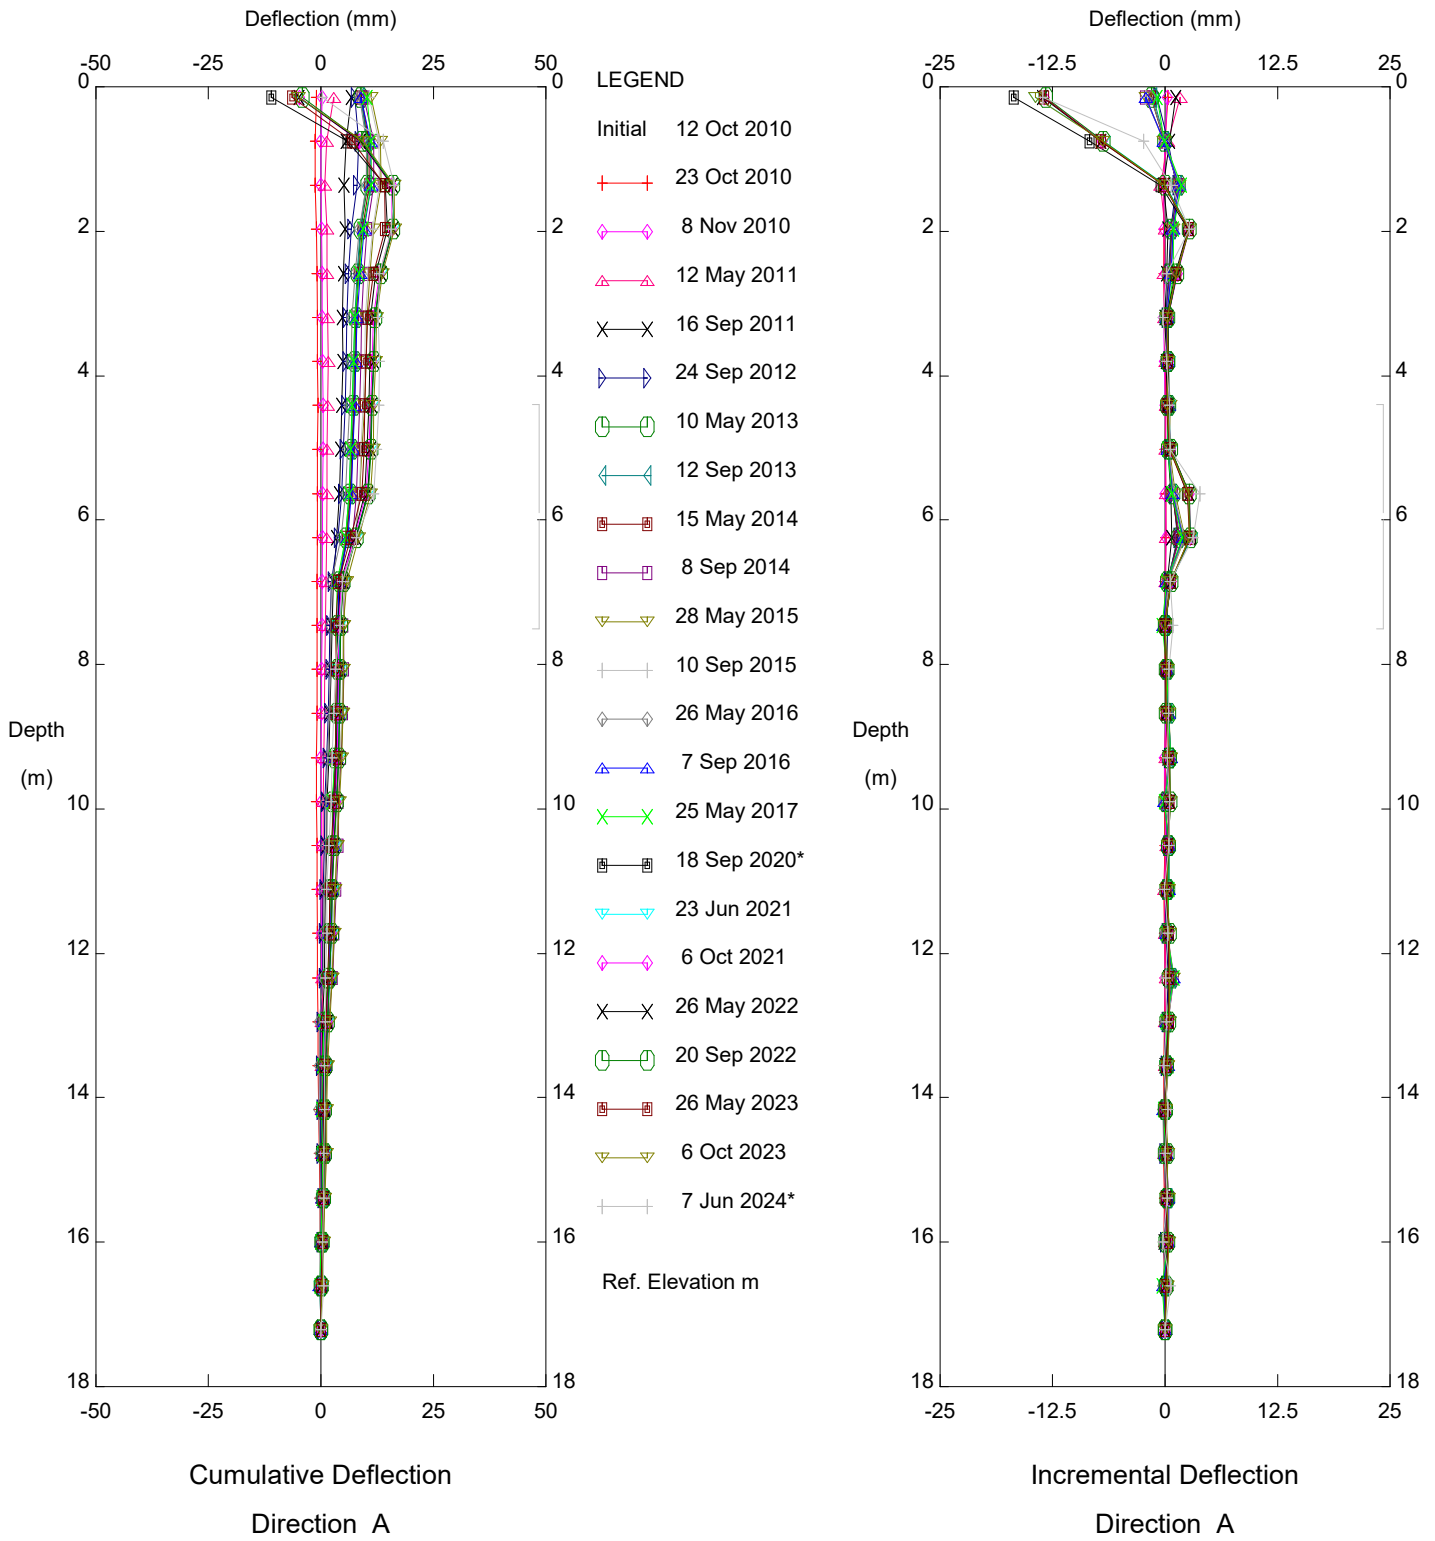
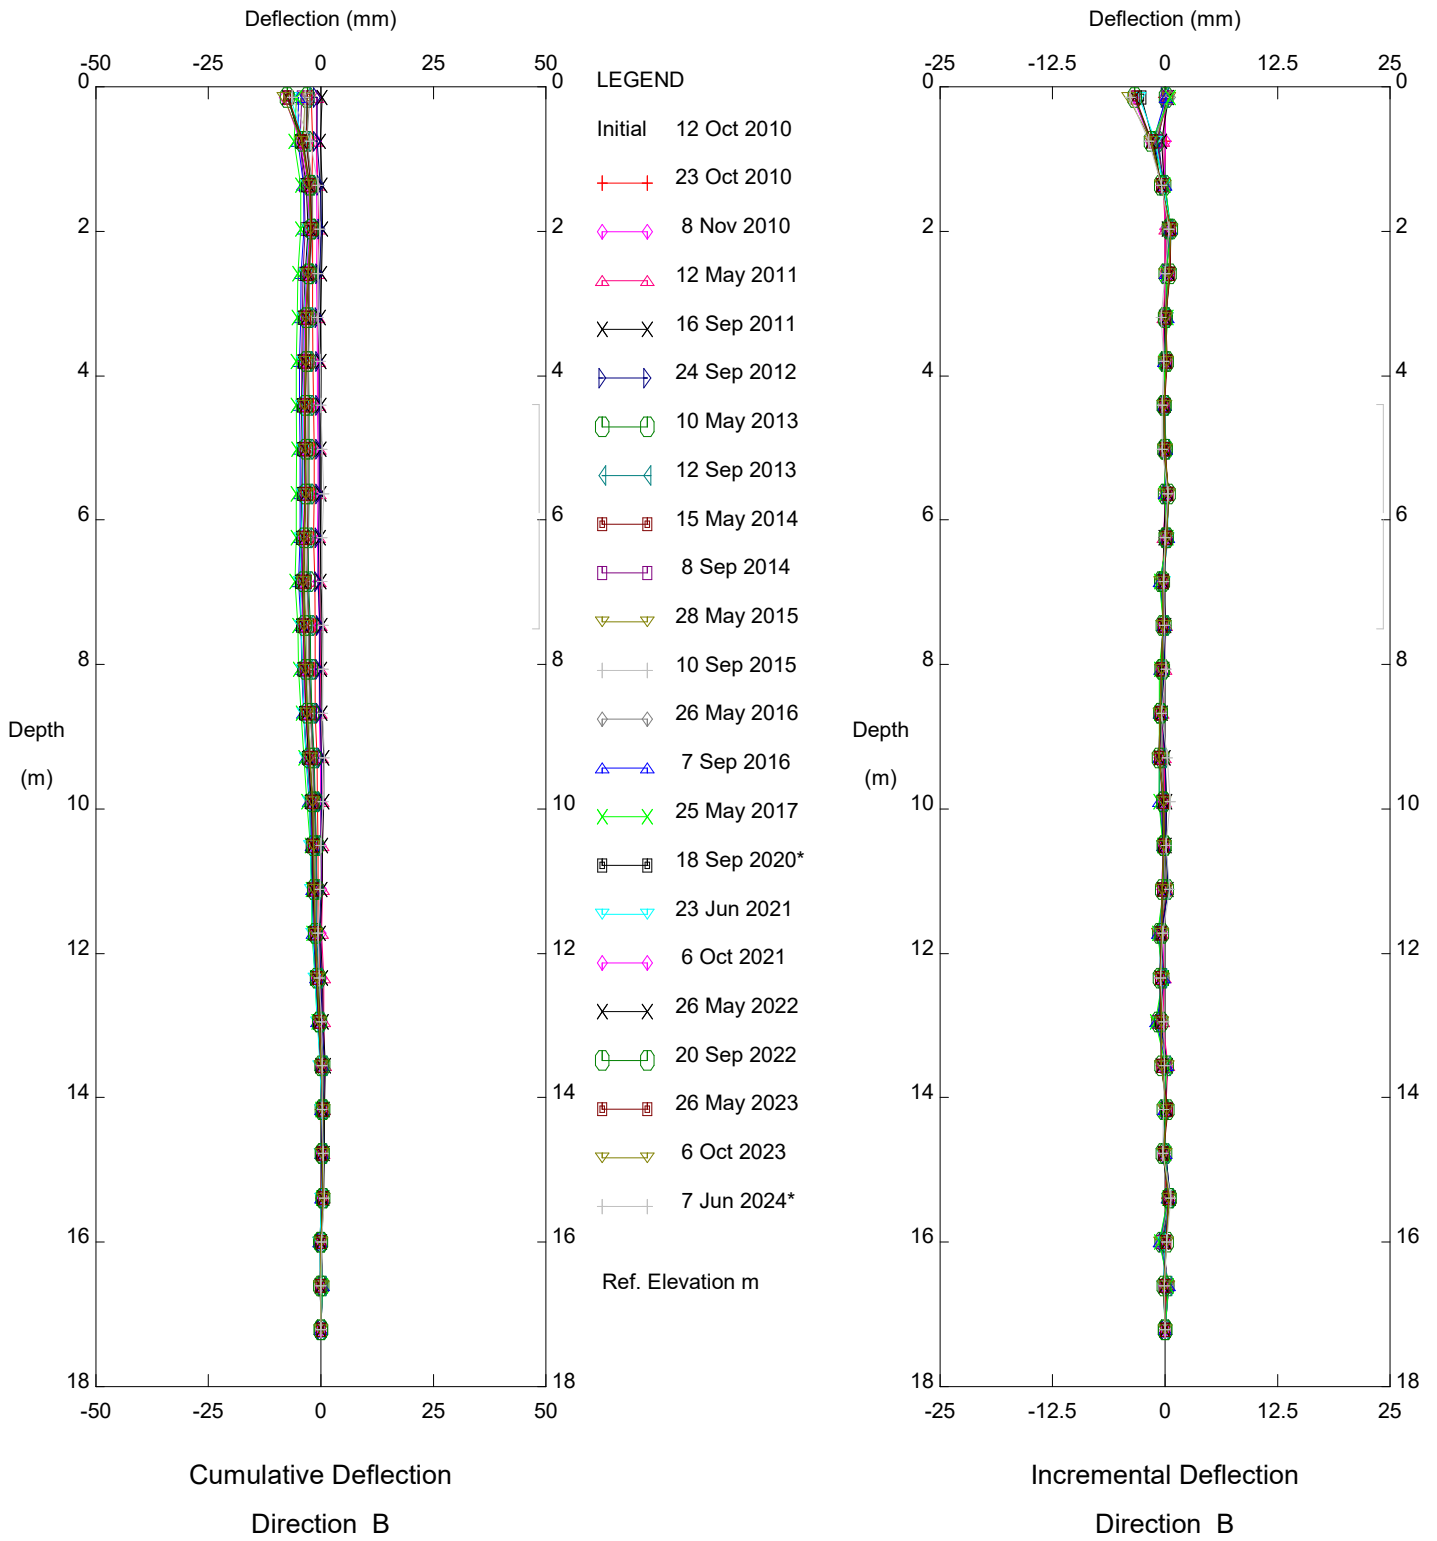
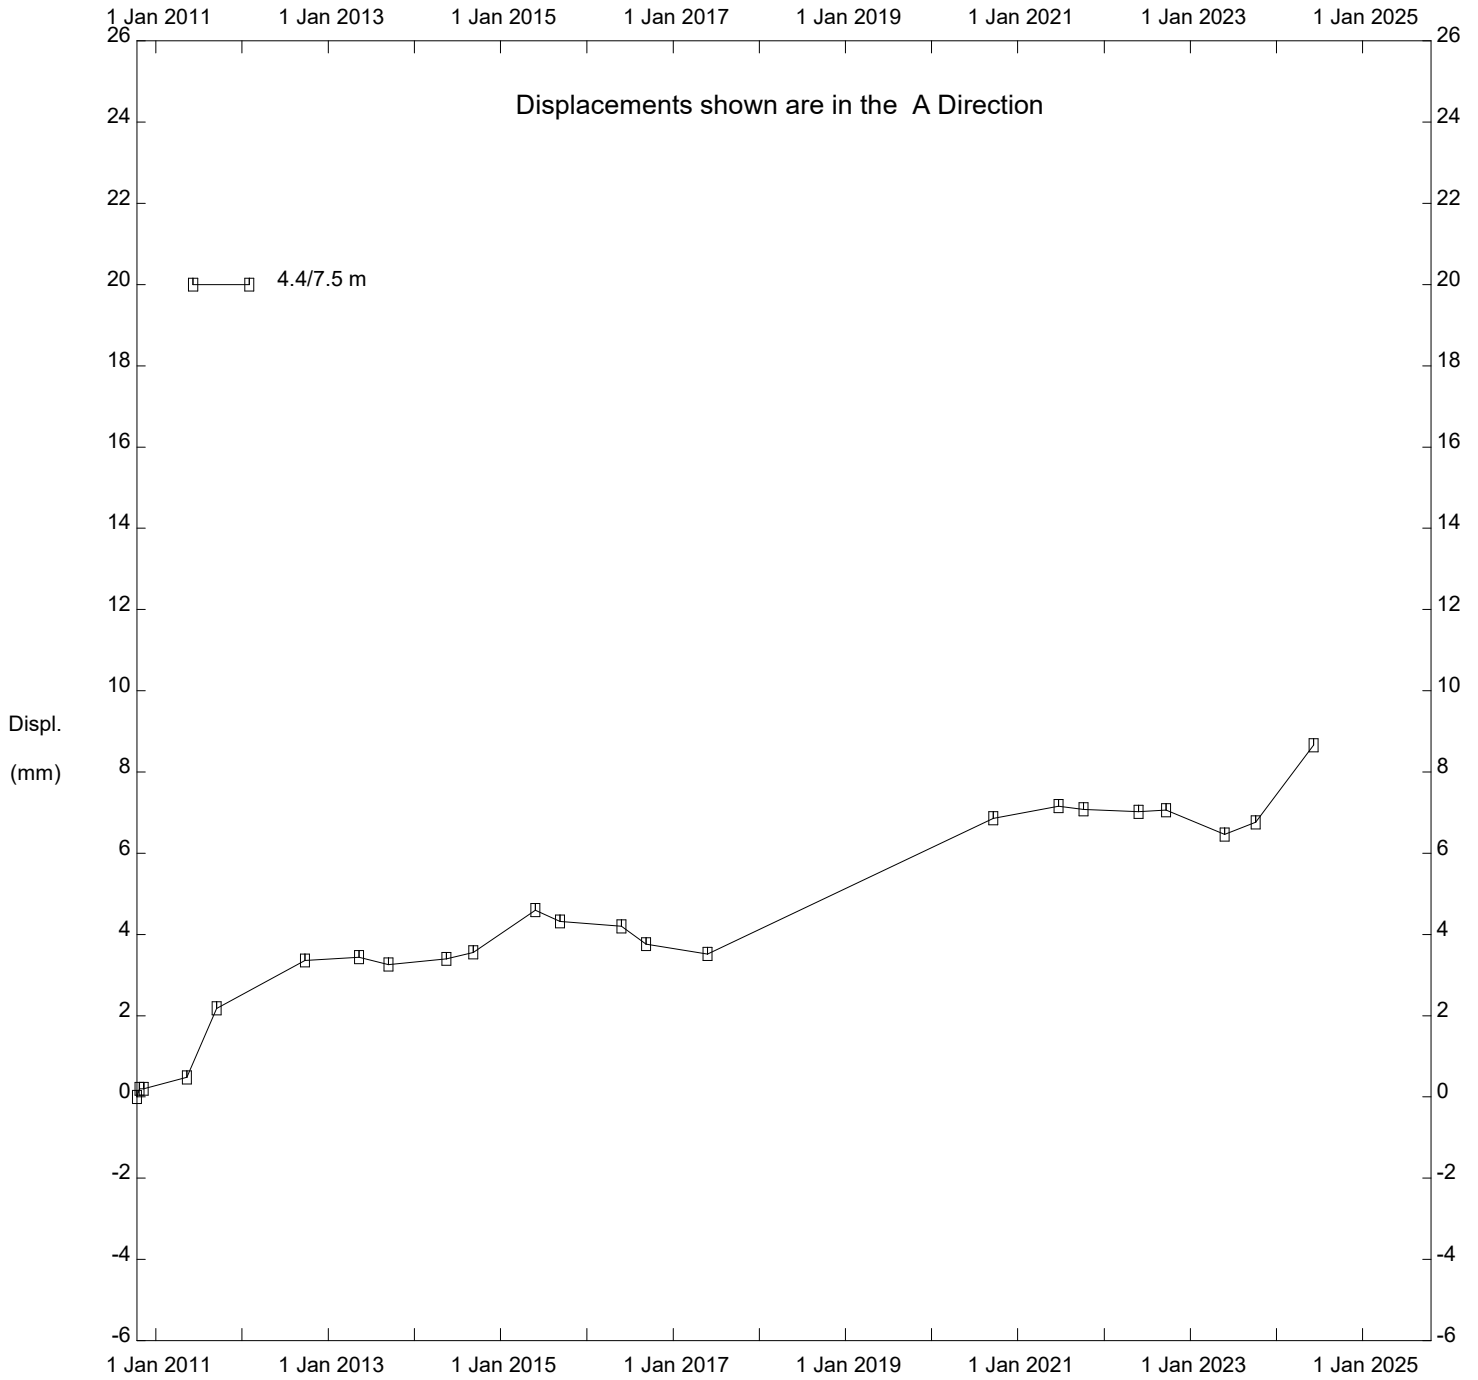
Hwy 41:23 Kehewin Lake (NC103), Inclinometer SI10-1

Discussion	
<b>Zones of New Movement:</b>	None
<b>Interpretation of Monitoring Results:</b>	<p>SI10-1, installed in the east highway ditch, showed a rate of movement of 2.8 mm/yr over 4.4 to 7.5 m depth since the fall of 2023 readings. SI10-3, installed at the bottom of the slope downslope of the pile wall location, showed no discernible movement since the fall of 2023 readings. SI11-1 showed a rate of movement of 1.0 mm/yr over 0.7 to 14.8 m depth. SI11-2 showed a rate of movement of 0.6 mm/yr over 0.7 m to 14.7 m depth. SI11-3 showed no discernible movement over 0.5 to 14.6 m depth since the fall of 2023 readings. SI11-4 showed a rate of movement of 0.3 mm/yr over 0.8 to 14.9 m depth.</p> <p>The cumulative movements in the SIs installed in the piles were as follows:</p>

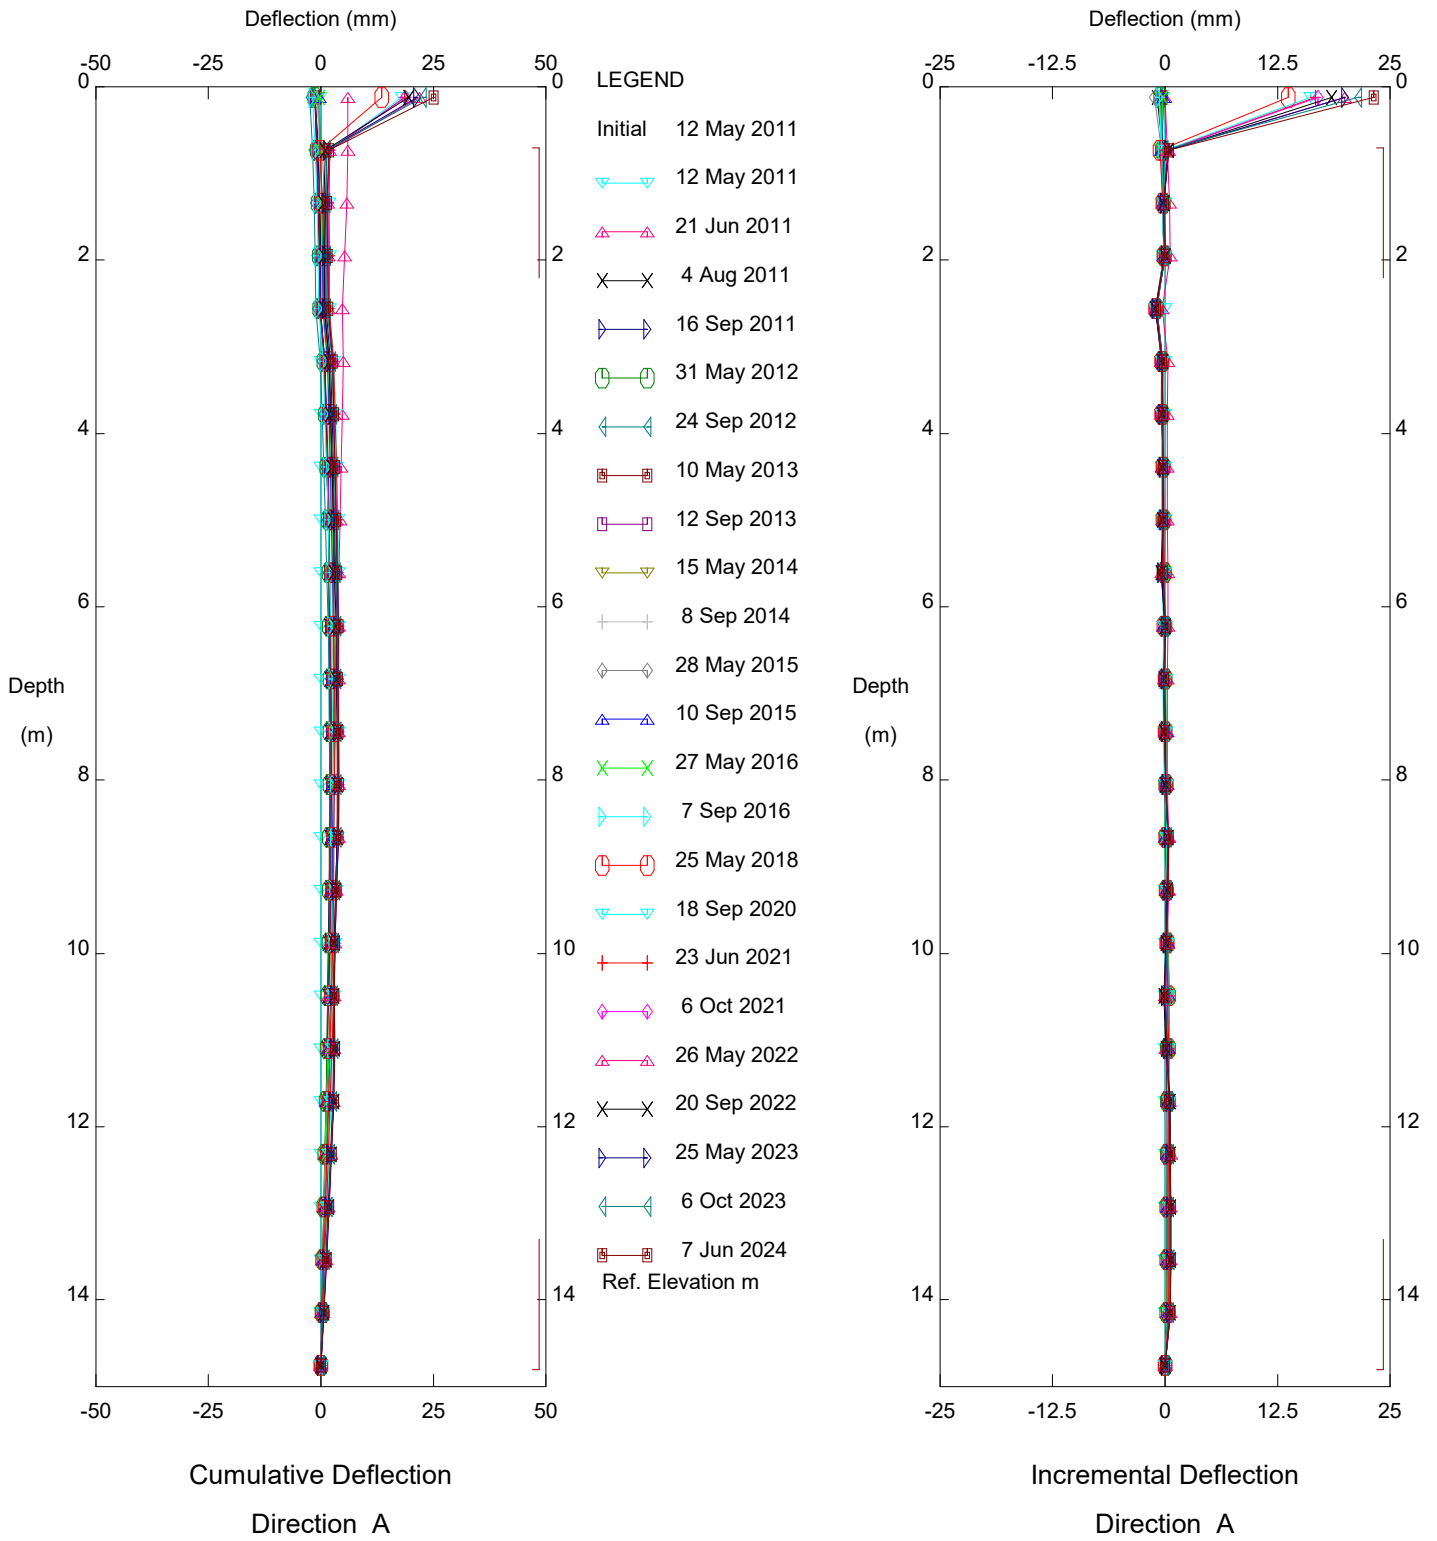
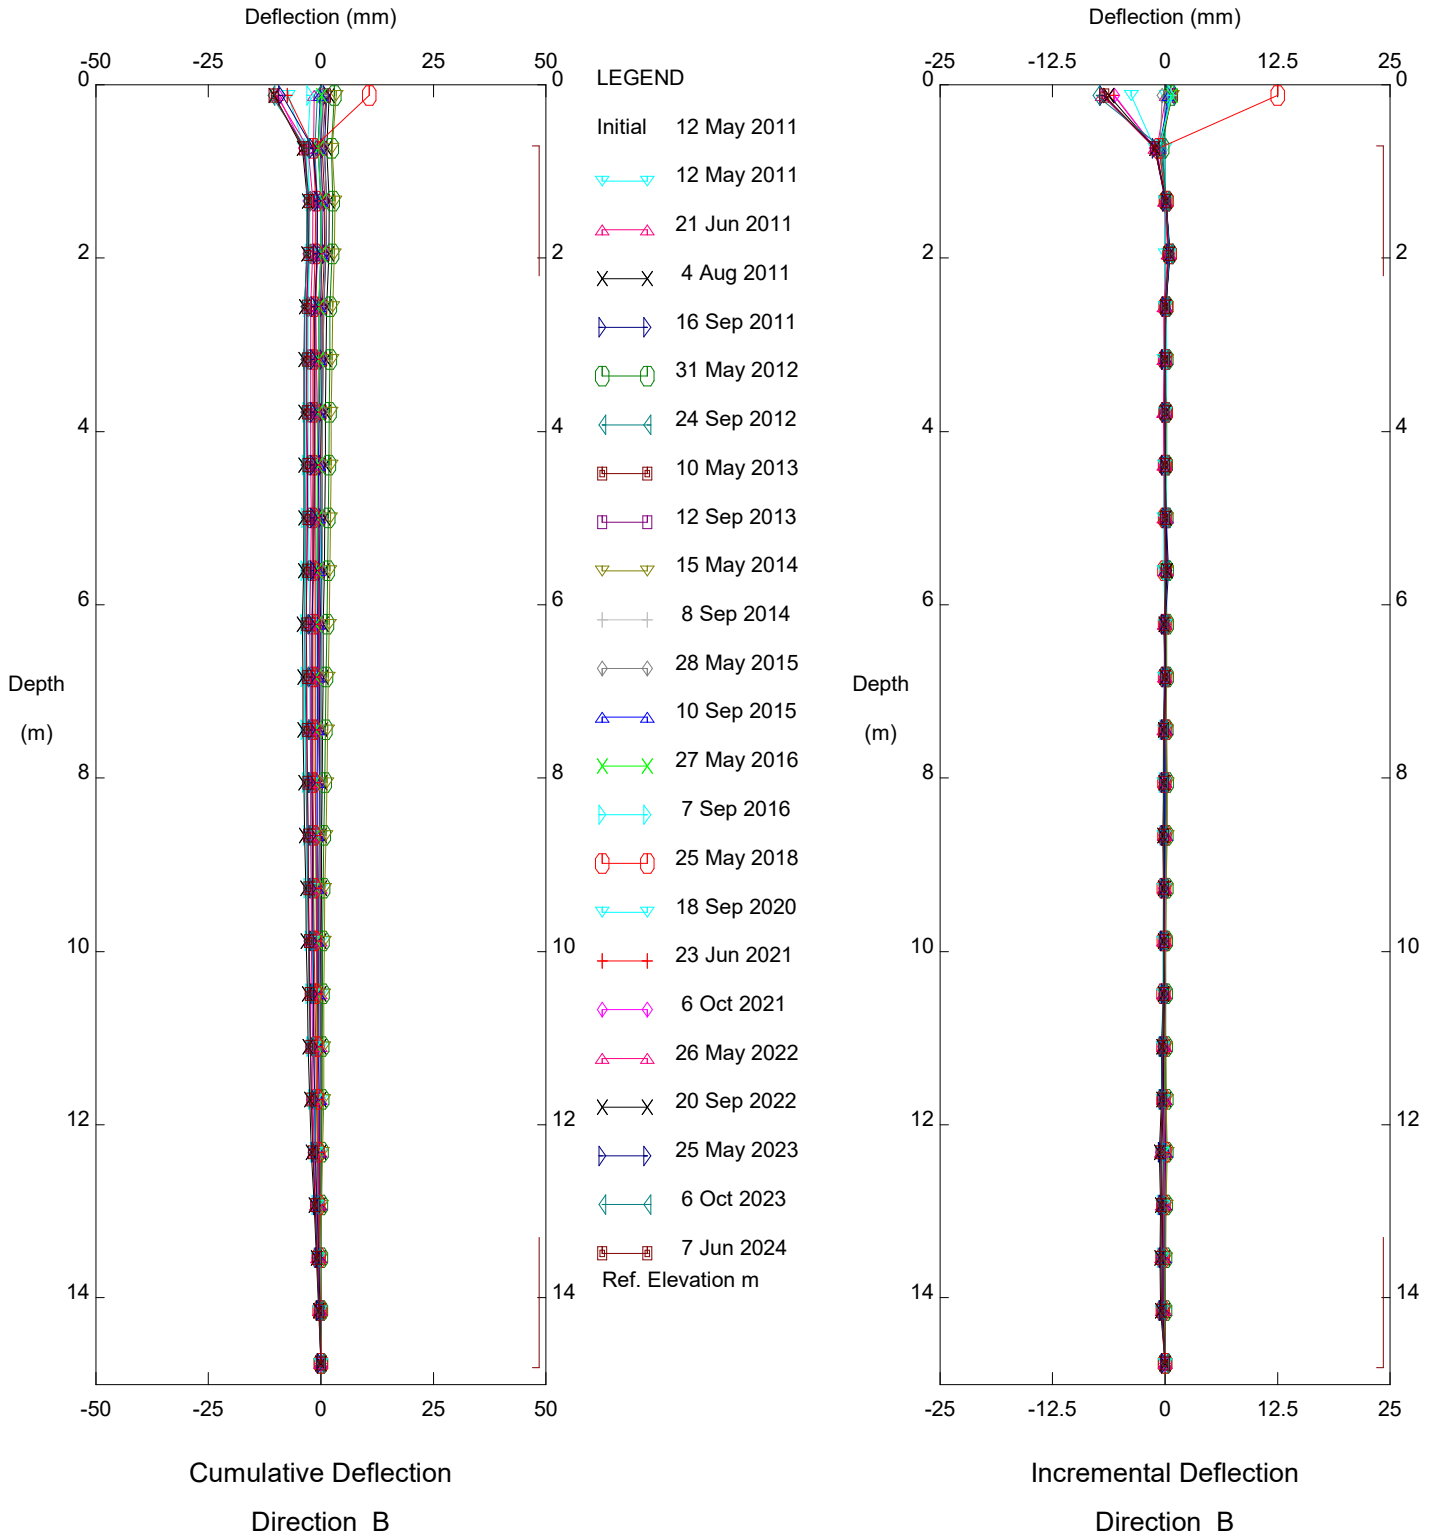
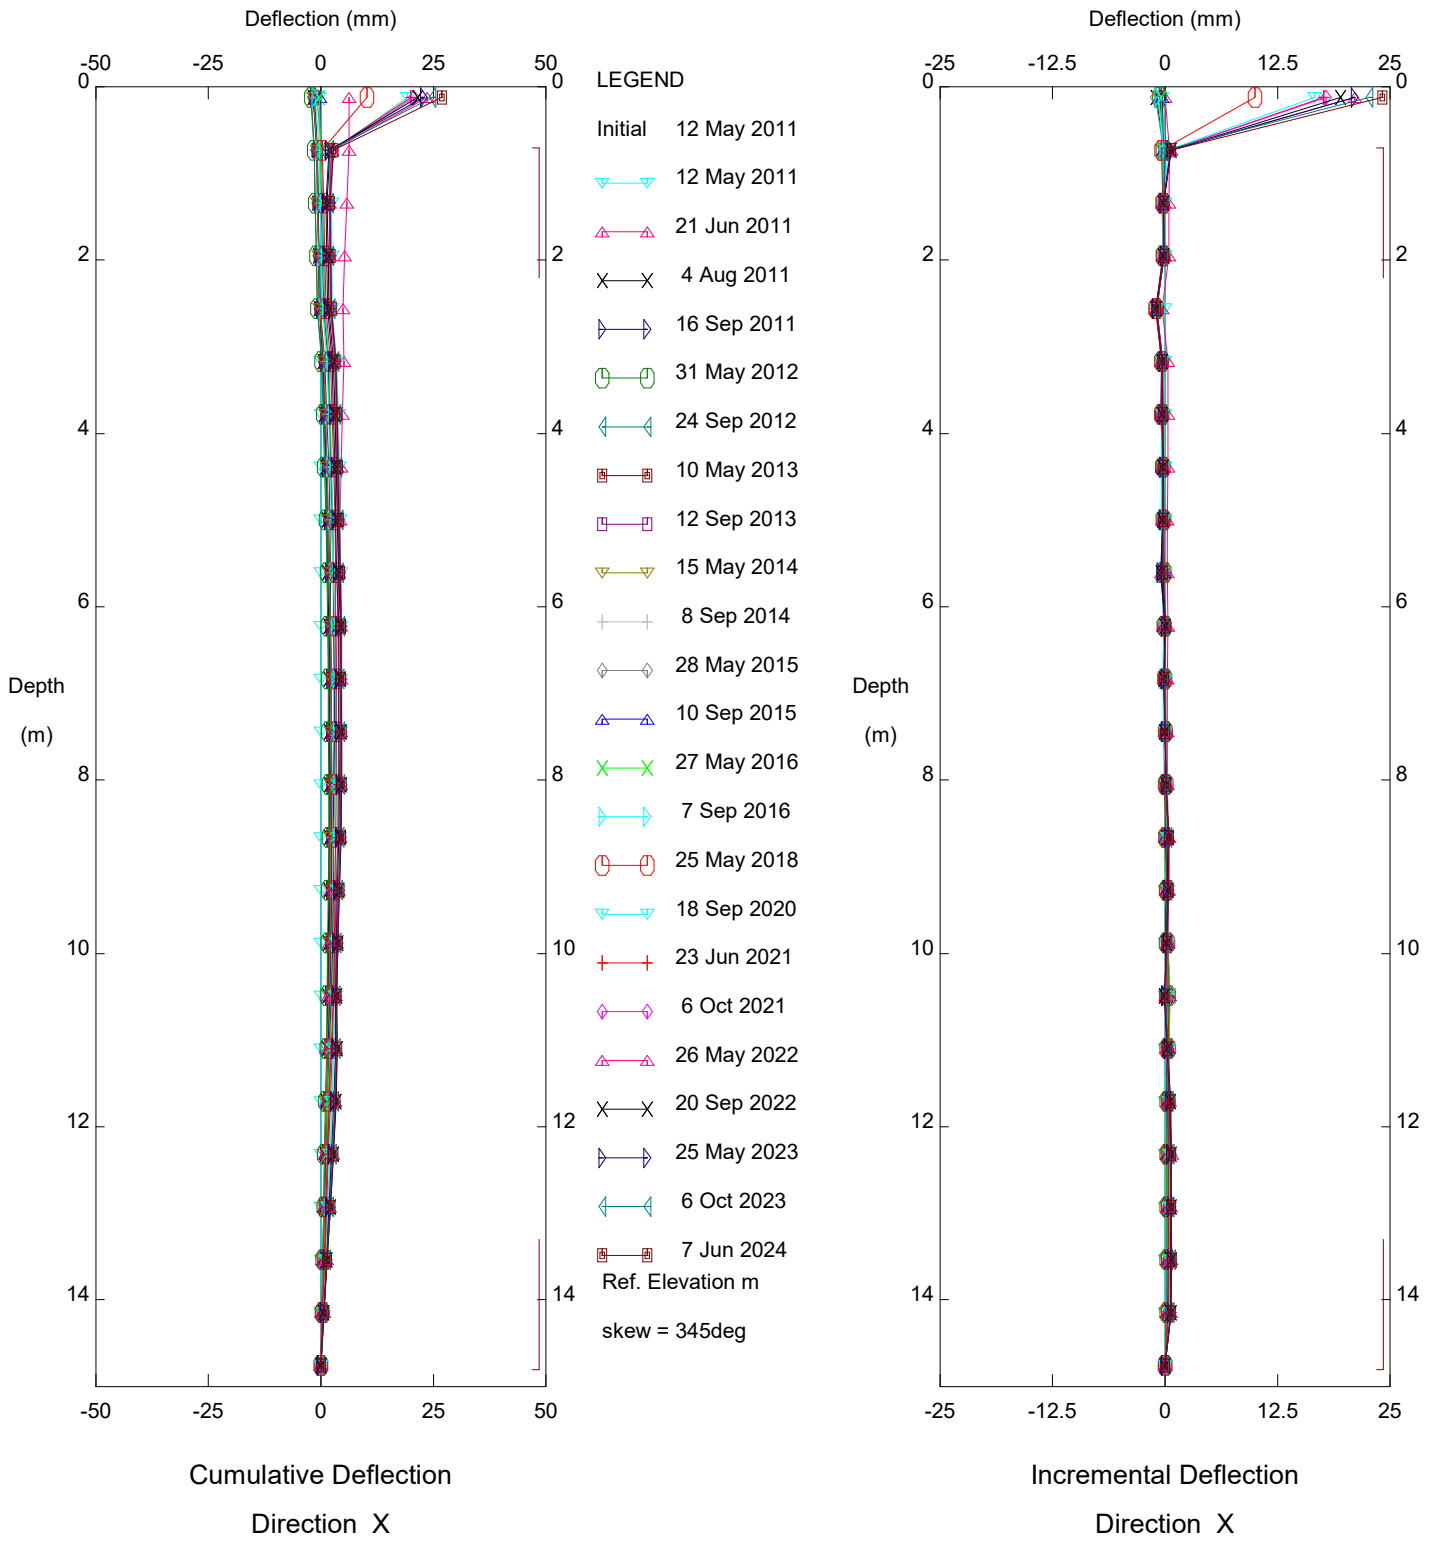
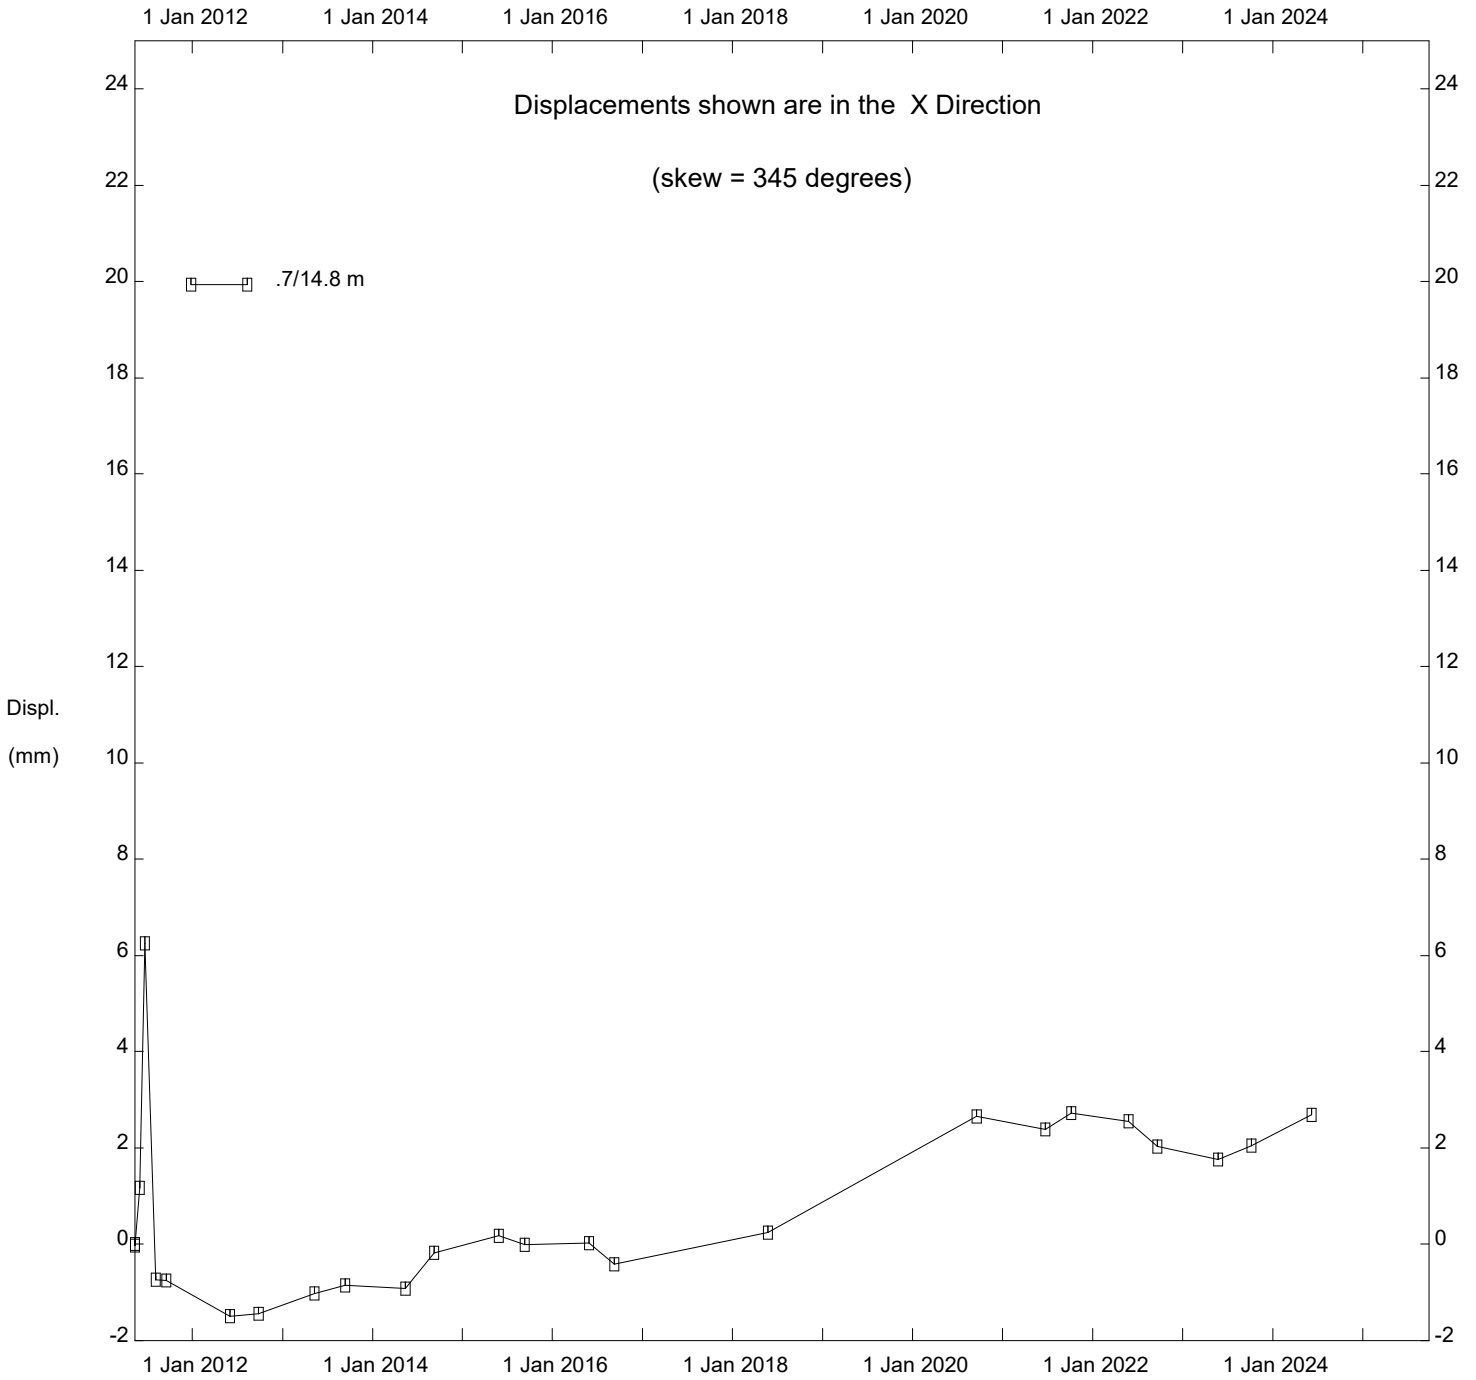
Hwy 41:23 Kehewin Lake (NC103), Inclinator SI11-1(P9)

<ul style="list-style-type: none"> <li>• SI11-1 = 2.7 mm pile head movement over 0.7 to 14.8 m depth</li> <li>• SI11-2 = 0.4 mm pile head movement over 0.7 to 14.7 m depth</li> <li>• SI11-3 = -7.5 mm pile head movement over 0.5 to 14.6 m depth</li> <li>• SI11-4 = -8.3 mm pile head movement over 0.8 m to 14.9 m depth</li> </ul> <p>Pneumatic piezometers PN10-1 and PN10-3 showed decreases in groundwater level of 0.43 m and 0.36 m, respectively, since the fall of 2023 readings.</p> <p>Standpipe piezometer PB10-1 and PB10-4 showed decreases in groundwater level of 0.14 m, and 0.01 m, respectively, since the fall of 2023 readings. Standpipe piezometer PB10-2 showed an increase in groundwater level of 0.19 m since the fall of 2023 readings.</p> <p>Load cells VC1706, VC1707, VC1708, VC1709, VC1712, VC1713, and VC1715 showed increases in the measured load of 2.26 kN, 3.72 kN, 2.48 kN, 1.45 kN, 1.39 kN, 1.63 kN, and 13.26 kN, respectively since the fall of 2023 readings. VC1714 showed a decrease of in the measured load of 90.35 since the fall of 2023 readings, however, this significant decrease could be attributed to the inconsistency of the number of operating wires between the fall of 2023 and the spring of 2024.</p> <p>The current measured load in VC1715 is the highest ever recorded in this load cells. Load cell VC1715 has shown a trend of gradually increasing loads for several reading cycles, indicating the load cell may be malfunctioning.</p> <p>The current load in VC1707 and VC1715 are the highest recorded in the instruments since they were installed. The load in VC1715 is about 41.7 percent higher than the lock off load. The remaining load cells have shown decreases in measured loads, when compared to the lock off load, ranging from 10.3 percent to 49.6 percent. However, the load cells with the largest variations in load values have lost one or more vibrating wire channels over several reading cycles. In addition, the reductions in the loads have not been consistent with the observed movement patterns of the walls, based on the slope inclinometer readings.</p> <p>If significant reductions in anchor loads occur in the future in response to the wall deflection towards west, the anchors will need to be restressed to maintain the wall's lateral deflection within the design limit.</p>
