ALBERTA TRANSPORTATION AND  
ECONOMIC CORRIDORS GRMP  
NORTH CENTRAL (ATHABASCA AND FORT  
McMURRAY DISTRICTS)  
INSTRUMENTATION MONITORING- SPRING 2024

Site Number	Location	Name	Hwy	km
NC103 (NC024-3)	HWY 41:23 C1 7.89	Kehiwin Lake	41:23	Km 7.8
<b>Legal Description:</b> 9-25-58-7 W4		<b>UTM Co-ordinates</b>		
		12U E 506737.94	N	5988417.59

<b>Current Monitoring:</b>	7-June-2024	<b>Previous Monitoring</b>	06-Oct-2023
<b>Instruments Read By:</b>	Mr. Niraj Regmi, G.I.T and Mr. Nixson Mationg, of Thurber

**ALBERTA TRANSPORTATION AND ECONOMIC CORRIDORS GRMP (CON0022163)  
NORTH CENTRAL (ATHABASCA AND FORT McMURRAY DISTRICTS)  
INSTRUMENTATION MONITORING RESULTS**

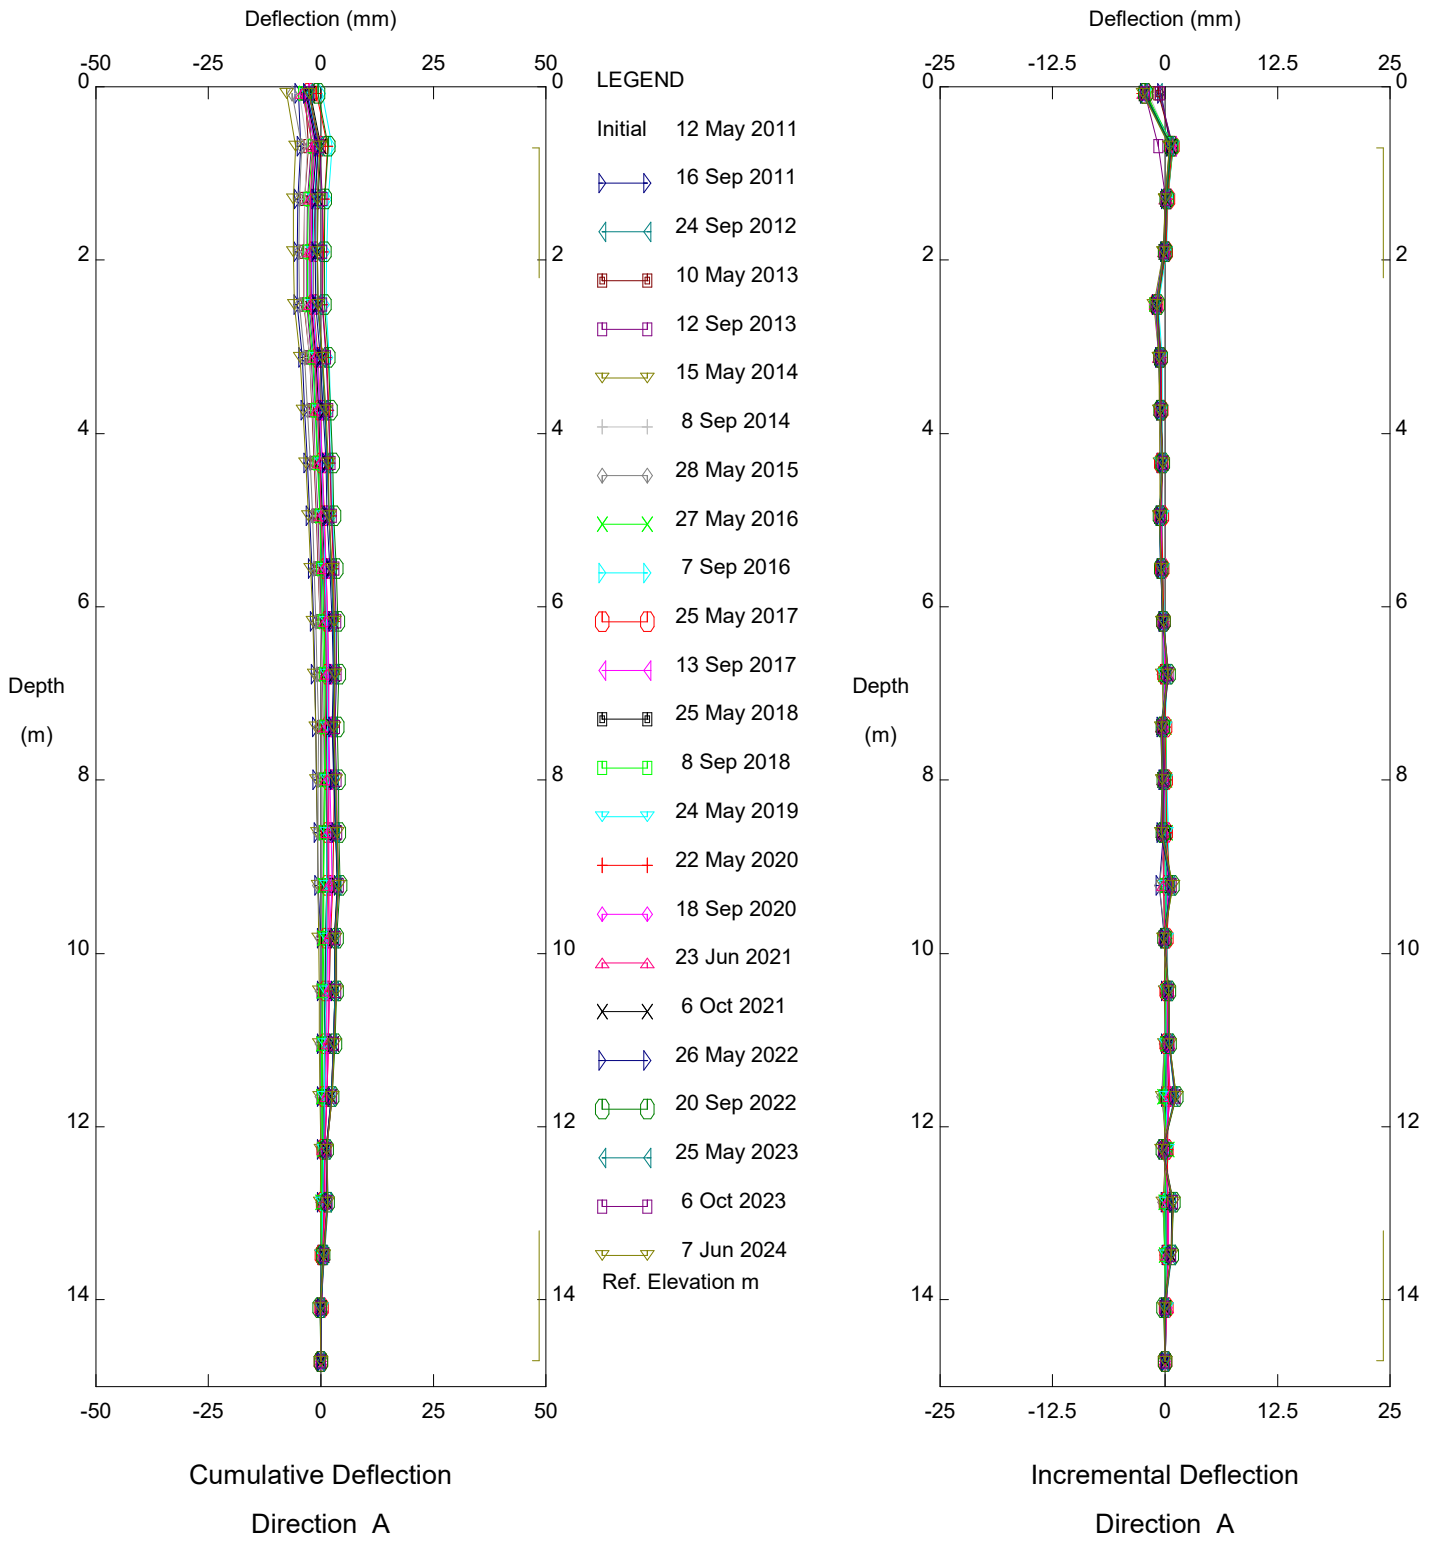
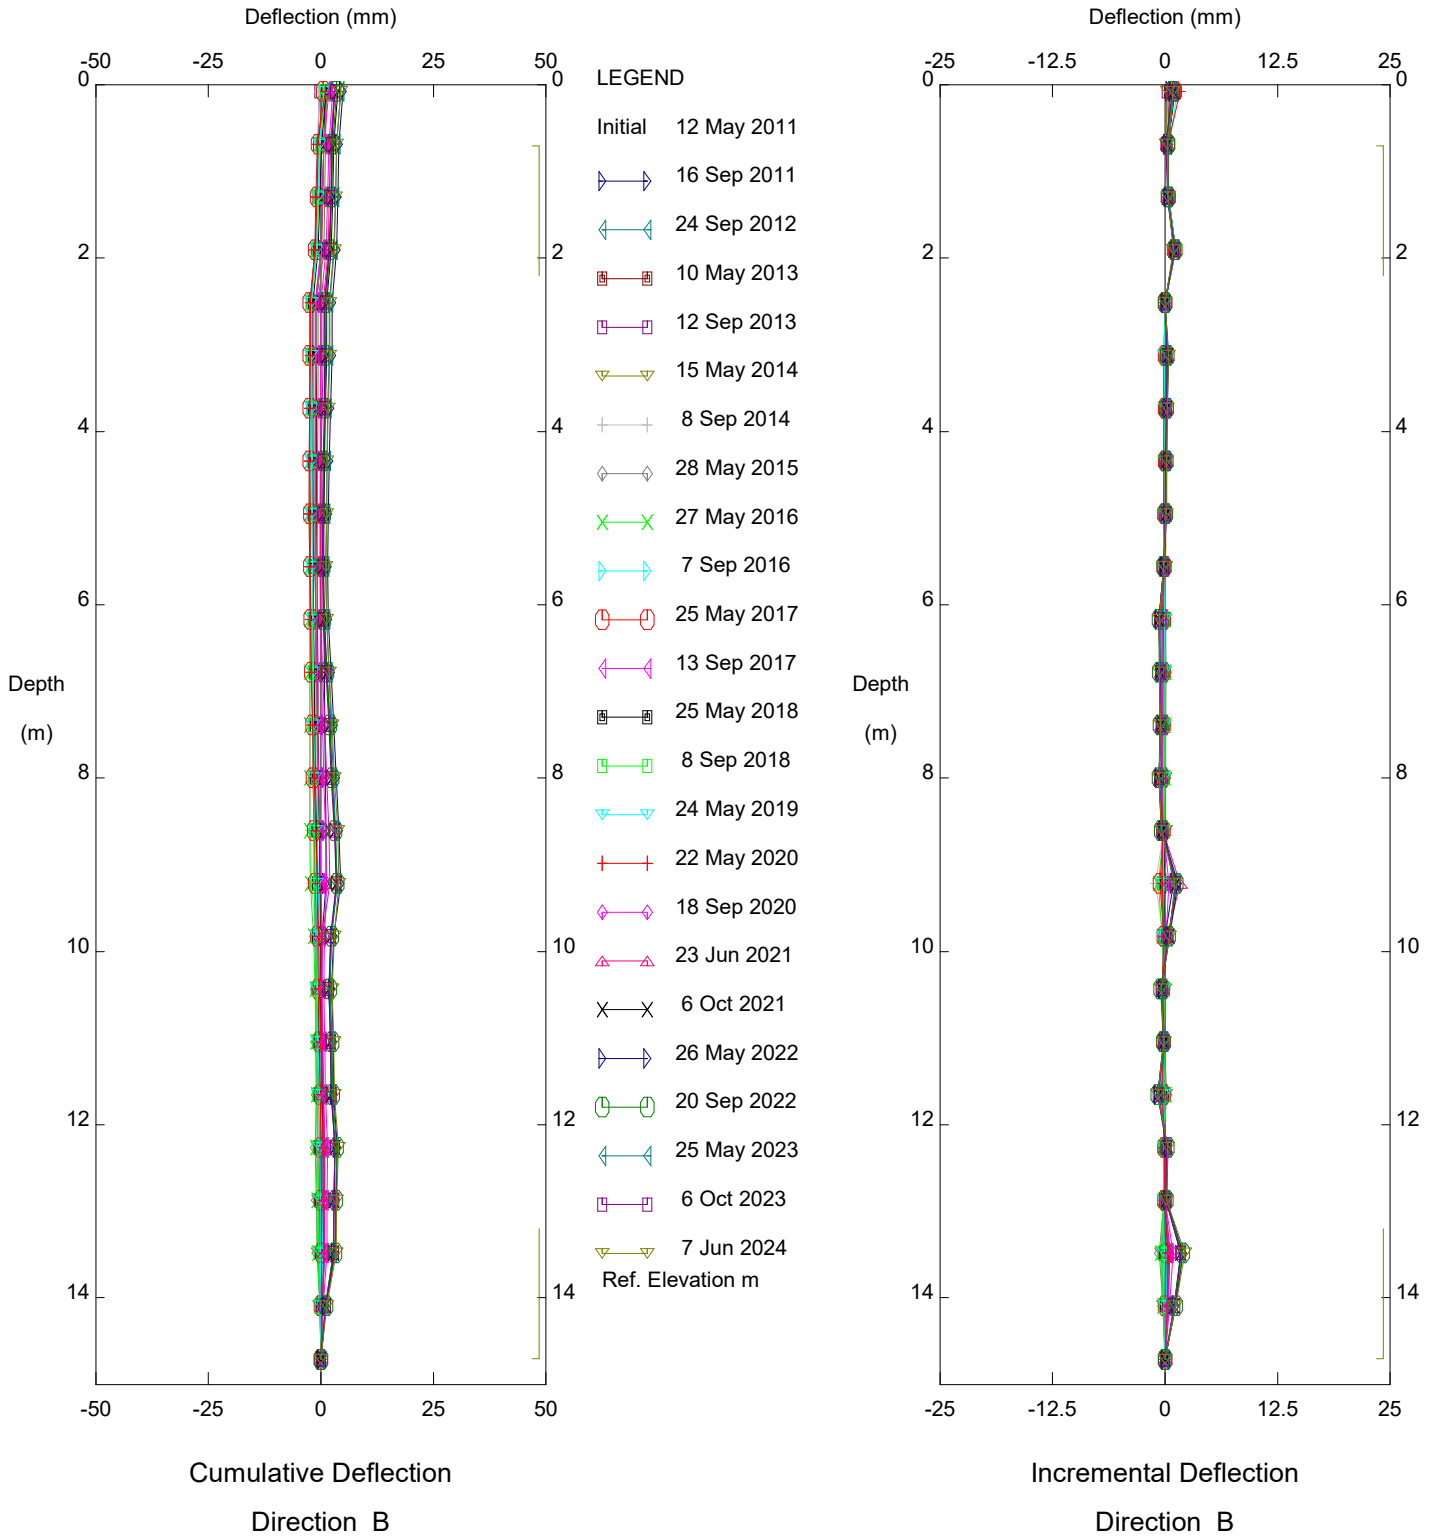
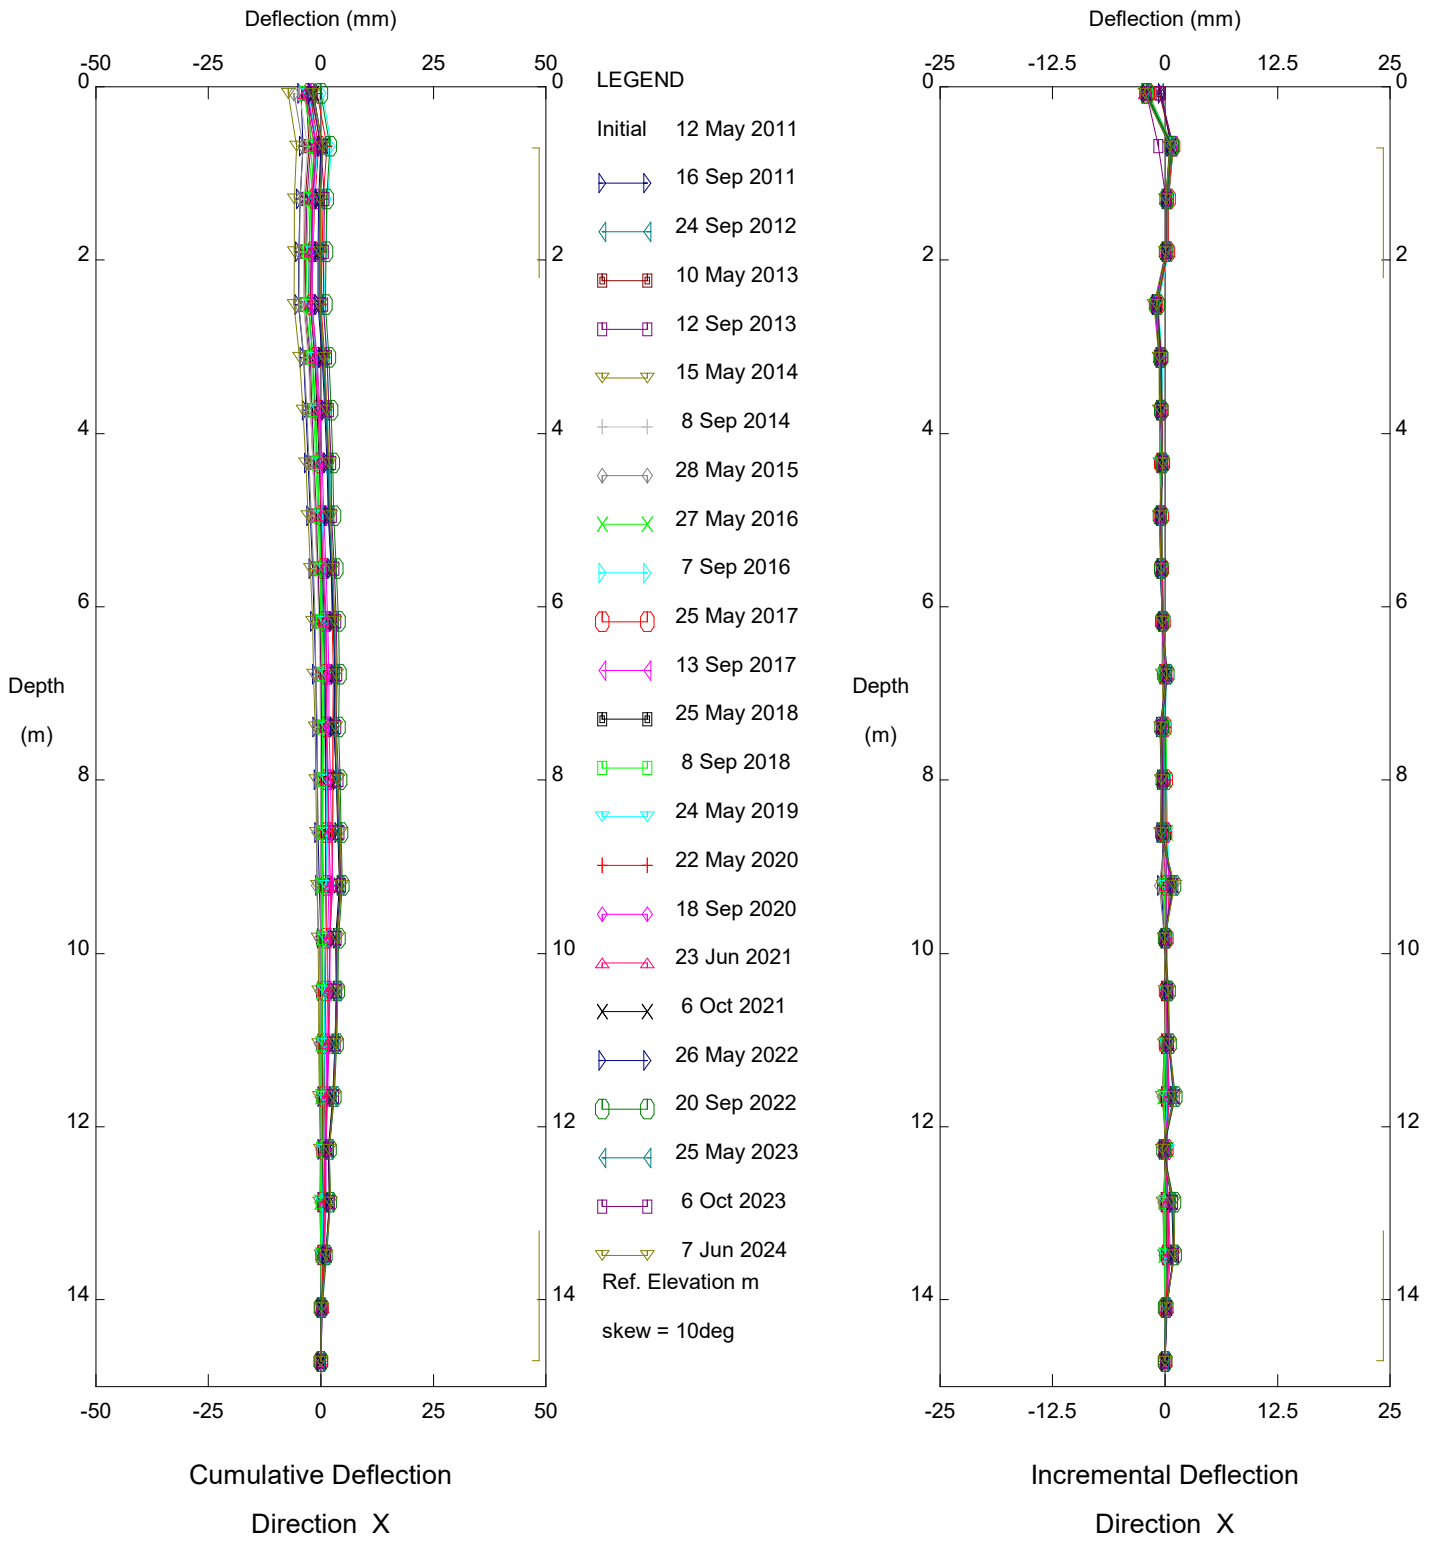
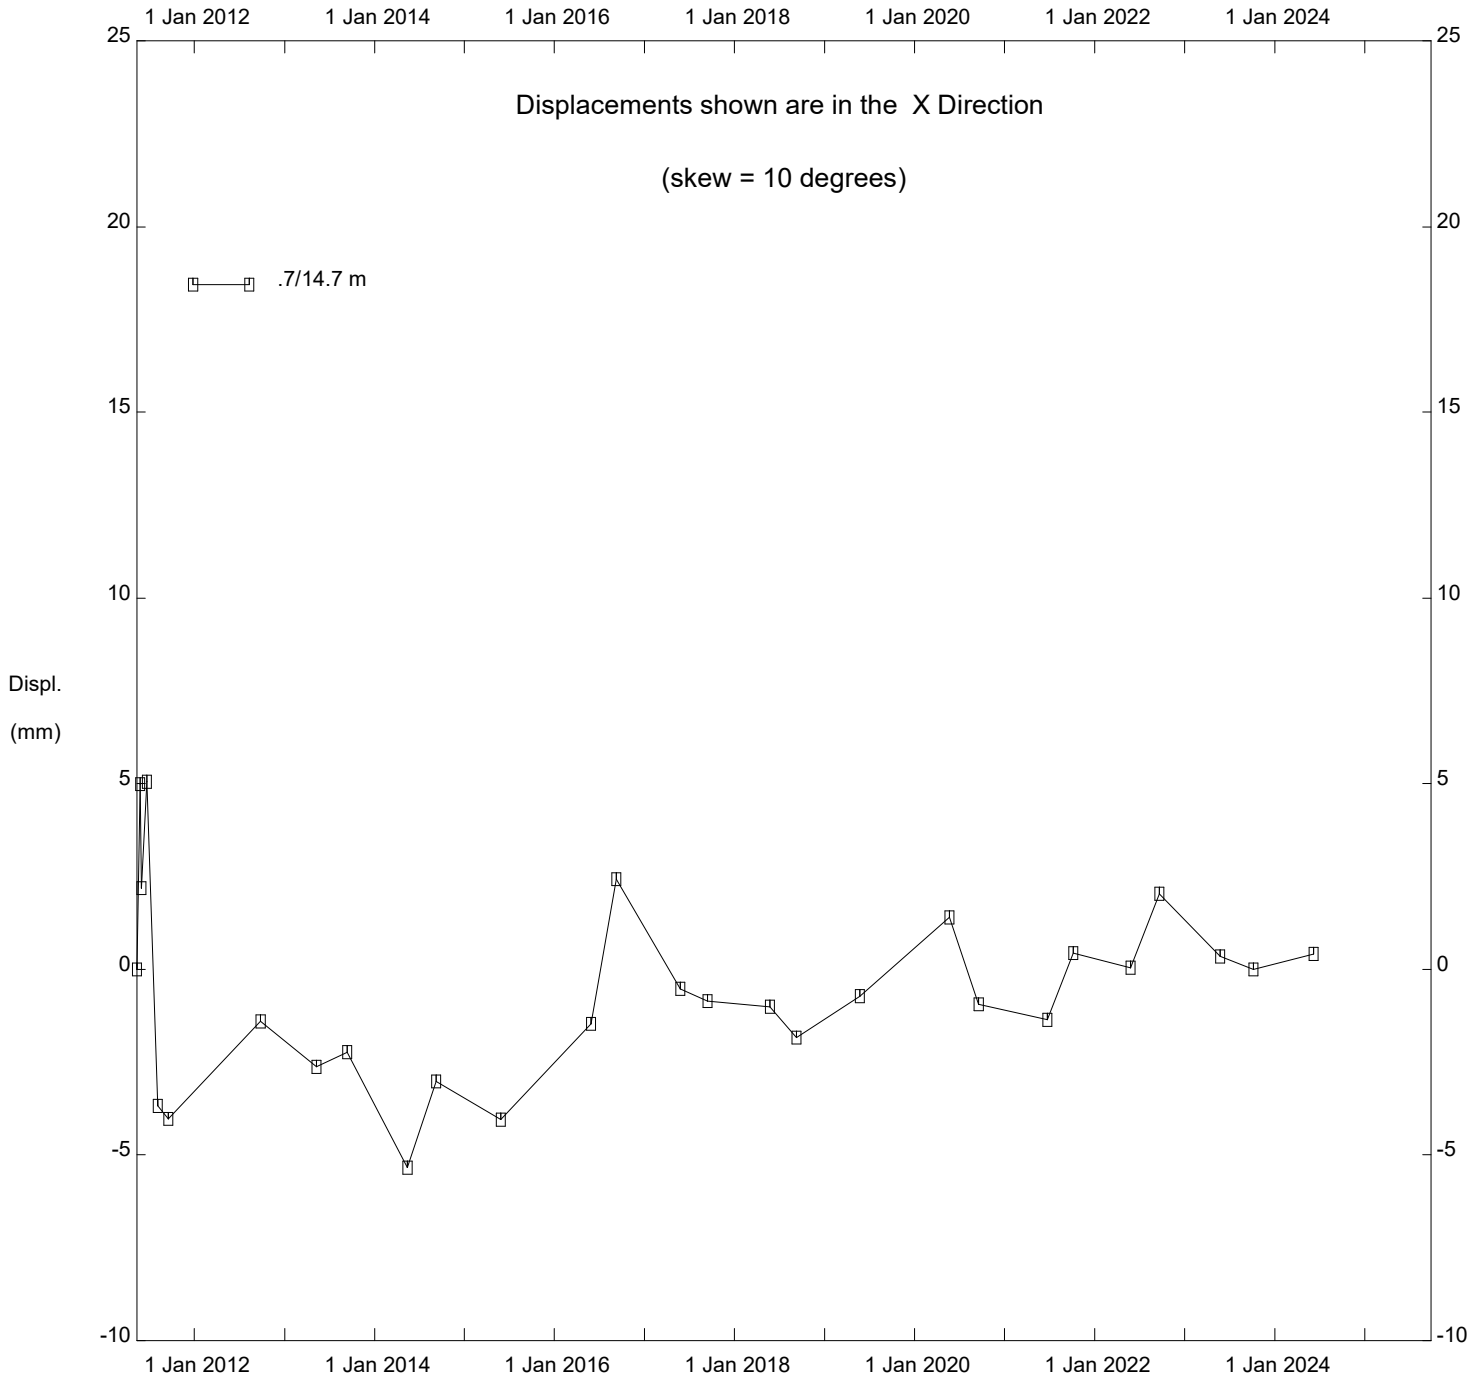
Hwy 41:23 Kehiwin Lake (NC103), Inclinator SI11-2 (P27)

<ul style="list-style-type: none"> <li>• SI11-1 = 2.7 mm pile head movement over 0.7 to 14.8 m depth</li> <li>• SI11-2 = 0.4 mm pile head movement over 0.7 to 14.7 m depth</li> <li>• SI11-3 = -7.5 mm pile head movement over 0.5 to 14.6 m depth</li> <li>• SI11-4 = -8.3 mm pile head movement over 0.8 m to 14.9 m depth</li> </ul> <p>Pneumatic piezometers PN10-1 and PN10-3 showed decreases in groundwater level of 0.43 m and 0.36 m, respectively, since the fall of 2023 readings.</p> <p>Standpipe piezometer PB10-1 and PB10-4 showed decreases in groundwater level of 0.14 m, and 0.01 m, respectively, since the fall of 2023 readings. Standpipe piezometer PB10-2 showed an increase in groundwater level of 0.19 m since the fall of 2023 readings.</p> <p>Load cells VC1706, VC1707, VC1708, VC1709, VC1712, VC1713, and VC1715 showed increases in the measured load of 2.26 kN, 3.72 kN, 2.48 kN, 1.45 kN, 1.39 kN, 1.63 kN, and 13.26 kN, respectively since the fall of 2023 readings. VC1714 showed a decrease of in the measured load of 90.35 since the fall of 2023 readings, however, this significant decrease could be attributed to the inconsistency of the number of operating wires between the fall of 2023 and the spring of 2024.</p> <p>The current measured load in VC1715 is the highest ever recorded in this load cells. Load cell VC1715 has shown a trend of gradually increasing loads for several reading cycles, indicating the load cell may be malfunctioning.</p> <p>The current load in VC1707 and VC1715 are the highest recorded in the instruments since they were installed. The load in VC1715 is about 41.7 percent higher than the lock off load. The remaining load cells have shown decreases in measured loads, when compared to the lock off load, ranging from 10.3 percent to 49.6 percent. However, the load cells with the largest variations in load values have lost one or more vibrating wire channels over several reading cycles. In addition, the reductions in the loads have not been consistent with the observed movement patterns of the walls, based on the slope inclinometer readings.</p> <p>If significant reductions in anchor loads occur in the future in response to the wall deflection towards west, the anchors will need to be restressed to maintain the wall's lateral deflection within the design limit.</p>

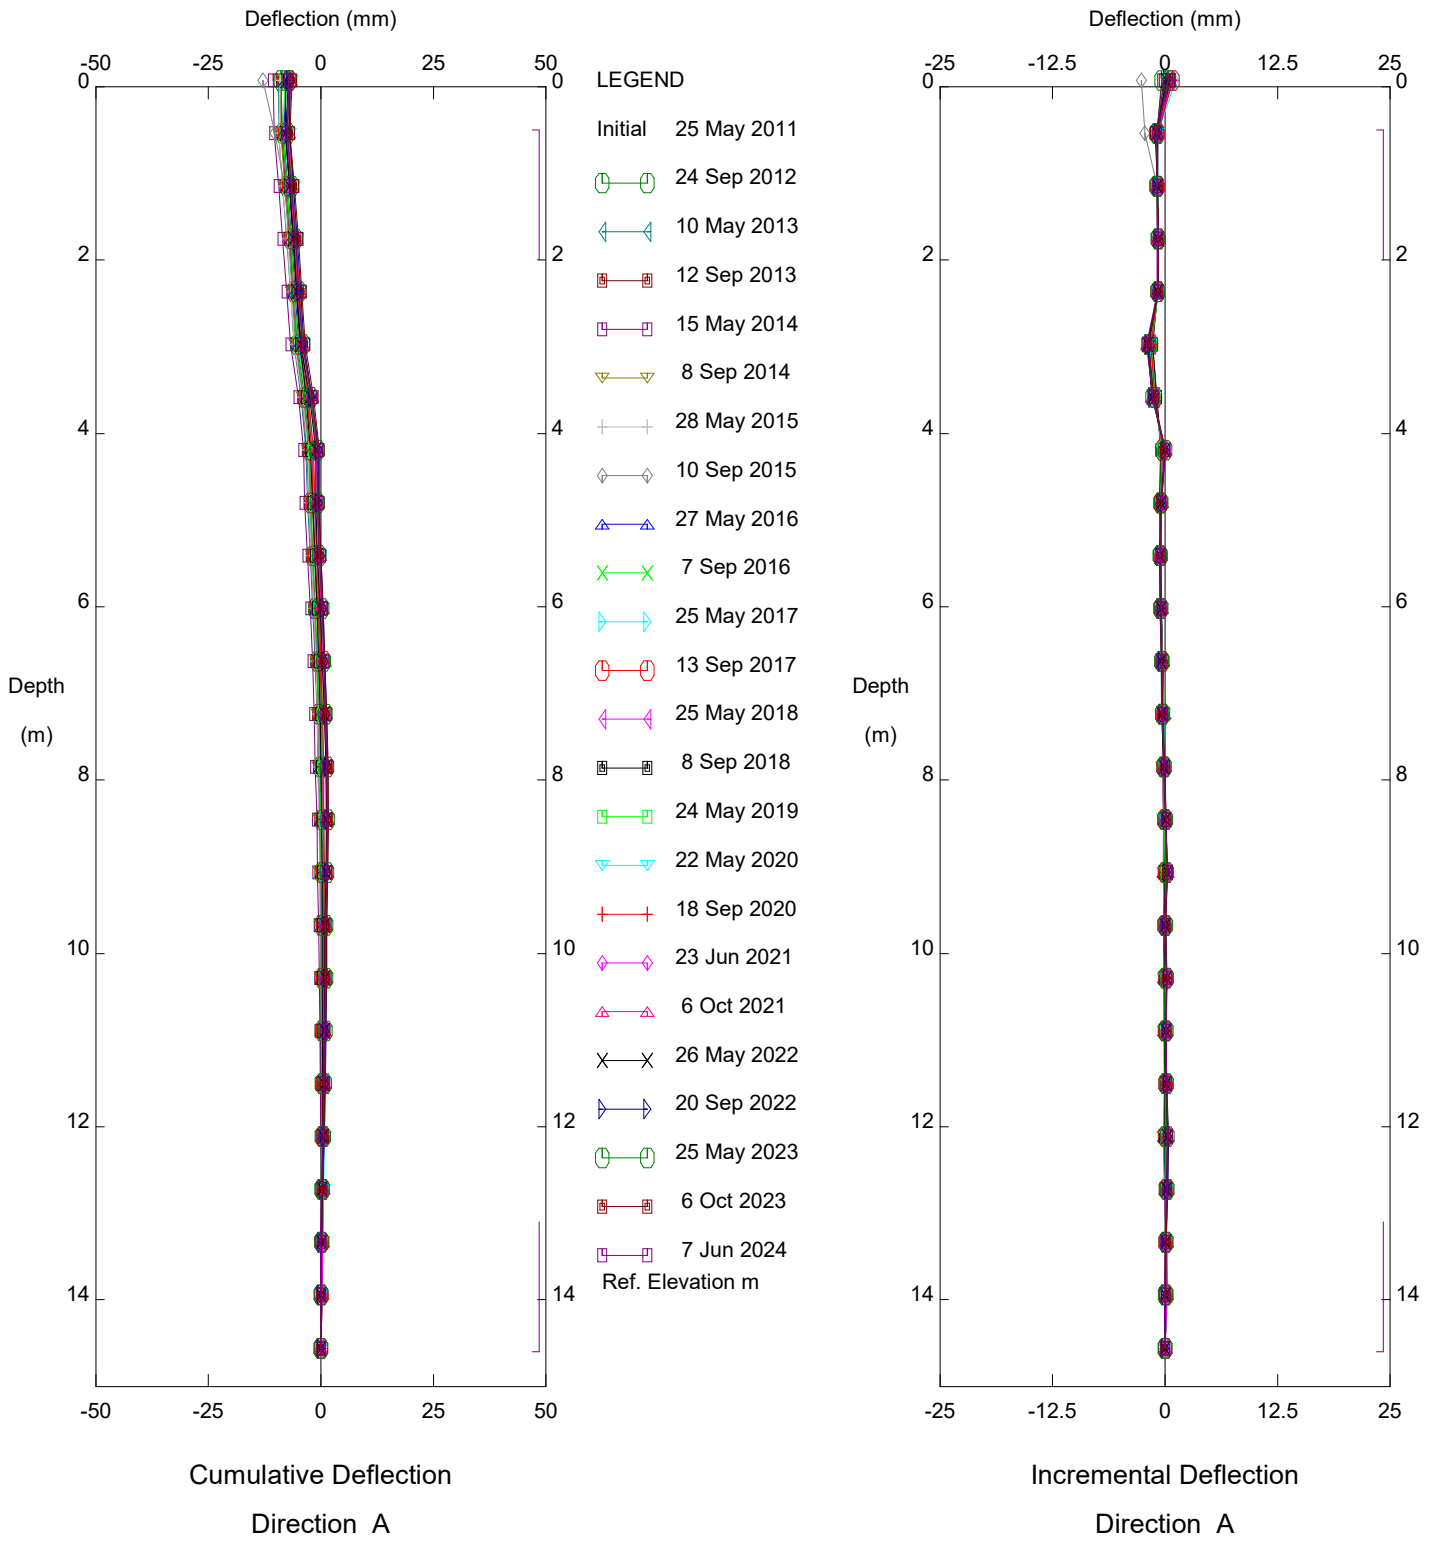
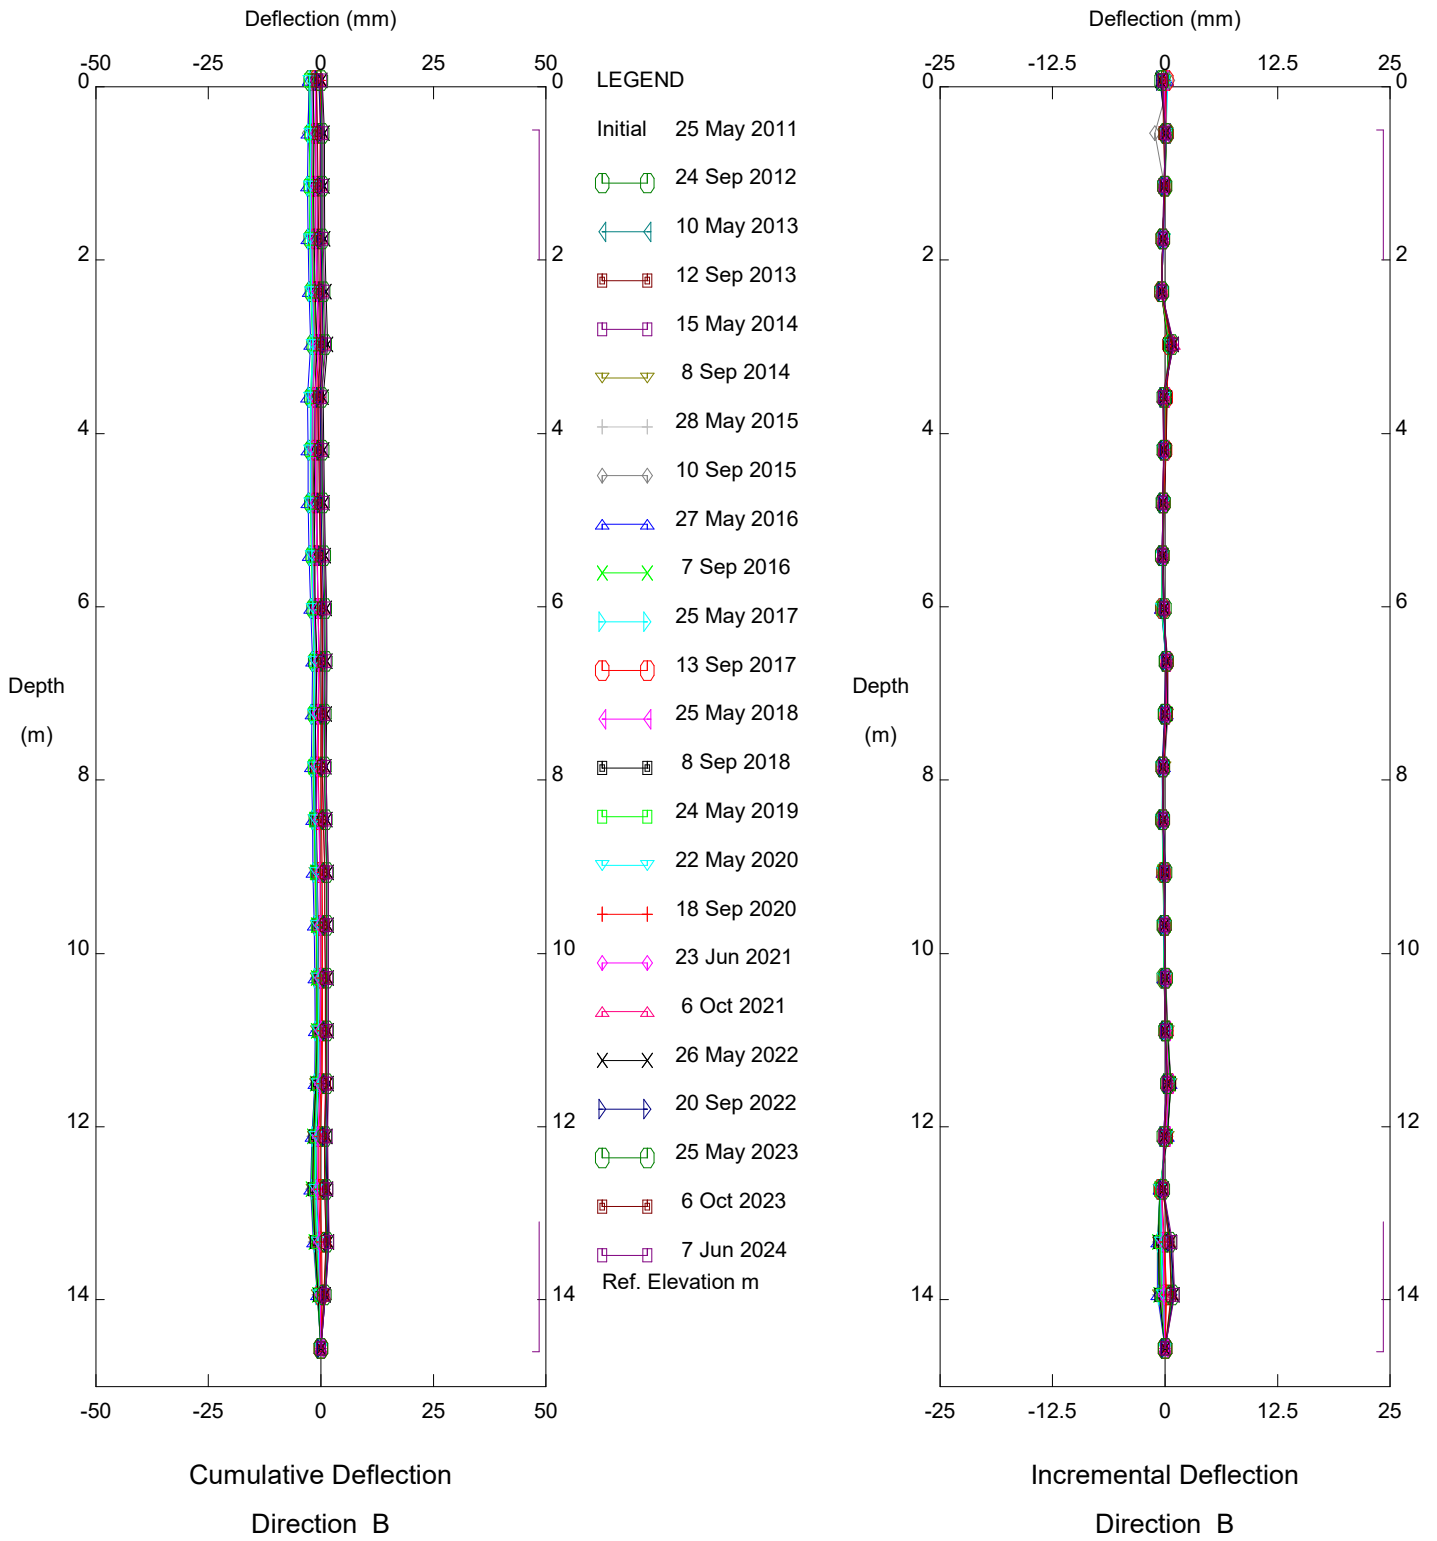
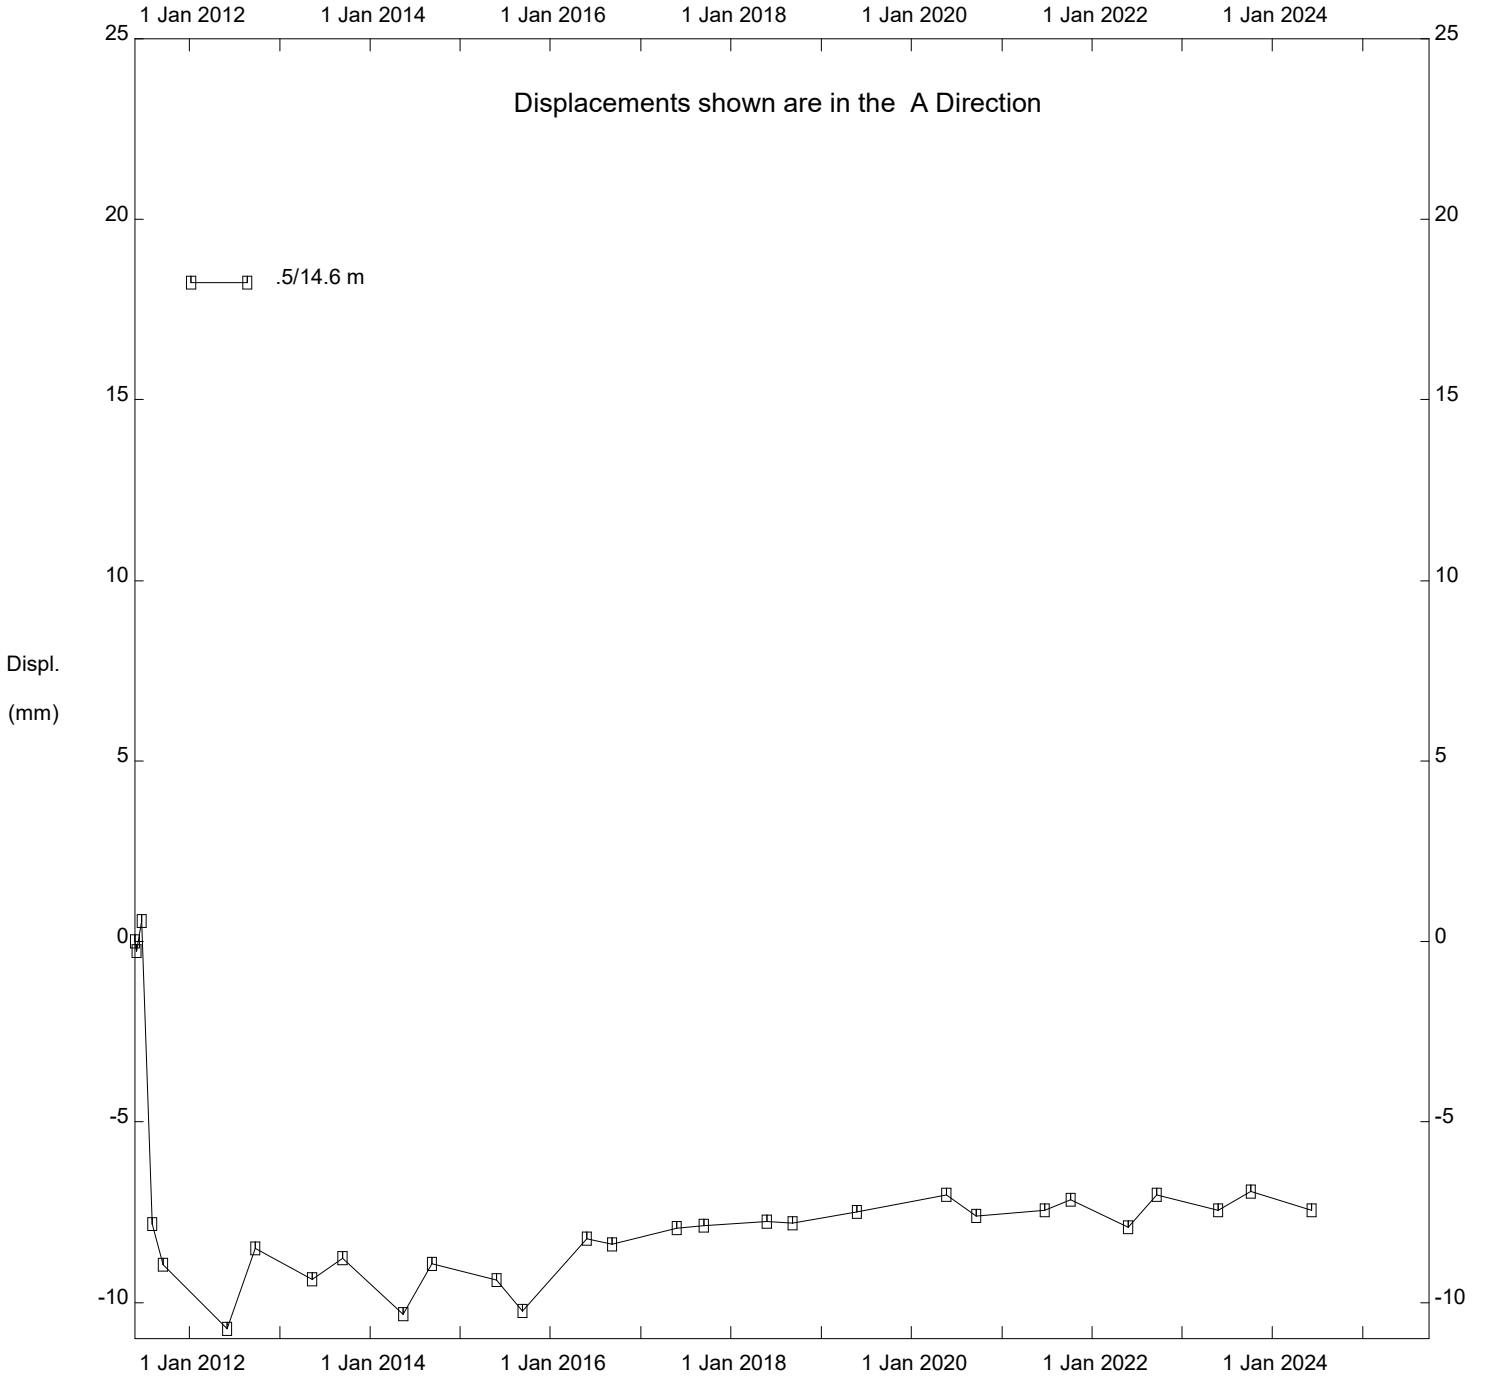
Hwy 41:23 Kehiwin Lake (NC103), Inclinometer SI11-3(P45)

SI11-3 (Pile 45)	May 25, 2011	-7.5 over 0.5 m to 14.6 m depth in 308° direction	14.2 on June 21, 2011	Operational	October 6, 2023	No discernible movement	N/A	-2.2
SI11-4 (Pile 60)	May 25, 2011	-8.3 over 0.8 m to 14.9 m depth in 349° direction	48.5 on June 21, 2011	Operational	October 6, 2023	0.3	0.3	0.8
