ALBERTA TRANSPORTATION AND  
ECONOMIC CORRIDORS GRMP  
NORTH CENTRAL (ATHABASCA AND FORT  
McMURRAY DISTRICTS)  
INSTRUMENTATION MONITORING- SPRING 2024

Site Number	Location	Name	Hwy	km
NC103 (NC024-3)	HWY 41:23 C1 7.89	Kehiwin Lake	41:23	Km 7.8
<b>Legal Description:</b> 9-25-58-7 W4		<b>UTM Co-ordinates</b>		
		12U E 506737.94	N	5988417.59

<b>Current Monitoring:</b>	7-June-2024	<b>Previous Monitoring</b>	06-Oct-2023
<b>Instruments Read By:</b>	Mr. Niraj Regmi, G.I.T and Mr. Nixson Mationg, of Thurber

**ALBERTA TRANSPORTATION AND ECONOMIC CORRIDORS GRMP (CON0022163)  
NORTH CENTRAL (ATHABASCA AND FORT McMURRAY DISTRICTS)  
INSTRUMENTATION MONITORING RESULTS**

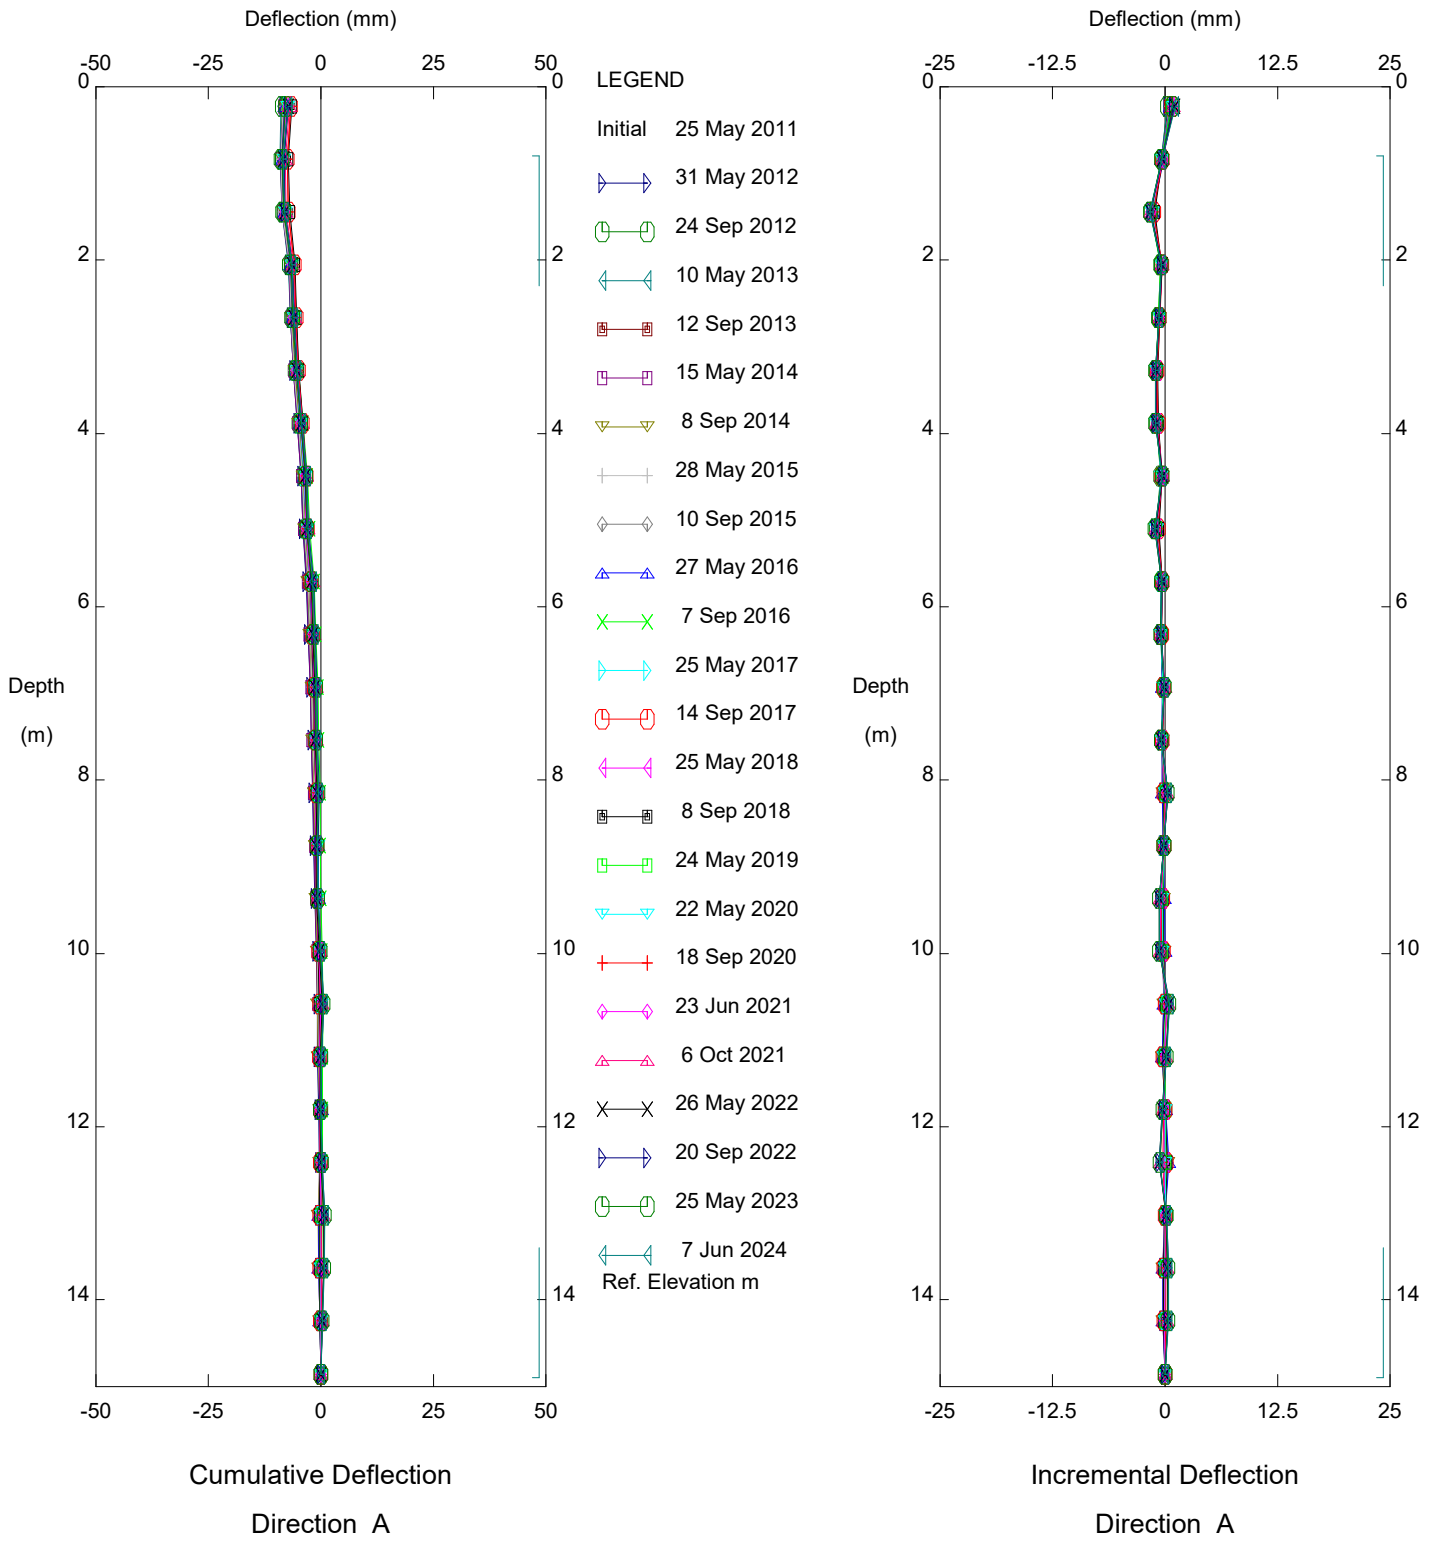
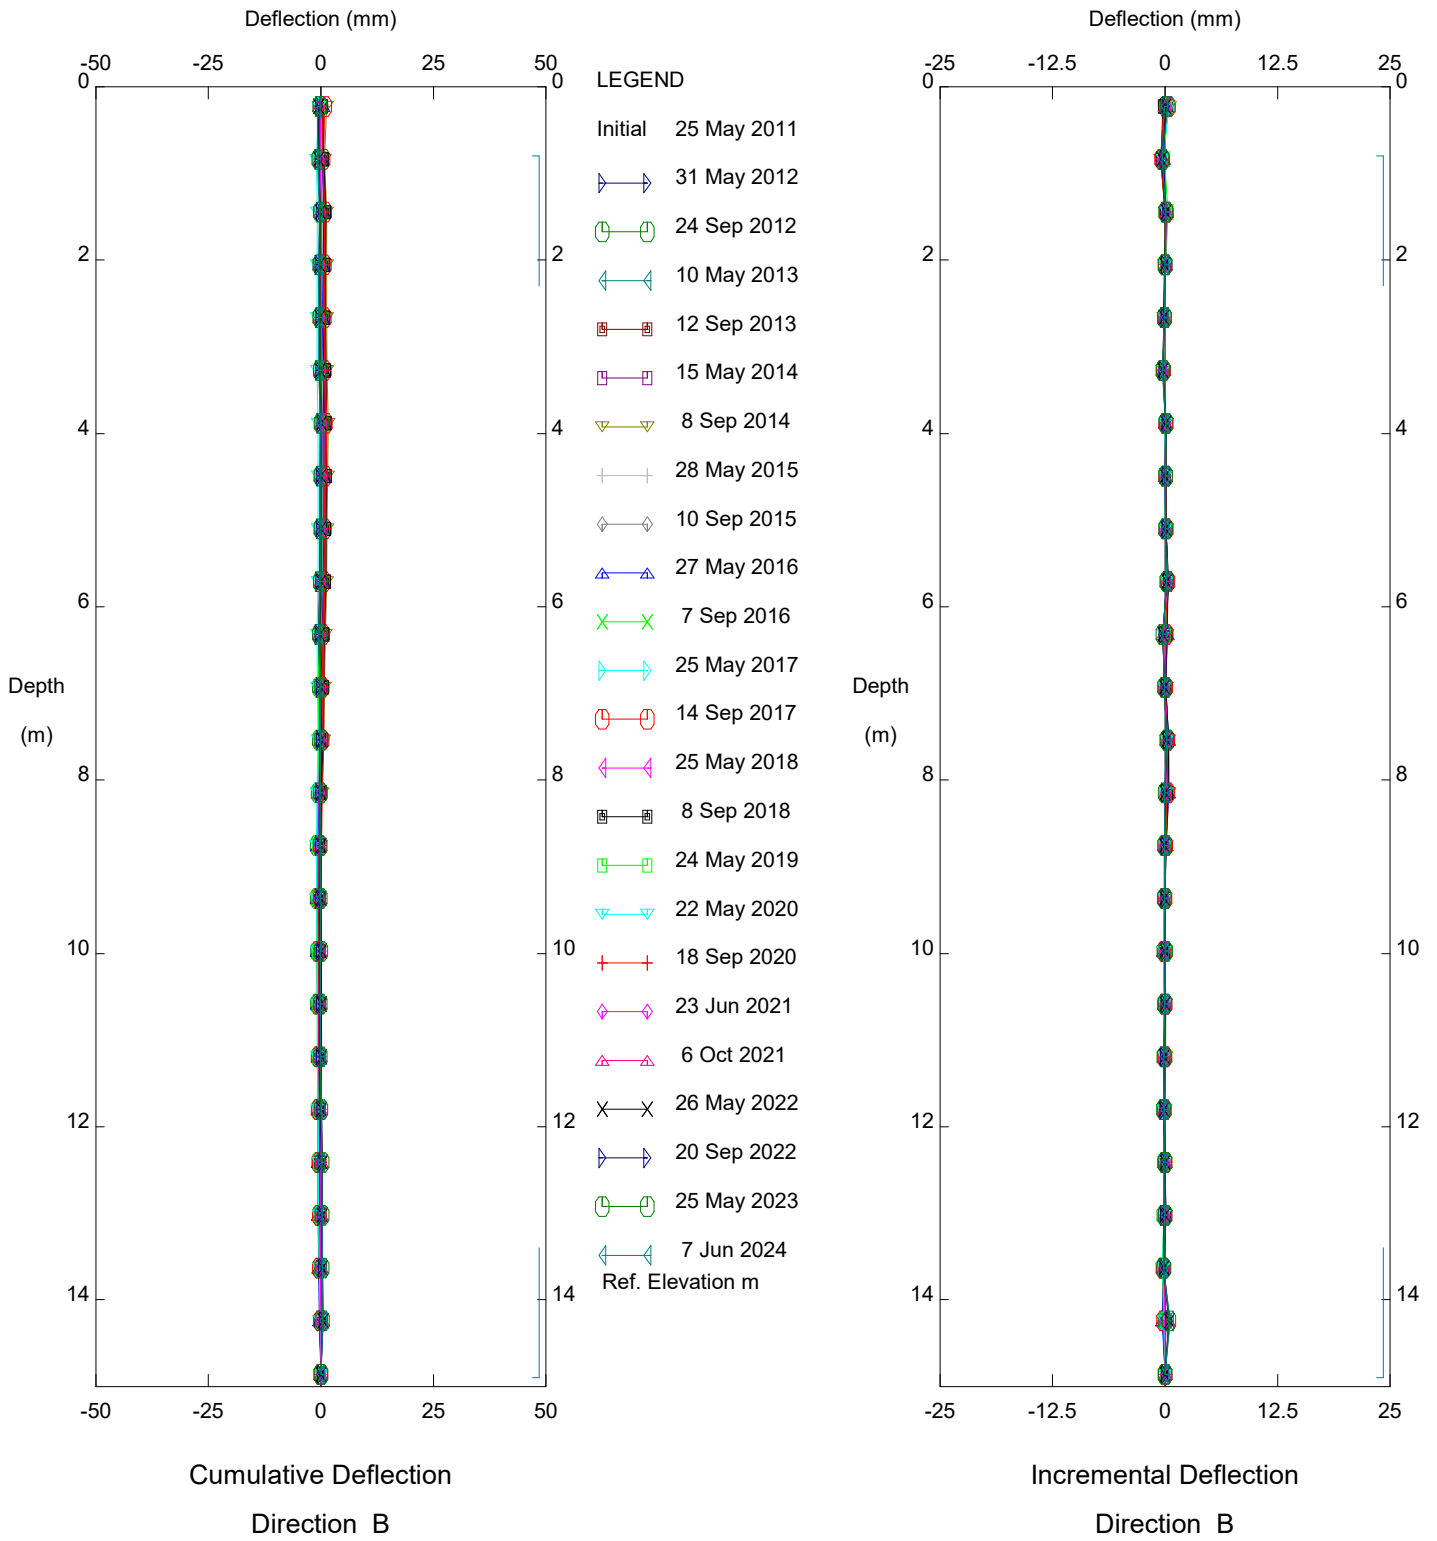
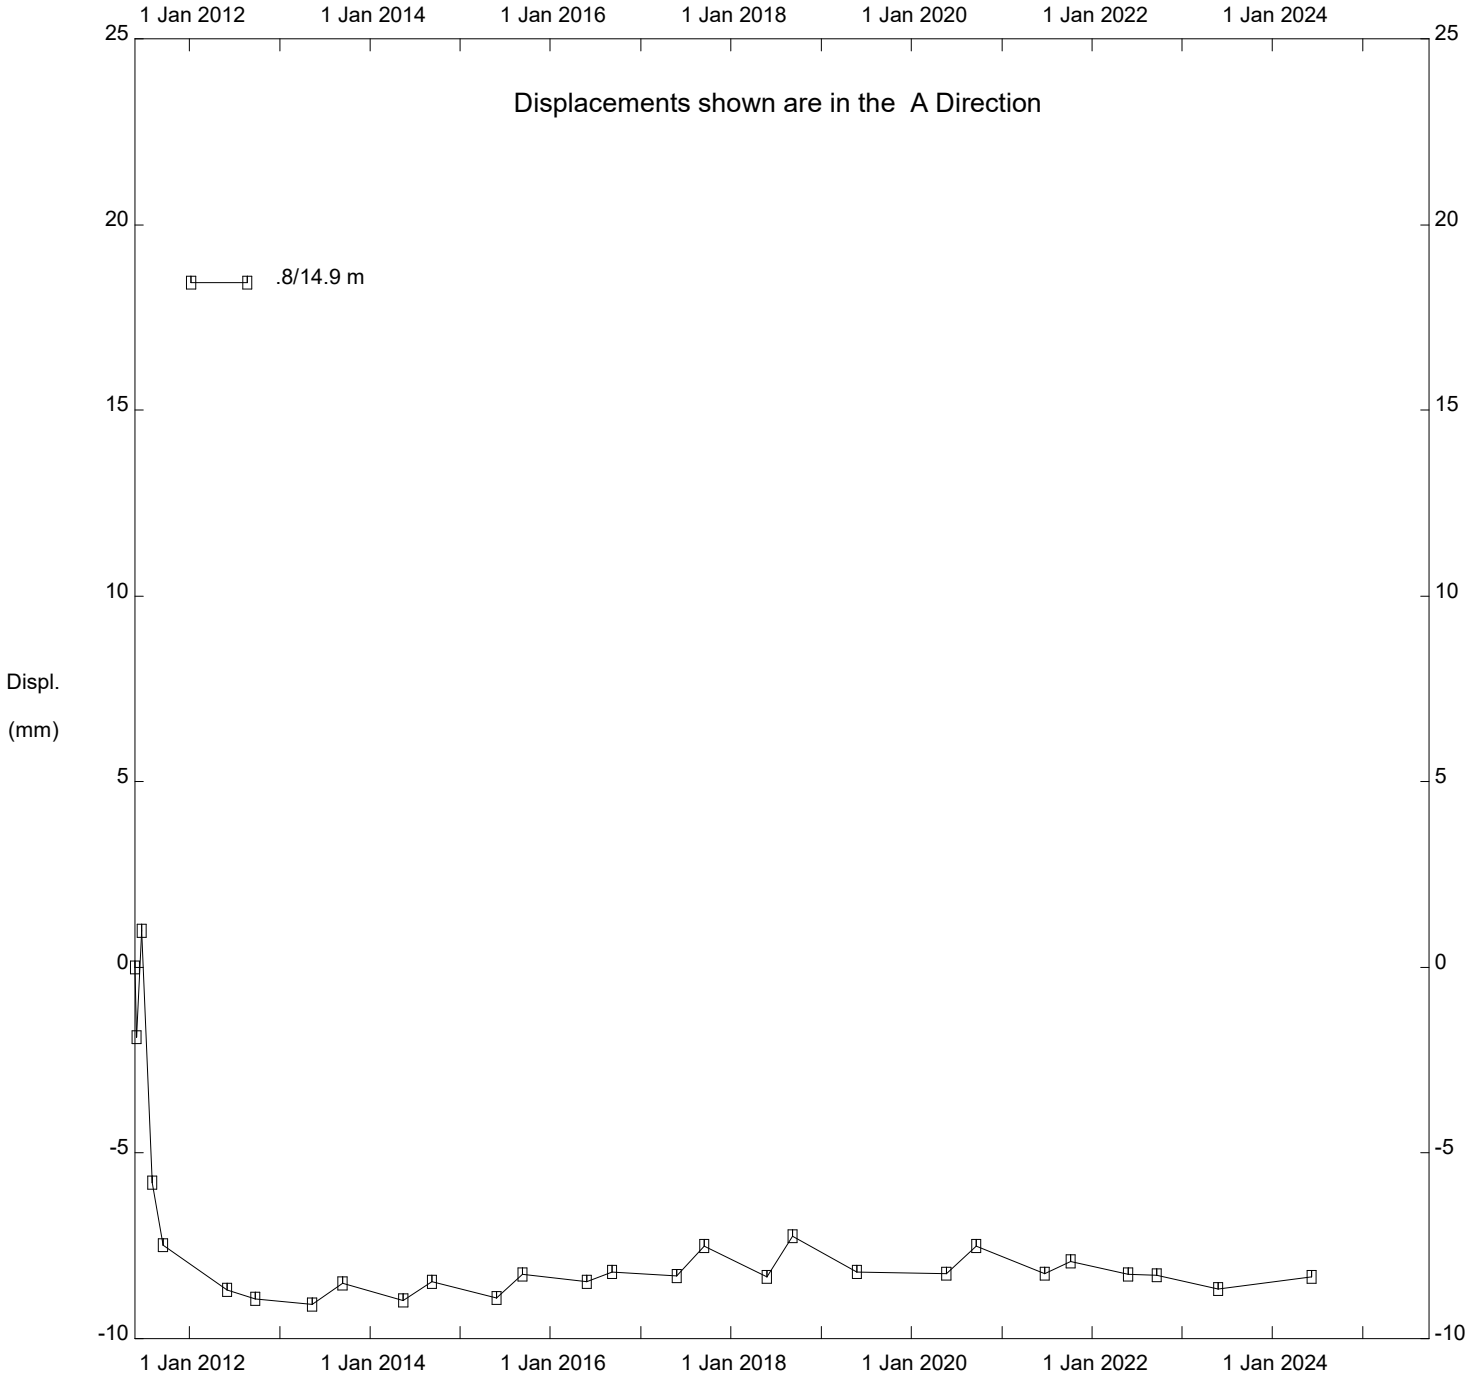
Hwy 41:23 Kehiwin Lake (NC103), Inclinometer SI11-4 (P60)

<ul style="list-style-type: none"> <li>• SI11-1 = 2.7 mm pile head movement over 0.7 to 14.8 m depth</li> <li>• SI11-2 = 0.4 mm pile head movement over 0.7 to 14.7 m depth</li> <li>• SI11-3 = -7.5 mm pile head movement over 0.5 to 14.6 m depth</li> <li>• SI11-4 = -8.3 mm pile head movement over 0.8 m to 14.9 m depth</li> </ul> <p>Pneumatic piezometers PN10-1 and PN10-3 showed decreases in groundwater level of 0.43 m and 0.36 m, respectively, since the fall of 2023 readings.</p> <p>Standpipe piezometer PB10-1 and PB10-4 showed decreases in groundwater level of 0.14 m, and 0.01 m, respectively, since the fall of 2023 readings. Standpipe piezometer PB10-2 showed an increase in groundwater level of 0.19 m since the fall of 2023 readings.</p> <p>Load cells VC1706, VC1707, VC1708, VC1709, VC1712, VC1713, and VC1715 showed increases in the measured load of 2.26 kN, 3.72 kN, 2.48 kN, 1.45 kN, 1.39 kN, 1.63 kN, and 13.26 kN, respectively since the fall of 2023 readings. VC1714 showed a decrease of in the measured load of 90.35 since the fall of 2023 readings, however, this significant decrease could be attributed to the inconsistency of the number of operating wires between the fall of 2023 and the spring of 2024.</p> <p>The current measured load in VC1715 is the highest ever recorded in this load cells. Load cell VC1715 has shown a trend of gradually increasing loads for several reading cycles, indicating the load cell may be malfunctioning.</p> <p>The current load in VC1707 and VC1715 are the highest recorded in the instruments since they were installed. The load in VC1715 is about 41.7 percent higher than the lock off load. The remaining load cells have shown decreases in measured loads, when compared to the lock off load, ranging from 10.3 percent to 49.6 percent. However, the load cells with the largest variations in load values have lost one or more vibrating wire channels over several reading cycles. In addition, the reductions in the loads have not been consistent with the observed movement patterns of the walls, based on the slope inclinometer readings.</p> <p>If significant reductions in anchor loads occur in the future in response to the wall deflection towards west, the anchors will need to be restressed to maintain the wall's lateral deflection within the design limit.</p>

SI11-3 (Pile 45)	May 25, 2011	-7.5 over 0.5 m to 14.6 m depth in 308° direction	14.2 on June 21, 2011	Operational	October 6, 2023	No discernible movement	N/A	-2.2
SI11-4 (Pile 60)	May 25, 2011	-8.3 over 0.8 m to 14.9 m depth in 349° direction	48.5 on June 21, 2011	Operational	October 6, 2023	0.3	0.3	0.8

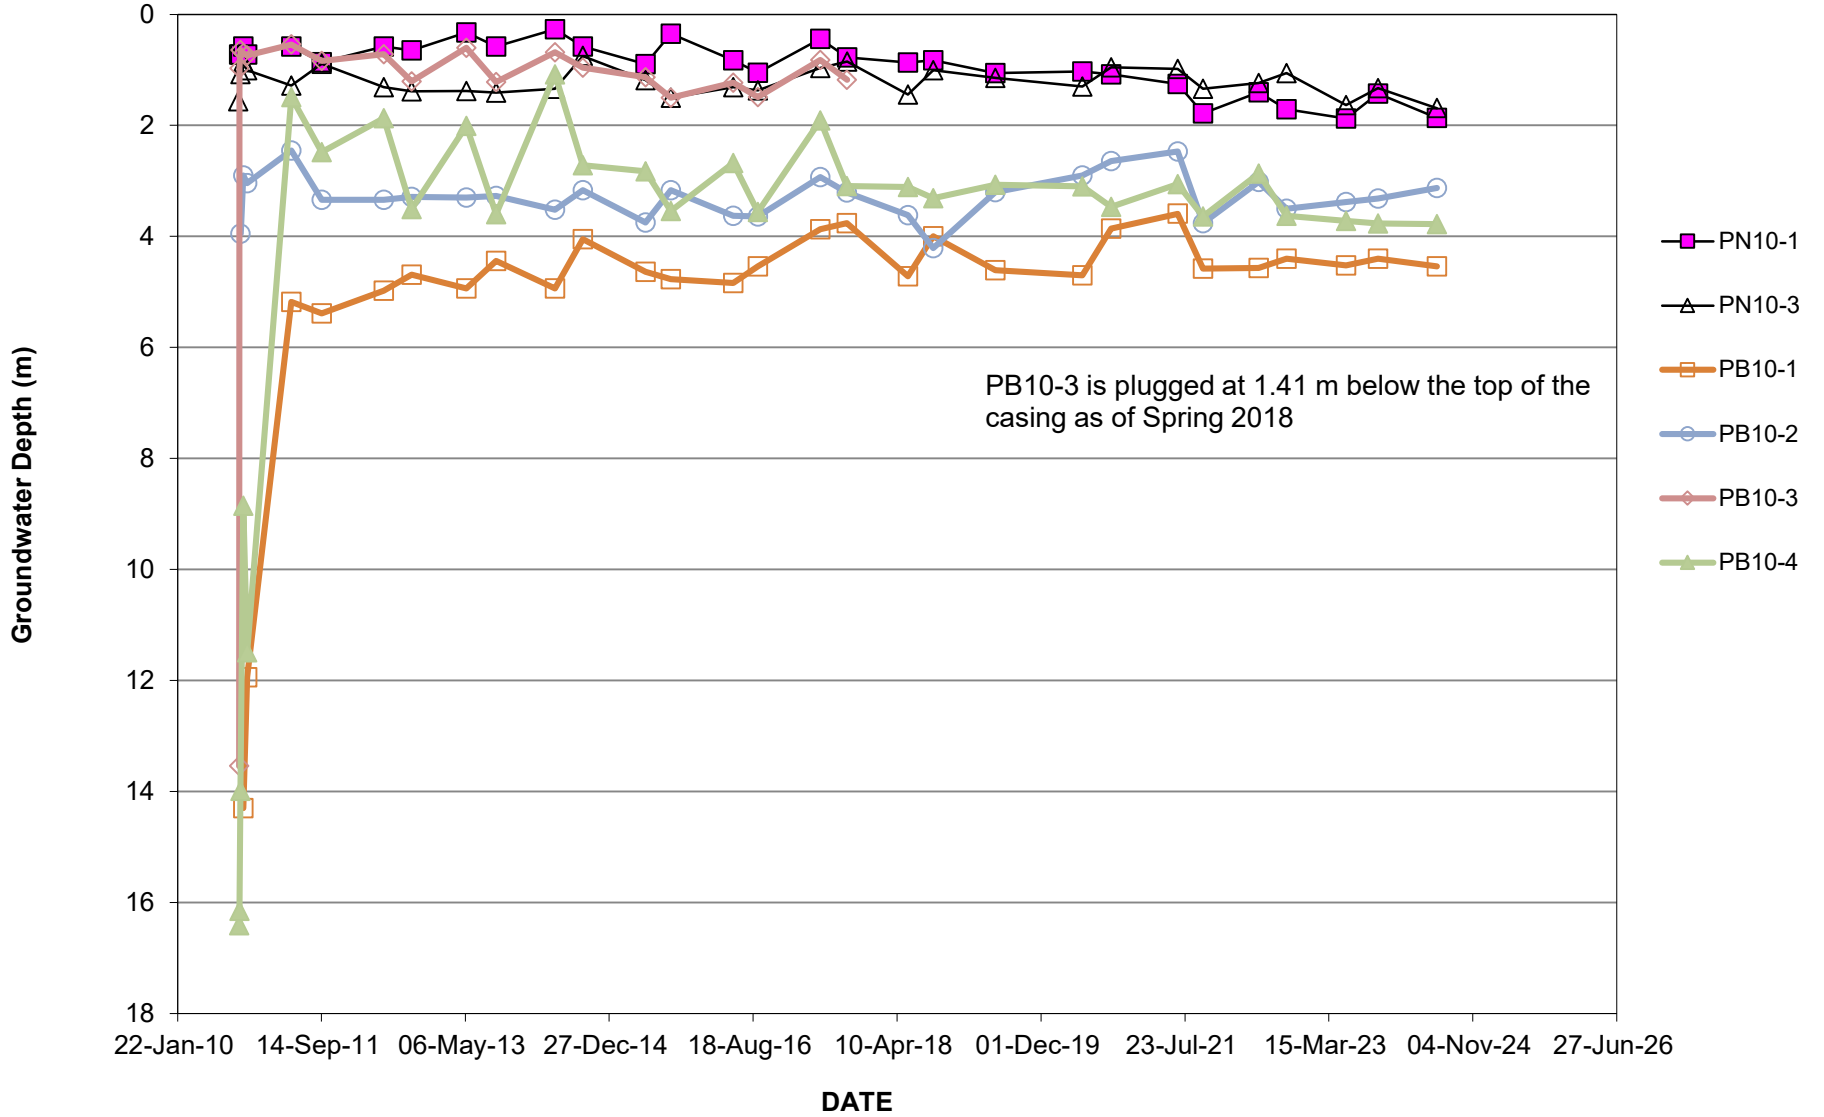
**FIGURE NC103-1  
PIEZOMETER DATA FOR HWY 41:23, KEHIWIN LAKE (KM 7.8)**

<b>INSTRUMENT #</b>	<b>DATE INITIALIZED</b>	<b>TIP DEPTH (m)</b>	<b>GROUND ELEV. (m)</b>	<b>CURRENT STATUS</b>	<b>HIGHEST MEASURED GROUNDWATER LEVEL BGS (m)</b>	<b>MEASURED PORE PRESSURE (kPa)</b>	<b>CURRENT GROUNDWATER LEVEL BGS (m)</b>	<b>PREVIOUS GROUNDWATER LEVEL BGS (m)</b>	<b>CHANGE IN WATER LEVEL SINCE PREVIOUS READING (m)</b>
PN10-1	October 5, 2010	6.55	-	Active	0.26 on May 15, 2014	46.0	1.86	1.43	-0.43
PN10-3	October 1, 2010	12.27	-	Active	0.75 on September 8, 2014	103.9	1.69	1.33	-0.36
