**ALBERTA TRANSPORTATION
GEOHAZARD ASSESSMENT PROGRAM
NORTH CENTRAL REGION – ATHABASCA &
FORT MCMURRAY DISTRICTS
2022 SITE INSPECTION**

Site Number	Location	Name	Hwy	km
NC087	20.75 km north of the junction of Hwy 55 and 63	FISCHER TRAIL SLIDE	63:02	20.75
Legal Description		UTM Co-ordinates (NAD 83)		
SE-22-69-17-W4M		12 N 6094104.70	E	404166.89

**NORTH CENTRAL REGION
(ATHABASCA AND FORT McMURRAY DISTRICTS)
2022 GEOHAZARD ASSESSMENT**

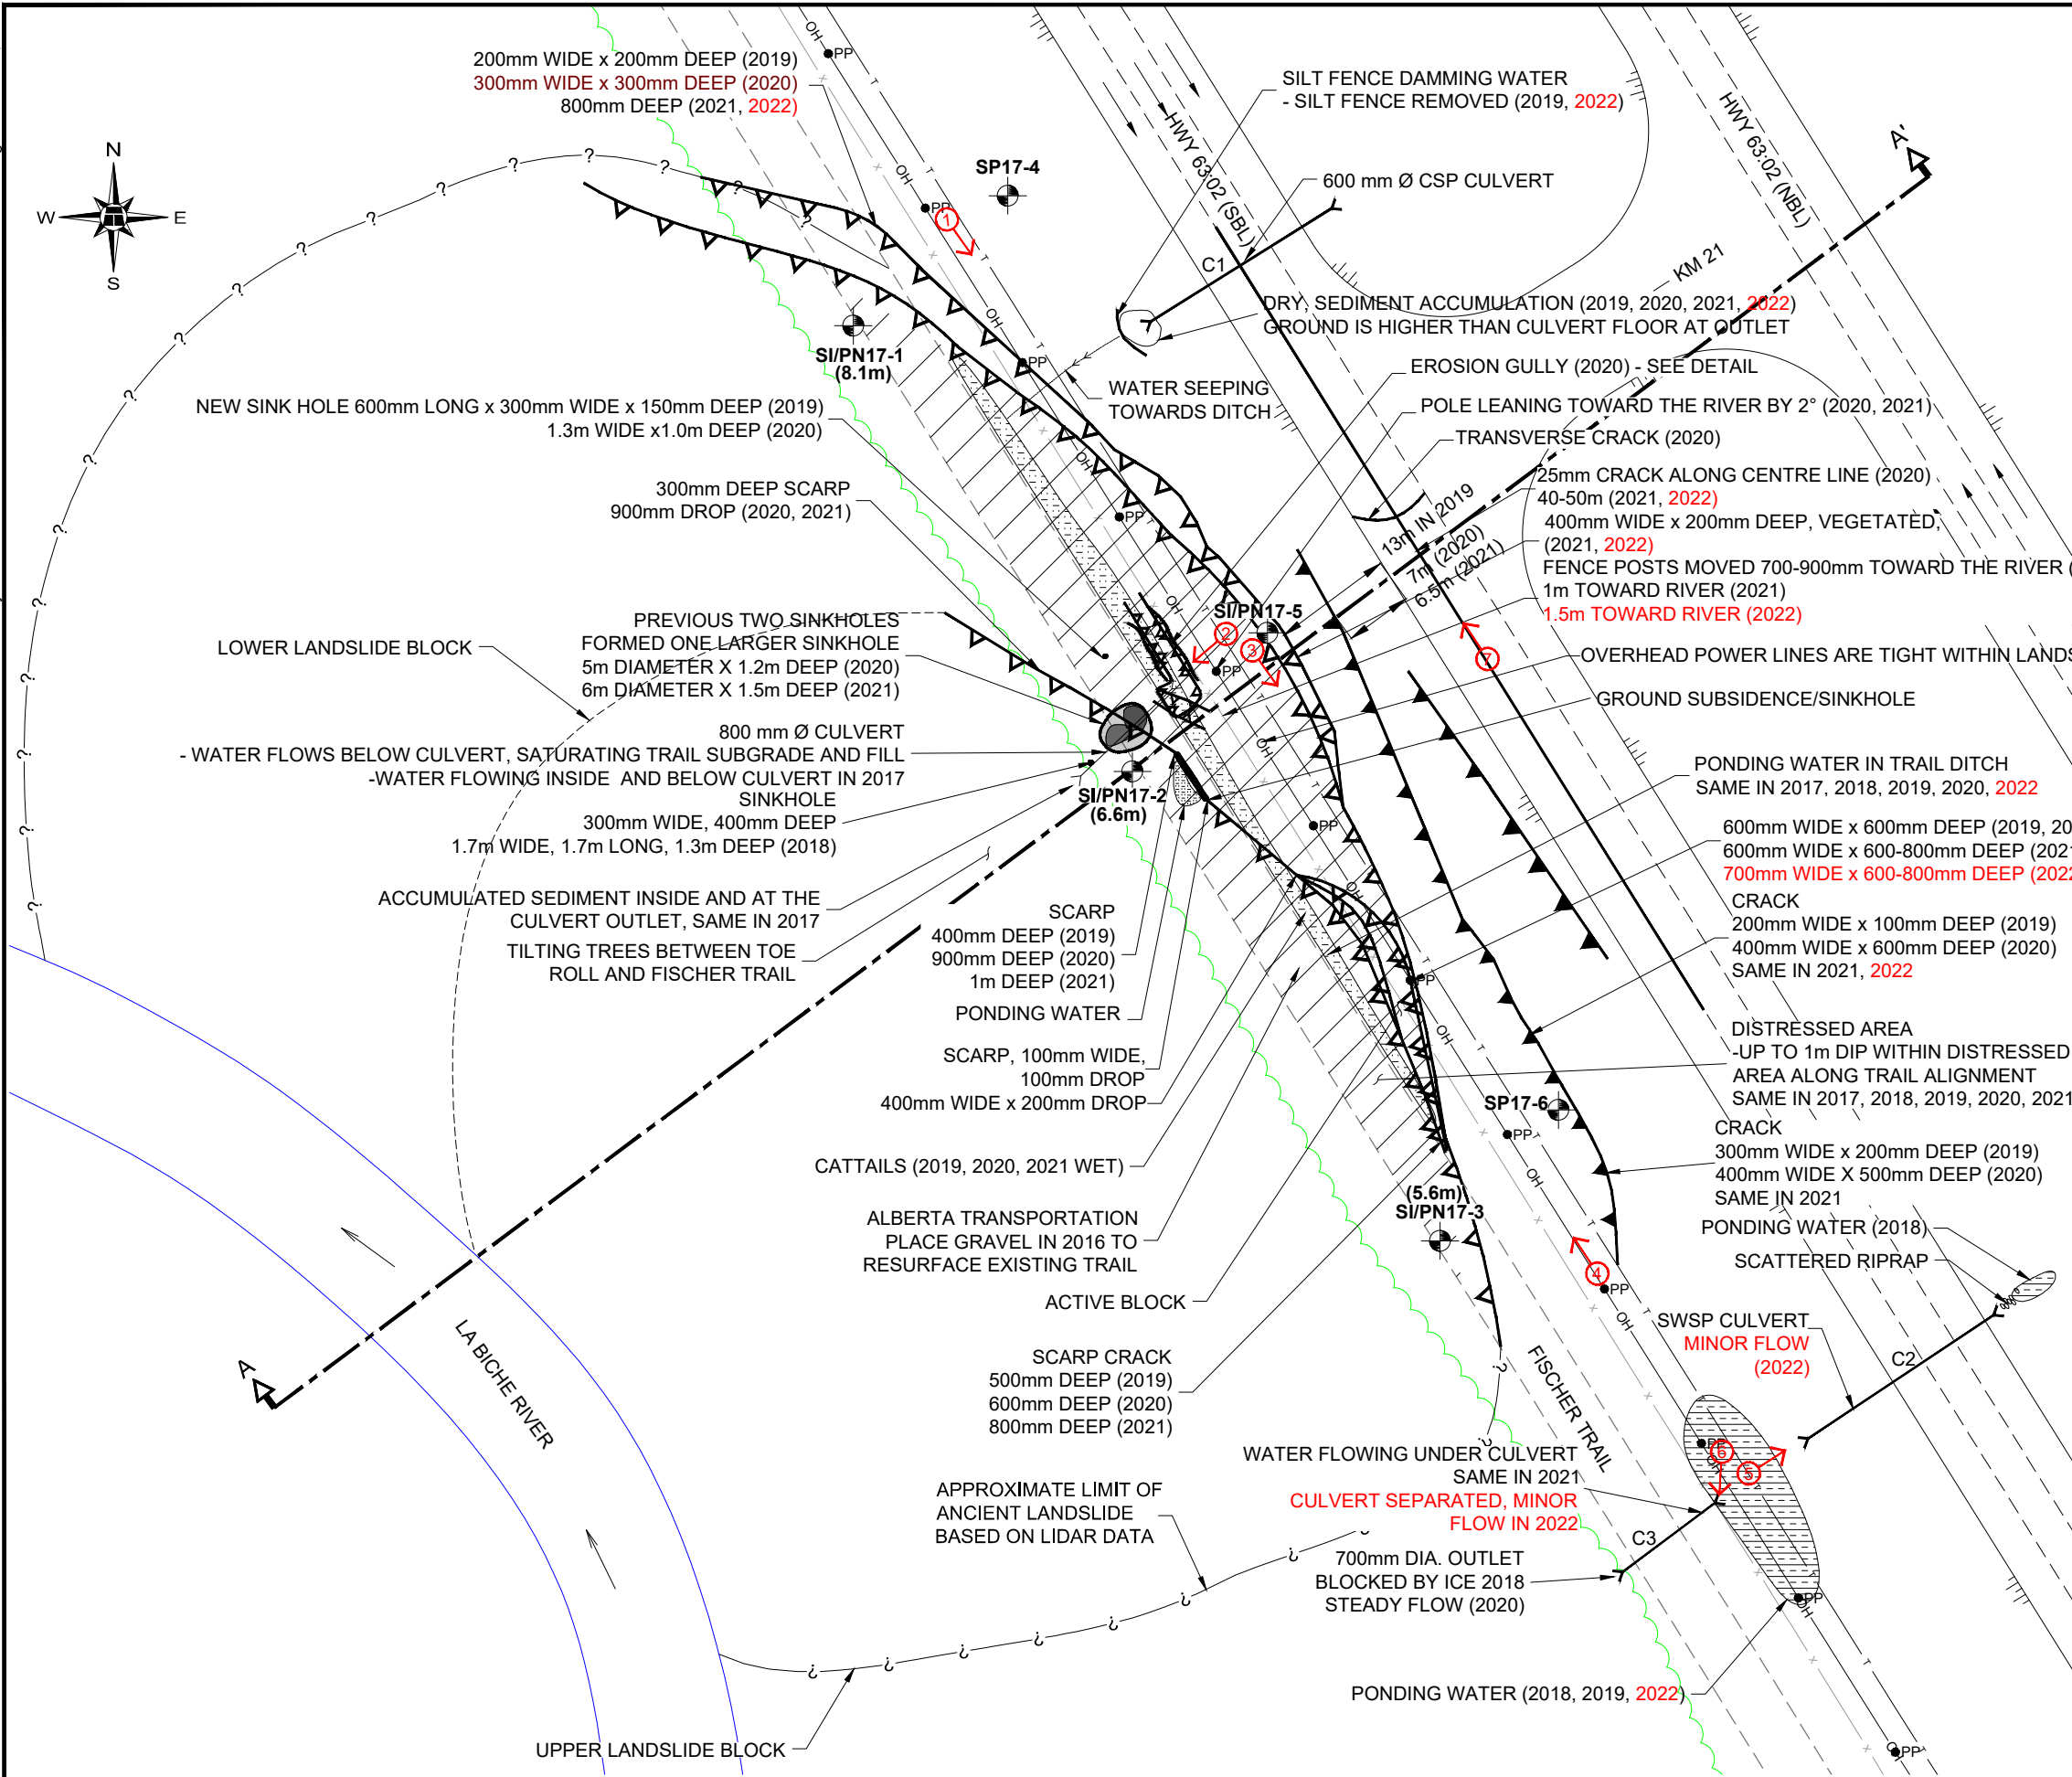
FIGURE 1

Based on the above site observations, and LiDAR information, the distress observed along Fischer trail and the side slope of the highway SBLs reflects an actively moving deep-seated landslide. The depth of movement ranges from 5.6 to 8.1 m below the trail surface. The landslide continues to cause severe distress of the trail surface and is retrogressing to the highway surface.

**NC087- HWY 63:02 FISCHER TRAIL SLIDE (km 20.7)
SITE SKETCH SHOWING LANDSLIDE FEATURES**

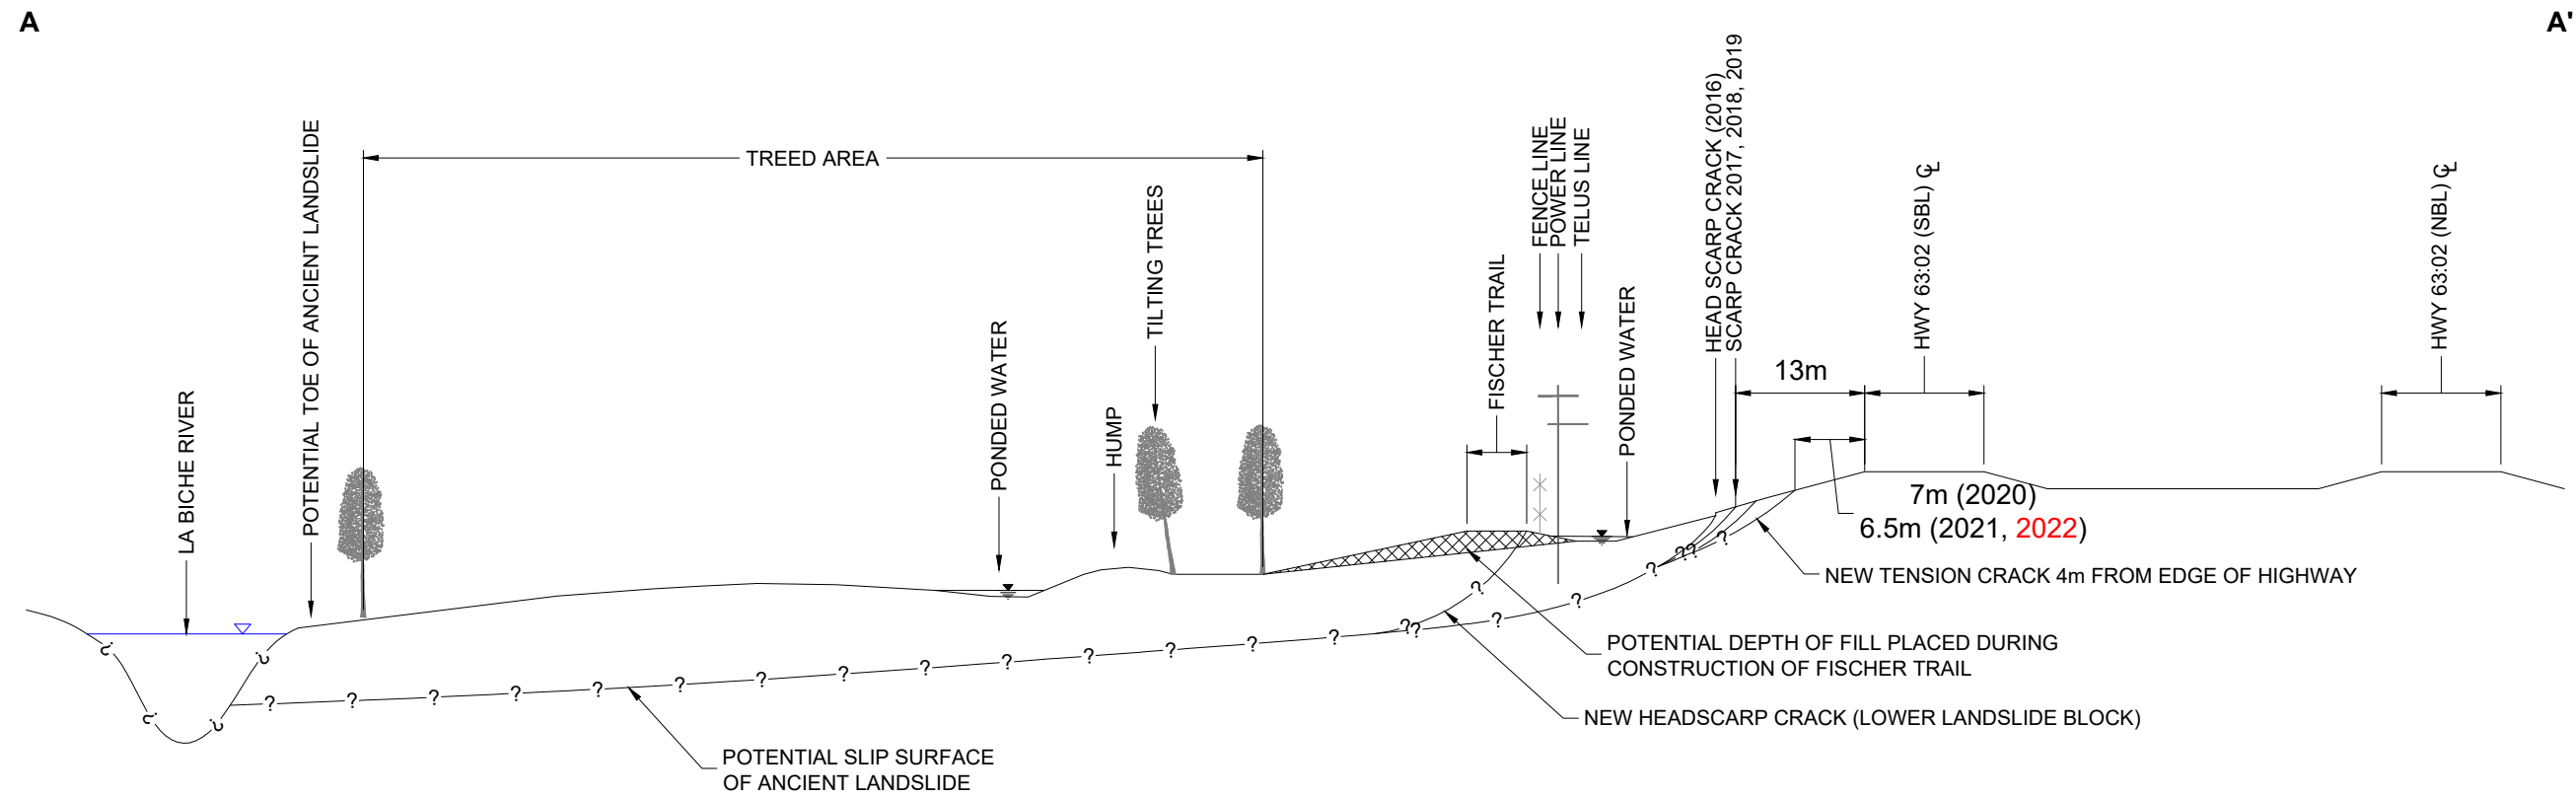
FIGURE 2

**NC087- HWY 63:02 FISCHER TRAIL SLIDE (km 20.7)
 CROSS-SECTION A-A'**

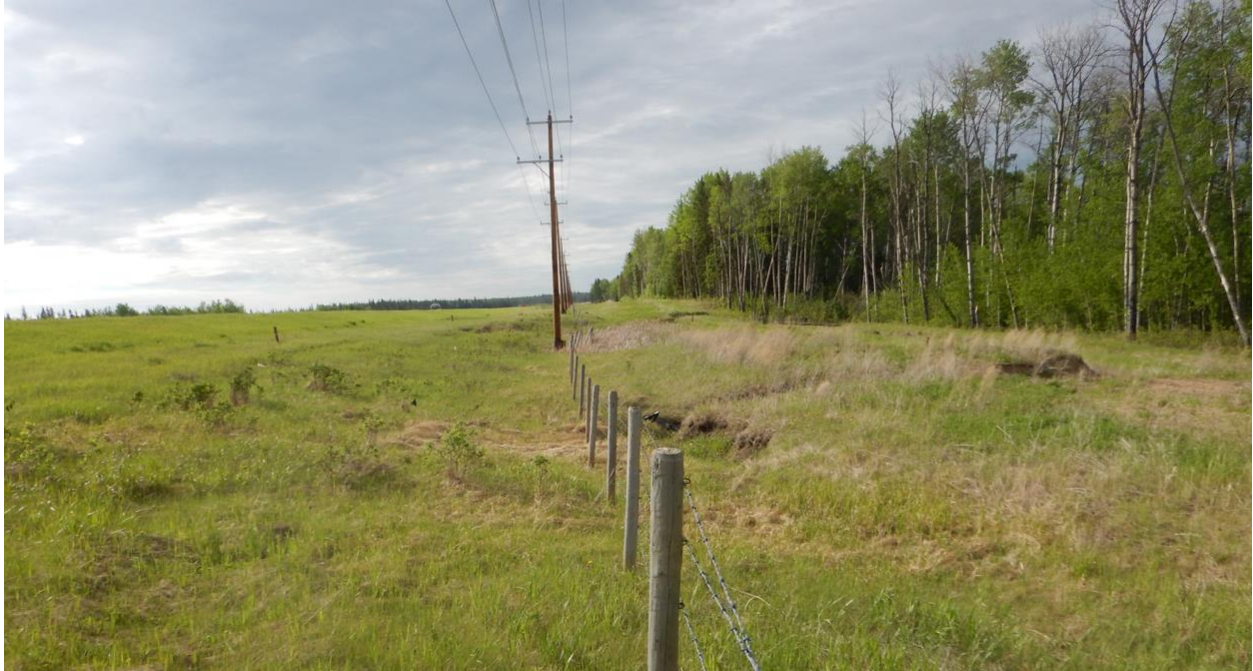
Photo No.1 – Head scarp crack of upper landslide block (Looking South)

- AT should contact the County, the trail owner, and utility companies to let them know about existing hazard(s).
- The local MCI should periodically monitor the head scarp crack for further opening or drop and measure the distance between the head scarp crack and the edge of the highway.
- Clear sedimentation and regrade the ground surface near culvert C1 outlet; inspect and maintain culverts C2 and C3 as needed to prevent further ponding of water in the highway west ditch and water flow under C3.

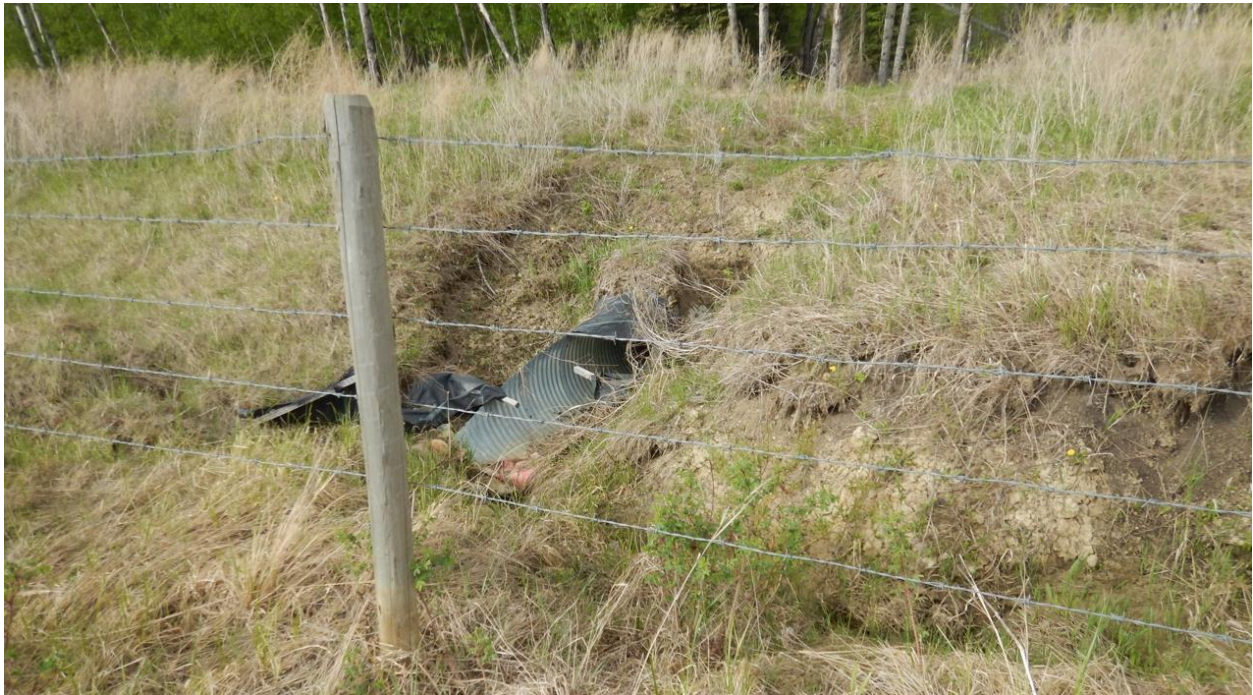
The surface water in the trail ditch flows below the separated 800 mm diameter culvert, resulting in the saturation and washout of trail fill and subgrade and recharging of the landslide mass. It is likely that the uncontrolled discharge of surface water below the trail will result in the formation of additional sinkholes and potentially complete failure of the trail.

Photo No.2 – Sinkhole above the 800 mm diameter culvert; looking at the culvert inlet

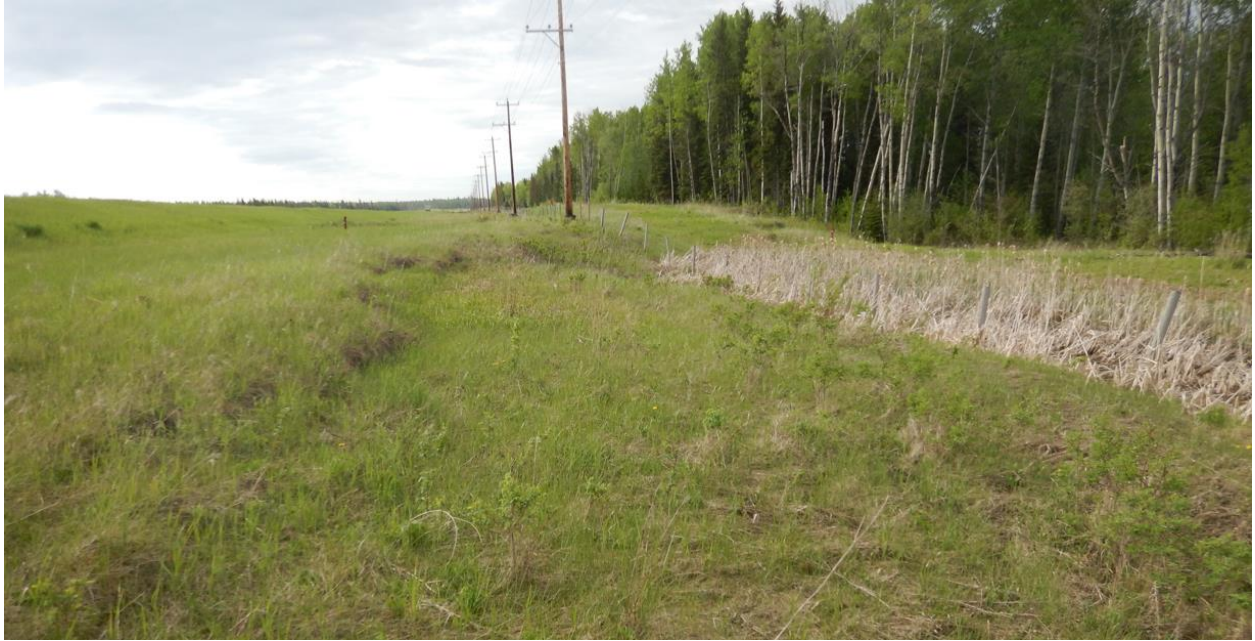
Photo No.3 – Looking south at the southern flank of the landslide (700 mm wide, 600-800 mm deep); water ponding along the ditch between the trail and the fence (note cattails in this area)

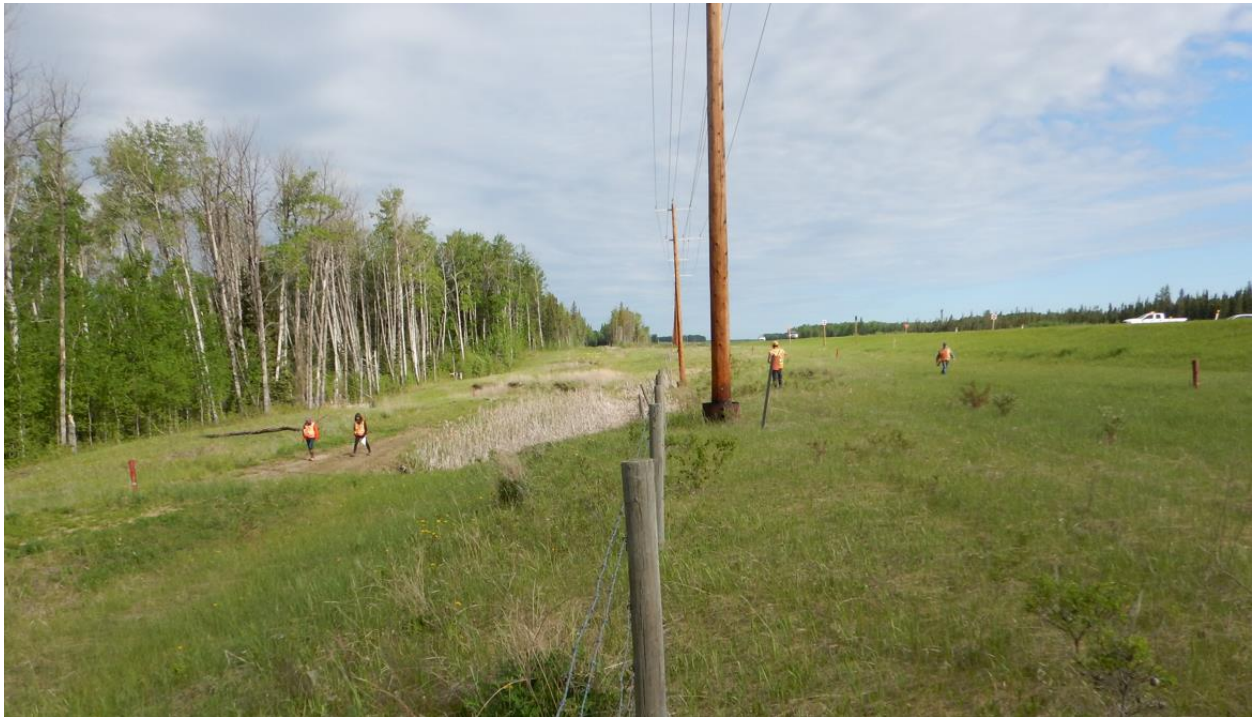
Photo No.4 – Looking north at the southern flank of upper and lower landslide blocks; note standing water within the flank and lateral shifting of existing fence; landslides are well vegetated

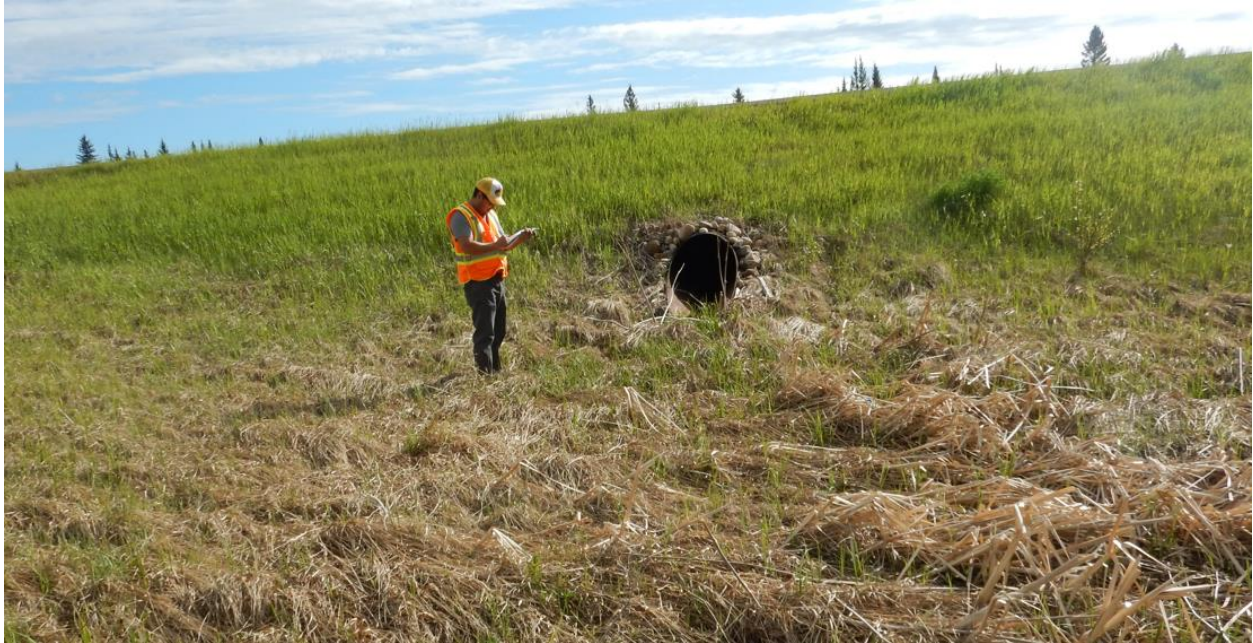
Photo No.5 – Outlet of SWSP culvert C2; minor flow observed in 2022

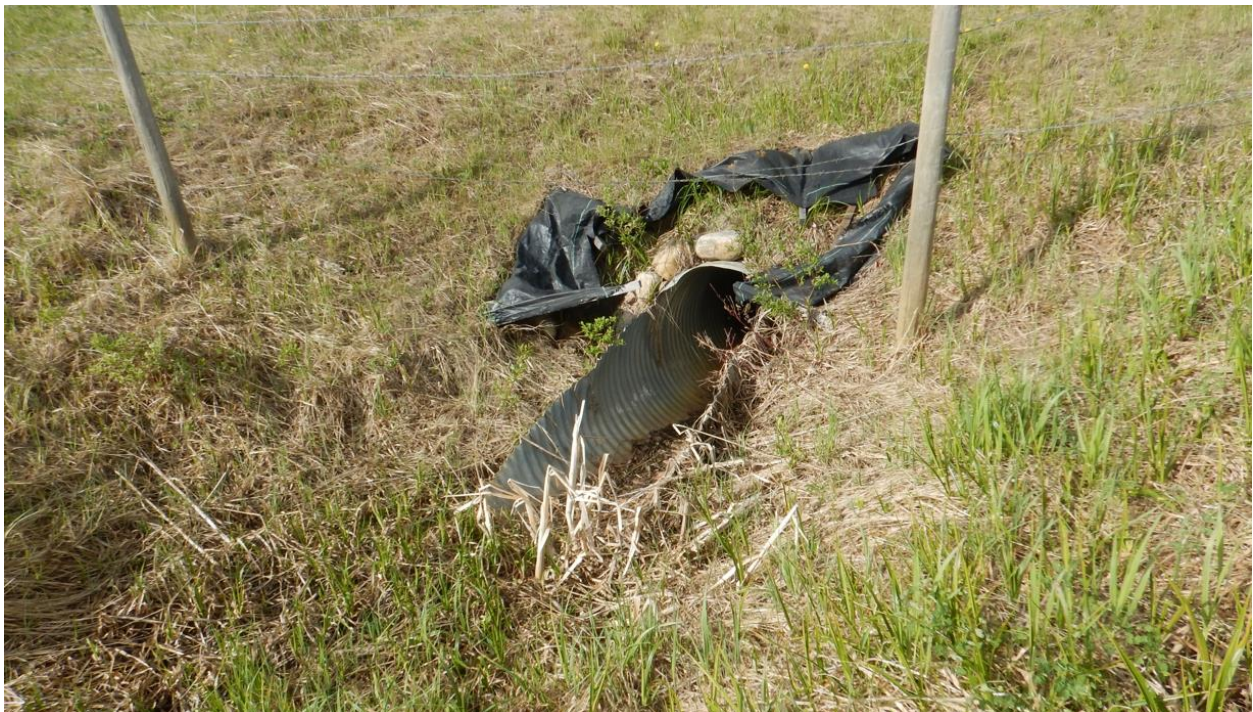
Photo No.6 – 700 mm diameter CSP culvert C3 inlet; culvert separated; minor flow noted in 2021

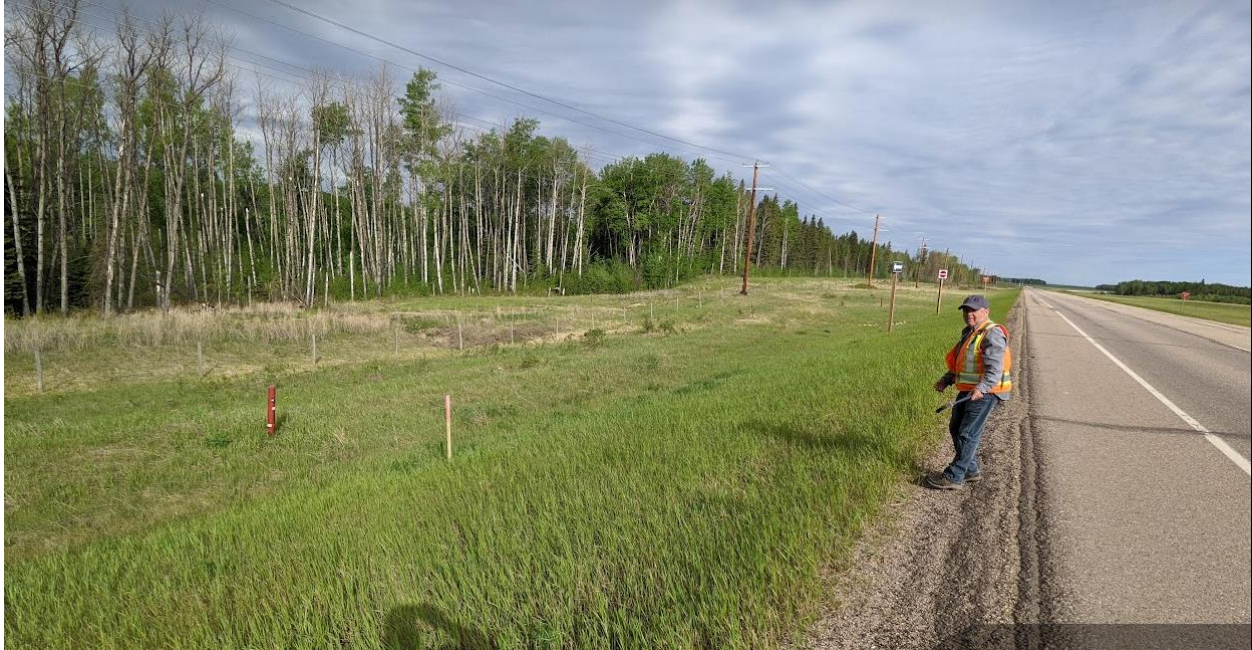
Photo No. 7 – Looking north at highway southbound lanes; landslide is not currently impacting the highway surface; head scarp crack is about 6.5 m away from the edge of pavement

It is understood that AT has no obligation to maintain the trail. Hence, the long-term measure may include the construction of a pile wall between the head scarp crack and the west edge of the highway to shelter the highway from potential retrogression of the head scarp crack into the highway surface. The ballpark cost of this option, excluding engineering, would be in the range of \$850,000 for a steel pile wall and \$2.0 Million for a tangent cast-in-place cantilever pile wall. It should be noted that this option will not address the impact of future movements downslope of the wall on existing trail and utility lines within the landslide mass.
