SITE NUMBER AND NAME C45 H9:04 Slides		HIGHWAY & KM	PREVIOUS INSPECTION DATE June 18, 2007	INSPECTION DATE June 13, 2008
LEGAL DESCRIPTION NE 35-28-20-W4	NAD 83 COORDINATES N 5699455 E 381200		RISK ASSESMENT PF: 9 CF: 2 TOTAL: 18

LAST READING DATE:	
PRIMARY SITE ISSUE: Slope Failures	
APPROXIMATE DIMENSIONS:	
DATE OF ANY REMEDIAL ACTION:

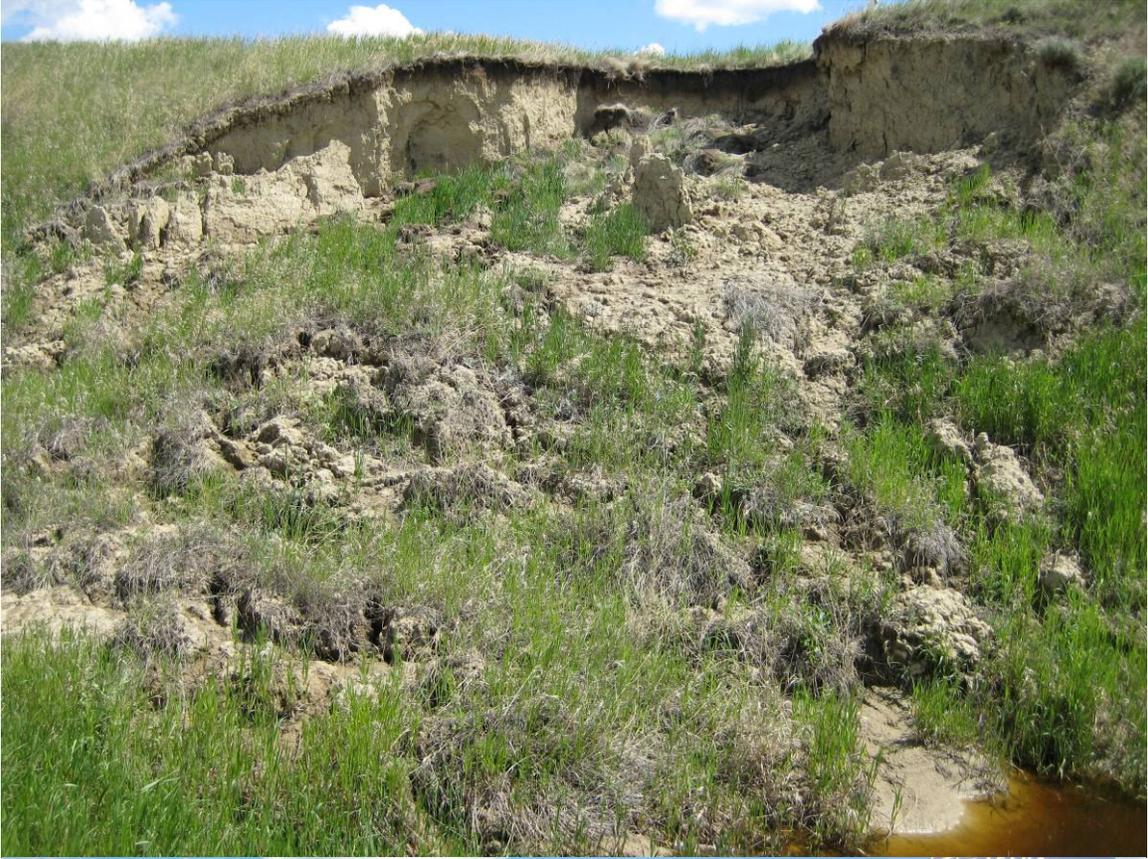
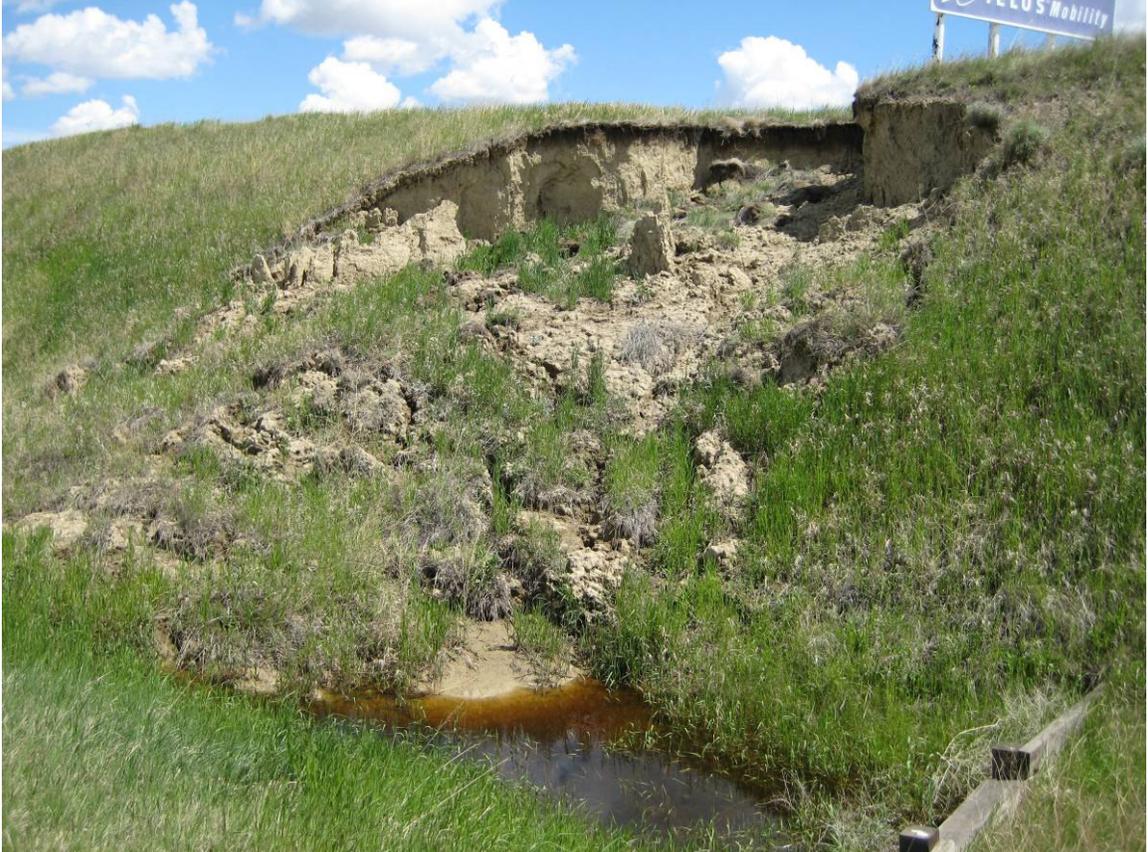
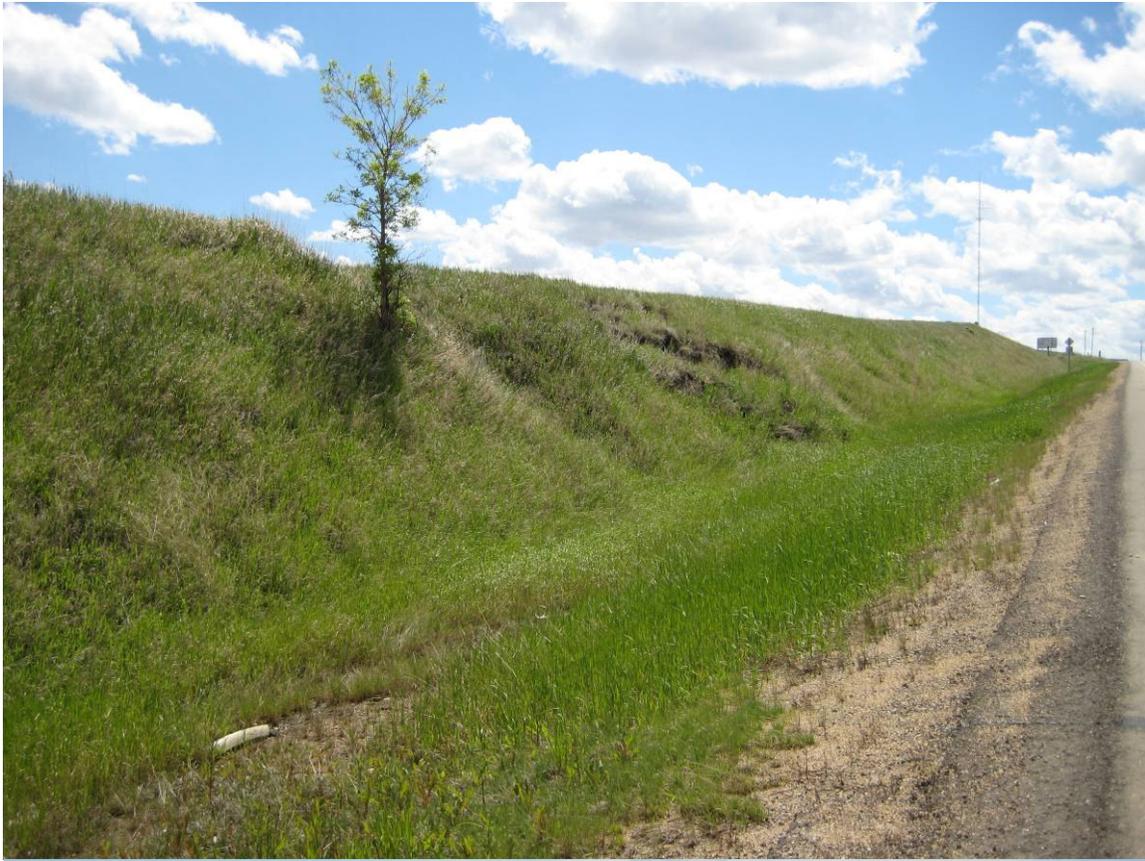
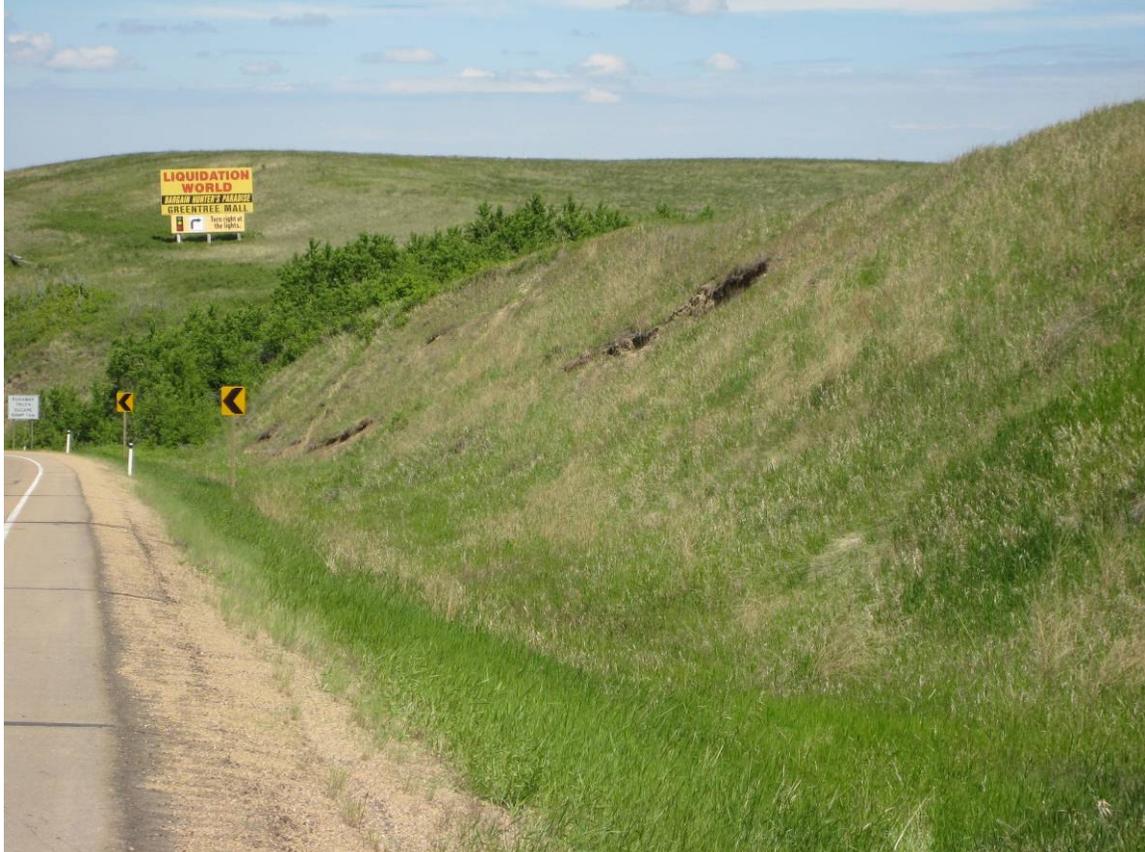
ITEM	CONDITION EXISTS		DESCRIPTION AND LOCATION	NOTICABLE CHANGE FROM LAST INSPECTION	
	YES	NO		YES	NO
Pavement Distress		X			X
Slope Movement	X		Surficial sloughing is occurring in the embankment above the highway. The highway is unaffected.		X
Erosion		X			X
Seepage		X			X
Culvert Distress		X			X

COMMENTS
Refer to attached photos.
It is recommended that the ditch be cleared regularly to prevent slough from blocking ditch flows.
