June 9, 2017

Alberta Transportation
4th Floor, Provincial Building
4920 51 Street
Red Deer, Alberta
T4N 6K8

**CON0017608 Central Region GRMP Instrumentation Monitoring
Site C061; H20:02, km 12.212 Frost Heave
Section C – 2017 Spring Readings
DRAFT**

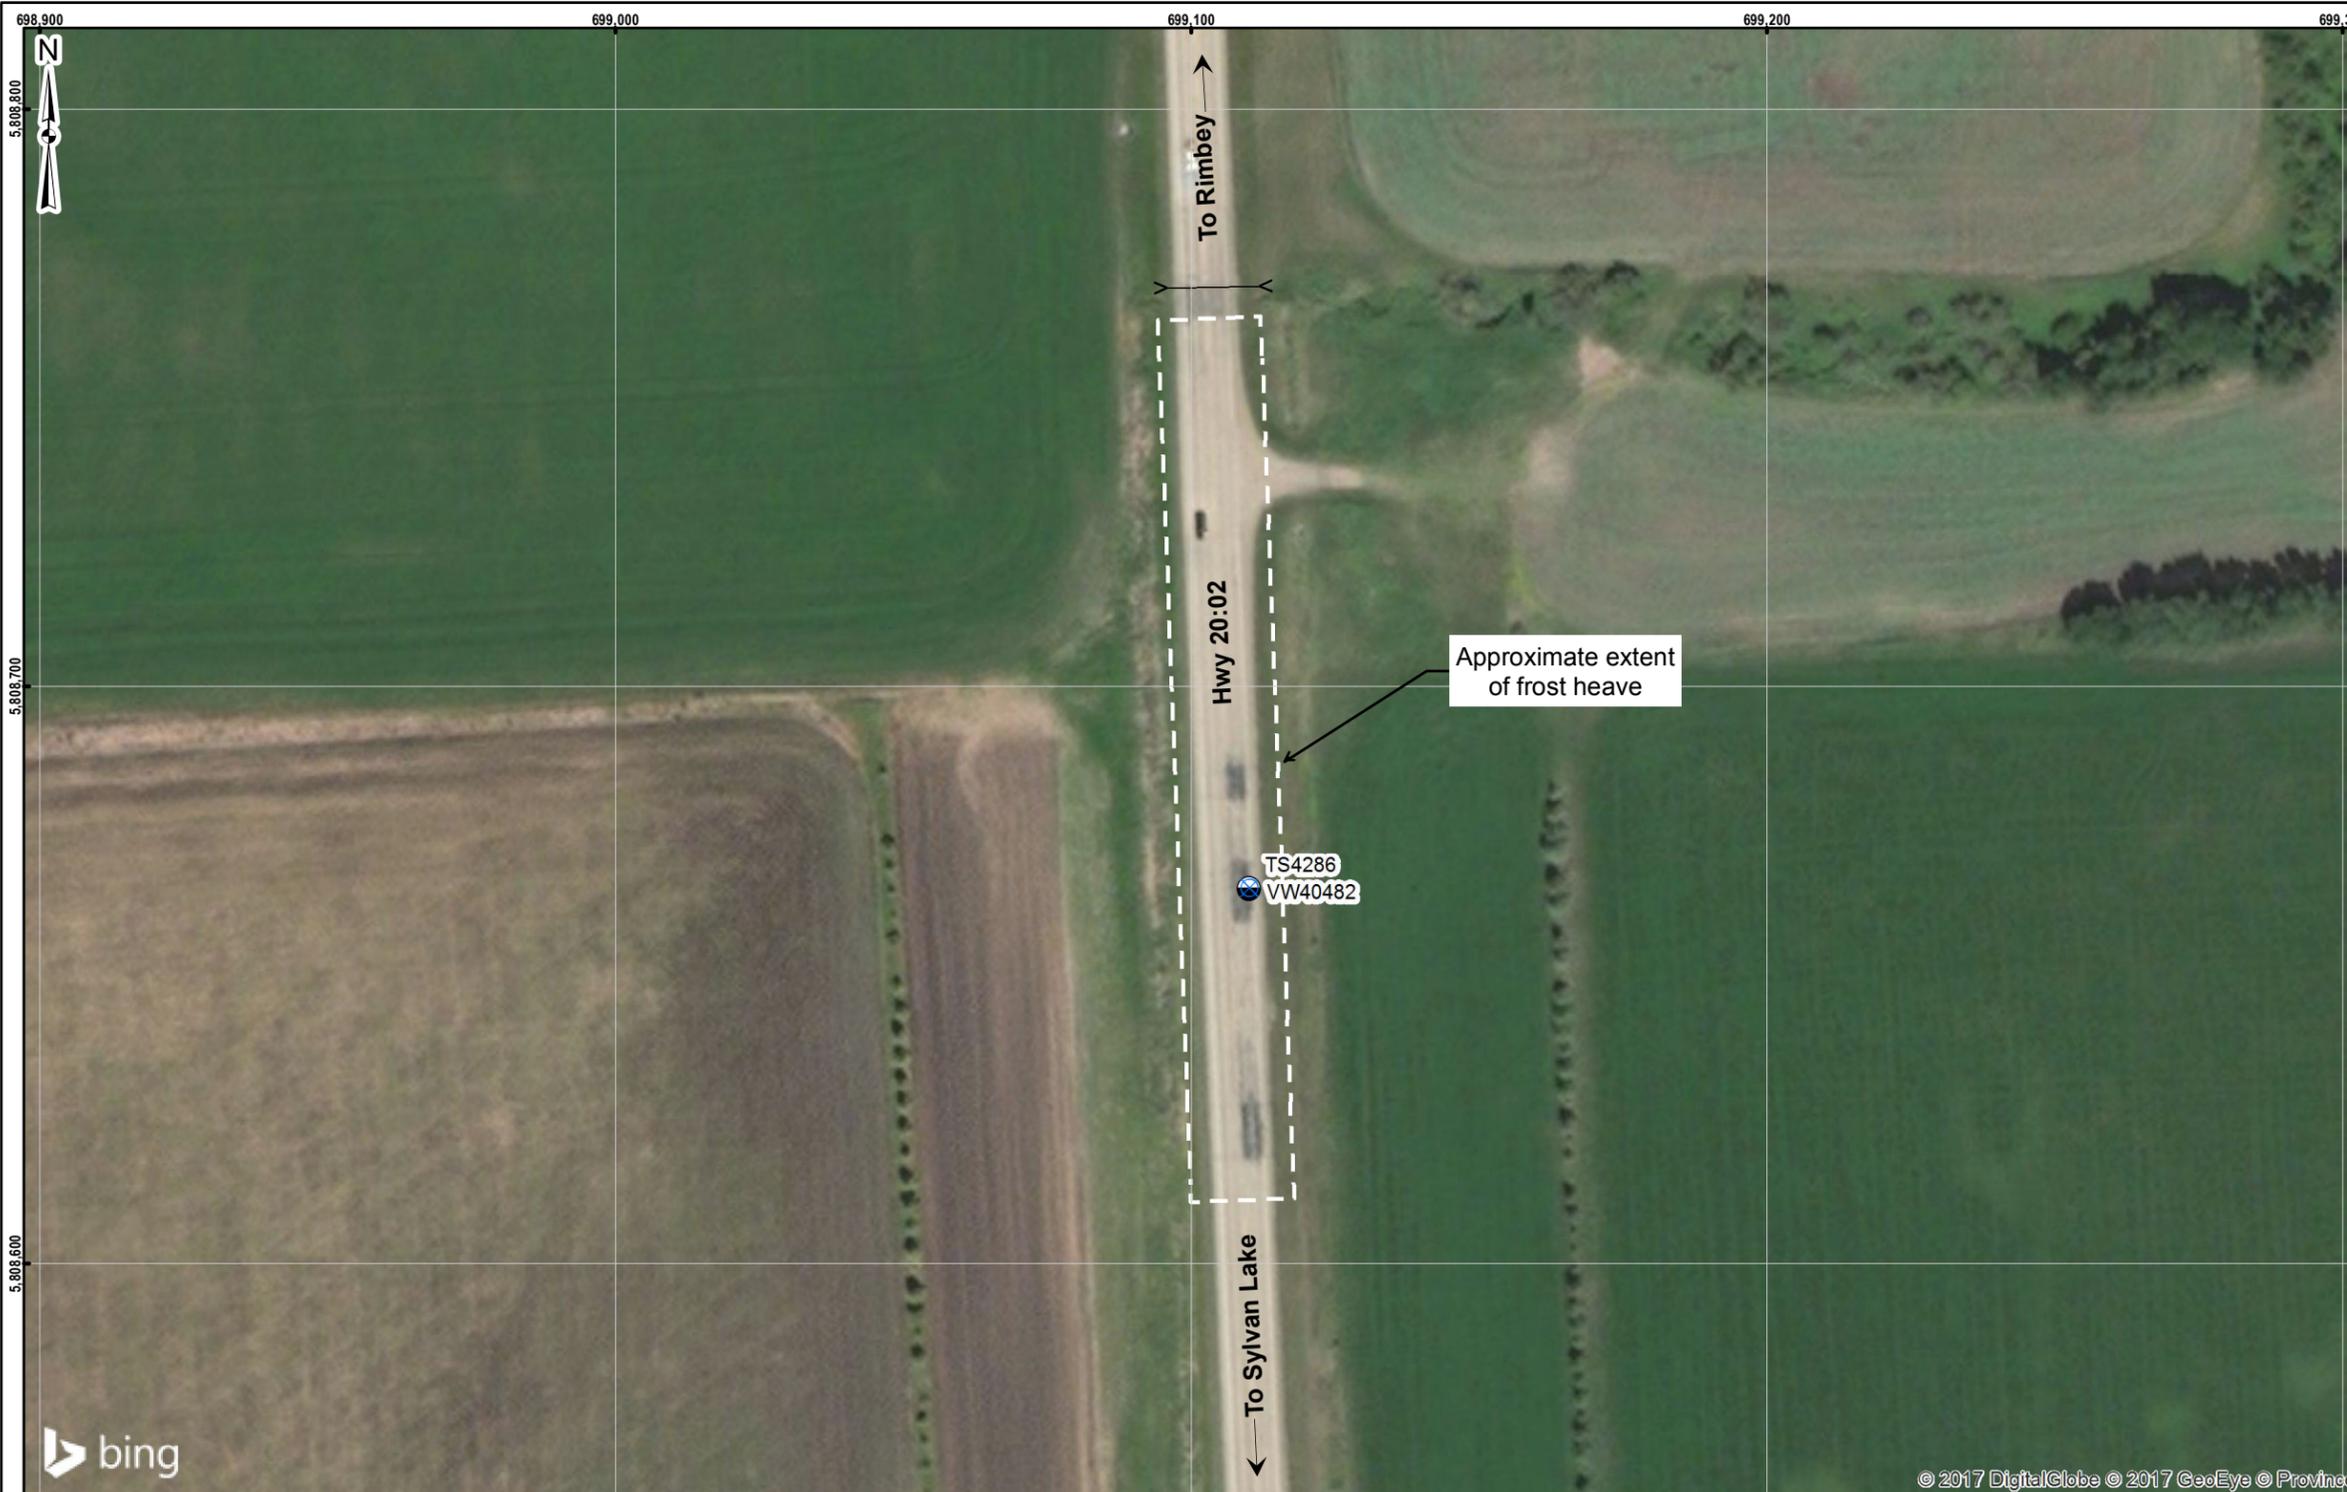
| | | FIG No. 1 |

One vibrating wire piezometer (VW40482) and one thermistor cable (TS4286) were read at geohazard site C061 on May 11, 2017 by Ms. Courtney Mulhall, E.I.T. and Mr. Lekan Mitchell, E.I.T. of Klohn Crippen Berger Ltd. (KCB). The site is located on Hwy 20:02, km 12.212, approximately 10 km north of Sylvan Lake, Alberta. The site coordinates are 52°23.564' N, 114°4.592' E (NAD 83). A site plan is presented in Figure 1.

The geohazard at C061 is frost heave. Each winter, heaving of frost susceptible materials in the highway embankment results in an approximate 400 m long section of Hwy 20 heaving, predominately in the northbound lane. Heaving at C061 is prominent in late February to early March, and is significant enough to have caused vehicle damage. Previous remedial actions include drainage redirection to the west ditch, and a series of gravel drains in the embankment in 2008. The maintenance contractor also fills in the depressions between heaves during the winter, and then cuts the asphalt when the heaves subside in spring.

Instrumentation installation details are tabulated in Table 1.1. Instrument locations are shown in Figure 1.

Repair options are currently being assessed by KCB and Alberta Transportation, and may include drainage improvement, reconstruction of the existing ditch, and frost heave repair where a culvert was removed. The site should continue to be inspected by the Maintenance Contract Inspector (MCI) and as part of the annual GRMP inspection program (Section B).
