SITE NUMBER AND NAME C061 Frost Heave		HIGHWAY & KM 20:02, 12.212	PREVIOUS INSPECTION DATE Feb 28, 2018	INSPECTION DATE Feb 21, 2019
LEGAL DESCRIPTION SE 33-39-1-W5M	NAD 83 COORDINATES: UTM Northing Easting 11 5808688 699107		RISK ASSESSMENT PF: 8 CF: 3 TOTAL: 24	
AVERAGE ANNUAL DAILY TRAFFIC (AADT): 5,930 (north) & 6,260 (south) (Ref No. 997219)			CONTRACT MAINTENANCE AREA (CMA): 19

SUMMARY OF SITE INSTRUMENTATION: Operational: One vibrating wire piezometer and one ground temperature cable. LAST READING DATE: May 11, 2017	INSPECTED BY: Chris Gräpel (KCB) Ryan Gazley (KCB) Tony Penney (AT) Dewayne Wlad (AT)
PRIMARY SITE ISSUE: Frost heave of road due to frost susceptible embankment fill.	
APPROXIMATE DIMENSIONS: Approximately 400 m along highway.	
DATE OF ANY REMEDIAL ACTION: Drainage redirected to southbound ditch

PROJECT	CENTRAL REGION GEOHAZARD RISK MANAGEMENT PROGRAM	
TITLE	C061 Site Inspection Hwy 20:02 km 12.212	
SCALE	PROJECT No.	FIG No.
1:1,000	A05115A02	1

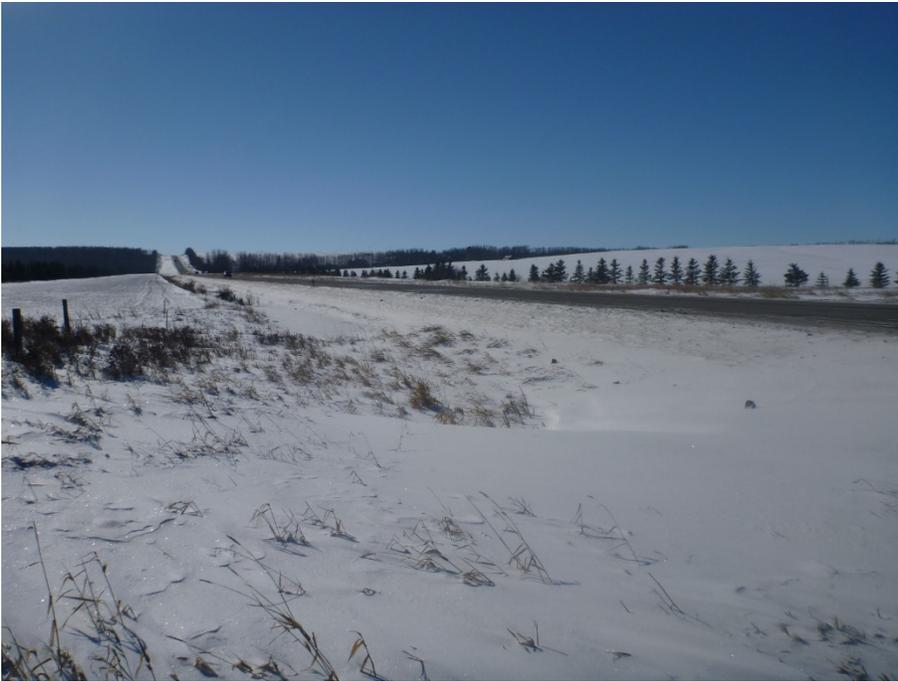
Photo 1 **Drainage ditch off the northbound lane of the highway. Photo taken February 21, 2019 looking southwest.**

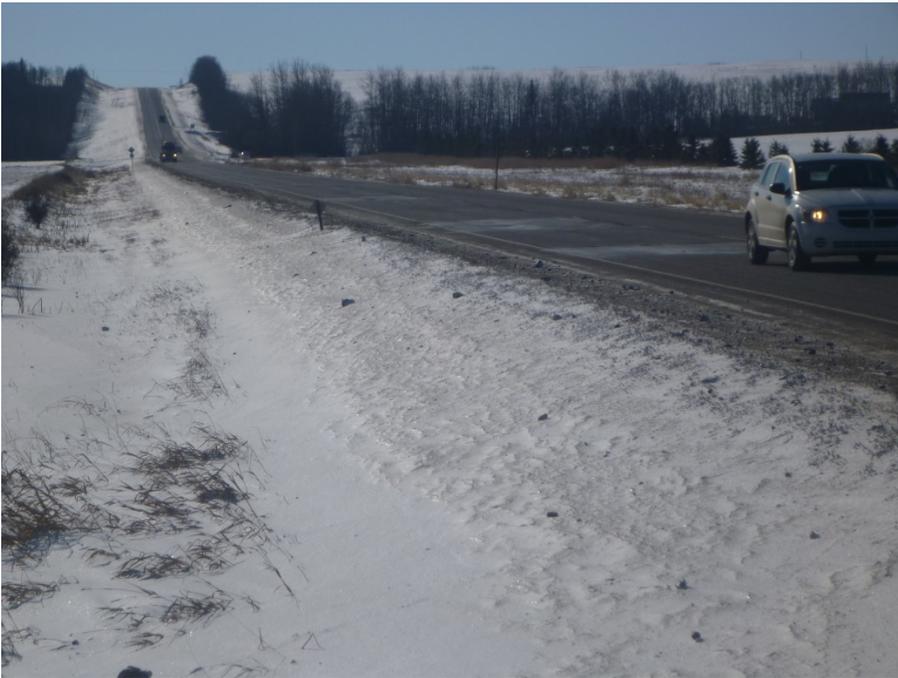
ITEM	CONDITION EXISTS		DESCRIPTION AND LOCATION	NOTICABLE CHANGE FROM LAST INSPECTION	
	YES	NO		YES	NO
Pavement Distress	X		Three patches on northbound lane in center of heaving area. Transverse pavement cracks were noted.		X
Slope Movement		X			X
Erosion		X			X
Seepage	X		A spring was observed in the southbound ditch at the south end of the site during the March 2, 2017 inspection		X
Culvert Distress		X			X

Photo 2 **View of the three previously patched areas on the northbound lane. Photo taken February 21, 2019 looking southwest.**

COMMENTS
Traffic does not seem to be slowing down despite hazard signs warning drivers of uneven pavement and a 65 km/hr speed limit.
Both lanes appear to be equally uneven. The MCI reported that the heaving conditions are better this winter as compared to last winter, which may be due to reduced levels of precipitation during 2018.
Transverse pavement cracks observed at the three patched areas. Pavement cracks extend the entire width of the highway.
The maintenance contractor has not had to place any levelling asphalt patches this winter.
This site will be repaired in spring 2019 as detailed in Alberta Transportation Tender TND0019153.
