SITE NUMBER AND NAME: C066 Ghostpine Creek Slide		HIGHWAY & KM: 27:10, 12.434	PREVIOUS INSPECTION DATE: June 14, 2017	INSPECTION DATE: June 13, 2018
LEGAL DESCRIPTION: 02-16-031-22 W4M	NAD 83 COORDINATES: UTM Northing Easting 12 5724022 357407		RISK ASSESSMENT: PF: 5 CF: 2 TOTAL: 10	
AVERAGE ANNUAL DAILY TRAFFIC (AADT): 1970 (west) & 1940 (east) (Ref No. 106260 & 105250)			CONTRACT MAINTENANCE AREA (CMA): 20

PROJECT CENTRAL REGION GEOHAZARD RISK MANAGEMENT PROGRAM		
TITLE Site Plan C066 - Ghostpine Creek Slide Hwy 27:10, km 12.434		
SCALE 1:800	PROJECT No. A05115A02	FIG No. 1

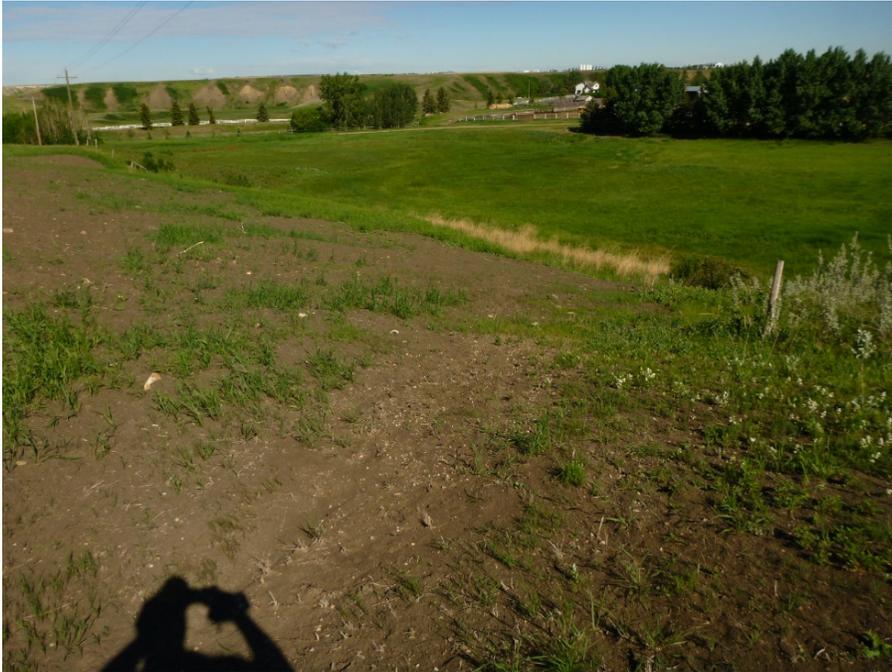
Photo 1 In the major slide zone, the fill material has been regraded and the mid slope bench that was present in 2017 has been removed. At the time of inspection there were no signs of recent erosion but the slope remains poorly vegetated. Photo taken June 13, 2018 looking northwest.

COMMENTS
Since the 2017 inspection, the stockpile of fill material has since been removed or has been used to regrade the slide zone. Currently there are no signs of erosion (i.e. rilling) on the slope. The slope is poorly vegetated and should be reseeded as soon as possible to limit the potential for erosion during a rainfall event. The five HDPE slope drains remain exposed at the toe of the slope but were not flowing at the time of inspection. Pavement cracking in the eastbound lane does not appear to be increasing.
Discussed remedial actions: The fence should be re-installed, and the regraded fill should be reseeded. If cracking and pavement deformations continue, a slope inclinometer should be installed to monitor depth of movement.
Inspect site very two years, unless additional movements occur.

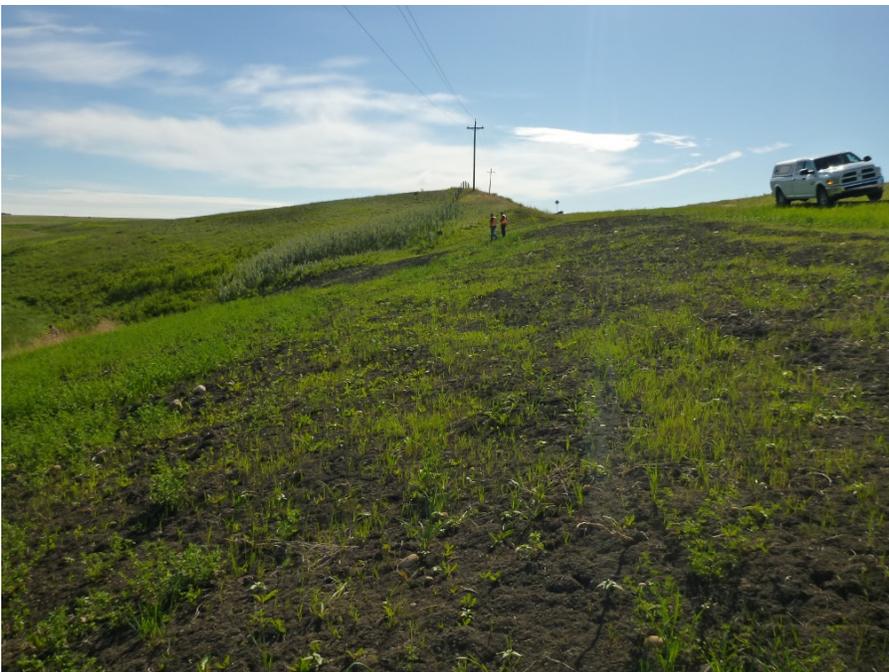
Photo 2 Secondary view of the poorly vegetated slope. Photo taken June 13, 2018 looking east.

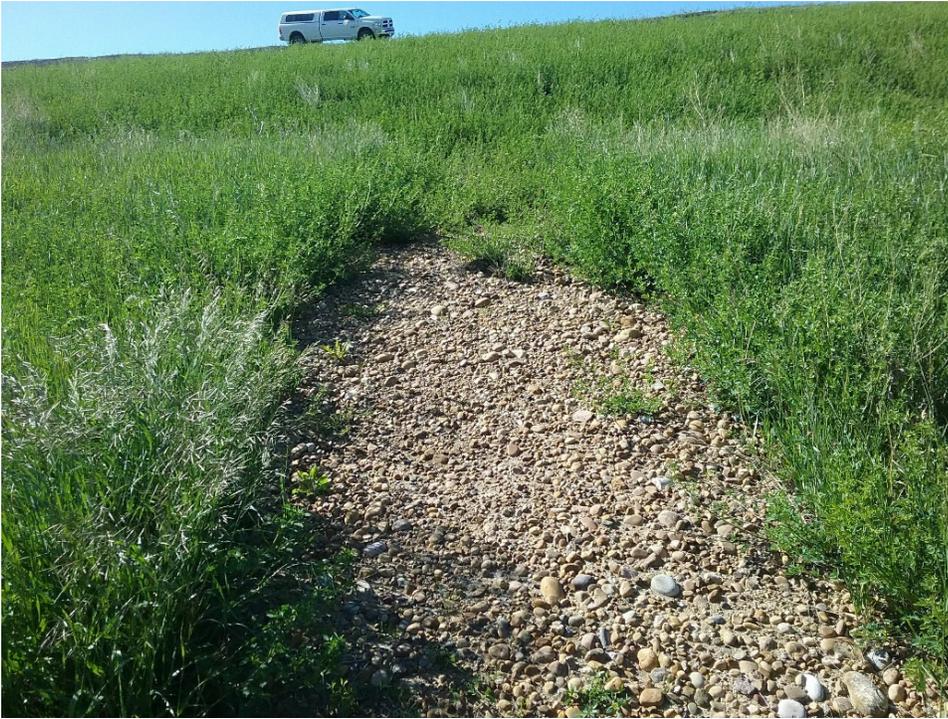
Photo 3 Photo taken downslope of one of the five exposed slope drains. No seepage flows were observed during the inspection. Photo taken June 12, 2018 looking south.

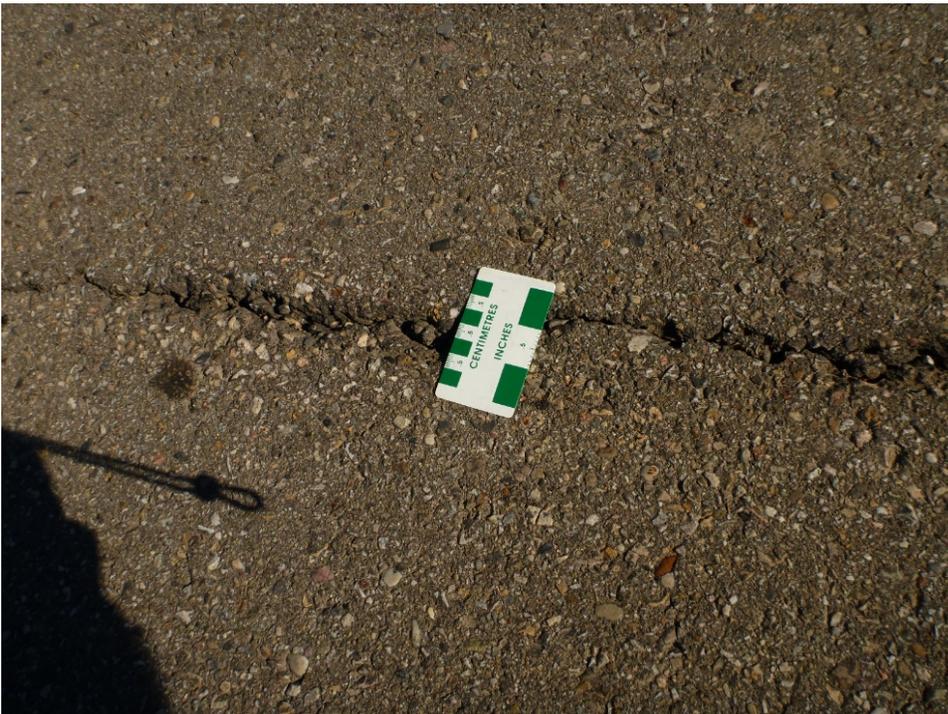
Photo 4 The pavement cracking in the eastbound lane above to slide area does not appear to be increasing. Photo taken June 12, 2018 looking north.
