SITE NUMBER AND NAME: C066 Ghostpine Creek Slide		HIGHWAY & KM: 27:10, 12.434	PREVIOUS INSPECTION DATE: June 13, 2018	INSPECTION DATE: May 30, 2022
LEGAL DESCRIPTION: 02-16-031-22 W4M	NAD 83 COORDINATES: UTM Northing Easting 12 5724022 357407		RISK ASSESSMENT: PF: 2 CF: 2 TOTAL: 4	
AVERAGE ANNUAL DAILY TRAFFIC (AADT): 1690 (west) & 1660 (east) (Ref No. 106260 & 105250)			CONTRACT MAINTENANCE AREA (CMA): 517

PROJECT CENTRAL REGION GEOHAZARD RISK MANAGEMENT PROGRAM		
TITLE Site Plan C066 - Ghostpine Creek Slide Hwy 27:10, km 12.434		
SCALE 1:1,000	PROJECT No. A05116A02	FIG No. 1

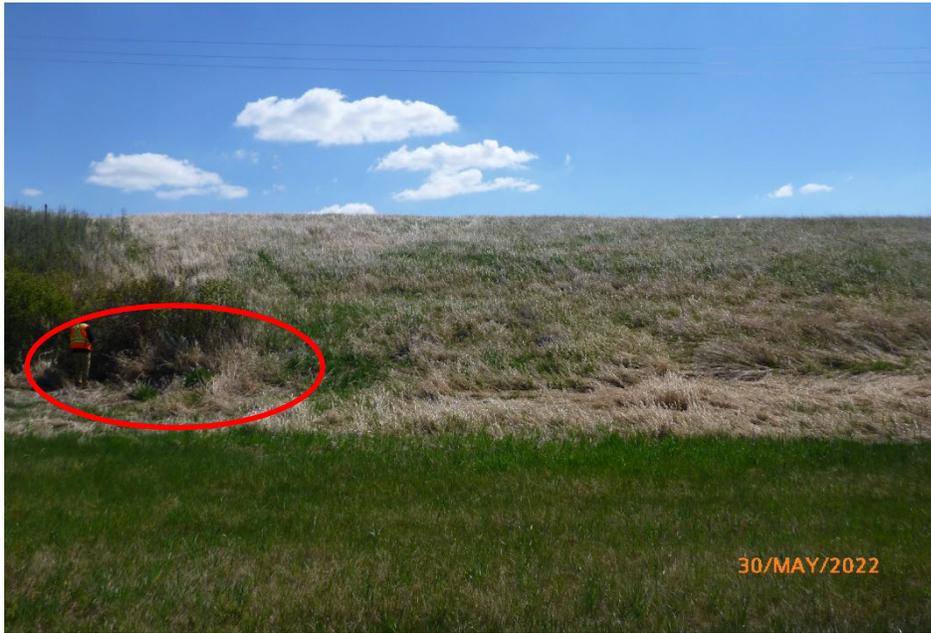
COMMENTS
Between 2017 and 2018 inspections, the stockpile of fill material was removed or was used to regrade the slide zone.
A potential toe roll was observed at the toe near the eastern slope drain outlet (Photo 1) (WP 147).
Since the 2018 inspection, the slope has become well vegetated and there are no signs of erosion (i.e., rilling) on the slope (Photo 1 and 2).
The five HDPE slope drains remain exposed at the toe of the slope and were dry during the 2022 inspection (Photo 3).
Pavement cracking and settlement in then north (westbound) lane does not appear to have worsened since the 2018 inspection (Photo 4).
The repair appears to be performing well and KCB recommends the site not be visited again during the current contract period. The site could be removed from the list of active Central Region GRMP sites.

- Photo 1** The vegetation cover at the major slide zone has improved significantly since the 2018 inspection. A potential toe roll was observed near the east side of the slide repair (indicated by red circle)(WP 147). Photo taken May 30, 2022, facing south.

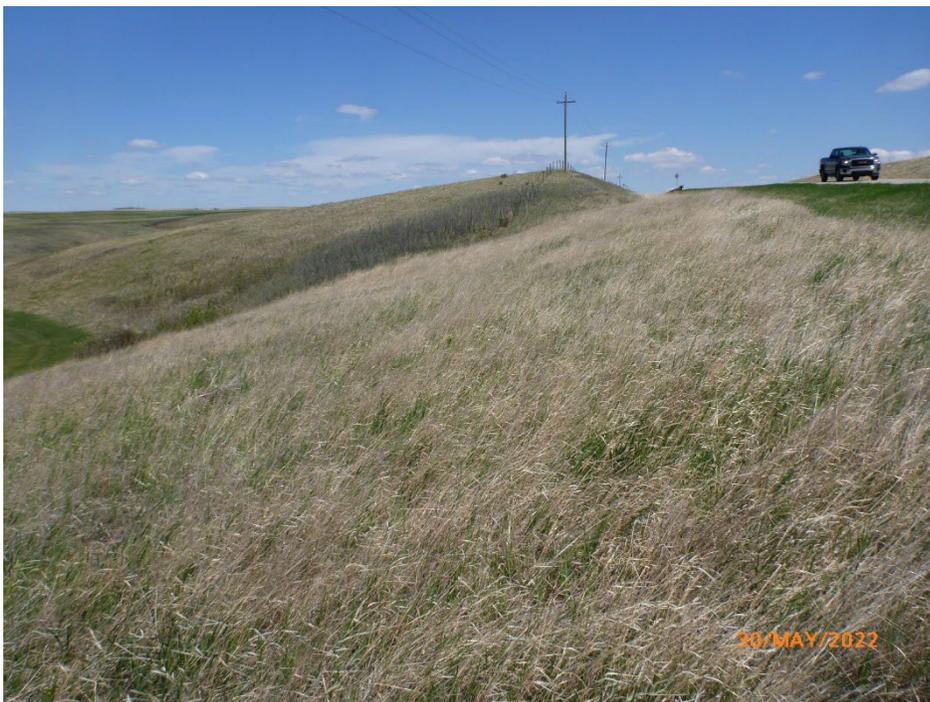
- Photo 2** The north highway embankment slope, where the major slide was repaired. Photo taken May 30, 2022, facing east.

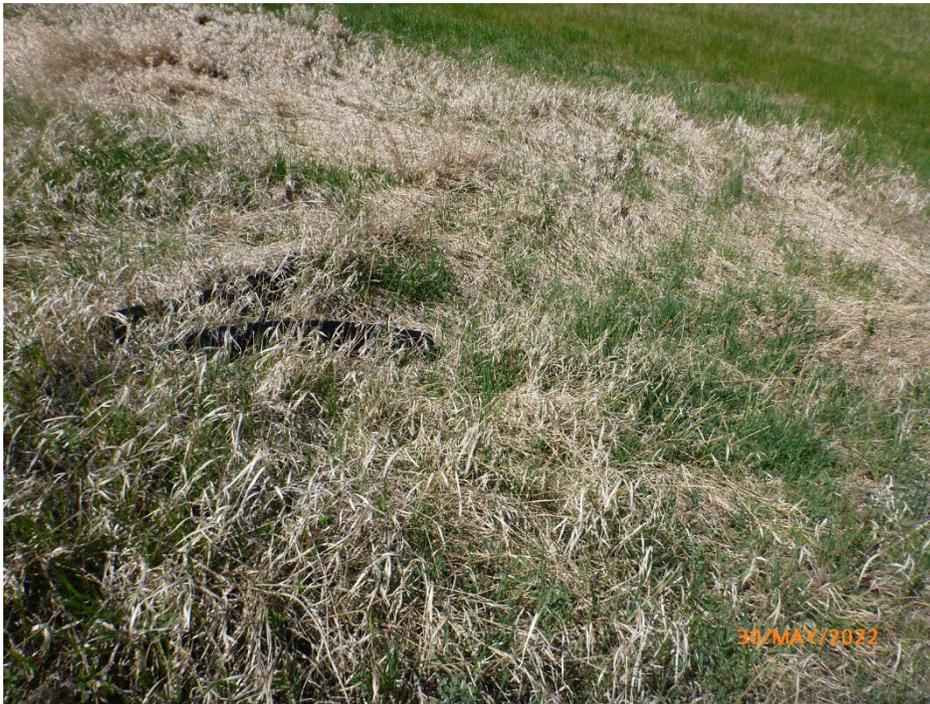
Photo 3 The drains installed during construction were dry during the inspection. Photo taken May 30, 2022, facing northwest.

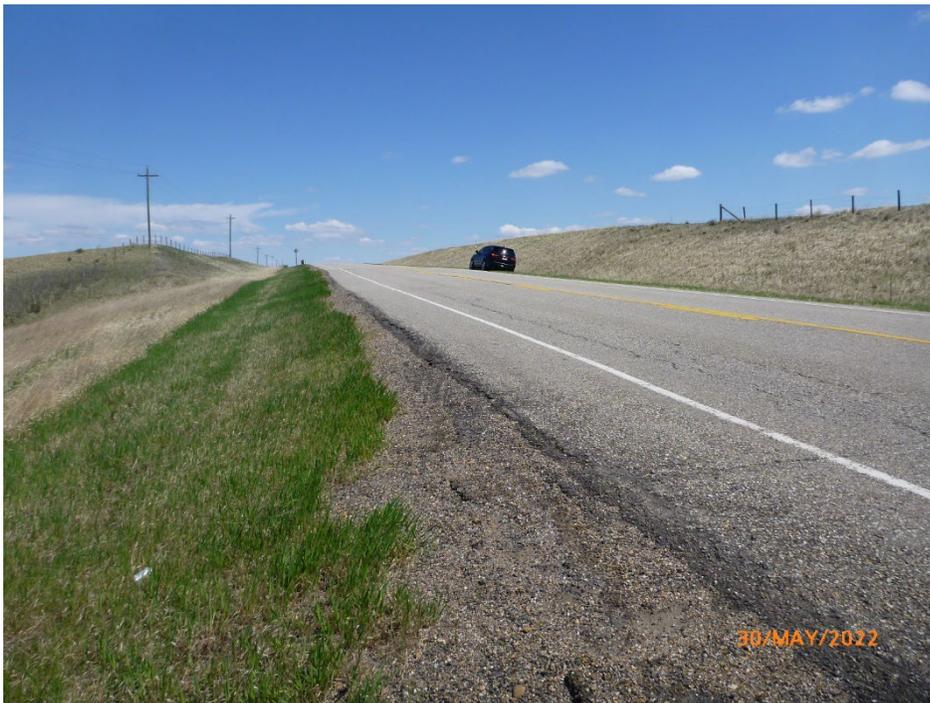
Photo 4 The pavement cracking and settlement above to slide area does not appear to have worsened since the 2018 inspection. Photo taken May 30, 2022, facing east.

- Since the slide appears to be inactive, the HMC could complete pavement patch to reduce the slight dip observed above the repaired area to improve the highway smoothness.
