**CENTRAL REGION  
GEOHAZARD RISK ASSESMENT  
SITE INSPECTION FORM**

SITE NUMBER AND NAME <b>C36 H2A Gabion Drop</b>		HIGHWAY & KM 1.6 km North of Innisfail	PREVIOUS INSPECTION DATE	INSPECTION DATE <b>May 26, 2005</b>
LEGAL DESCRIPTION	NAD 83 COORDINATES N 5768712 E 299070	RISK ASSESMENT PF: 9 CF: 1 TOTAL: <b>9</b>

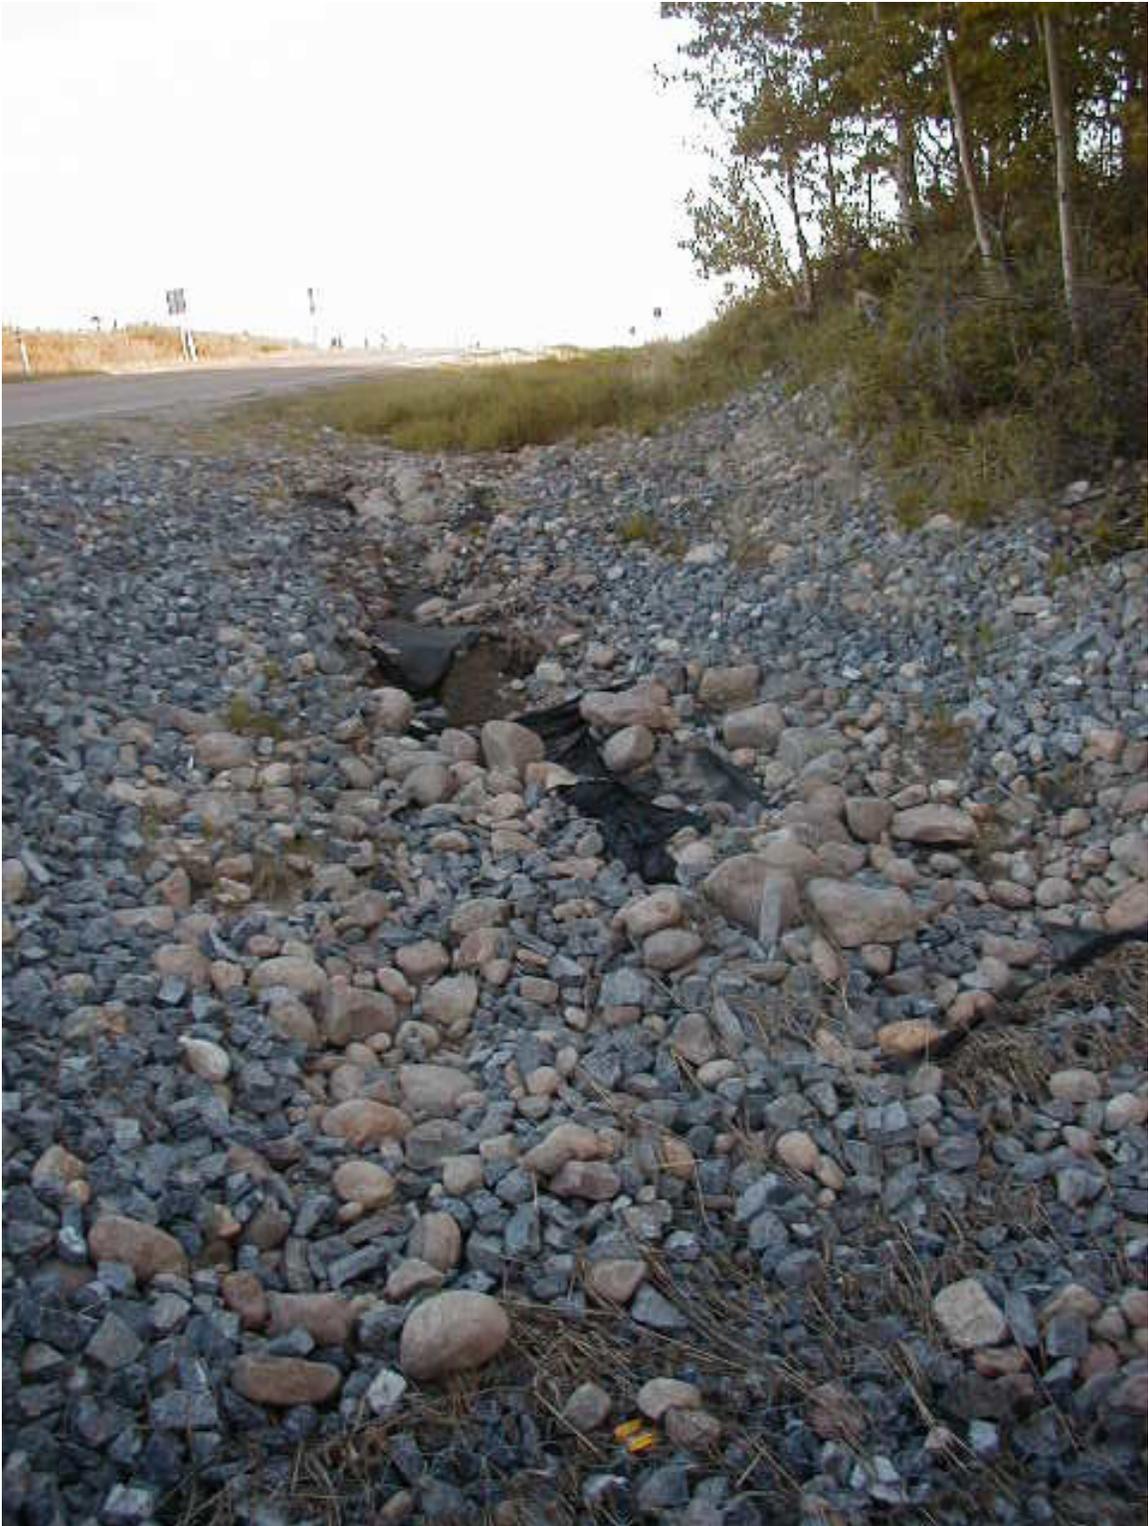
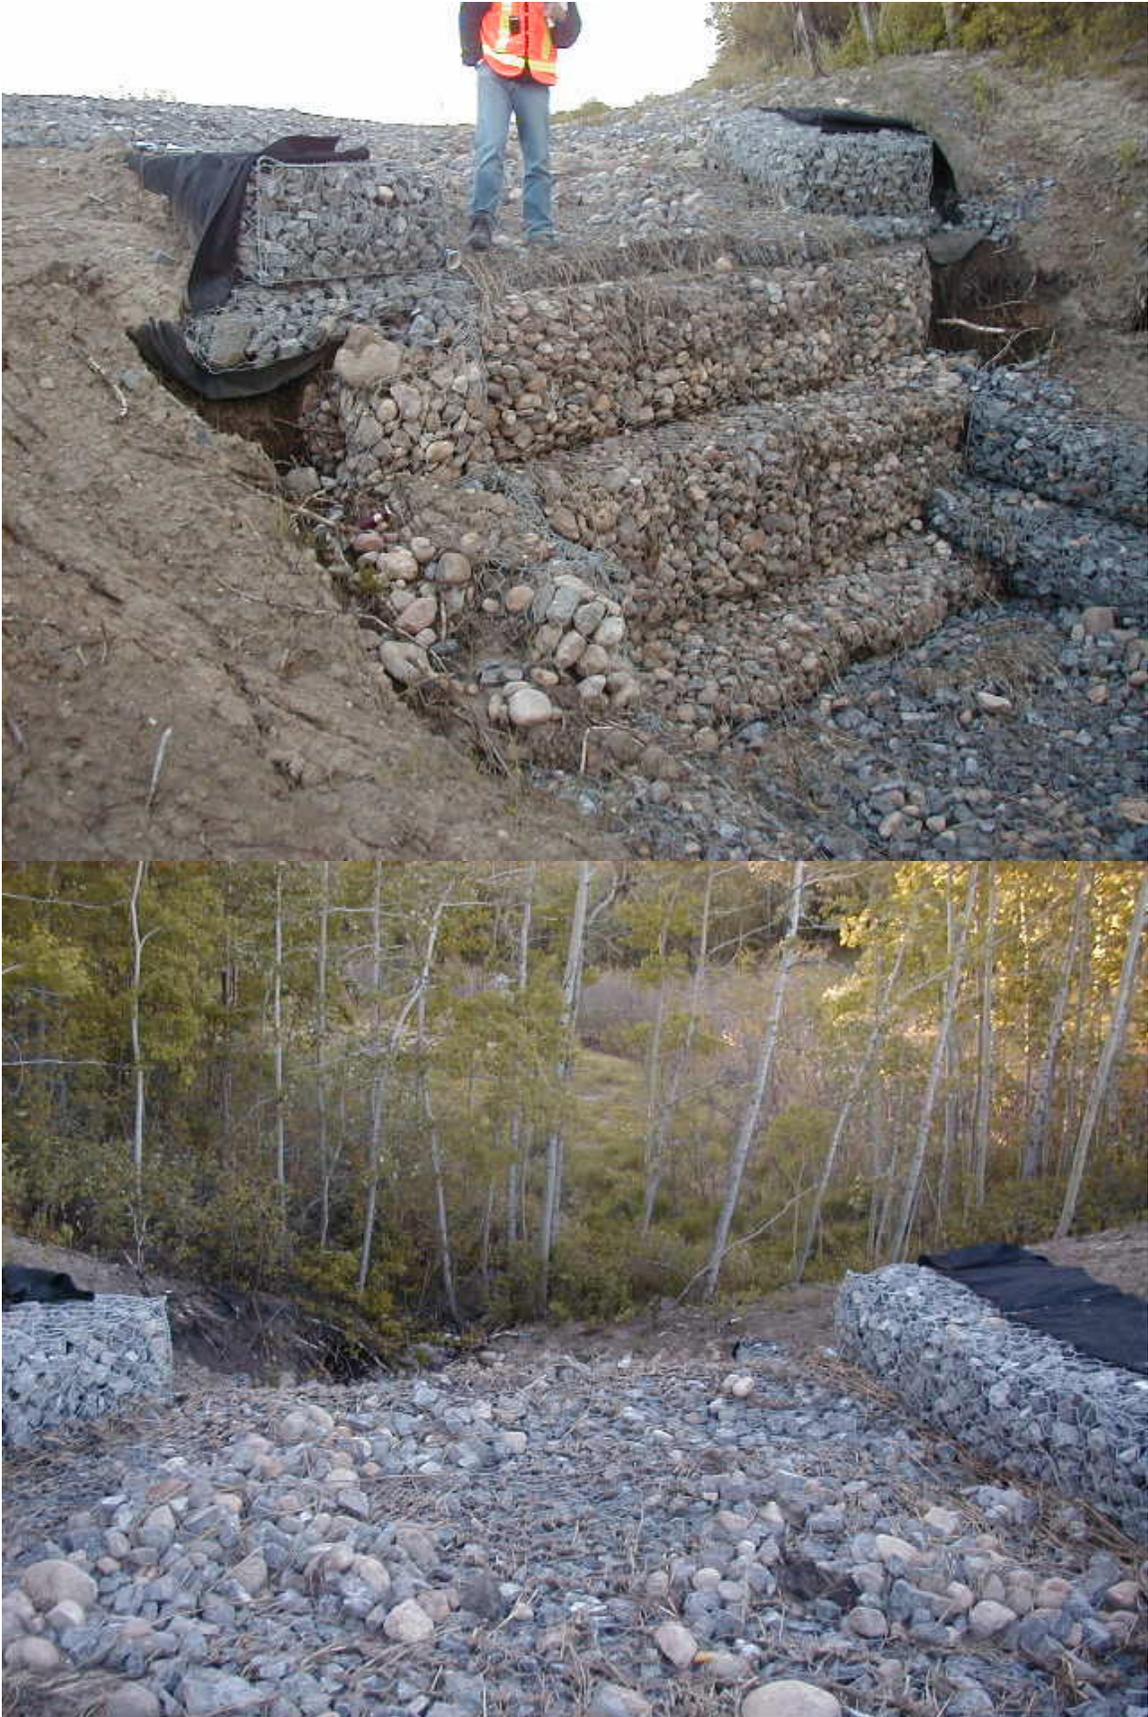
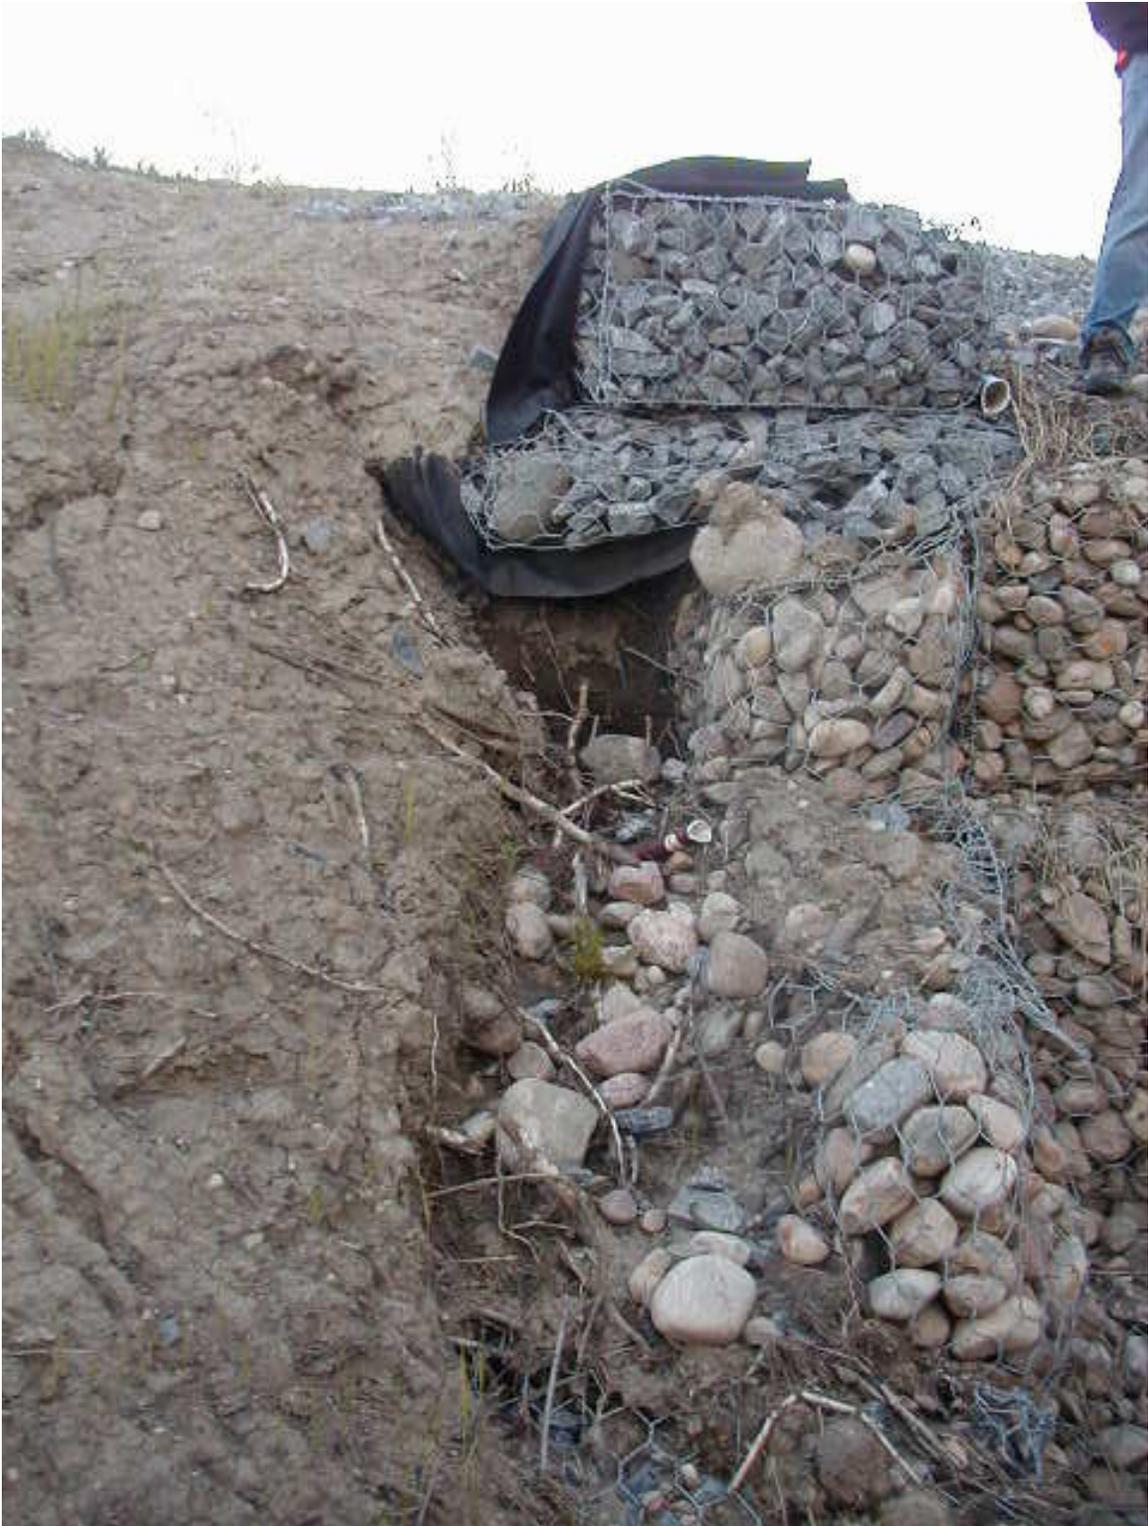
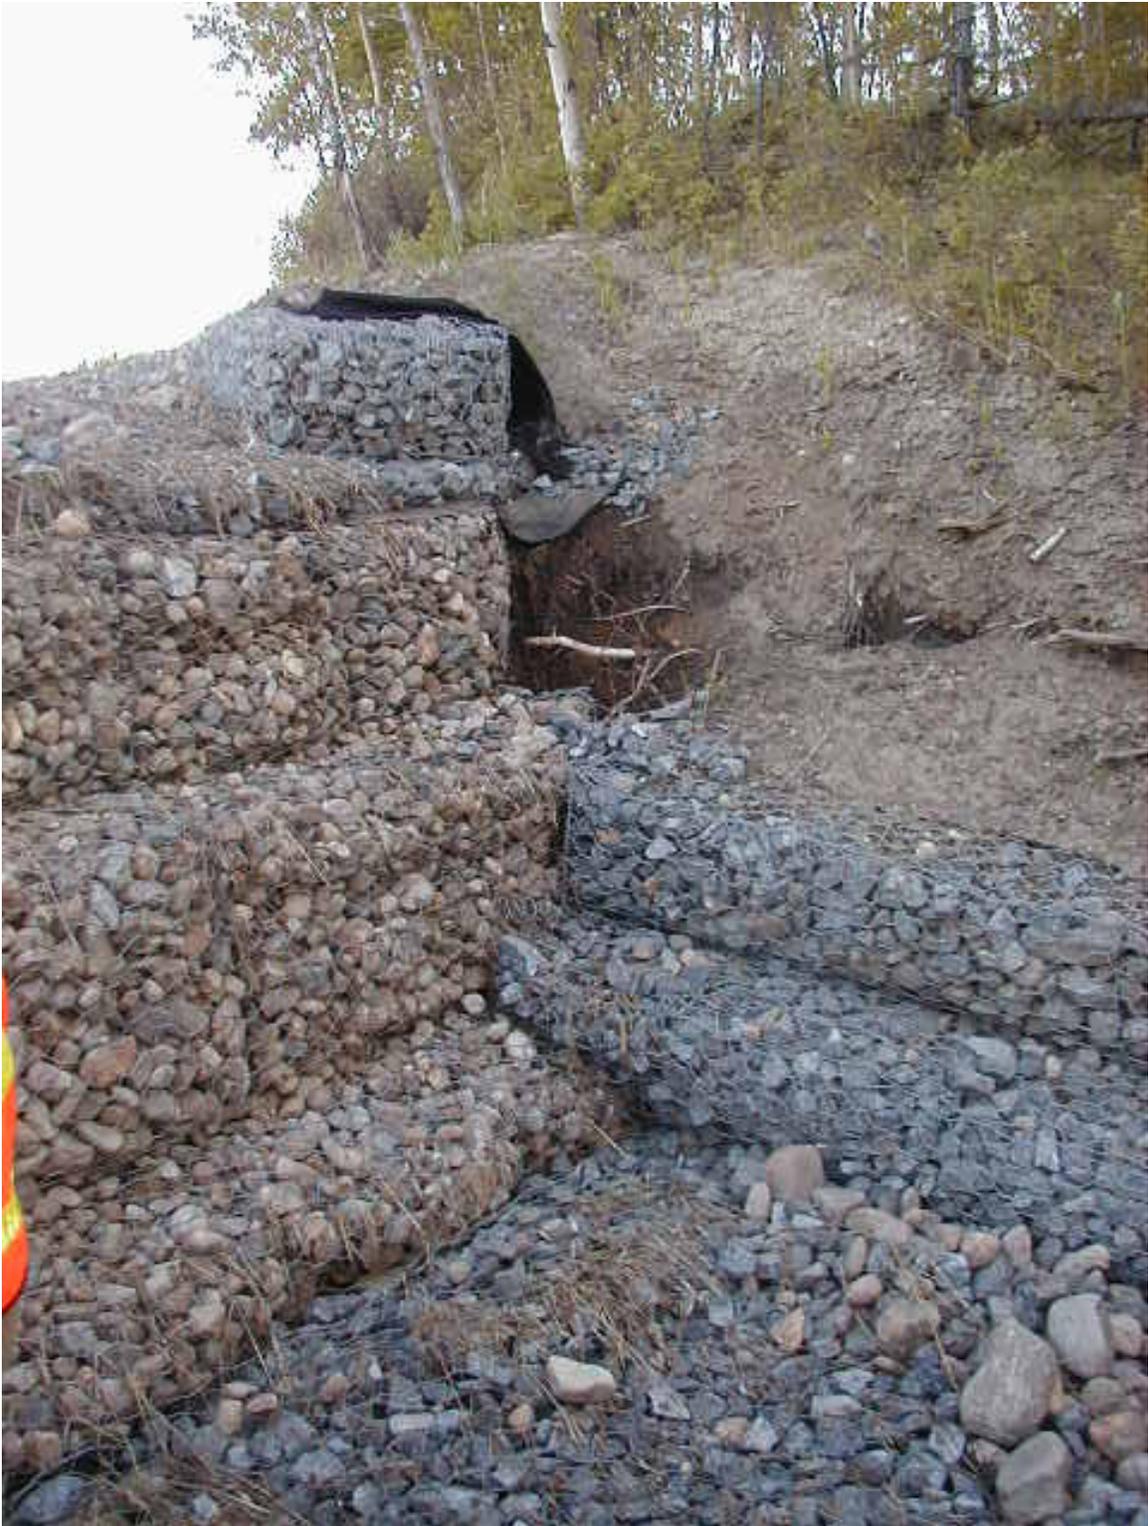
LAST READING DATE:	
PRIMARY SITE ISSUE: Erosion around gabion drop structure	
APPROXIMATE DIMENSIONS:	
DATE OF ANY REMEDIAL ACTION:

ITEM	CONDITION EXISTS		DESCRIPTION AND LOCATION	NOTICABLE CHANGE FROM LAST INSPECTION	
	YES	NO		YES	NO
Pavement Distress					
Slope Movement					
Erosion	X		Approx. 3 m high gabion drop structure. Minor erosion is occurring around sides of structure.		
Seepage					
Culvert Distress

<b>COMMENTS</b>
Refer to attached photos
It is recommended that some re-grading and flow training is undertaken to keep flows centred over the gabion drop.
