SITE NUMBER AND NAME C36 H2A Gabion Drop		HIGHWAY & KM 1.6 km North of Innisfail	PREVIOUS INSPECTION DATE May 26, 2005	INSPECTION DATE May 16, 2006
LEGAL DESCRIPTION	NAD 83 COORDINATES N 5768712 E 299070	RISK ASSESMENT PF: 9 CF: 1 TOTAL: 9

LAST READING DATE:	
PRIMARY SITE ISSUE: Erosion around gabion drop structure	
APPROXIMATE DIMENSIONS:	
DATE OF ANY REMEDIAL ACTION: 2005 (additional baskets added)

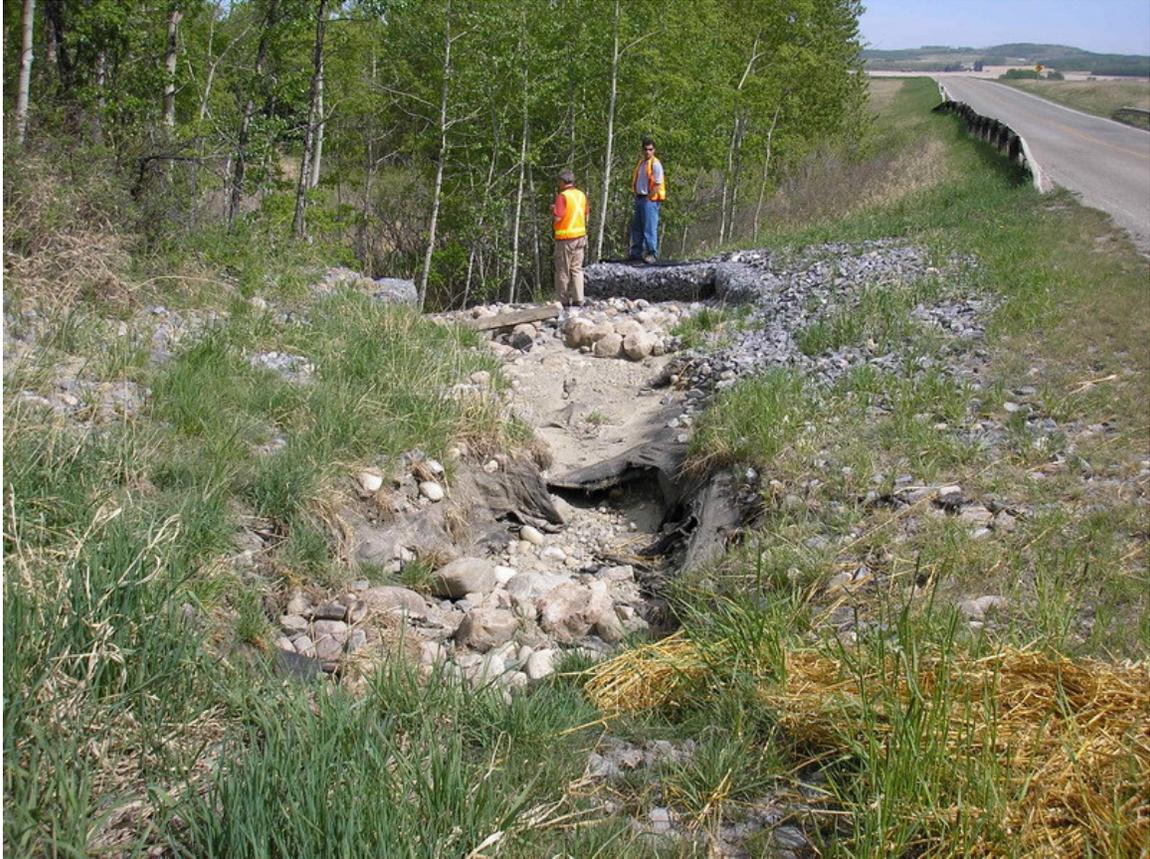
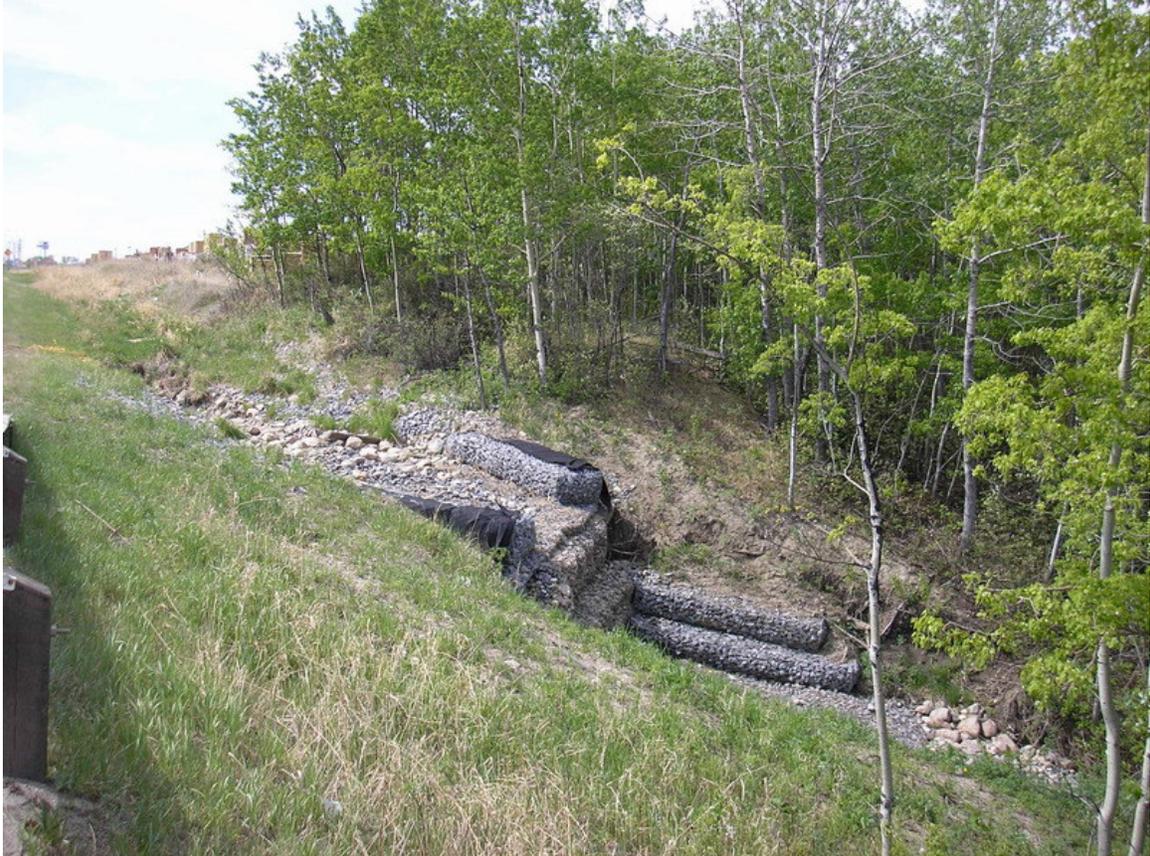
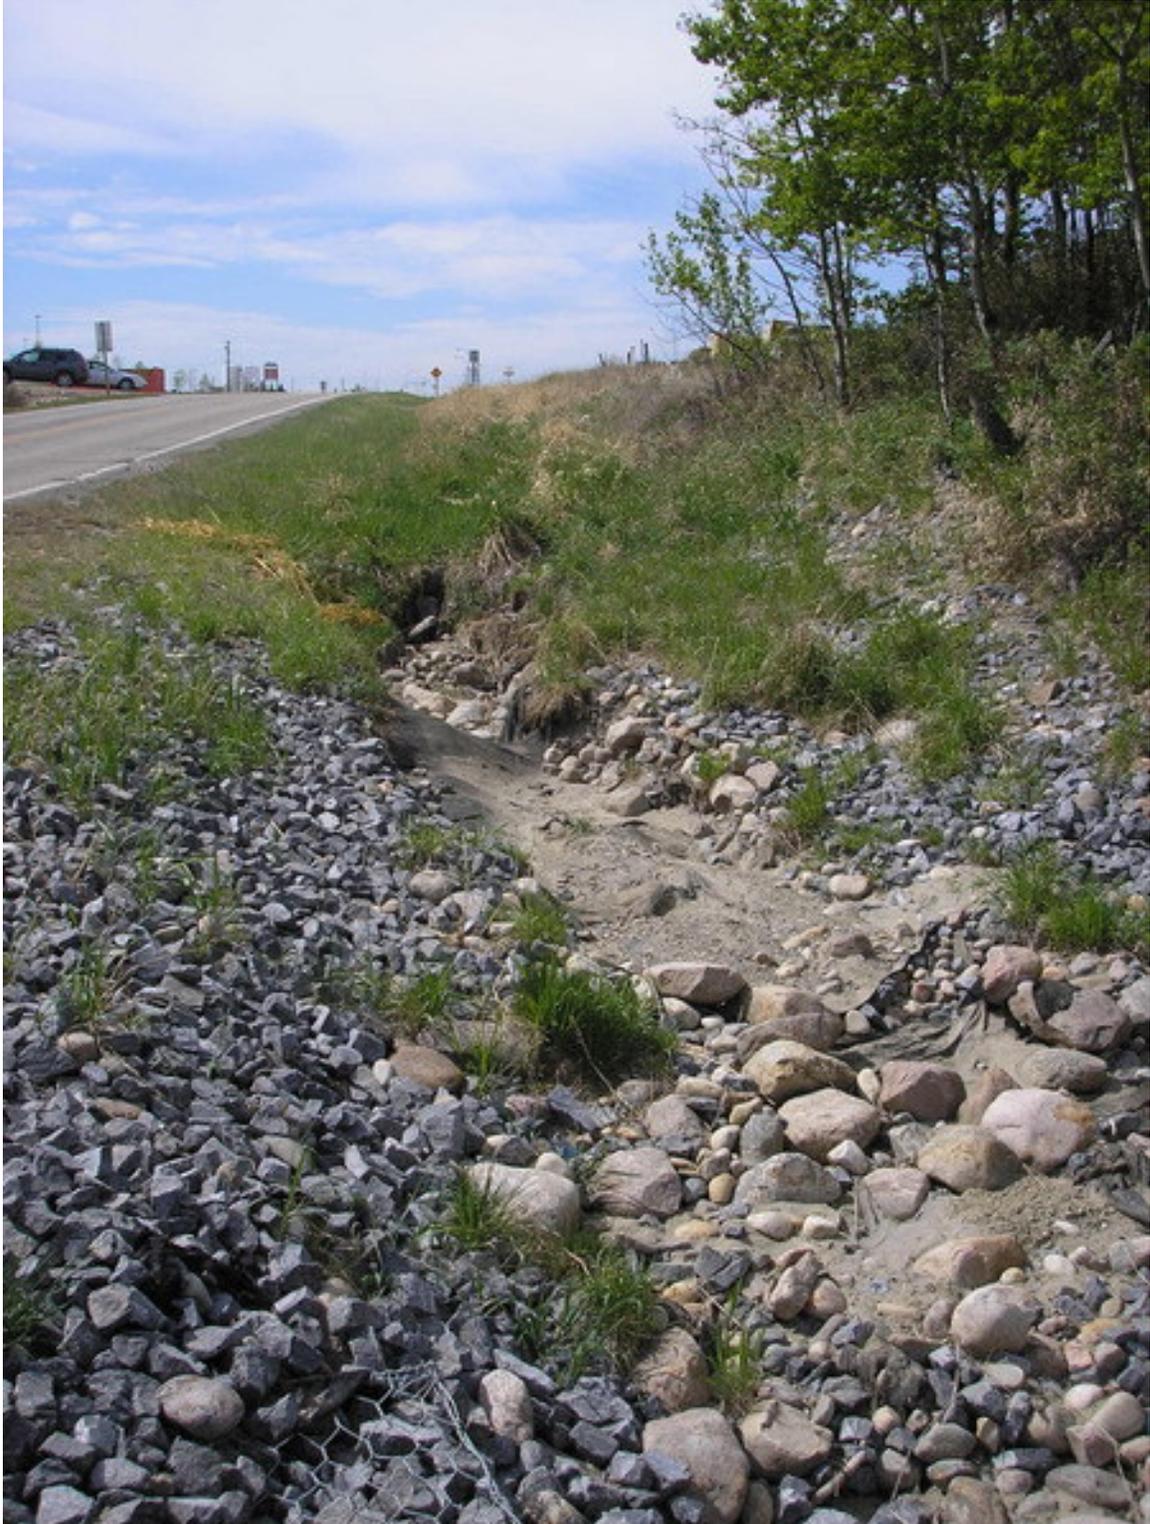
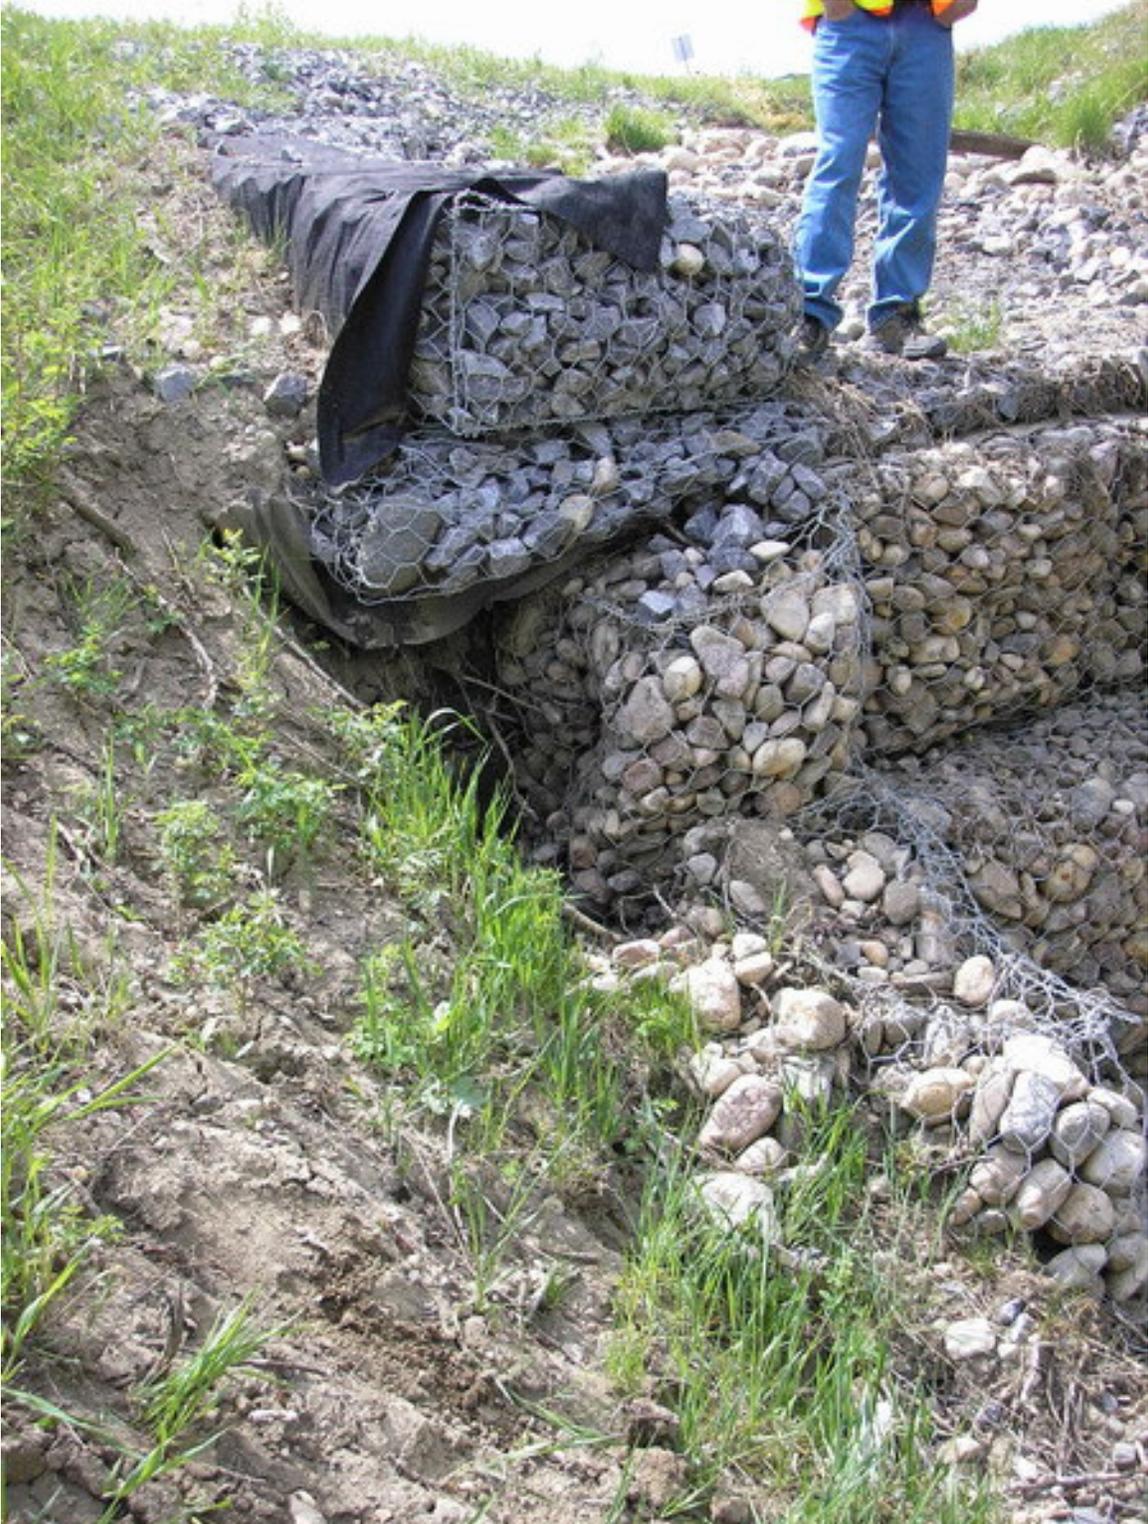
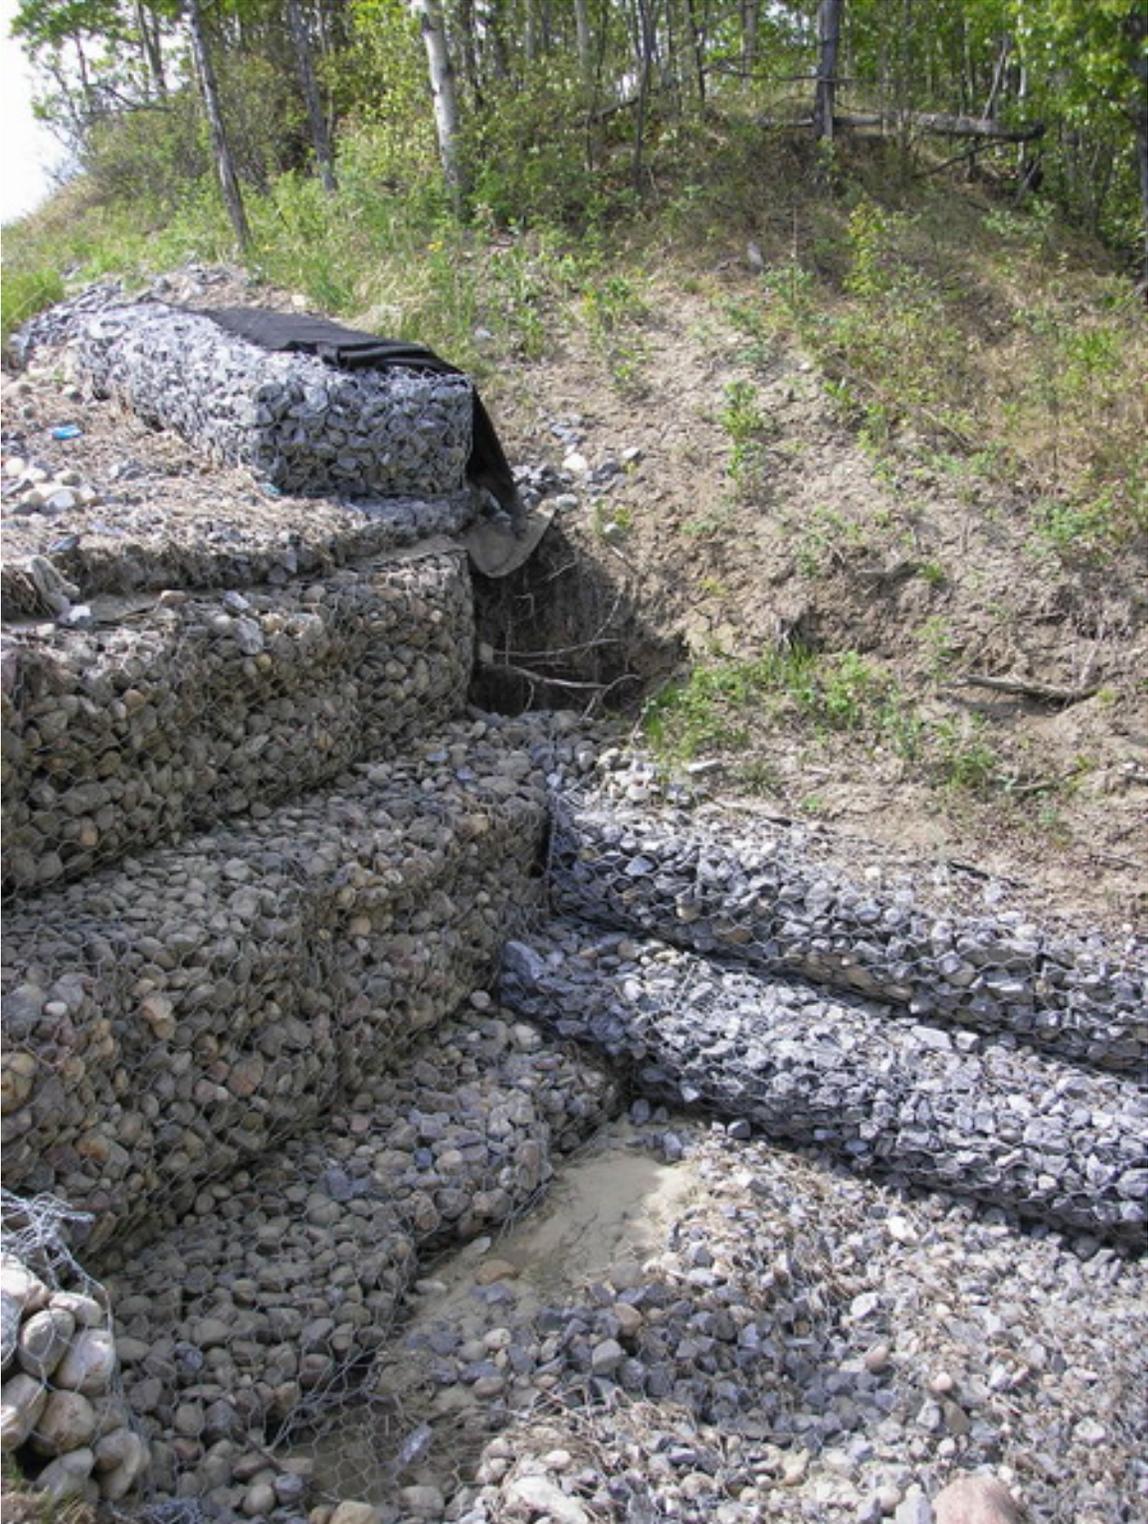
ITEM	CONDITION EXISTS		DESCRIPTION AND LOCATION	NOTICABLE CHANGE FROM LAST INSPECTION	
	YES	NO		YES	NO
Pavement Distress					
Slope Movement					
Erosion	X		Approx. 3 m high gabion drop structure. Minor erosion is occurring around sides of structure.	X	
Seepage					
Culvert Distress

COMMENTS
Refer to attached photos
The additional baskets have prevented the flows from going around the structure; however some movement of the rock upstream of the drop structure has occurred. It is recommended that either larger rock be provided or the gabion mat be extended upstream.
