SITE NUMBER AND NAME C49 A H614:02 Ditch Erosion		HIGHWAY & KM	PREVIOUS INSPECTION DATE May 14, 2007	INSPECTION DATE June 25, 2008
LEGAL DESCRIPTION SE 16-46-4-W4	NAD 83 COORDINATES N 5867933 E 532914		RISK ASSESMENT PF: 9 CF: 2 TOTAL: 18

Site C49 A H614:02 Ditch Repair
June 25, 2008

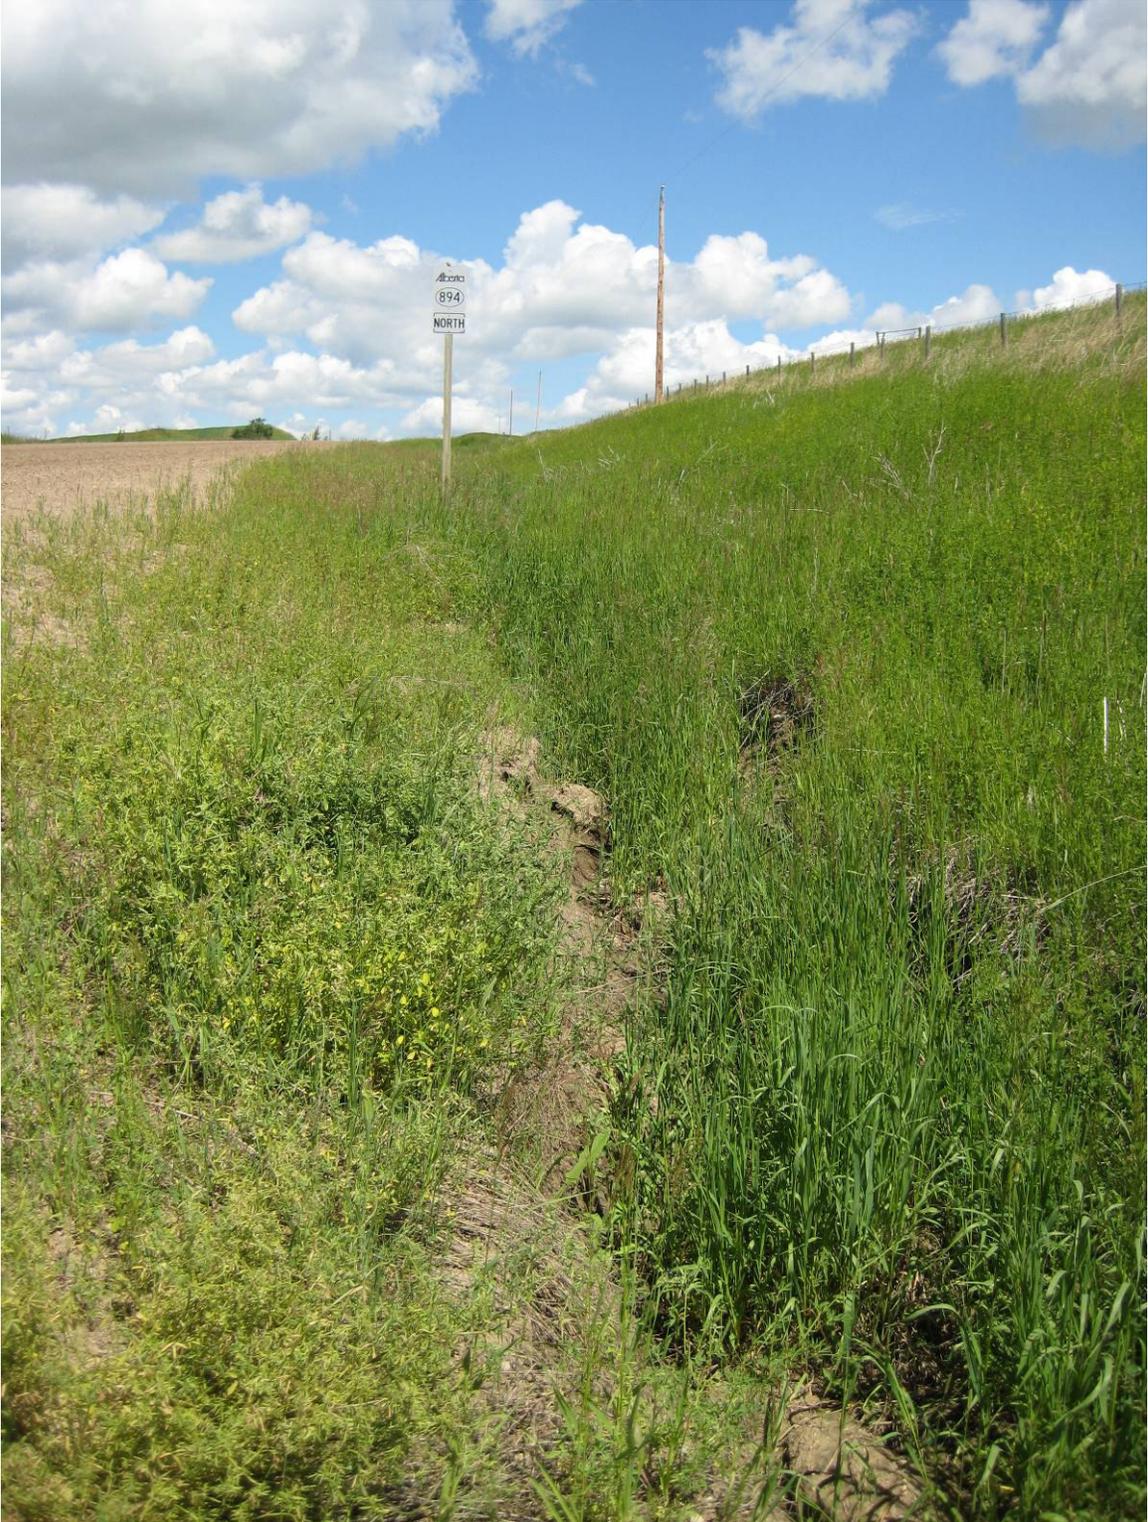
LAST READING DATE:	
PRIMARY SITE ISSUE: Shallow erosion channel in northeast ditch of intersection between H614:02 and H894:02.	
APPROXIMATE DIMENSIONS: 30 m long, 1 m wide, 0.3 m deep	
DATE OF ANY REMEDIAL ACTION:

ITEM	CONDITION EXISTS		DESCRIPTION AND LOCATION	NOTICABLE CHANGE FROM LAST INSPECTION	
	YES	NO		YES	NO
Pavement Distress		X			X
Slope Movement		X			X
Erosion	X		Eroded area appears to be re-vegetating itself.	X	
Seepage		X			X
Culvert Distress		X			X

COMMENTS
See attached photos and previous site assessment form.
The channel is at least 4 m from the highway edge and does not represent a hazard to traffic. It is recommended that the site be allowed to re-vegetate naturally.
