ALBERTA INFRASTRUCTURE & TRANSPORTATION CENTRAL REGION
Geohazard Assessment Site C6
H881:10 Myrnam Spring Frost Heave Repair

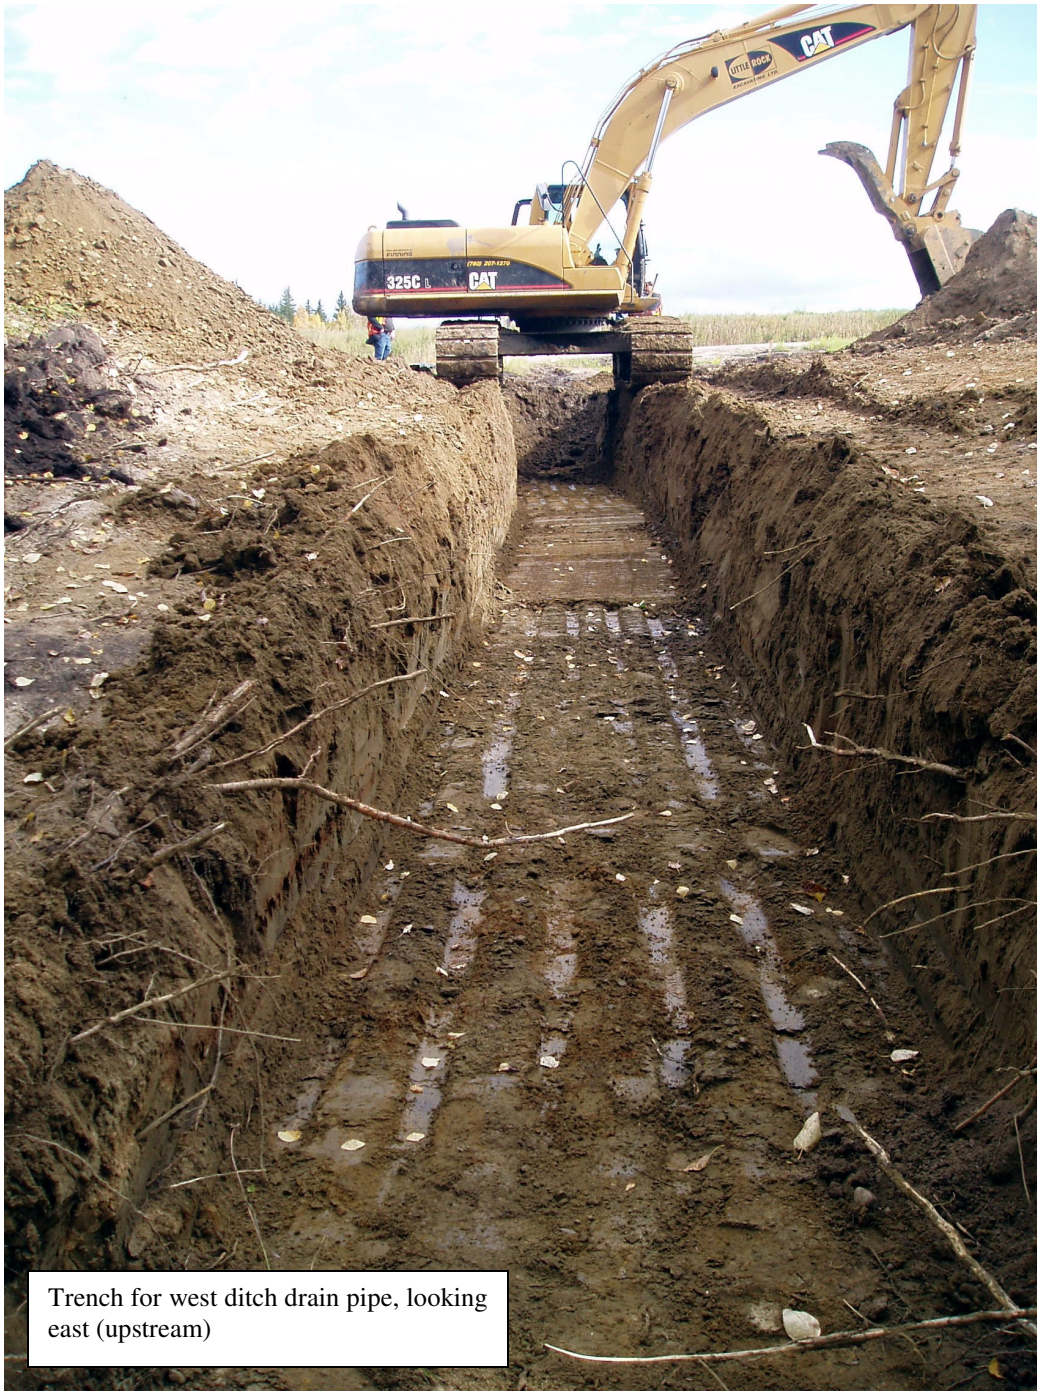
Trench for west ditch drain pipe, looking east (upstream)

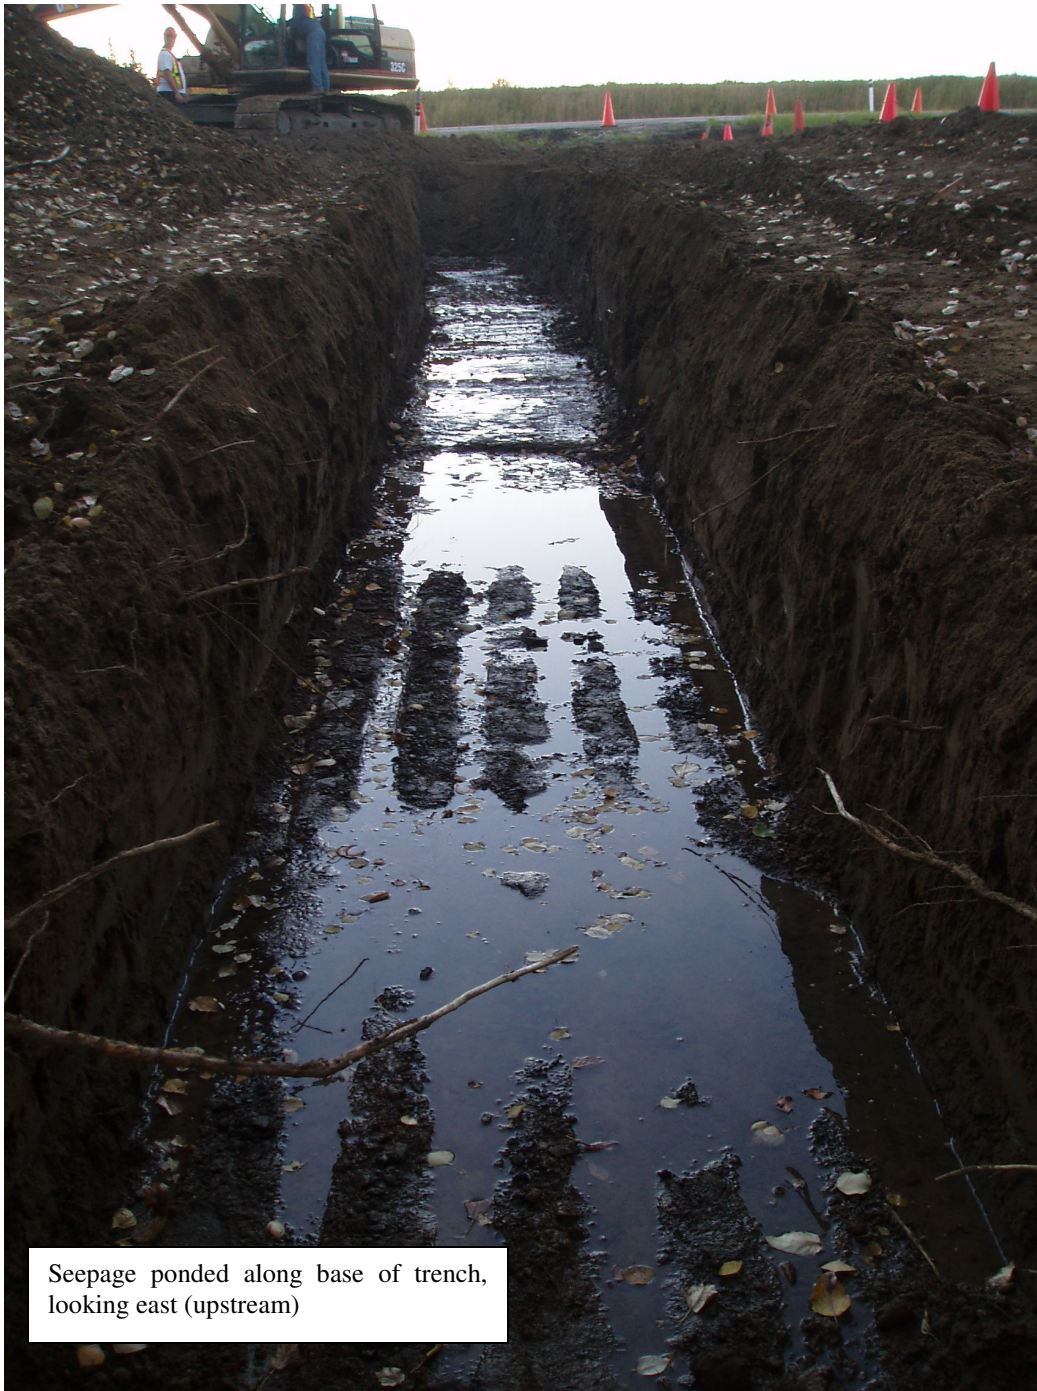
Seepage ponded along base of trench,
looking east (upstream)

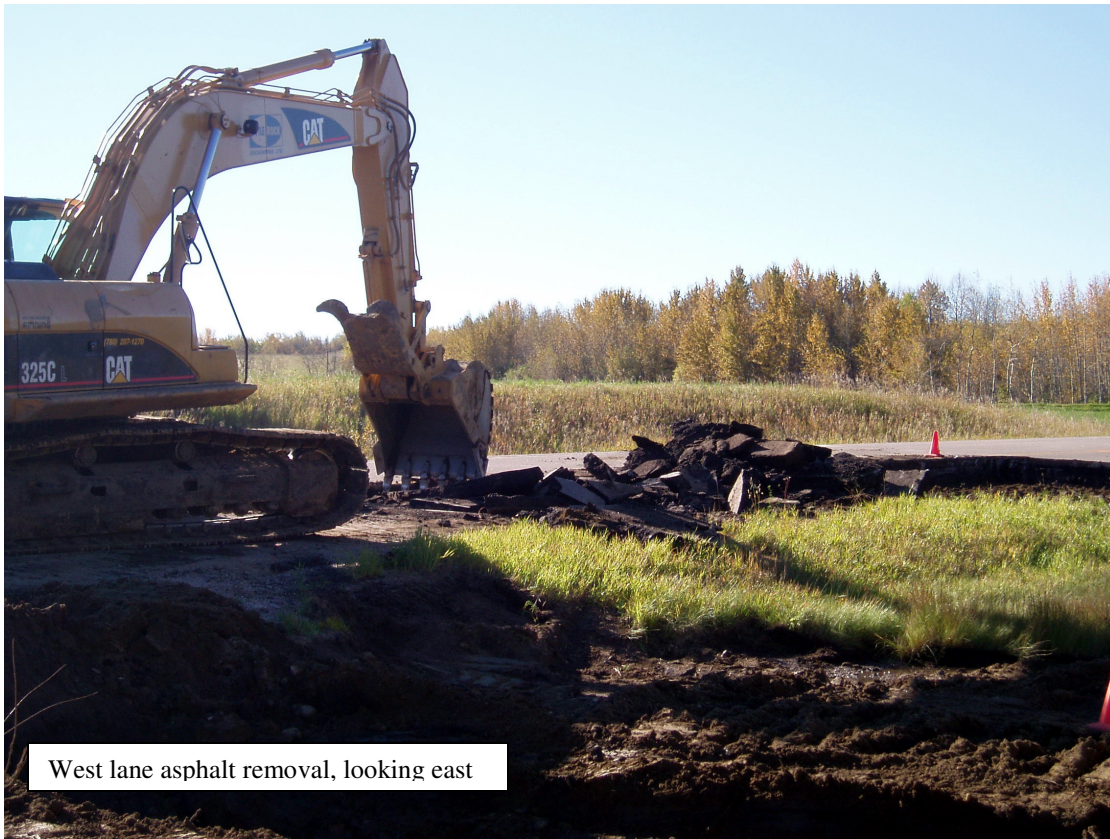
West lane asphalt removal, looking east

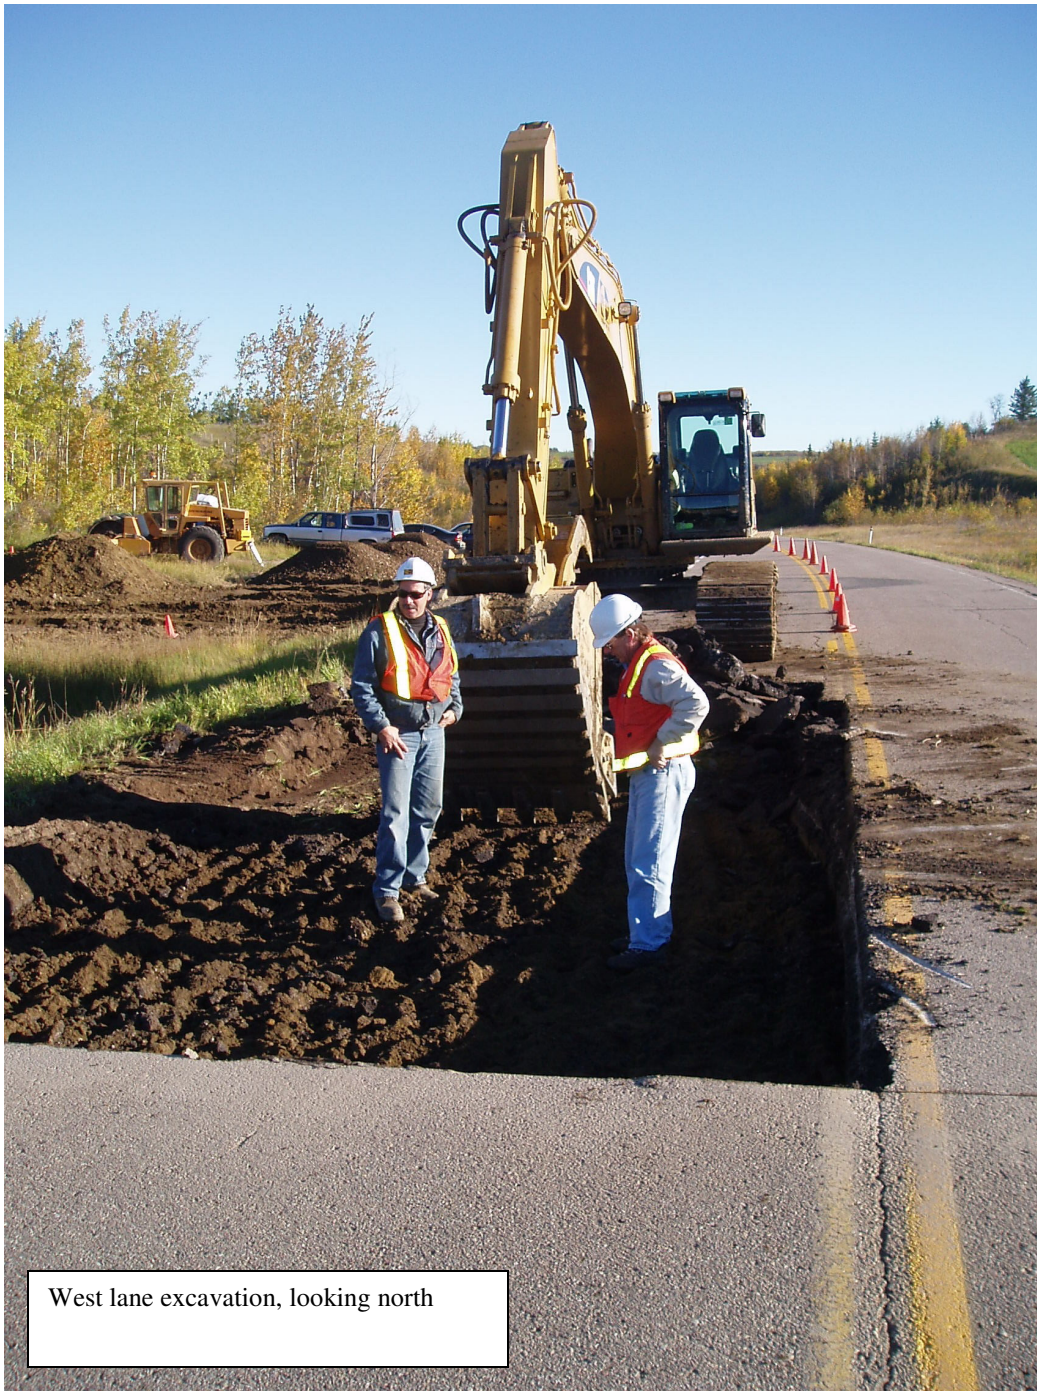
West lane excavation, looking north

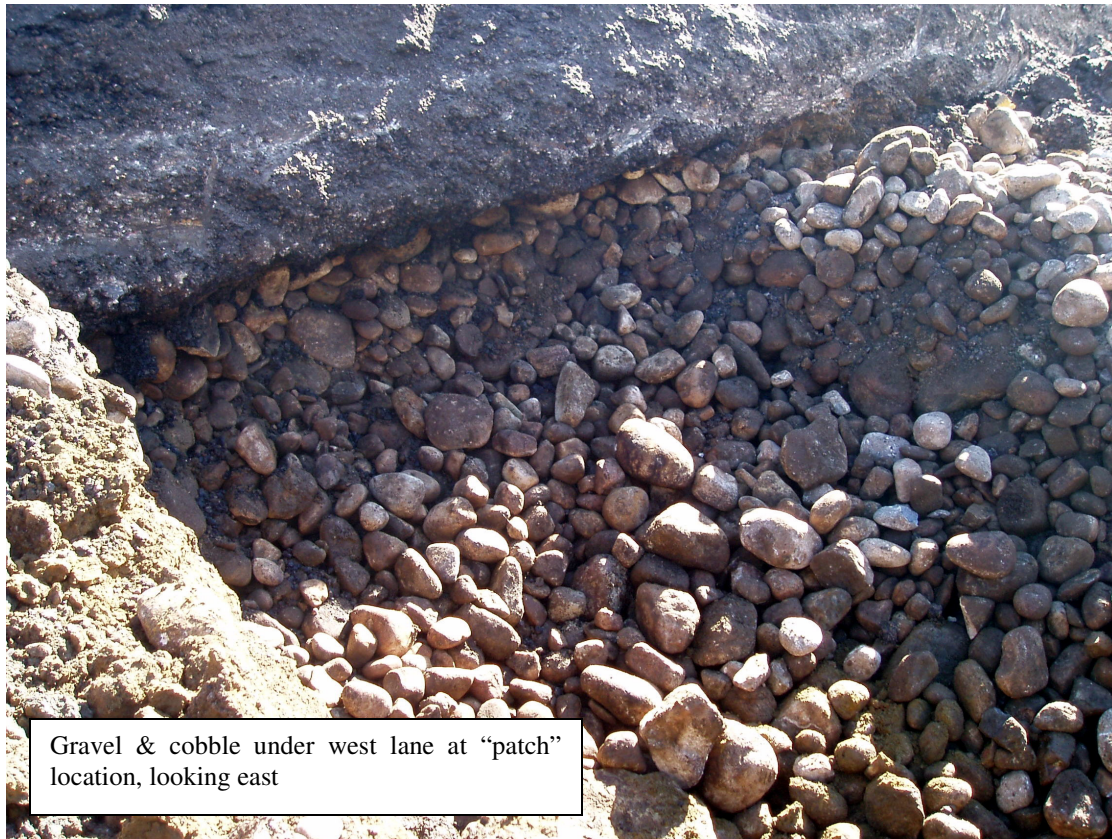
Gravel & cobble under west lane at "patch" location, looking east

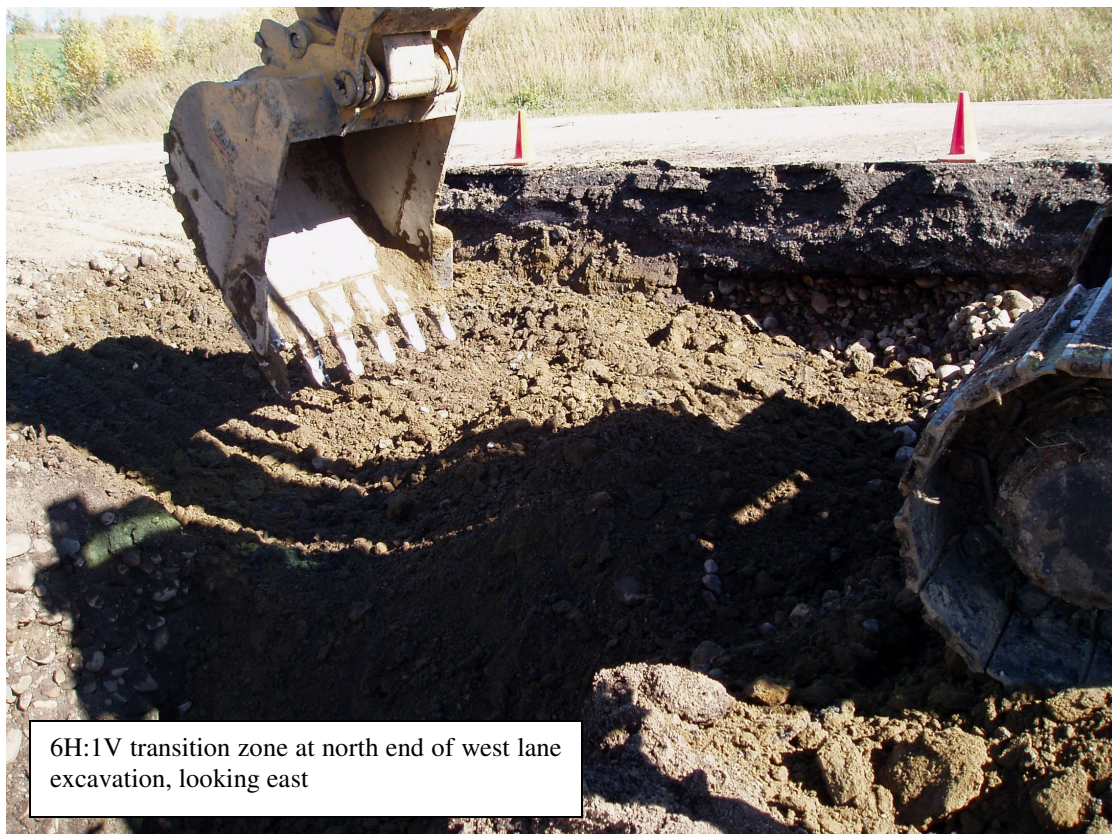
6H:1V transition zone at north end of west lane excavation, looking east

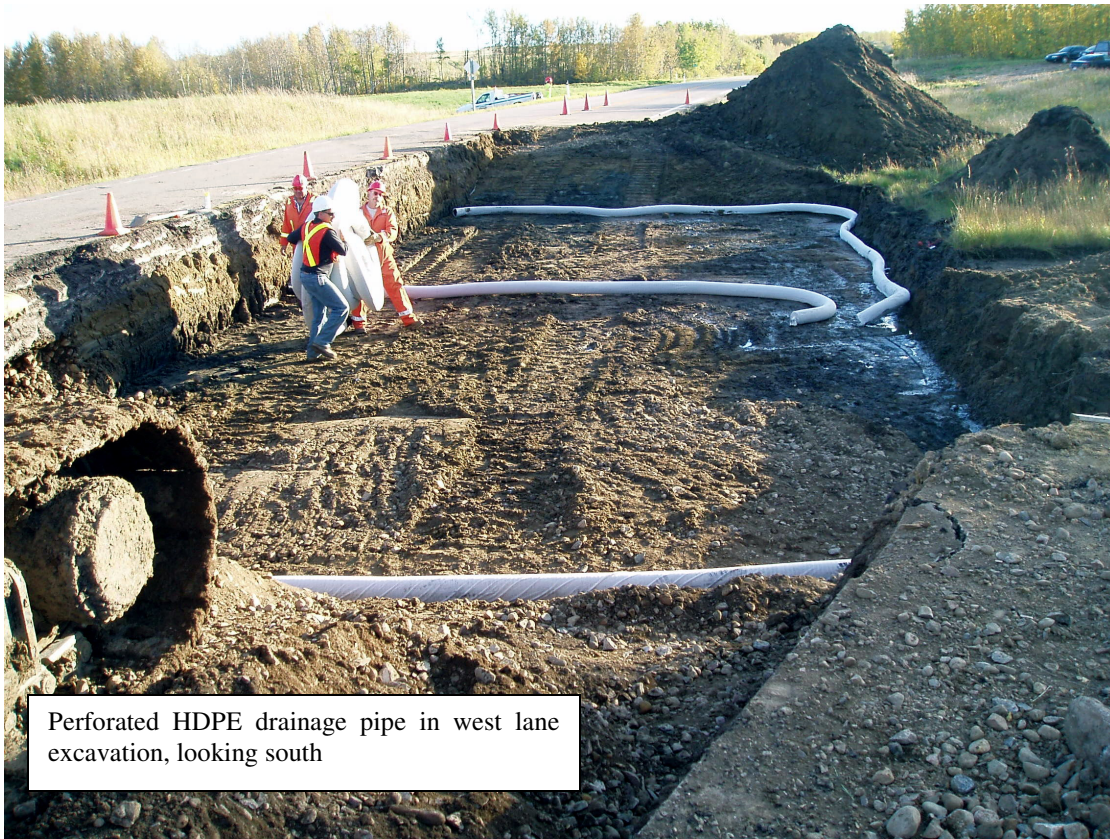
Perforated HDPE drainage pipe in west lane excavation, looking south

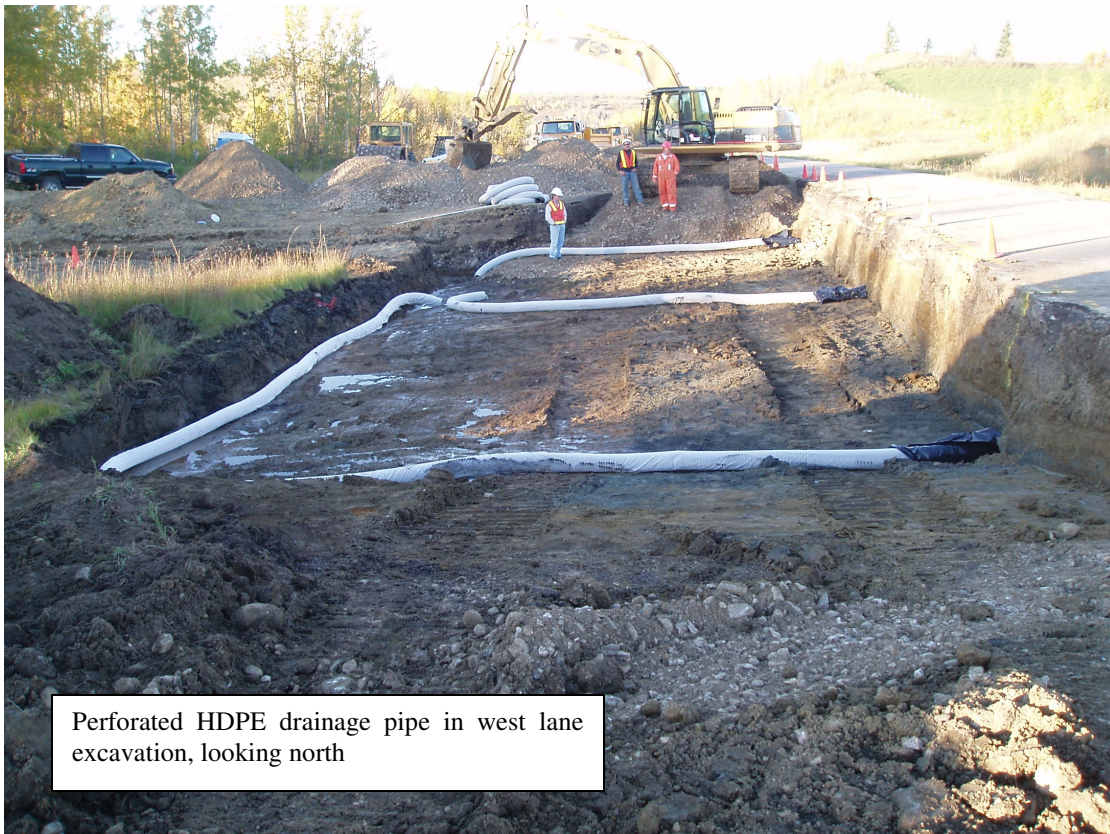
Perforated HDPE drainage pipe in west lane excavation, looking north

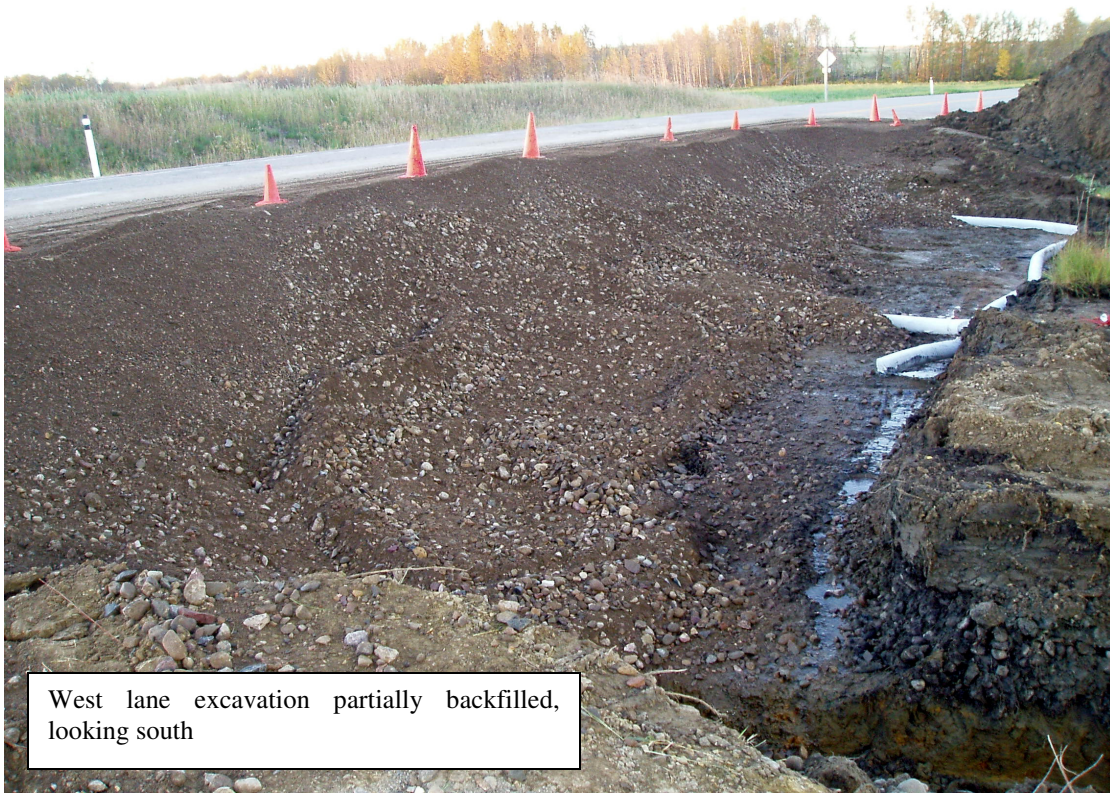
West lane excavation partially backfilled,
looking south

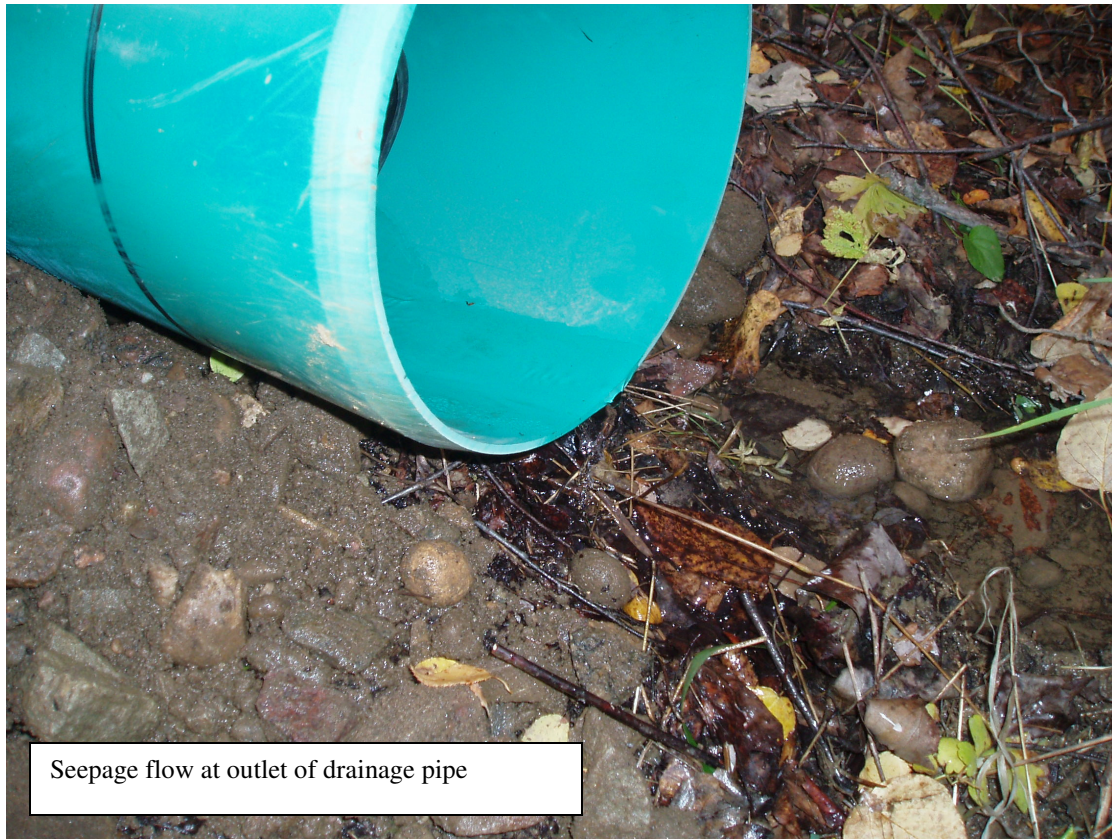
Seepage flow at outlet of drainage pipe

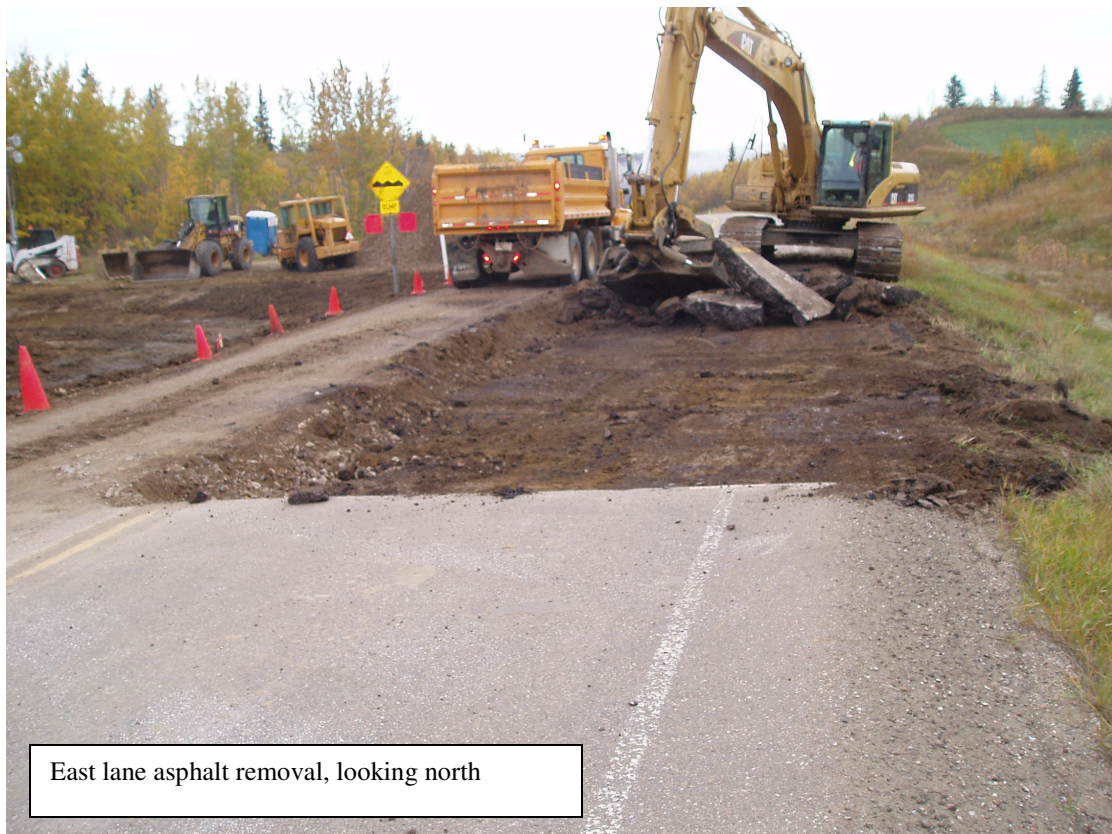
East lane asphalt removal, looking north

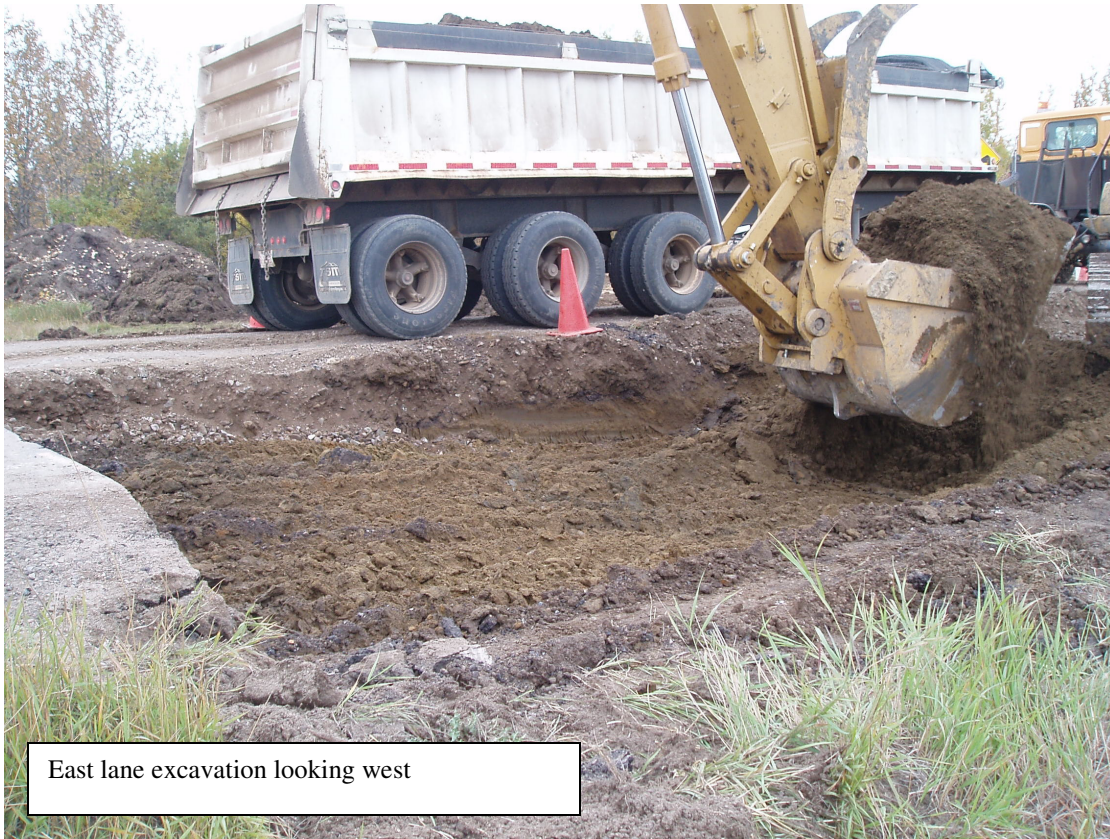
East lane excavation looking west

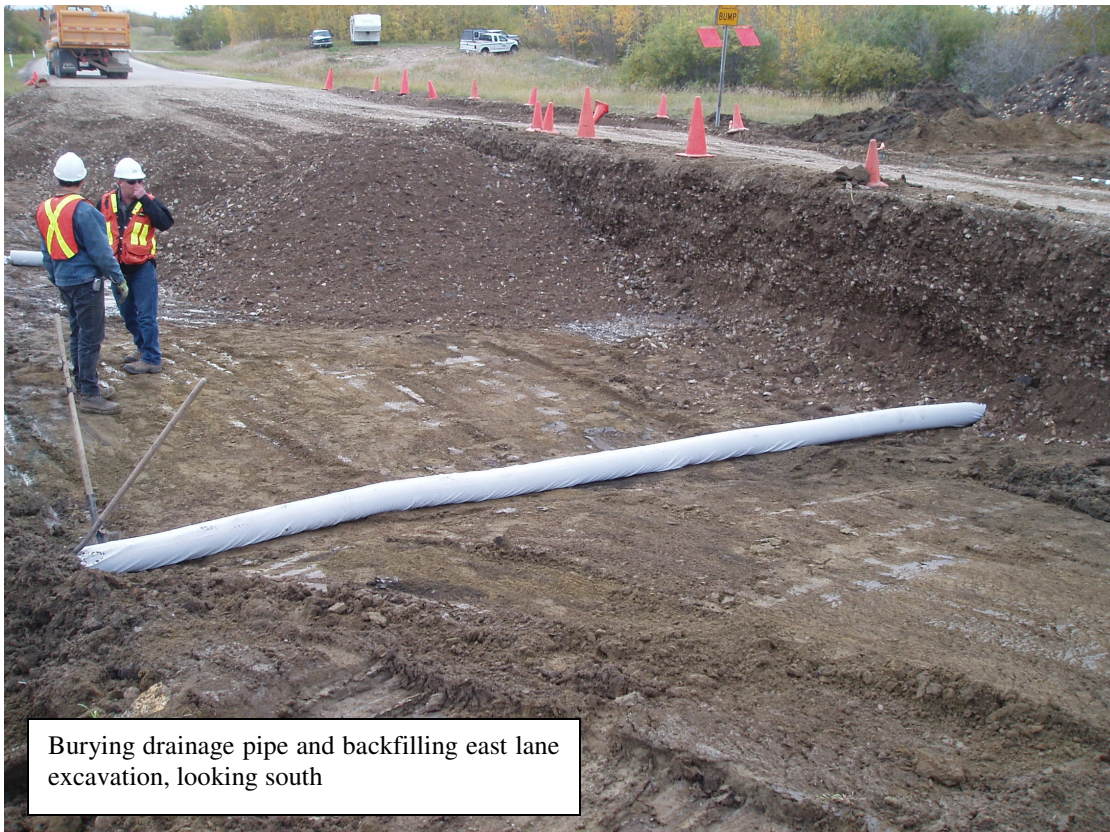
Burying drainage pipe and backfilling east lane excavation, looking south
