SITE NUMBER AND NAME: C007 Kenilworth Lake		HIGHWAY & KM: 16:30, 23.89	PREVIOUS INSPECTION DATE: June 21, 2018	INSPECTION DATE: July 12, 2019
LEGAL DESCRIPTION: 11-27-050-04 W4M	NAD 83 COORDINATES: UTM Northing Easting 12 5910761 532907		RISK ASSESSMENT: PF: 3 CF: 2 TOTAL: 6	
AVERAGE ANNUAL DAILY TRAFFIC (AADT): 7,710 (west) & 7,460 (east) (Ref No. 137470 & 134470)			CONTRACT MAINTENANCE AREA (CMA): 15

SUMMARY OF SITE INSTRUMENTATION: Operational: Two slope inclinometers installed along the H-pile wall. Inoperable: Two slope inclinometers and two standpipe piezometers. LAST READING DATE: May 16, 2019		INSPECTED BY: Chris Gräpel (KCB) Ryan Gazley (KCB) Rishi Adhikari (AT) Tom Sommerville (AT)
PRIMARY SITE ISSUE: Slope failure on south side slope of eastbound lanes, and settlement of eastbound lanes. Pavement cracking has continued after pile wall was installed.		
APPROXIMATE DIMENSIONS: Approximately 60 m long. Slope is approximately 20 m high sloped at 6H:1V.		
DATE OF ANY REMEDIAL ACTION: 2001 – keyed in berm constructed at toe of failing slope, changing the effective slope angle to 6V:1H. 2015 – H-pile wall constructed at top of failing slope and asphalt overlay constructed on e

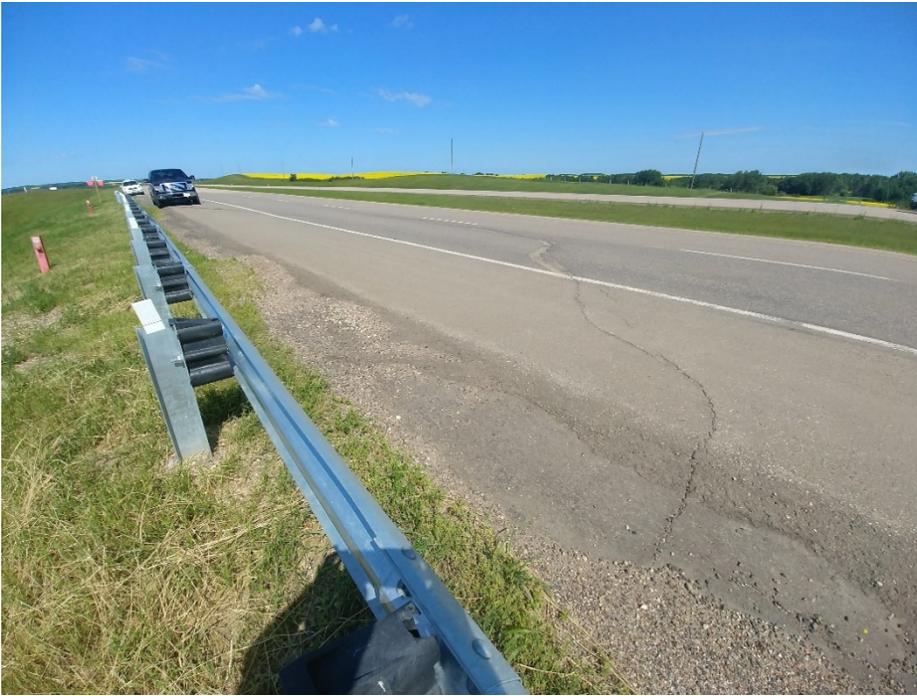
Photo 1 View of cracking on the south side of eastbound lanes and new guardrail adjacent to SIs. Photo taken July 12, 2019 looking west.

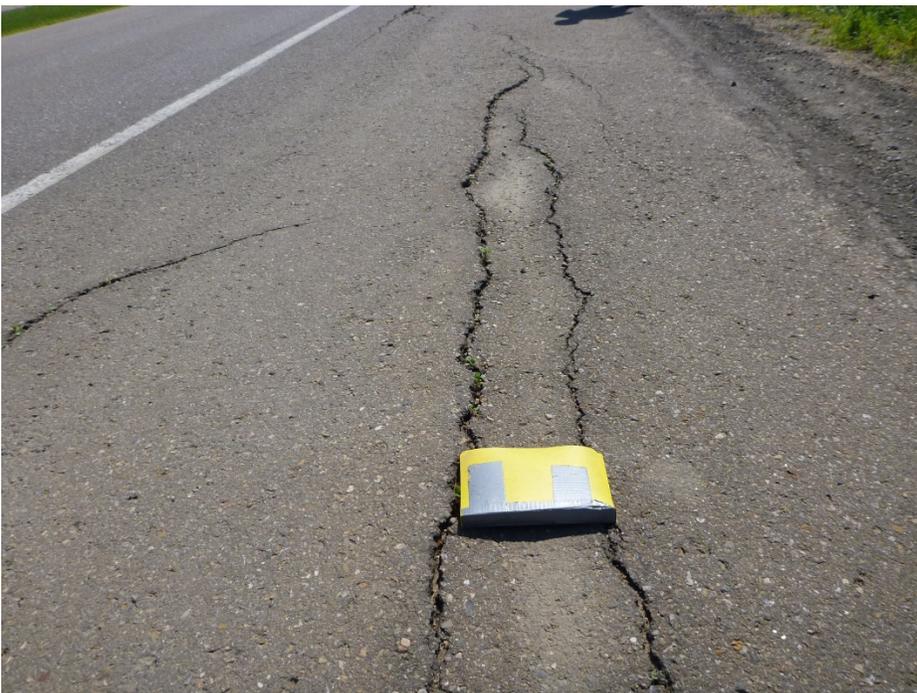
Photo 2 Photo showing settlement and expansion of pavement cracks. Photo taken July 12, 2019.

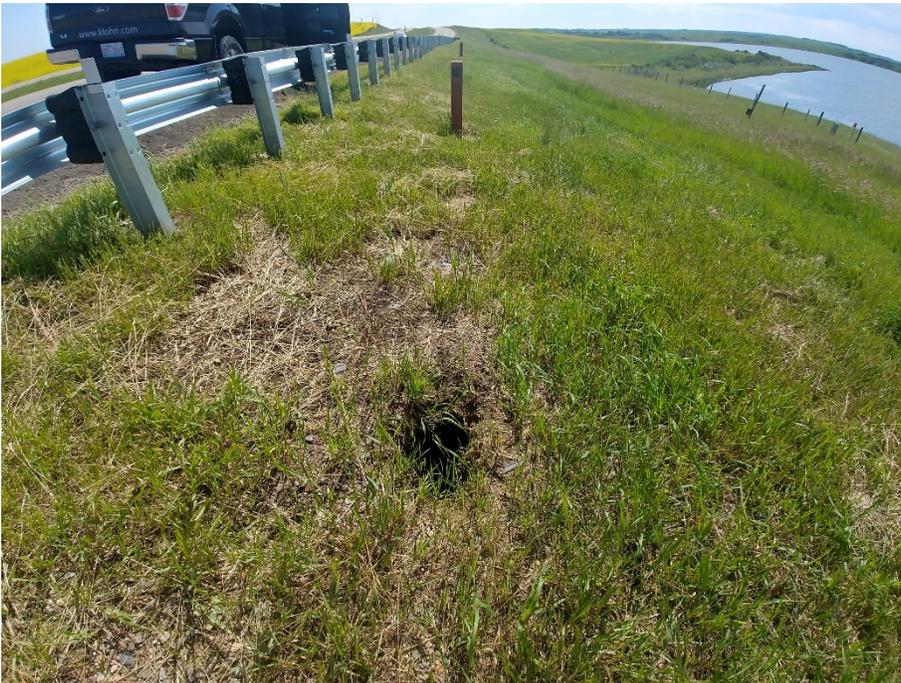
Photo 3 Sinkholes continuing to develop along the top of H-pile wall. Photo taken July 12, 2019 looking east.

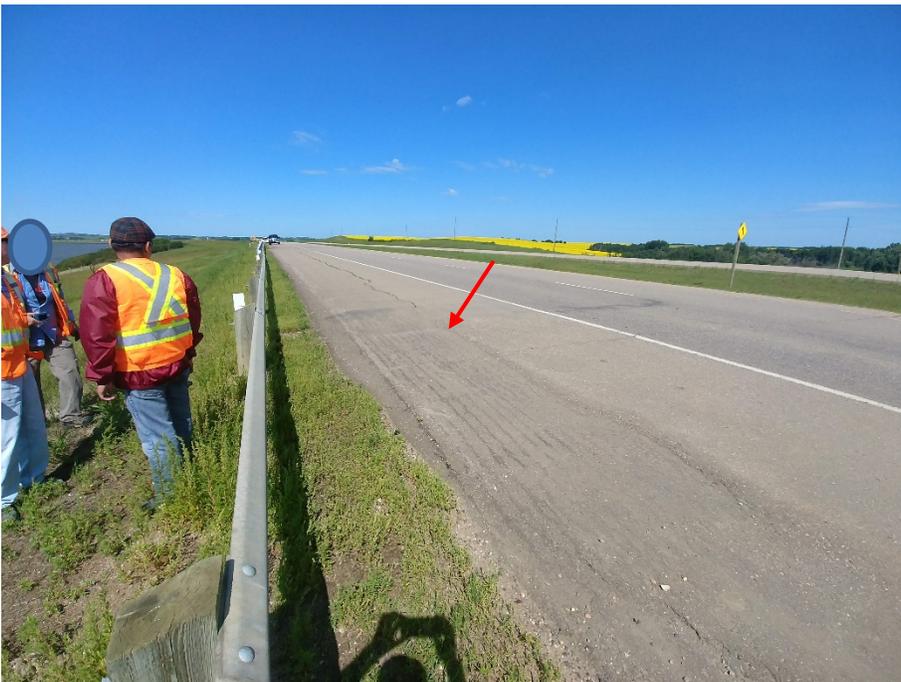
Photo 4 Cracking along south shoulder of east bound lanes, east of H-pile wall. Photo taken July 12, 2019 looking west.
