<b>SITE NUMBER AND NAME:</b> C067 Kneehill Creek Slide		<b>HIGHWAY &amp; KM:</b> 21:14, 12.988	<b>PREVIOUS INSPECTION DATE:</b> July 11, 2019	<b>INSPECTION DATE:</b> <b>June 23, 2021</b>
<b>LEGAL DESCRIPTION:</b> 19-29-23-W4M	<b>NAD 83 COORDINATES:</b> UTM Northing Easting 12 5707671 344892		<b>RISK ASSESSMENT:</b> PF: 8 CF: 5 TOTAL: 40	
<b>AVERAGE ANNUAL DAILY TRAFFIC (AADT):</b> 689 (southbound) and 654 (northbound) (Ref No. 60211450)			<b>CONTRACT MAINTENANCE AREA (CMA):</b> 517

PROJECT CENTRAL REGION GEOHAZARD RISK MANAGEMENT PROGRAM		
TITLE Site Plan C067 - Kneehill Creek Slide Hwy 21:14, km 12.988		
SCALE 1:3,000	PROJECT No. A05116A02	FIG No. 1

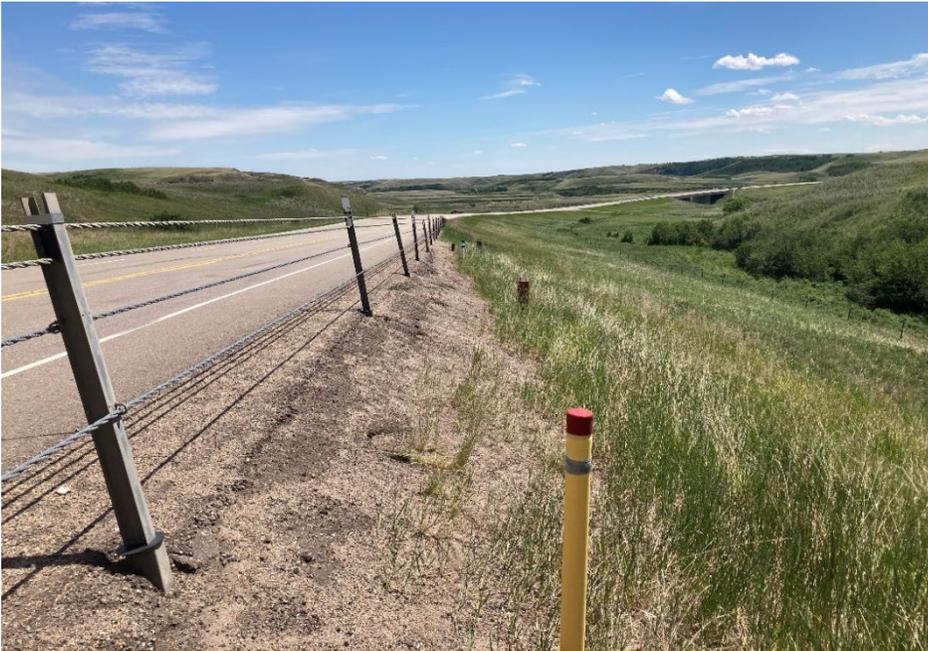
**Photo 1** Highway embankment and instrumentation downslope of Hwy 21. Photo taken June 23, 2021 facing south.

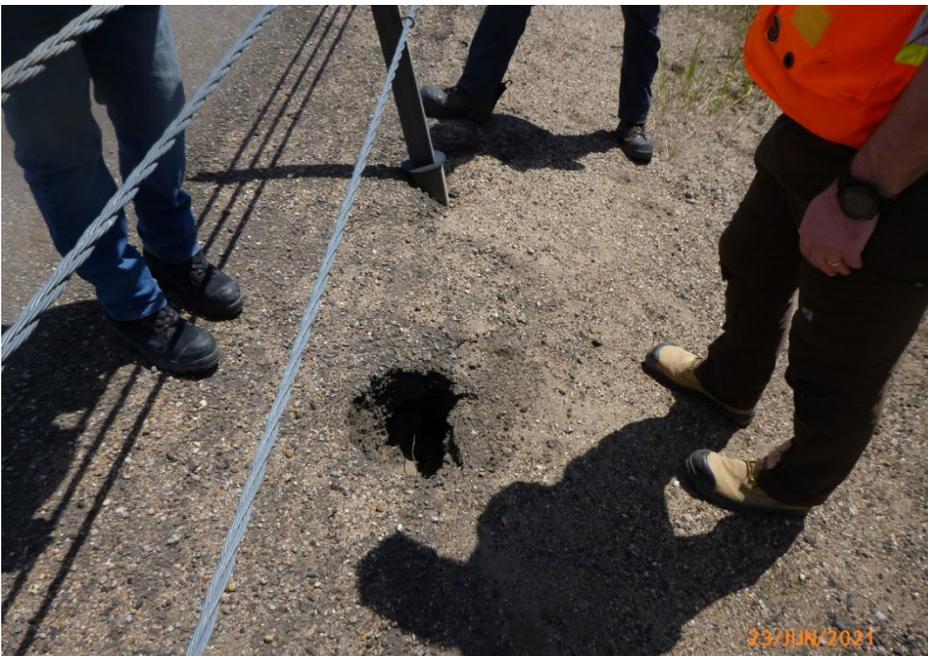
**Photo 2** Two voids were observed on the west (southbound) shoulder of Hwy 21. KCB and AT believe they were caused by removing guardrail posts during construction. Photo taken June 23, 2021.

<b>COMMENTS</b>
No new pavement cracking, deformations, or slope movement was observed during the inspection. The pavement cracks that appeared following construction of the pile wall have been sealed, and do not appear to have gotten worse since 2019. The condition of the high-tension cable barrier (HTCB) is good; however, some of the metal brackets holding the cables against the posts have been sheared off.
The operable SIs have been recording decreasing rates of movement in the pile wall at Site A and B since installation. The current maximum rate of movement in the pile-wall SIs is 2.1 mm/year. The previous maximum recorded rate of movement in the pile-wall SIs was 345.1 mm/year. In total, the pile walls have deflected up to a maximum of 23 mm. Based on KCB's 2017 design report, the pile walls were expected to deflect up to 200 mm in the three to four years following construction.
Two voids (approximately 150 mm in diameter) were observed in the west (southbound) shoulder. AT and KCB suspect they formed due to guardrail removal during construction. If the voids increase in size, they should be backfilled, as they could impact the shoulder of the highway and become a hazard to highway traffic.
