SITE NUMBER AND NAME: C025 Western Monarch Slide		HIGHWAY & KM: 569:02, 18.469	PREVIOUS INSPECTION DATE: May 31, 2022	INSPECTION DATE: June 18, 2024
LEGAL DESCRIPTION: 02-20-27-18-W4M	NAD 83 COORDINATES: UTM Northing Easting 12 5686096 395423		RISK ASSESSMENT: PF: 9 CF: 4 TOTAL: 36	
AVERAGE ANNUAL DAILY TRAFFIC (AADT): 140 (east) and 80 (west) (Reference No. 111210 & 113210)			CONTRACT MAINTENANCE AREA (CMA): 521

PROJECT CENTRAL REGION GEOHAZARD RISK MANAGEMENT PROGRAM		
TITLE Site Plan C025 - Western Monarch Slide Hwy 569:02, km 18.469		
SCALE 1:2,750	PROJECT No. A05116A02	FIG No. 1

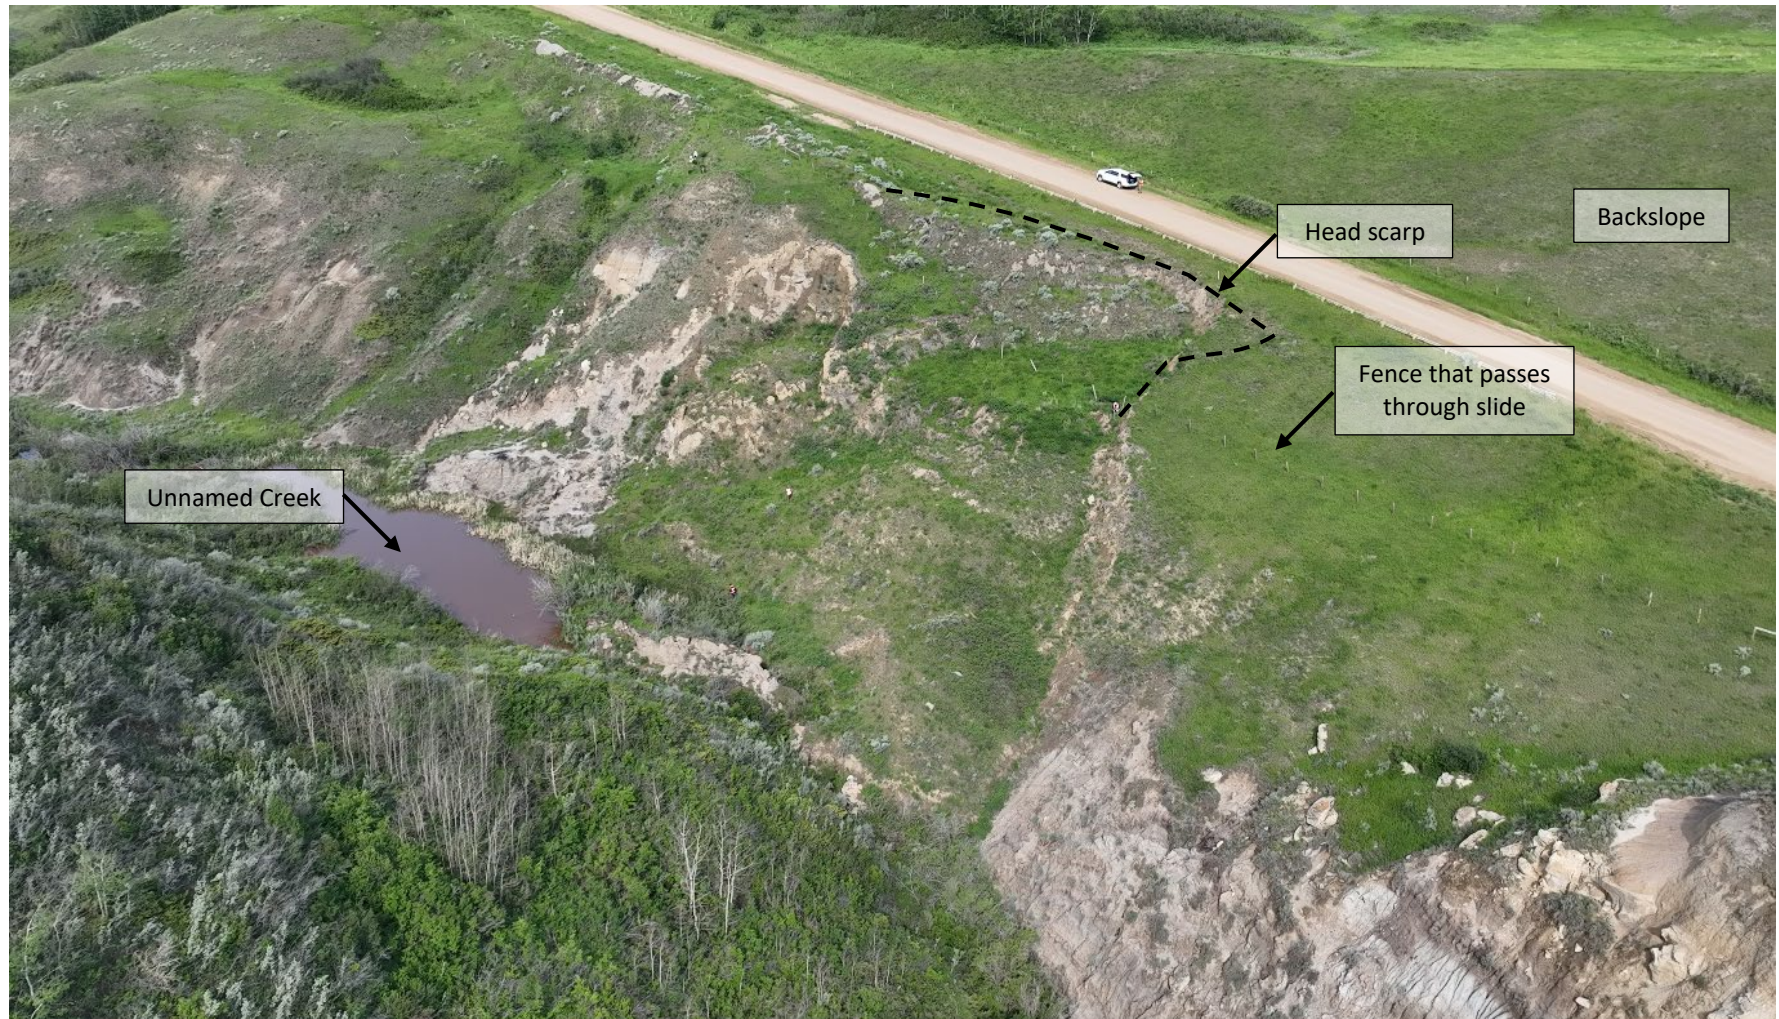
Between the 2022 and 2024 inspections, the rate of movement of the slide has increased. There has been expansion to the south (left) of the slide by approximately 10 m with ground cracks observed along the head scarp. The slide expansion appears to be lateral movement only, and the head scarp is not noticeably closer to the guardrail. The slide expansion appears to be attributed to a slide further downslope of the main slide (Photos 1 and 2).

The slide mass appears to have moved downslope since the 2022 inspection (as evident by ground cracks within the slide mass and the slide mass constricting the unnamed creek along the toe of the slope (Photos 1, 2, and 4)). The ground cracks observed appear to be older (i.e., may not be from spring 2024) since the edges of the cracks appeared more rounded than sharp.

Photo 1 **Oblique aerial photo of the C025 slide. Photo taken June 18, 2024, facing northwest.**

- Drainage improvements (e.g., construct ditches) to direct flows away from the slide area.
 - Re-alignment of the road upslope (i.e., north) towards the backslope, which would require land acquisition. The realignment would need to avoid areas undermined by coal mining (e.g., near the intersection of Hwy 569 and Hwy 10/Hwy 564).

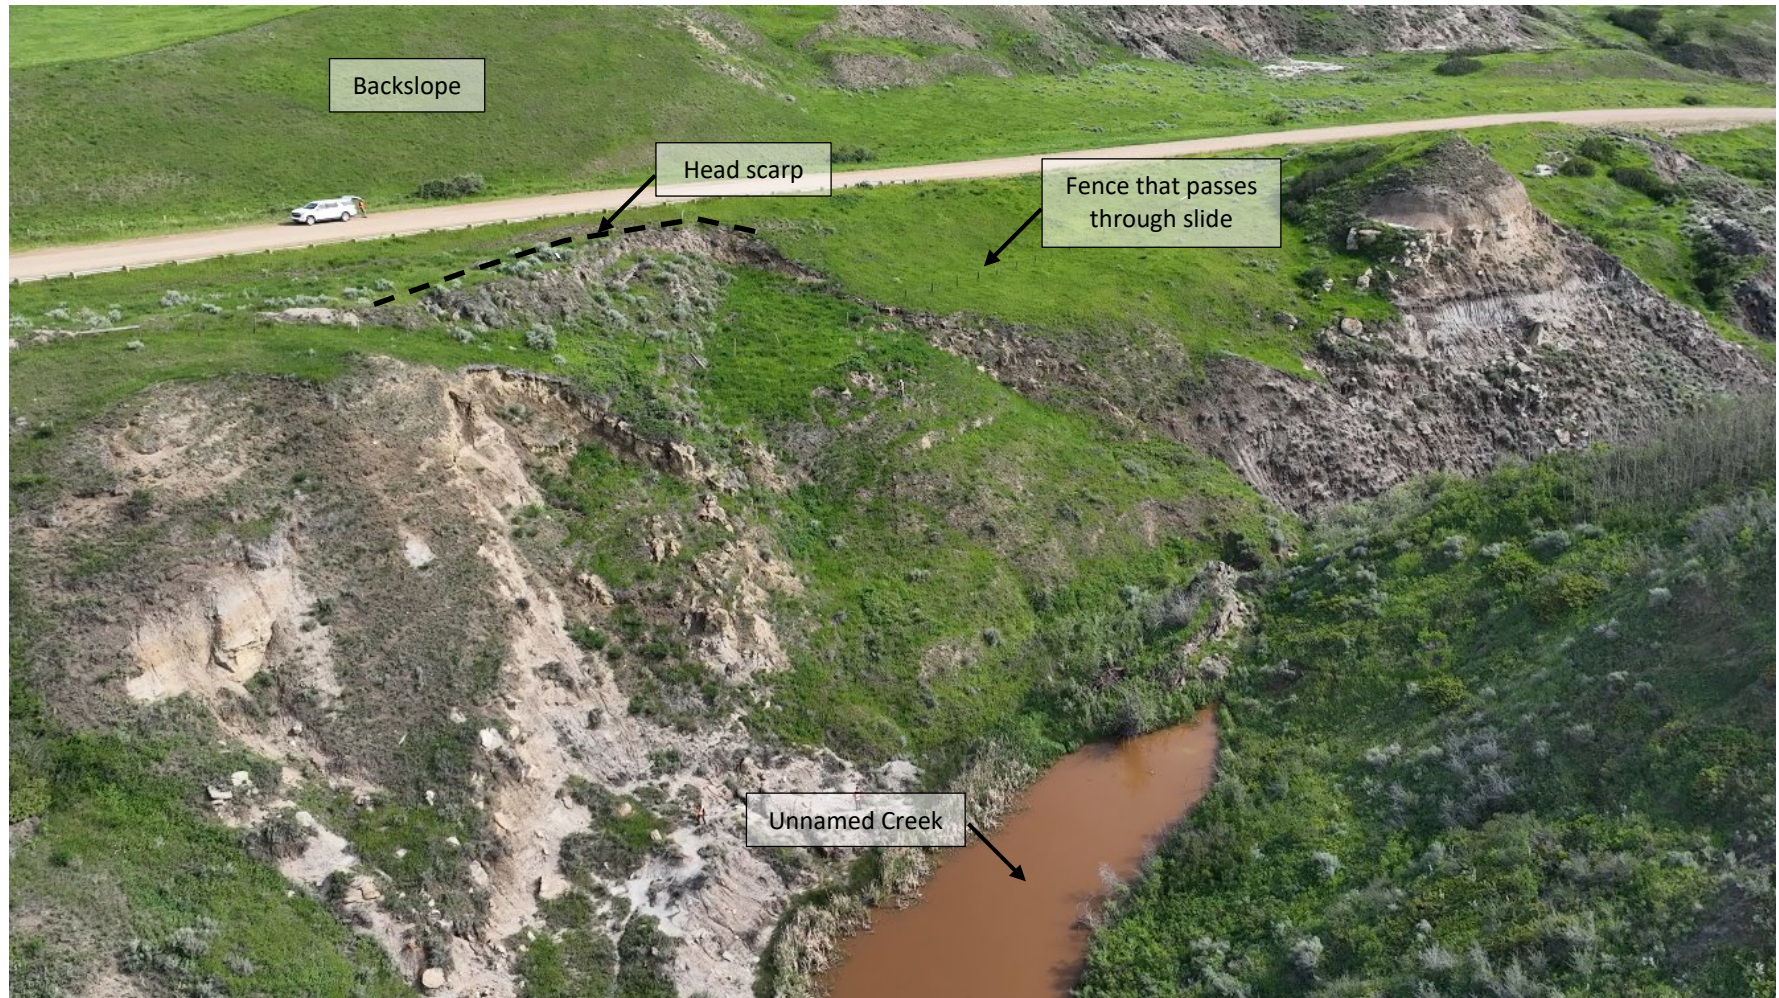
Photo 2 **Oblique aerial photo of the C025 slide. Photo taken June 18, 2024, facing north-northeast.**

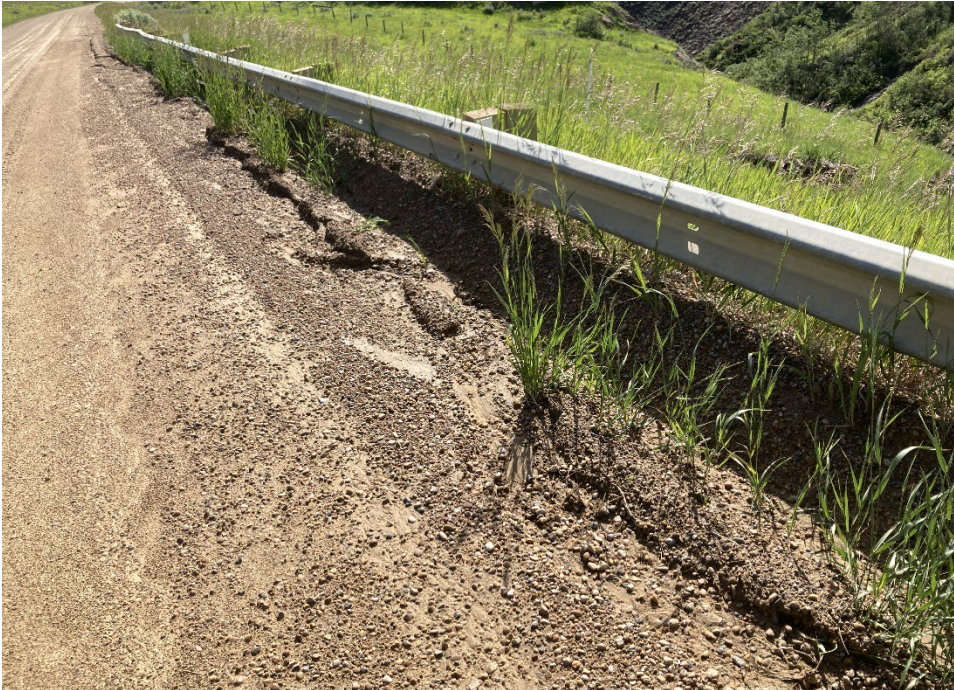
Drainage at the site is poor, with surface water flows over the slide area. Rills have formed along the south (eastbound) shoulder of the highway (Photo 3).

Photo 3 **Minor erosion along the south edge of the highway upslope of the slide. Photo taken June 18, 2024, facing southeast.**

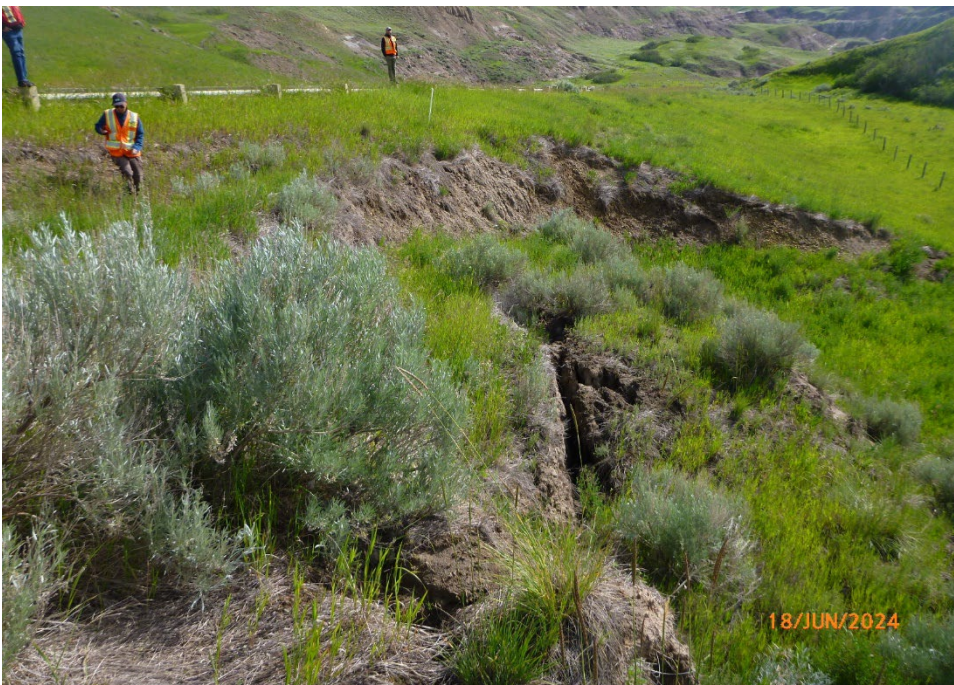
Photo 4 **Head scarp of the slide where ground cracks were observed. Extent (number and width) of ground cracks have increased since the 2022 inspection. Photo taken June 18, 2024, facing east.**

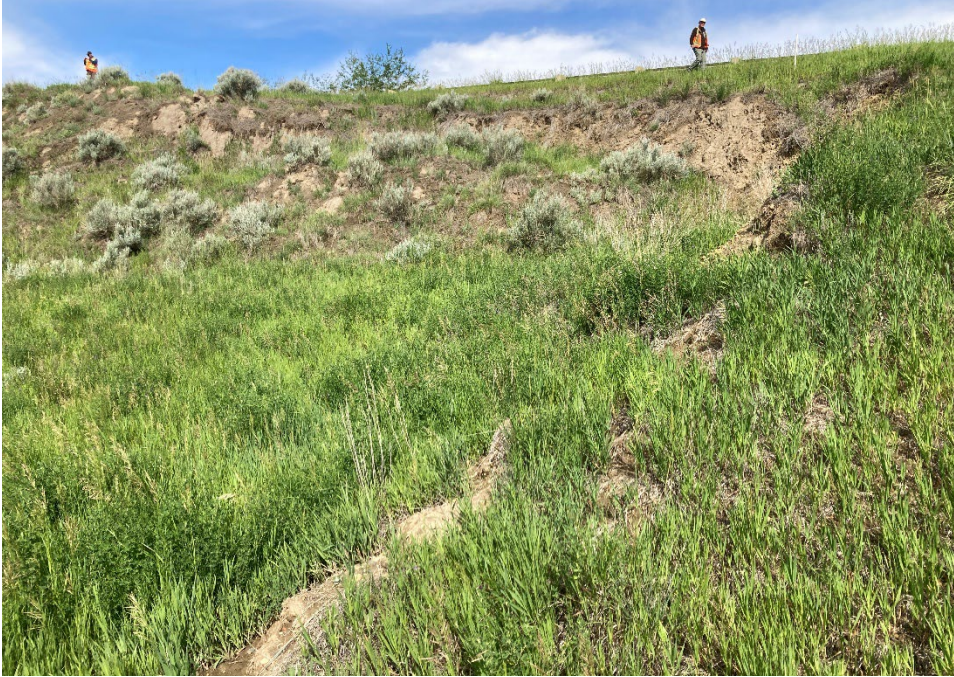
The slope and slide area, except for the near-vertical back and side scarps, are well vegetated with grass (Photo 5 and 6). The north edge of the slide is at the tree line.

Photo 5 **Head scarp of the slide. The slide mass is well vegetated, but the vertical face of the head scarp shows evidence of recent erosion. Photo taken June 18, 2024, facing north.**

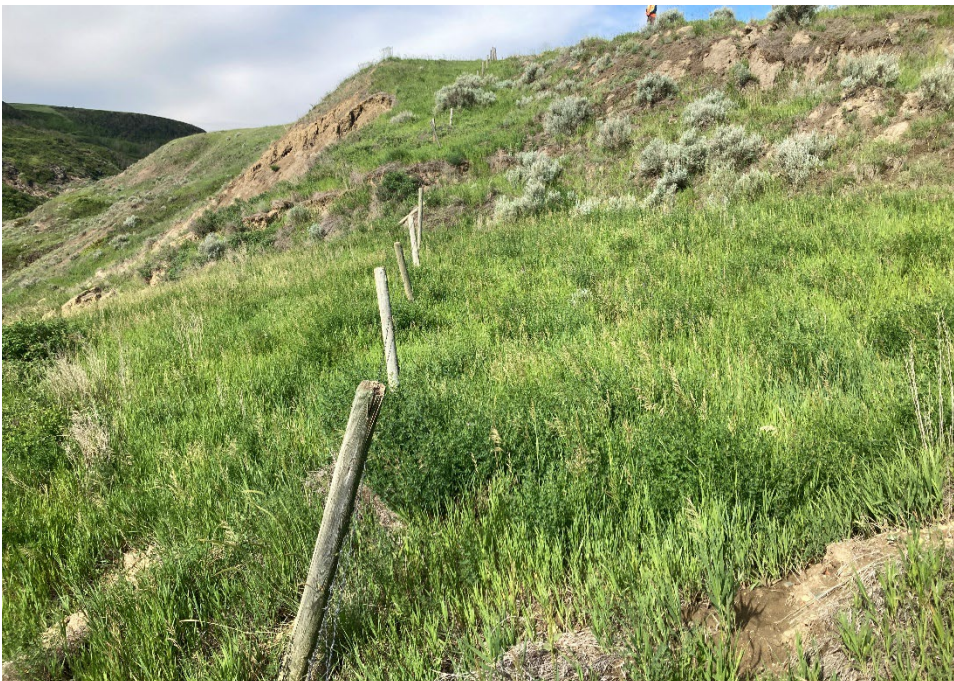
Photo 6 **Damaged fence that runs through the slide area. Photo taken June 28, 2024, facing west.**
