September 12, 2022

Alberta Transportation  
4th Floor, Provincial Building  
4920 51 Street  
Red Deer, Alberta  
T4N 6K8

**CON0022160 Central Region GRMP Instrumentation Monitoring  
Site C043; H619:06, km 12.206 Soil Nail Site  
Section C – 2022 Spring Readings**

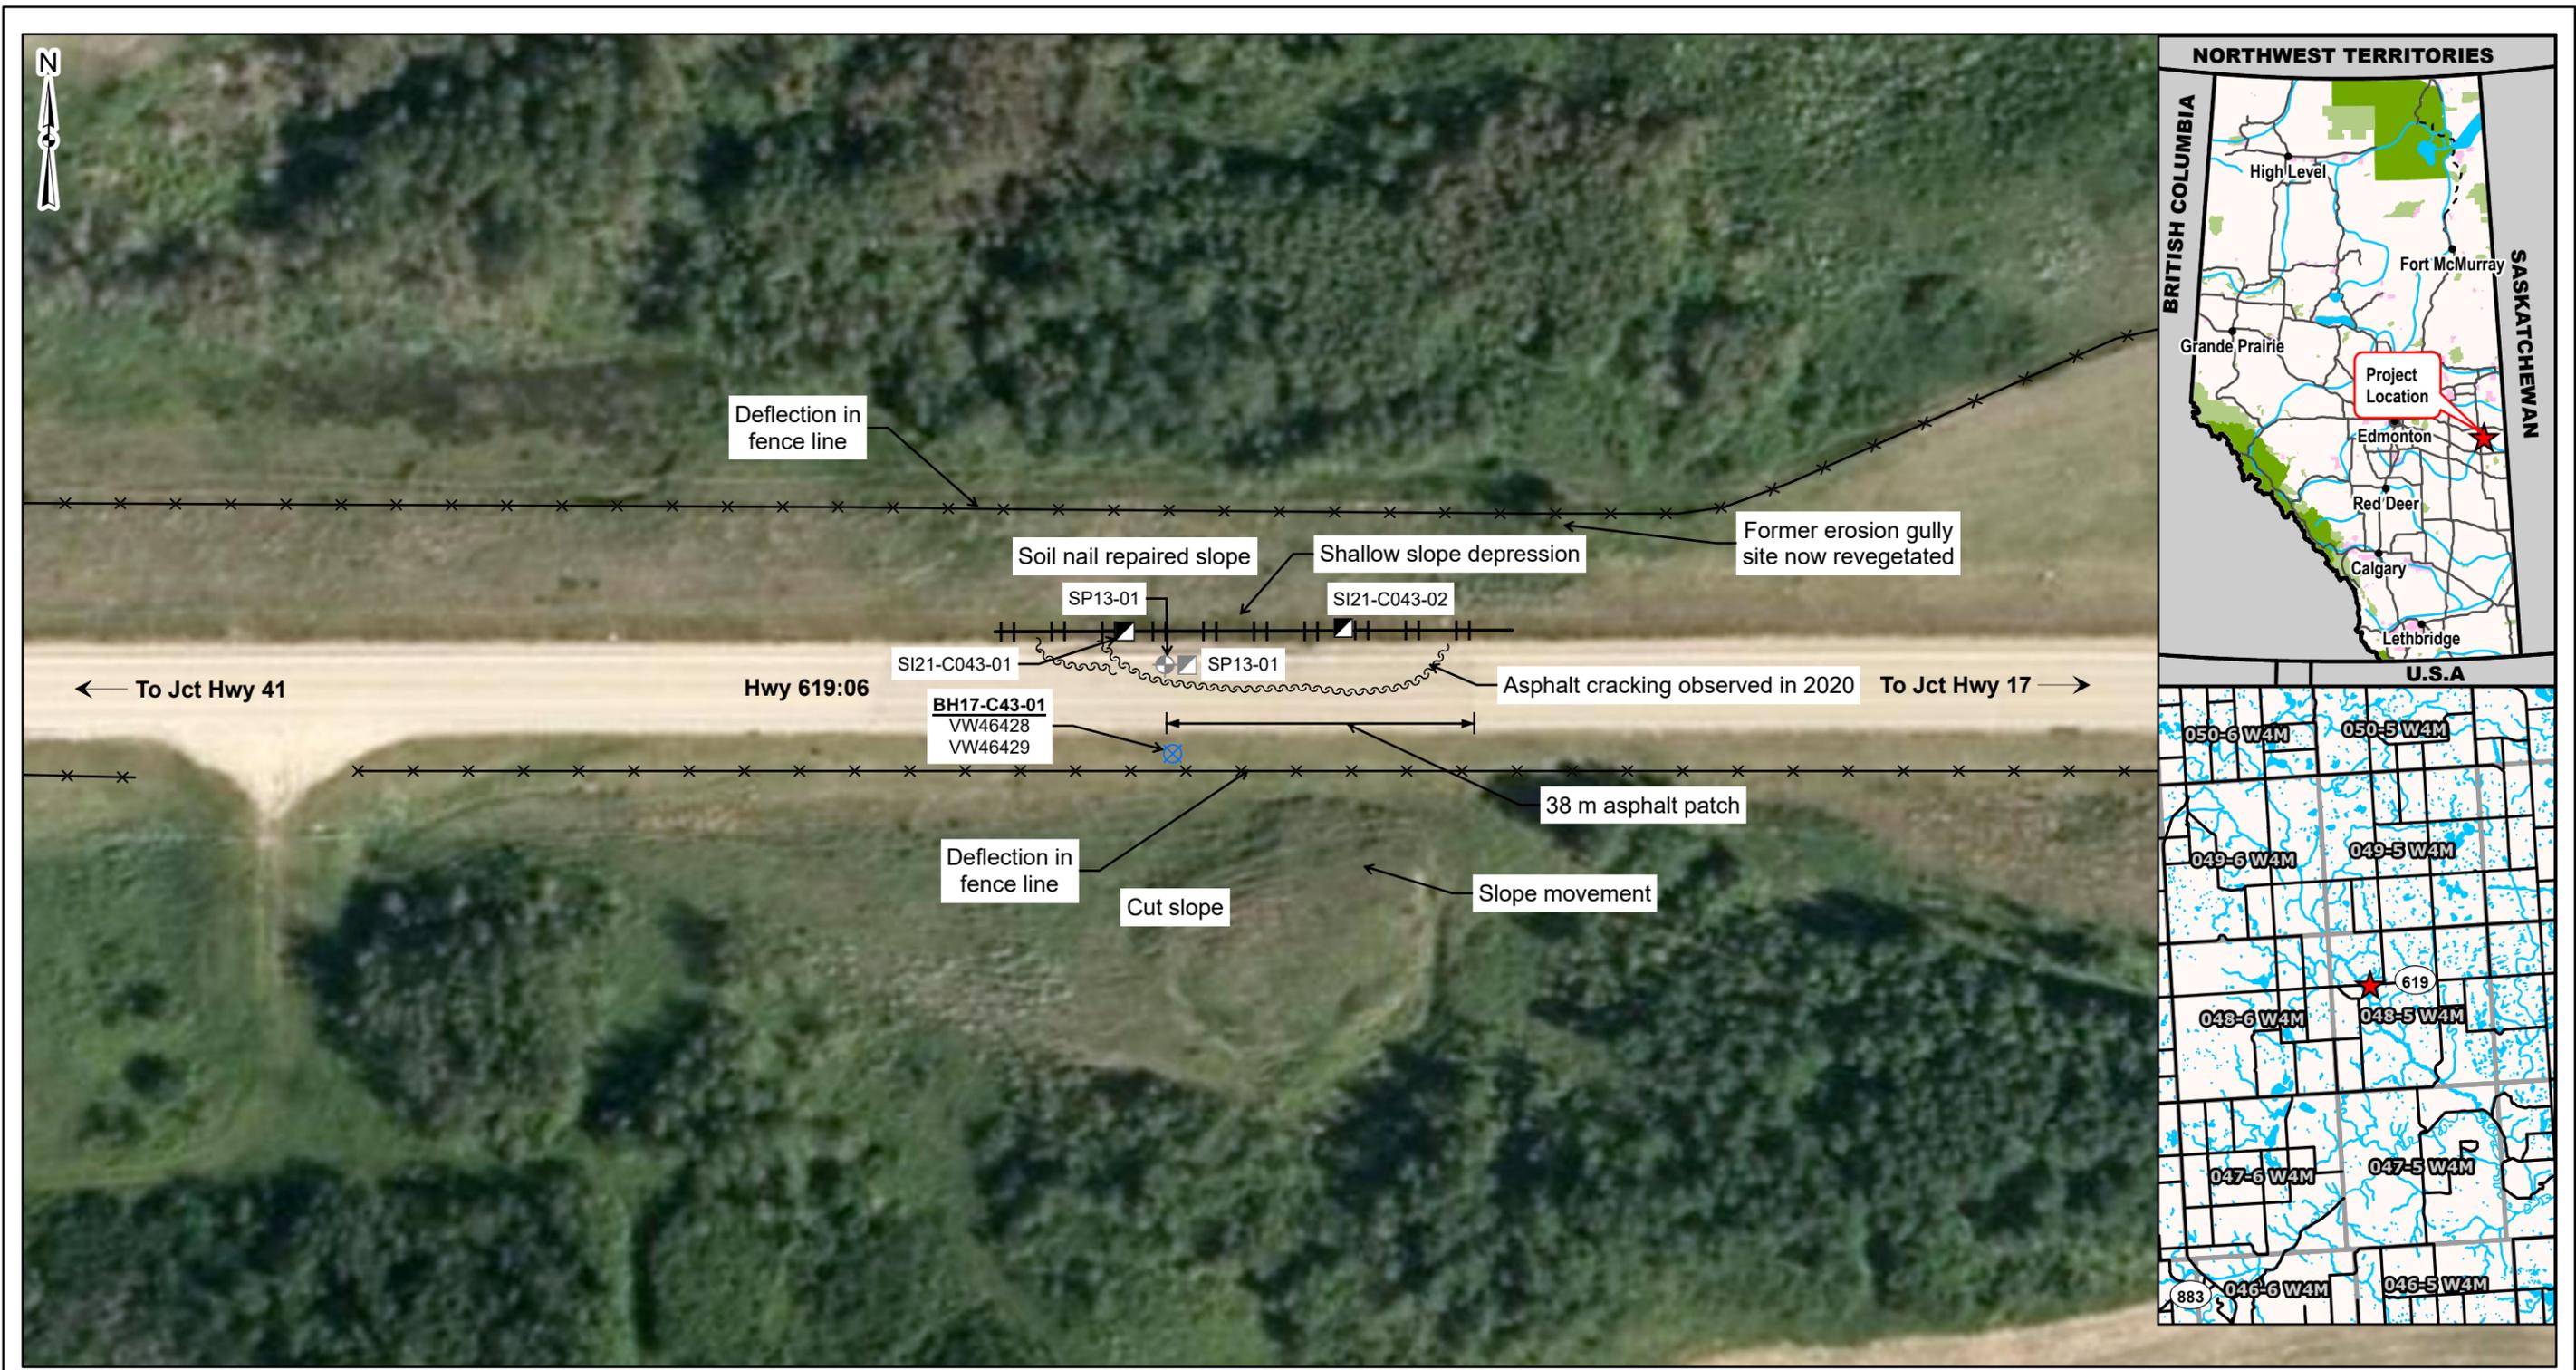
PROJECT CENTRAL REGION GEOHAZARD RISK MANAGEMENT PROGRAM		
TITLE Site Plan C043 - Soil Nail Site Hwy 619:06, km 12.206		
SCALE 1:800	PROJECT No. A05116A02	FIG No. 1

The geohazard at the C043 site consists of an embankment slope failure on the north side (westbound lane) of Hwy 619:06 and a backslope failure on the south side (eastbound lane) of Hwy 619:06.

On March 23, 2021, KCB installed two SIs (SI21-C43-01 and SI21-C43-02) in steel pockets between the web and flanges of the 2021 H-piles to monitor deflection of the H-pile wall. SI21-C43-01 and SI21-C43-02 are located approximately one-third (21 m) from either end of the H-pile wall.

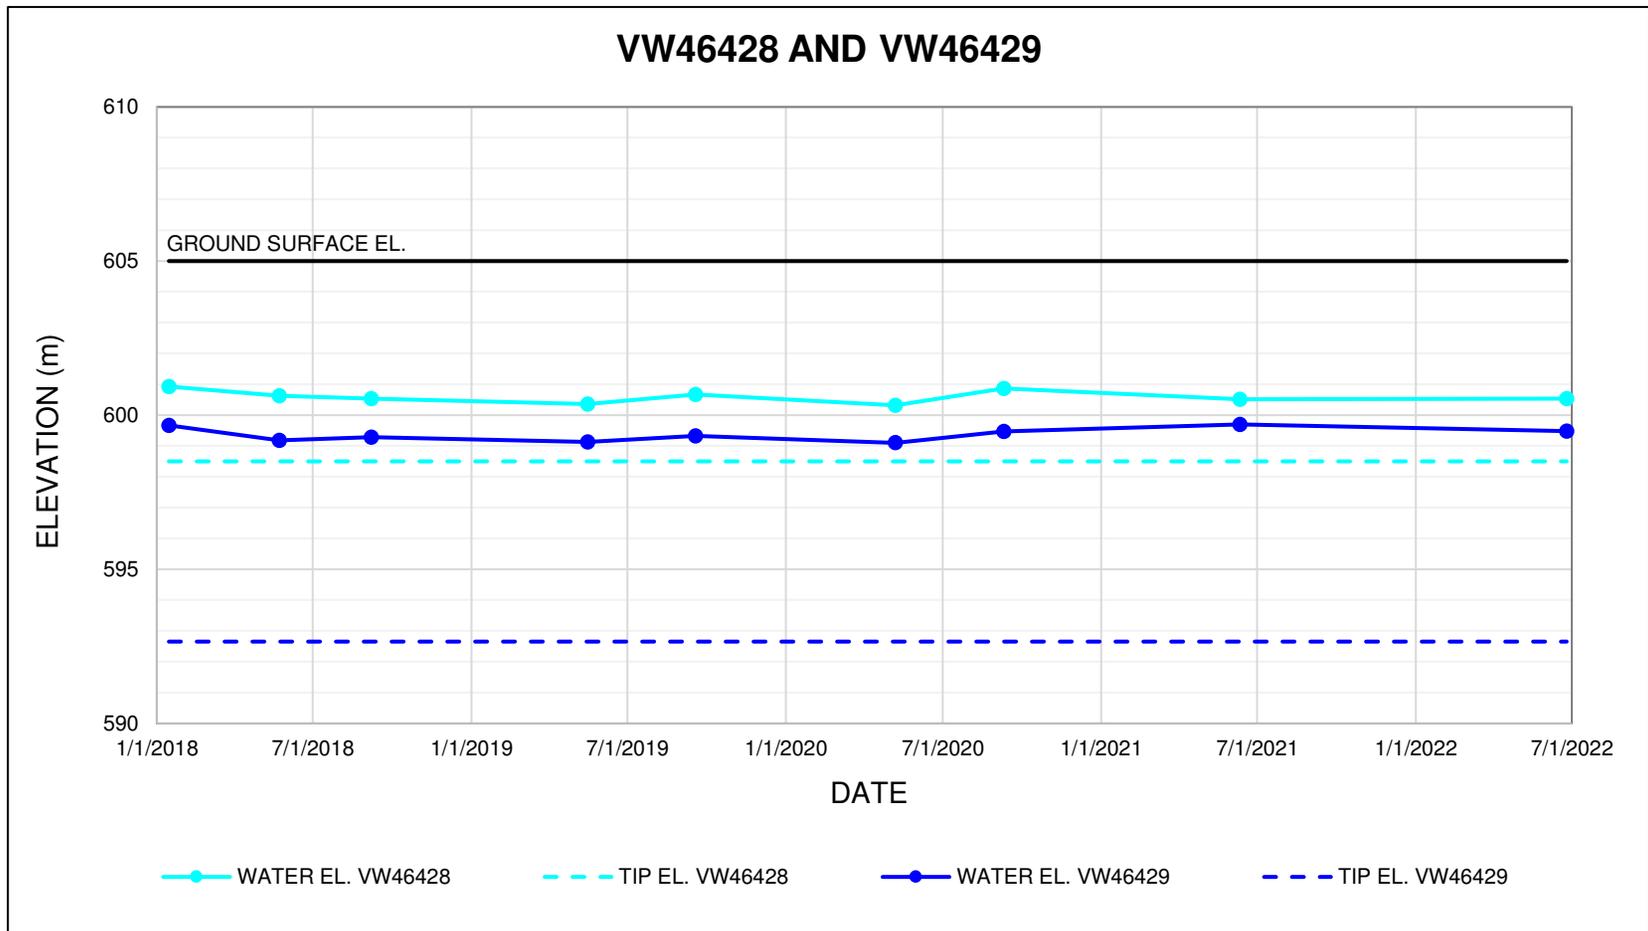
TITLE	
		Piezometer Data C043 - Soil Nail Site Hwy 619:06, km 12.206	
SCALE	PROJECT No.	A05116A02	FIG No.

Instrument ID / Serial No.	Date			Ground Surface Elevation (m)	Tip Depth (mbgs <sup>1</sup> )	Water Level		
	Installed	Previous Reading	Most Recent Reading			Previous Reading (mbgs <sup>1</sup> )	Most Recent Reading (mbgs <sup>1</sup> )	Change from Previous Reading (m)
VW46428	Nov. 20, 2017	Sep. 10, 2020	Jul. 23, 2022	605	6.5	4.5	4.5	0.0
VW46429	Nov. 20, 2017	Sep. 10, 2020	Jul. 23, 2022	605	12.3	5.3	5.5	-0.2

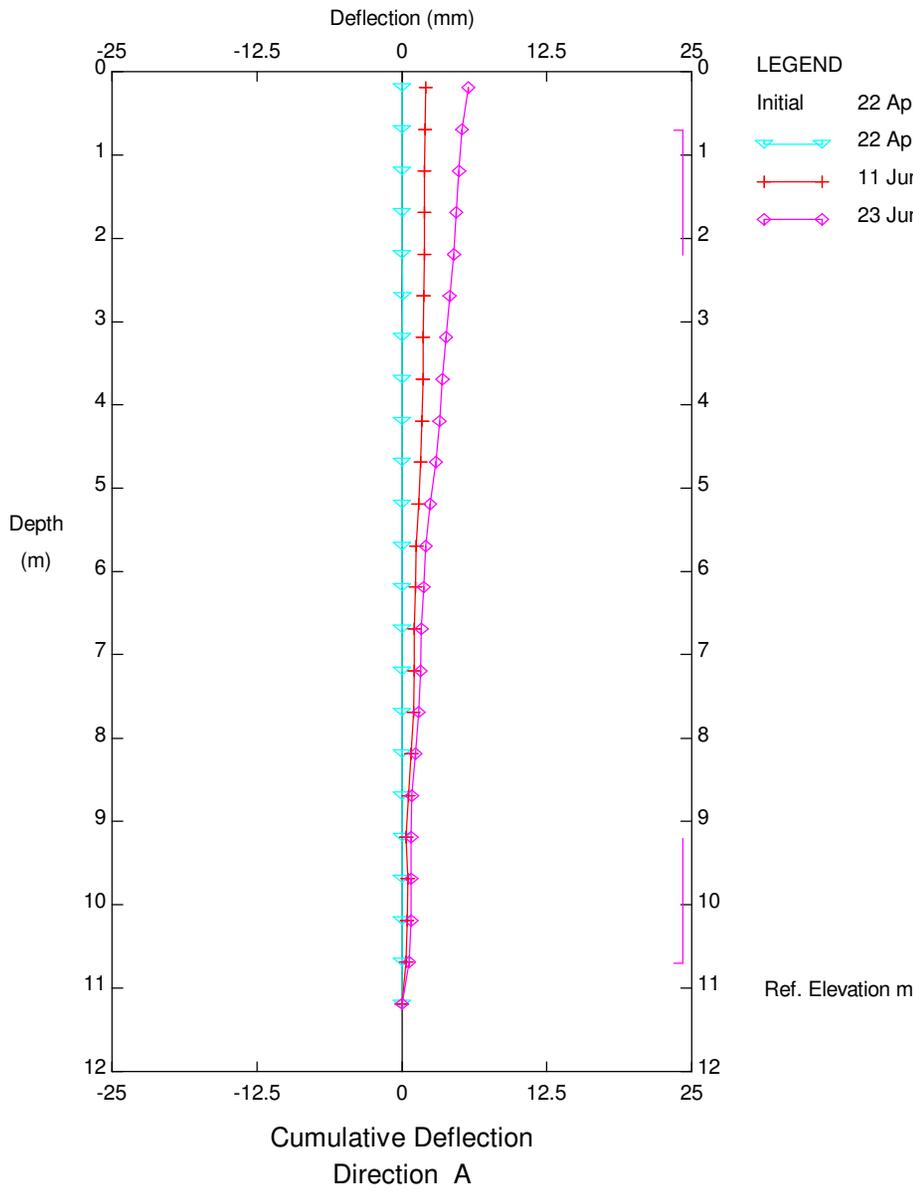
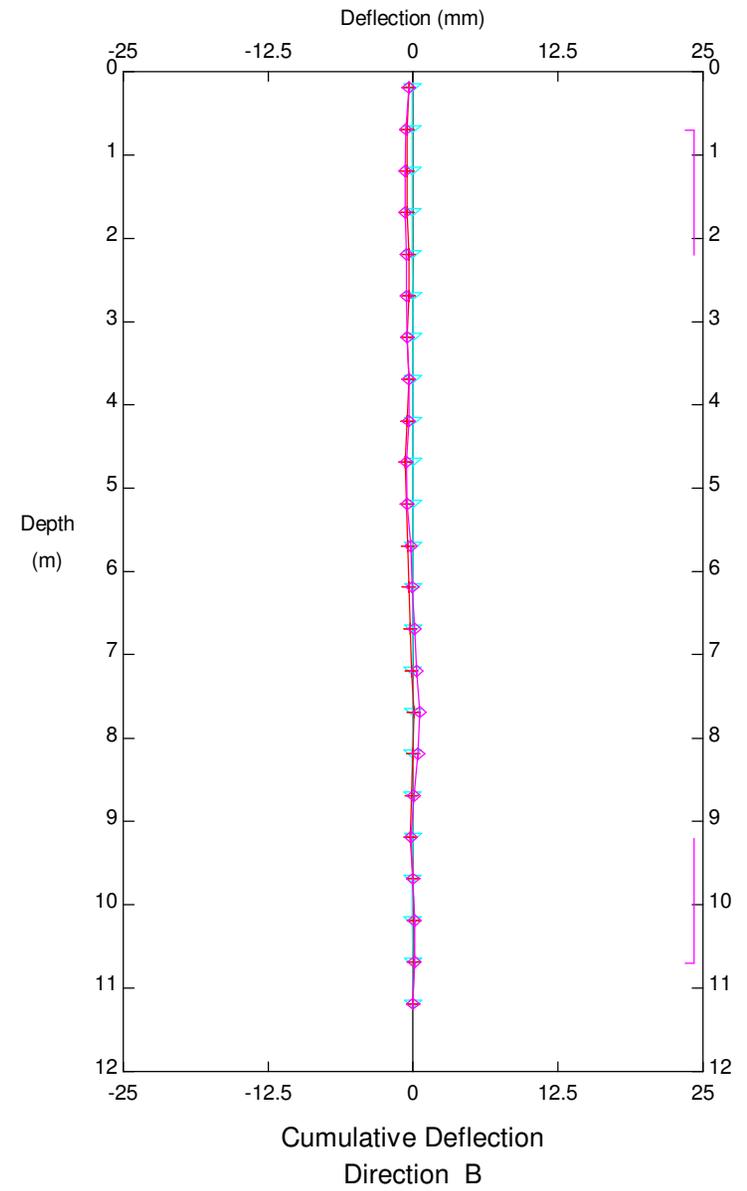
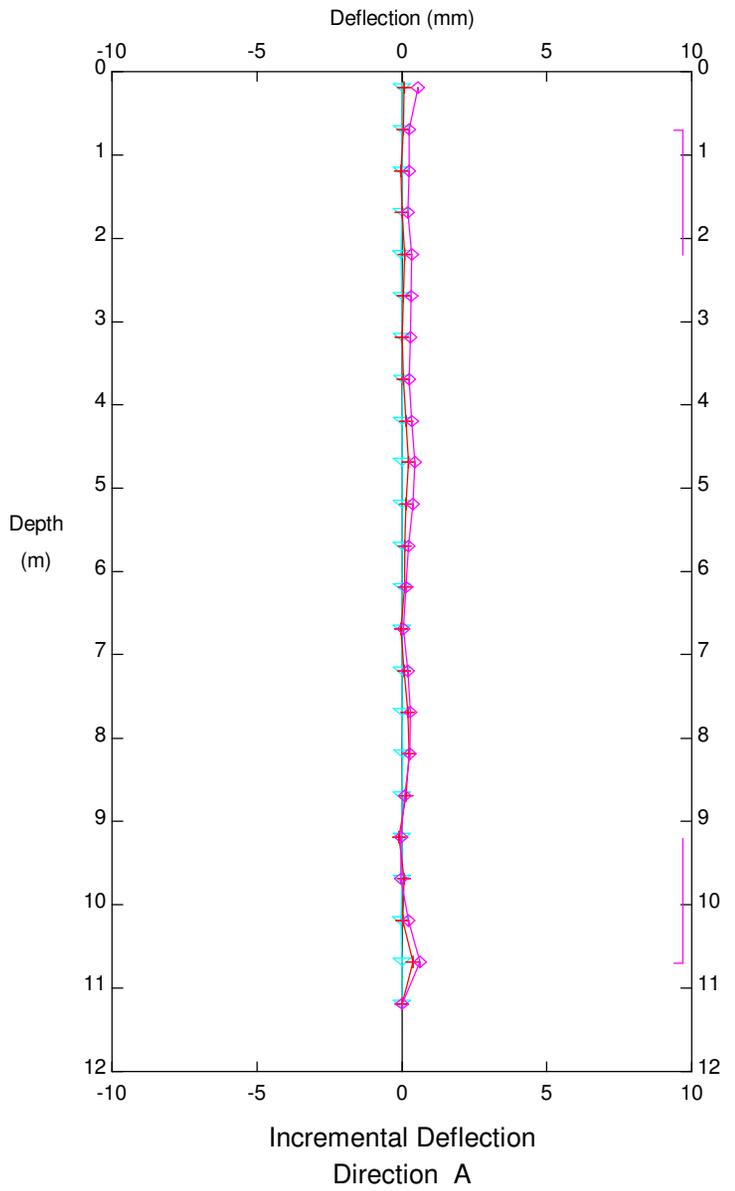
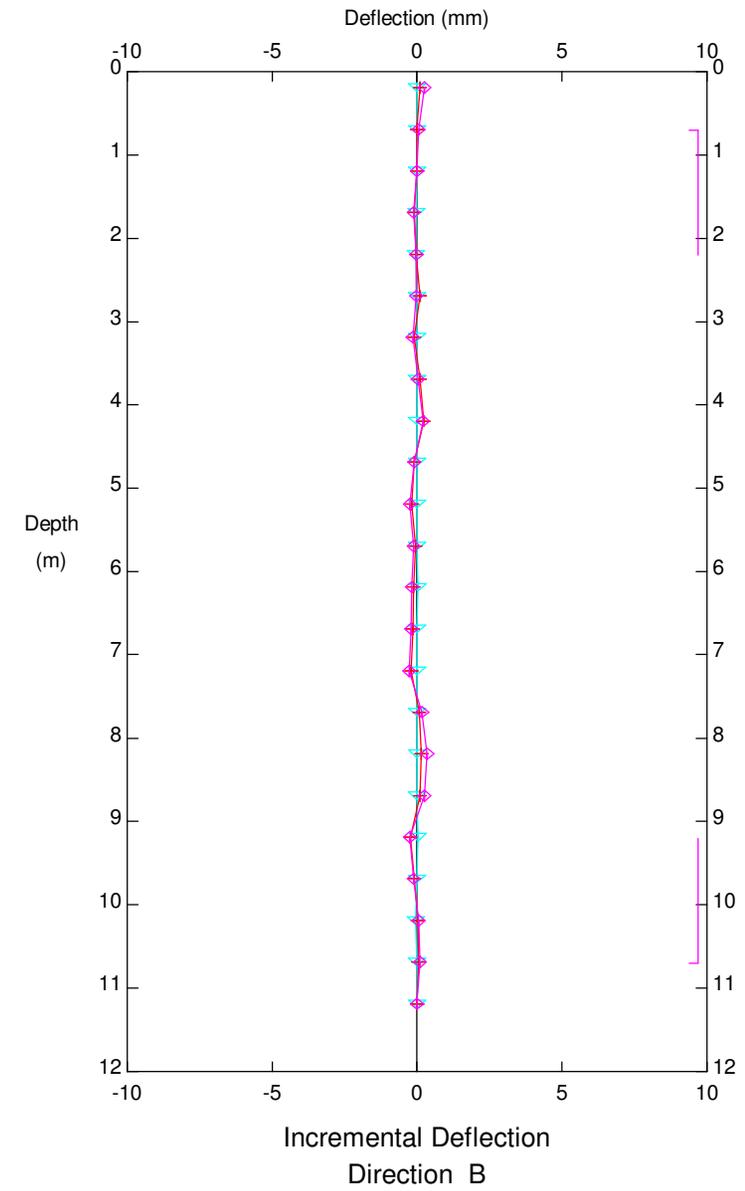
C043; H619:06; Soil Nail Site, Inclinator SI21-01  
Alberta Transportation

Distributed movement is being recorded in the SIs installed in the H-pile wall (SI21-C43-01 and SI21-C43-02) from top of casing to an approximate depth of 7 m below ground surface. The H-pile wall is 12 m deep, and SI21-C43-01 and SI21-C43-02 are approximately 10.9 and 11.4 m deep, respectively.

The depth of movement being recorded in the pile-wall SIs appears to be occurring approximately 4 m above the base of the H-pile wall and approximately 2 m below the depth of movement previously recorded in SI13-01. This indicates the H-pile wall has intercepted the failure surface and is continuing to deflect, transferring load to depths below the failure plane as the piles stabilize the slide mass.

The June 2022 data obtained from the pile-wall SIs indicates that the top of the H-pile wall has deflected up to approximately 5 mm since installation. In the spring of 2021, shortly after construction of the H-pile wall, the maximum rate of movement recorded in these SIs was between approximately 6 mm/year and 12 mm/year. The rate of movement has since decreased and is now less than 5 mm/year. KCB anticipated that the rate of movement shortly after installation would be highest and would decrease as the H-pile wall picked up load stabilizing the sliding mass. However, last year and the spring of 2022 were relatively dry. Increased movement may occur in response to periods of heavy or prolonged rainfall, resulting in higher groundwater conditions. More data is needed to assess long-term trends for these instruments.

All operable instruments should continue to be read once per year (spring) until movements attenuate, and the rate of pavement cracking and deformation decreases.
