<b>SITE NUMBER AND NAME:</b> C023-I and -II Battle River Crossing Erosion and Slope Failure		<b>HIGHWAY &amp; KM:</b> 854:01, 14.017	<b>PREVIOUS INSPECTION DATE:</b> June 24, 2020	<b>INSPECTION DATE:</b> <b>May 31, 2022</b>
<b>LEGAL DESCRIPTION:</b> 16-07-043-17 W4M	<b>NAD 83 COORDINATES:</b> UTM    Northing    Easting 12      5839557      402074		<b>RISK ASSESSMENT:</b> C023-I    PF: 10    CF: 3    TOTAL: 30 C023-II   PF: 8    CF: 4    TOTAL: 32	
<b>AVERAGE ANNUAL DAILY TRAFFIC (AADT):</b> 130 (south) & 90 (north) (Ref No. 114370 & 997079)			<b>CONTRACTOR MAINTENANCE AREA (CMA):</b> 513

PROJECT CENTRAL REGION GEOHAZARD RISK MANAGEMENT PROGRAM		
TITLE Site Plan C023 - Battle River Crossing Erosion and Slope Failure Hwy 854:01, km 14.017		
SCALE 1:1,250	PROJECT No. A05116A02	FIG No. 1

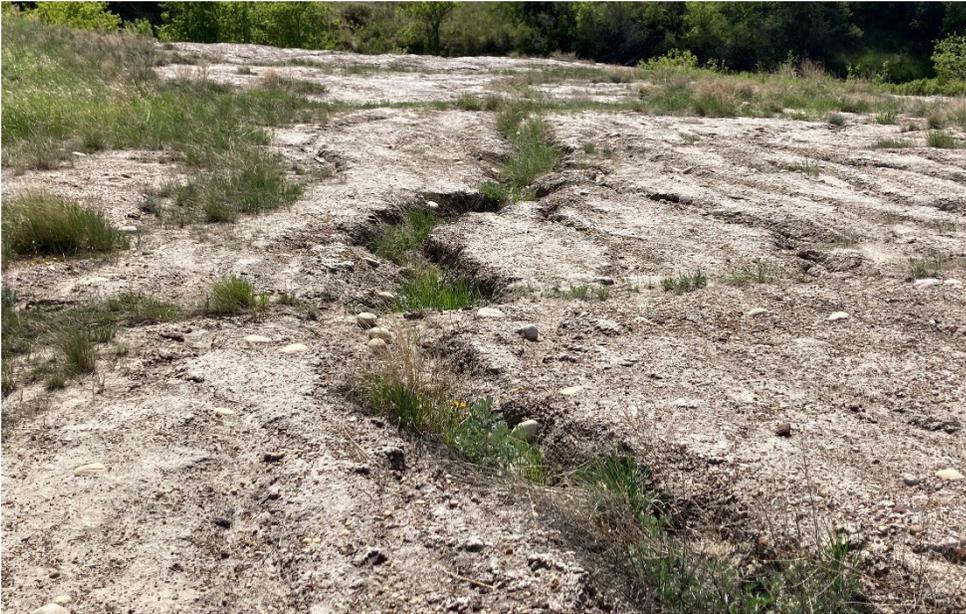
<b>COMMENTS</b>
<p>C023-I:</p> <ul style="list-style-type: none"> <li>The west side gabion catch basin inlet structure continues to overflow onto the unvegetated slope into the existing erosion gully (first observed during the 2018 inspection) (Photo 1). Although the erosion gully has not expanded significantly since the 2020 inspection, it will continue to expand if left unrepaired.</li> <li>Grass growth is limited to the areas where coir rolls, now deteriorated, retained sediments and seeds from previous seeding.</li> <li>The inlet and outlet gabion catch basin structures on the north side of the bridge remain clogged with no significant change since the 2020 inspection (Photos 2 and 3).</li> </ul>

- Photo 1** Gully erosion occurring on the north slope of the river valley, south of the gabion basket inlet structure. Erosion most likely caused by the inlet structure overflowing since it is clogged with sediment and vegetation. Photo May 31, 2022, facing southwest.

- The sediments and vegetation in the gabion basket inlet and outlet structures should be removed.
- The erosion gullies in the slope and berm downstream of the gabion basket inlet structure should be backfilled with fine-grained material. The slope should be graded and seeded with a suitable Badlands seed mix to promote grass growth. Given that bedrock is exposed at surface, to give the seeds a better chance to germinate and form a stable vegetative cover on the western erosion site, the seed could be applied via hydro-mulch or a bonded-fiber matrix, flexible growth medium and then hydro-seeded. Silt fence should be erected at the toe of the slope and maintained until vegetation is established.

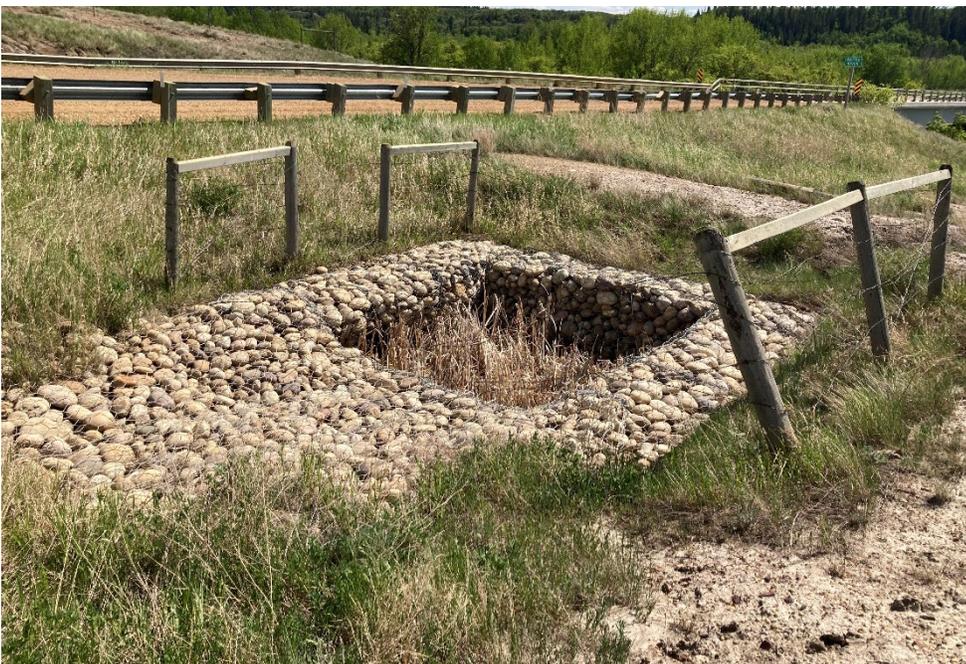
- Photo 2** Vegetation and sediment build-up at the catch basin structure at the inlet of the culvert. Photo taken May 31, 2022, facing southeast.

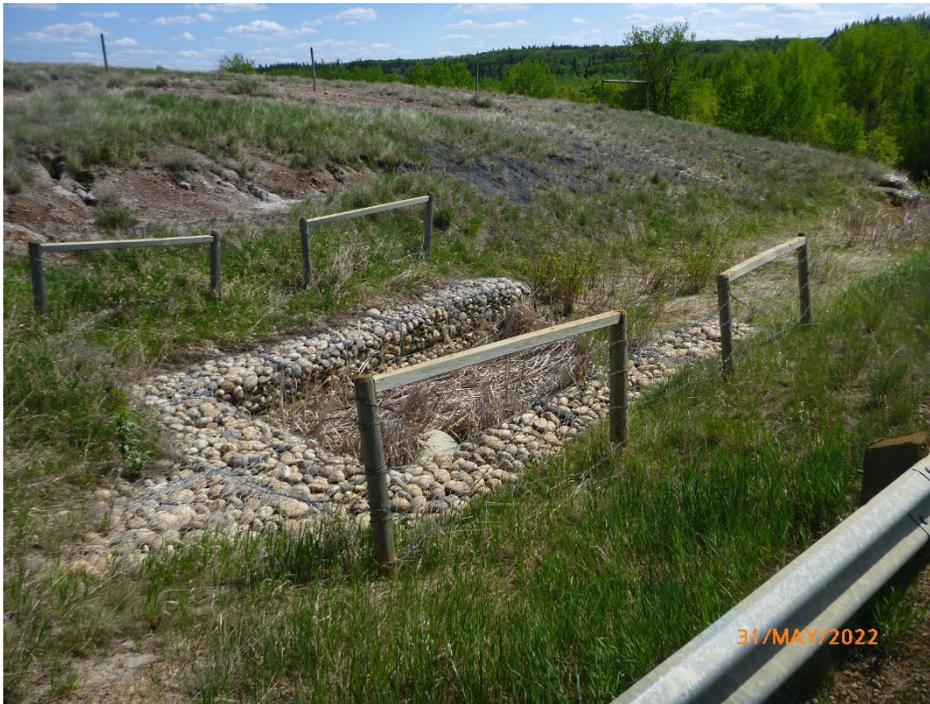
**Photo 3** Gabion basket outlet structure on east side of highway is clogged with sediments and dense vegetation. Photo taken May 31, 2022, facing east-southeast.

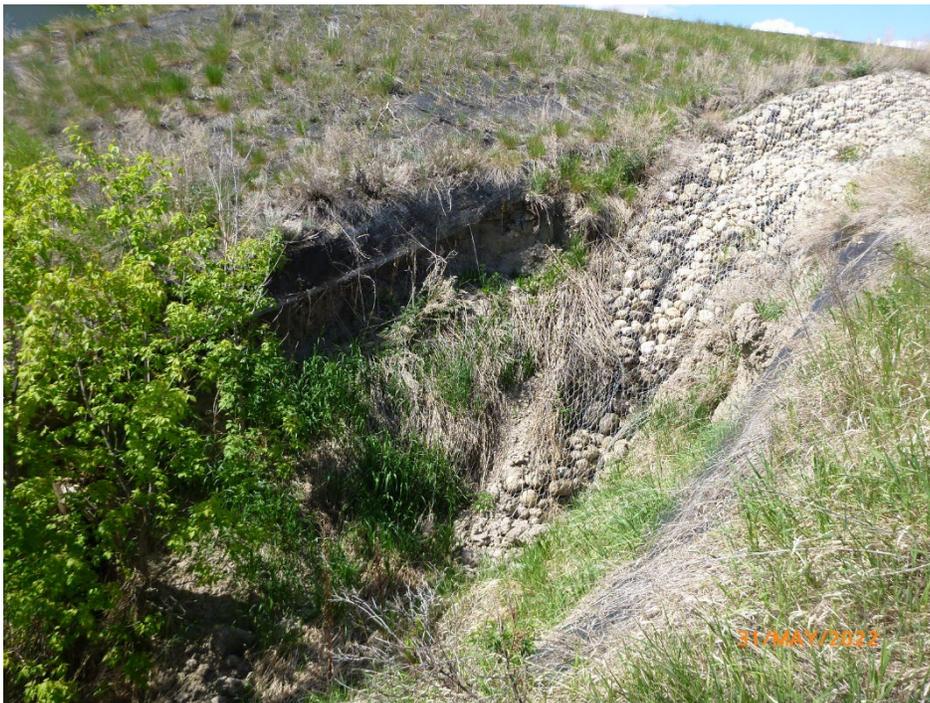
- Gabion mattress channel lining the ditch on east the side of highway has not been repaired (Photo 4). Water will continue to undermine the mattress until it is repaired. Gabion mattress channel lining at the discharge point into the river is still in good condition.
- Some undermining/erosion of the slope under the RECP was observed during the 2022 inspection.

**Photo 4** Failed section of the gabion mattress lined channel east of the highway. Photo taken May 31, 2022, facing northwest.

- The failed gabion mattress downslope of the gabion basket outlet structure should be removed. The area should be graded to a channel shape, lined with non-woven geotextile or suitable bedding material, and armoured with riprap. Check trenches should be installed at regular intervals to reduce the likelihood of undermining the repaired channel.

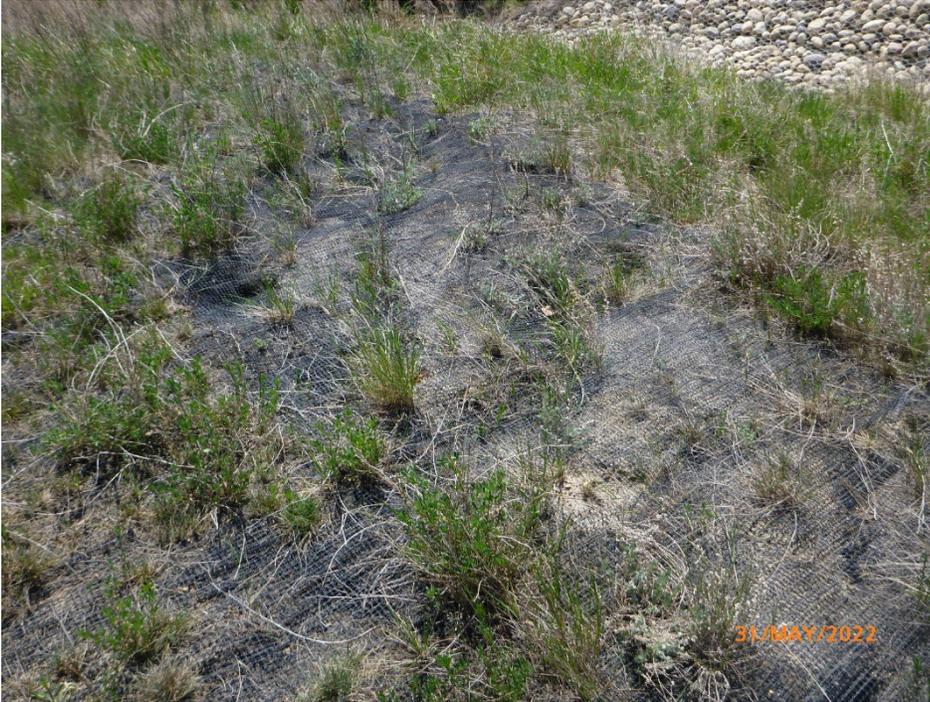
**Photo 5**      **Poor vegetation cover on the slope east of the highway and gabion mattress lined ditch. There are small erosion gullies forming on the east slope, undermining the geosynthetic covering the slope. Photo taken May 31, 2022, facing west.**
