**ALBERTA TRANSPORTATION
GEOHAZARD ASSESSMENT PROGRAM
PEACE REGION –
GRANDE PRAIRIE DISTRICT – NORTH
2022 INSPECTION**

Site Number	Location	Name	Hwy	km
PH036	Dunvegan	Dunvegan South Elephant Trunk	2:68	16.216
Legal Description		UTM Co-ordinates		
NW¼ 06-080-04 W6M		11U E 398549	N 6196741

2022 PH036 INSPECTION PLAN

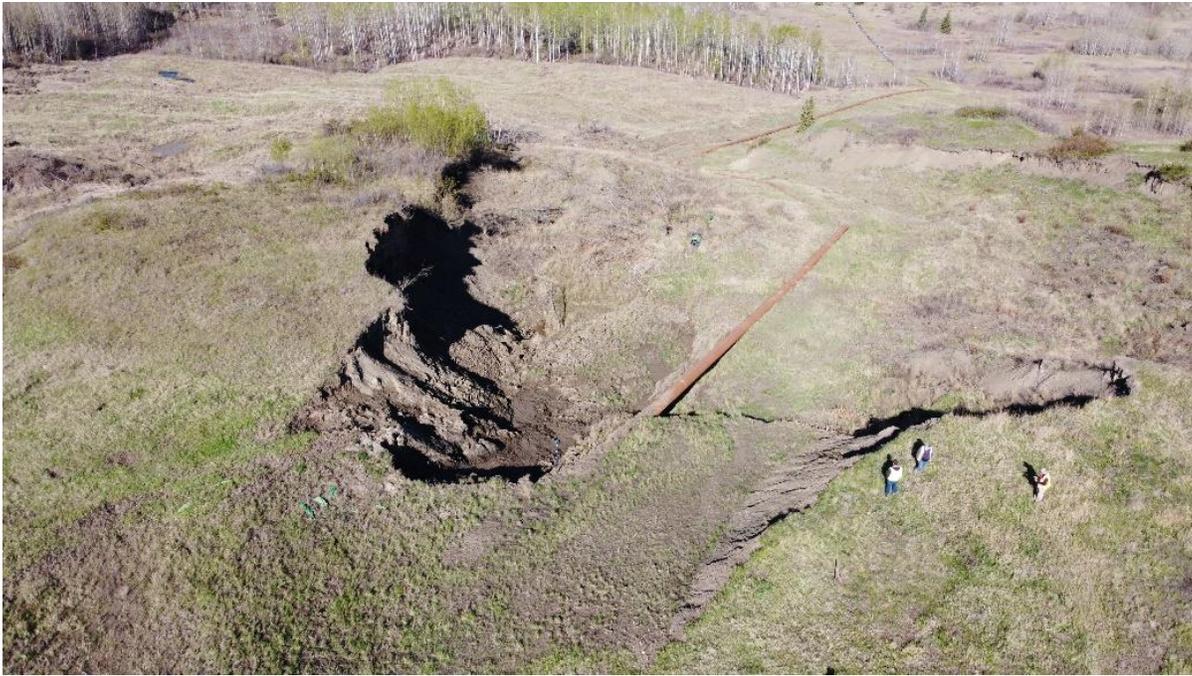
Photo D1.
Overall view of
elephant trunk
looking west
with a drone

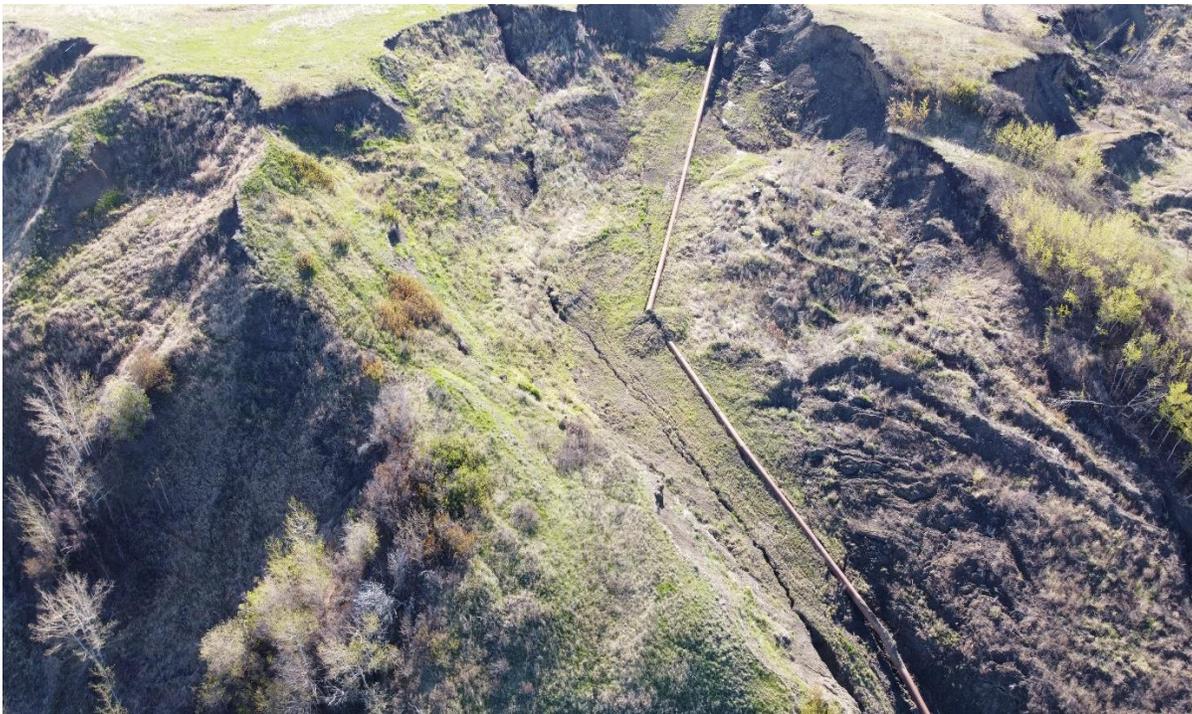
Photo D2.
Oblique drone
view of
elephant trunk
on upper slope

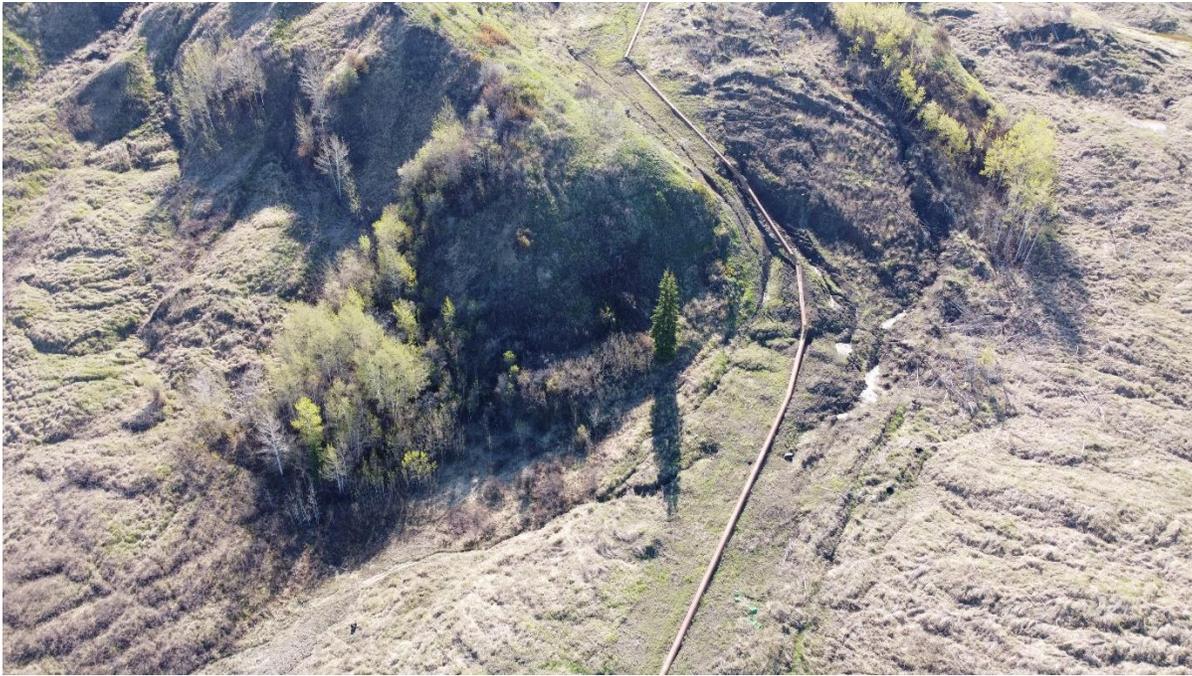
Photo D3.
Oblique drone
view of
elephant trunk
alignment on
mid slope

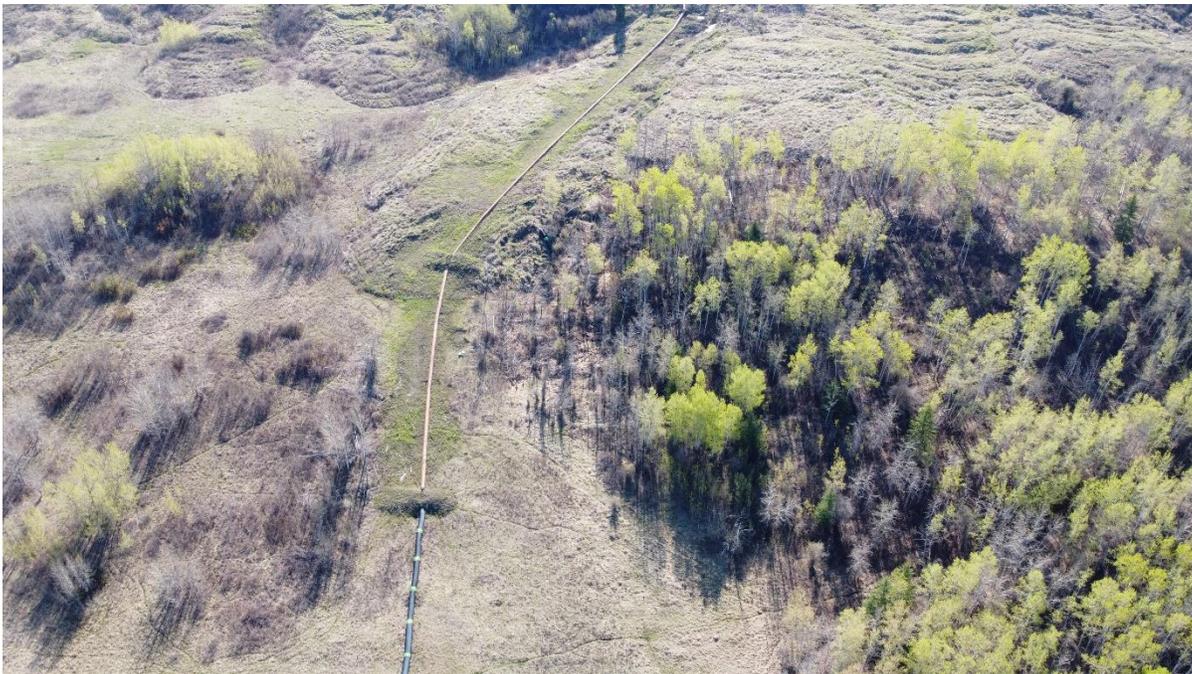
Photo D4.
Oblique drone
view of
elephant trunk
on lower slope

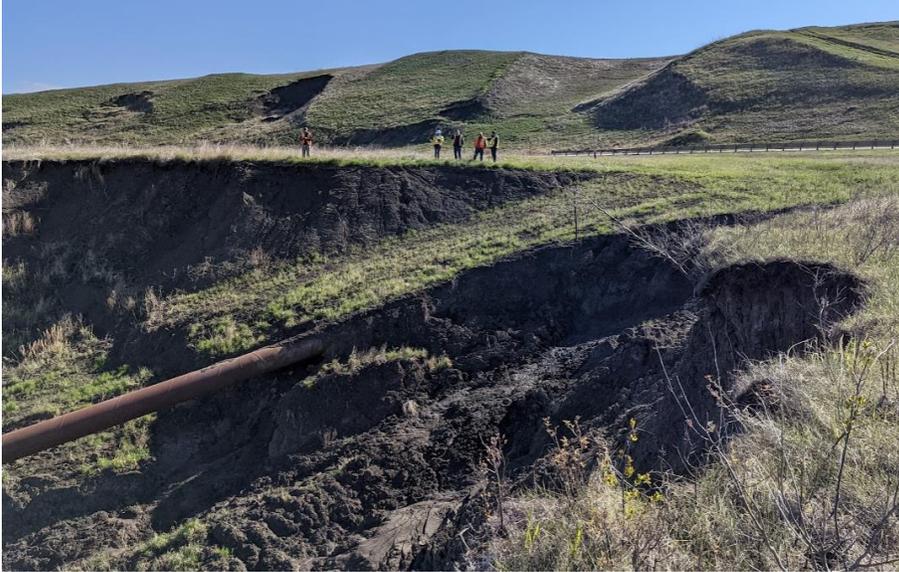
Photo 1.
Looking northeast from Sta. 2+320 towards the Dunvegan Elephant Trunk consisting of a 760 mm diameter smooth wall steel pipe installed in 2020.

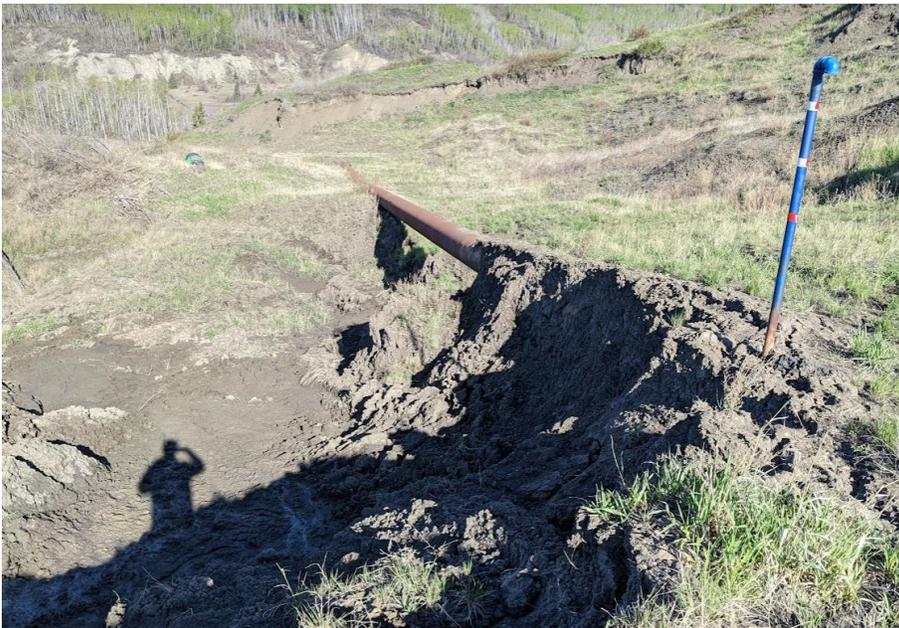
Photo 2.
Looking west from the crest of the valley bench. Note seepage on the bottom left of the photo

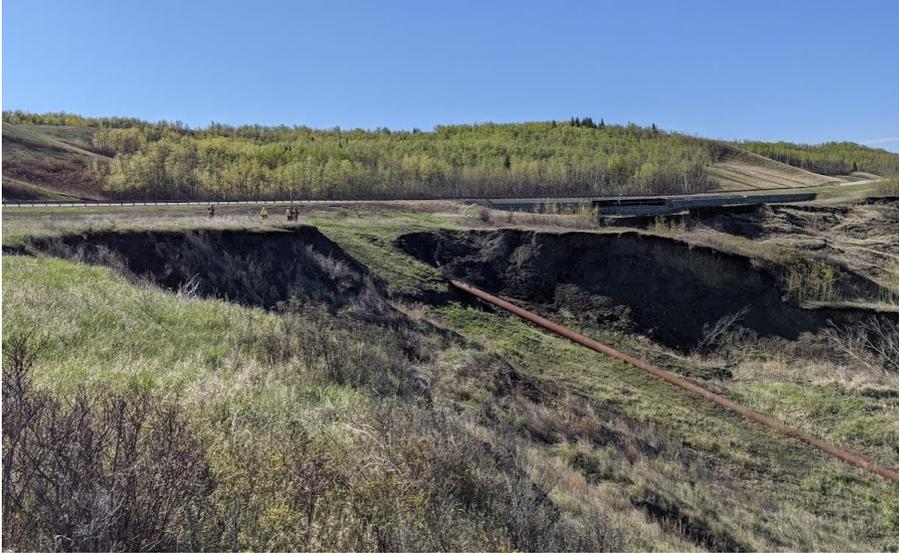
Observations:	Description	Worsened?
<input type="checkbox"/> Pavement Distress		<input type="checkbox"/>
<input checked="" type="checkbox"/> Slope Movement	There is continuing shallow and deep slide movement through the gully along which the Elephant Trunk was routed. Slope movements extend to near the head of the gully, with a significant scarp as shown in Photo 1. Scarps continue to develop across the head of the gully, with additional scarps extending south towards the 2+500 slide – The backscarp of the larger slide area is now up to 10 m high (Photo 3). The landslide mass that the new SWSP drainpipe	<input checked="" type="checkbox"/>

Photo 3. Looking south from 2+200, about 110m west of Hwy 2:68. Overall increase in slide activity along the backscarp in the upper portion of the Elephant Trunk drainpipe since 2021. Note up to 1.3 m of settlement of slide mass under the SWSP downslope of where it exits the fill cover.

Recommendations:		
<p>The surface of the trench backfill over the SWSP alignment between the highway and the backscarp should be topped up with topsoil, smoothed out and re-seeded.</p> <p>Local regrading of the subgrade along/under the section of the pipe that descends the valley slope over the landslide mass should be carried out when required to maintain support to the pipe to avoid long unsupported gaps that could overstress the pipe. There is a piece of old big o pipe that was used to drain a gully under the new SWSP. This section of big o and the gully channel leading to and from it should also be improved while doing the subgrade repairs.</p>

In the future, consideration should be given to using screw piles with crossbeams to support the portions of the SWSP that have been developing gaps under the pipe, if the required grading repairs become too significant.

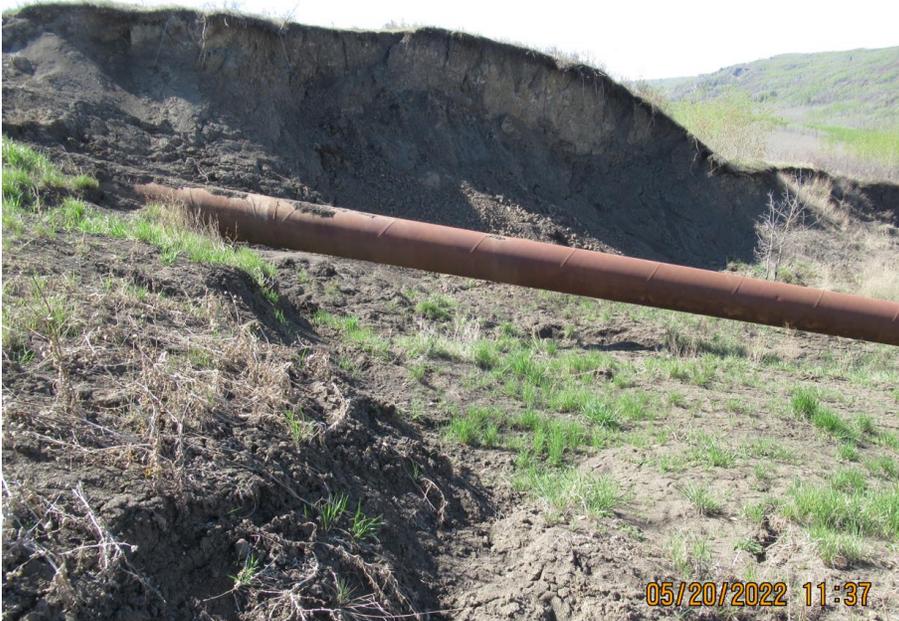
Photo 4. Close up of the settlement gap mentioned in Photo 3.

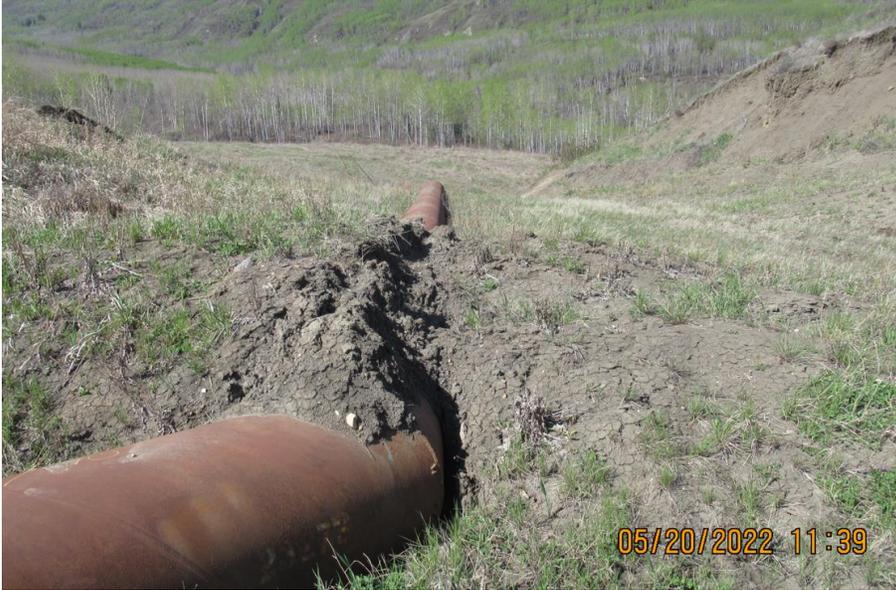
Photo 5.
Looking west at the upper most pipe bend. Note the pipe shifted by about 250 mm at this location due to thermal effects

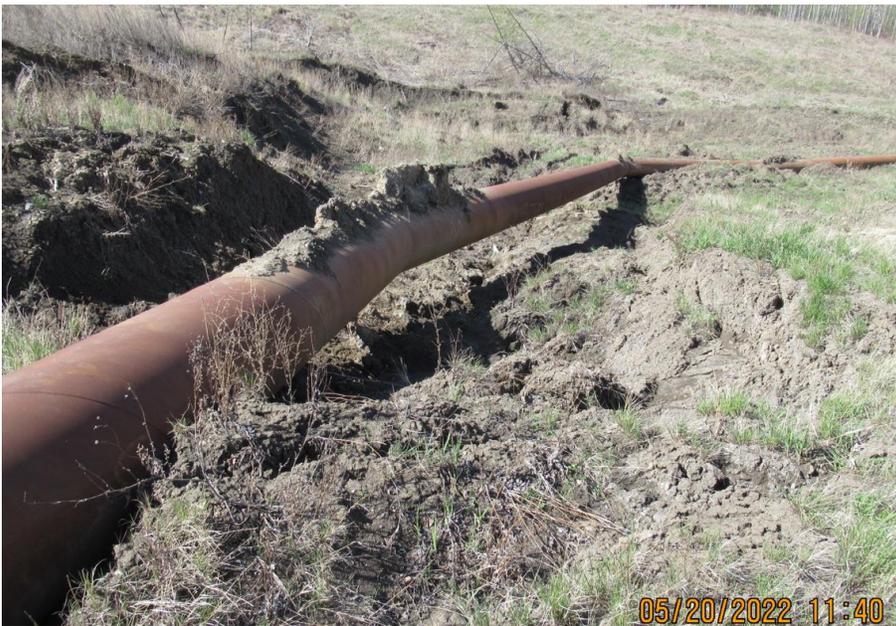
Photo 6.
Looking west at the middle pipe bend. Note how the movement of the landslide under the pipe results in a gap approximately 1 m high. Trickle of water noted under the gap below the pipe

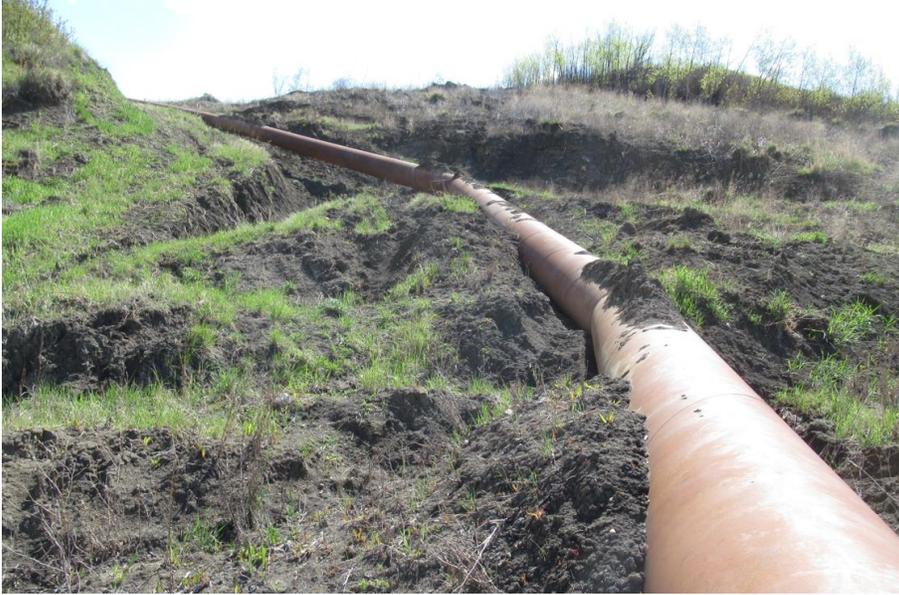
Photo 7.
Looking
upstream at
SWSP middle
bend and soil
berm.

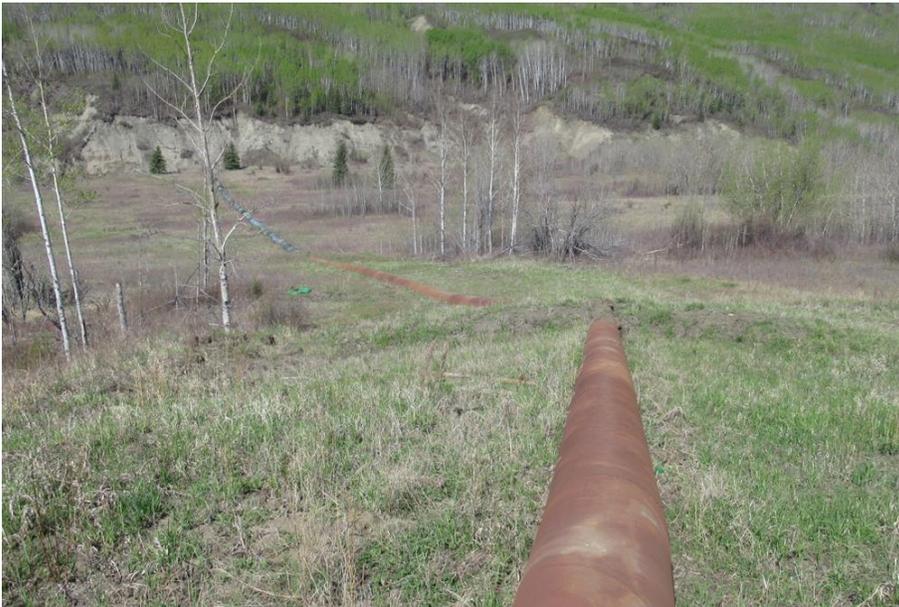
Photo 8.
Looking
downslope at
SWSP lower
bend and soil
berm.
