**ALBERTA TRANSPORTATION
GEOHAZARD ASSESSMENT PROGRAM
PEACE REGION – PEACE RIVER/HIGH LEVEL
2018 INSPECTION**

Site Number	Location	Name	Hwy	km
PH22	13 km W. Cleardale	Clear River East Hill-Site 6	64:02	22.8-23.1
Legal Description		UTM Co-ordinates (NAD 83)		
S28-84-11-W6		11 N 6243933	E 334702

Date	PF	CF	Total
Previous Inspection:	June 1, 2017	10	3	30
Current Inspection:	May 18, 2018	10	3	30
Road AADT:	420		Year:	2017
Inspected By:	Barry Meays, Don Proudfoot (Thurber); Ed Szmata, Ken Szmata, Roger Skirrow (AT).			
Report Attachments:	<input checked="" type="checkbox"/> Photographs		<input checked="" type="checkbox"/> Plans	<input type="checkbox"/> Maintenance Items

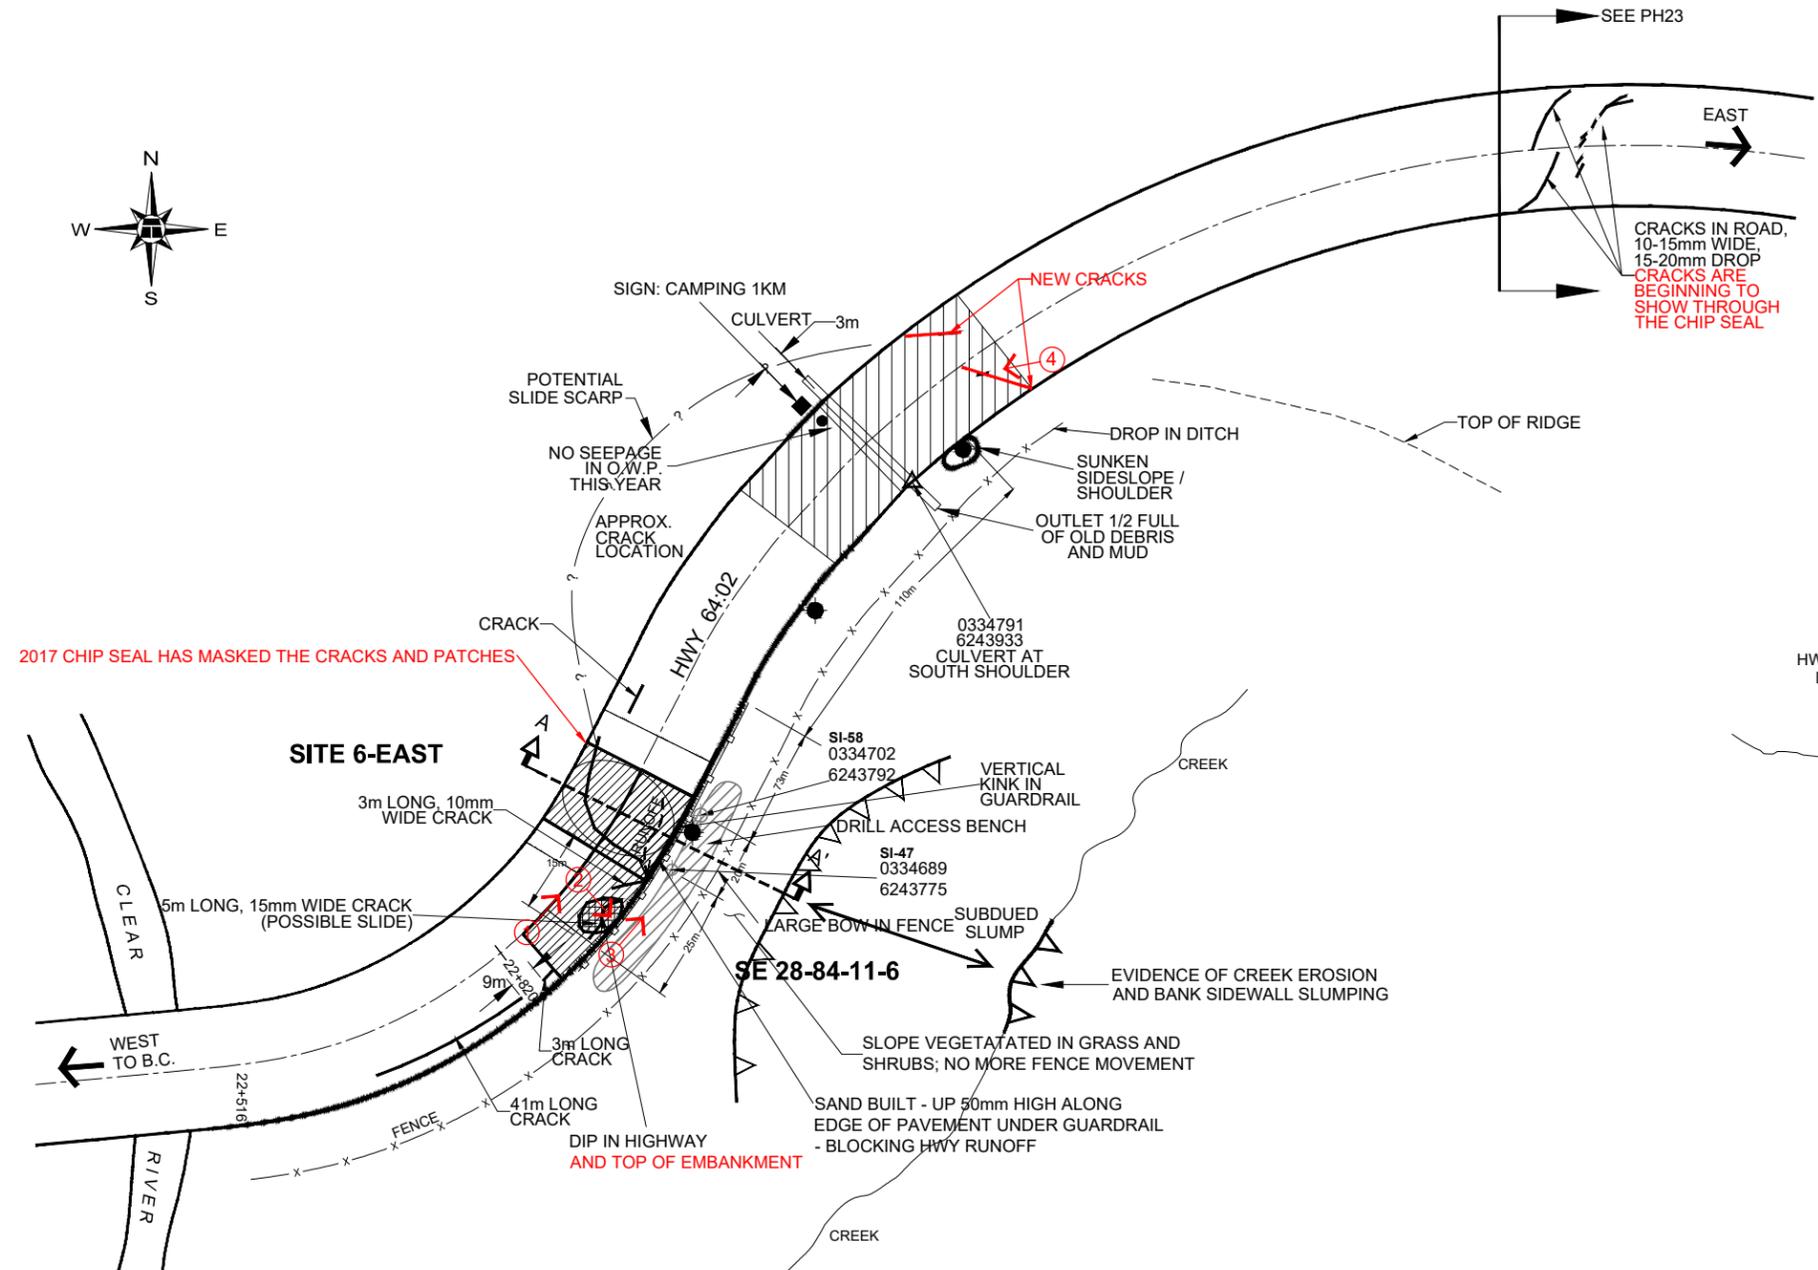
FIGURE PH22, SITE #6

Assessment (Refer to Figure PH22-1):
It was concluded in 2011 that the drains mentioned in the old road files 50 m downslope of hwy may not have been installed, since they could not be located. Movements that were previously monitored in SI58 appear to be ongoing (but slow) based on a kink in the south guardrail and bow in the fence on the south embankment at this location. There is a possibility that a large slide scarp circles north of highway and joins the two observed dips spaced 200 m apart along the highway.

Obtain LiDAR for this site (currently no coverage in AT's database), and review to see if a circular slide plane that joins both dip areas can be delineated. Perform a geotechnical Investigation to define the slide plane, consisting of 3 test holes containing Sl's and Piezometers (as shown on Figure PH22-1) to depths of 35 m.

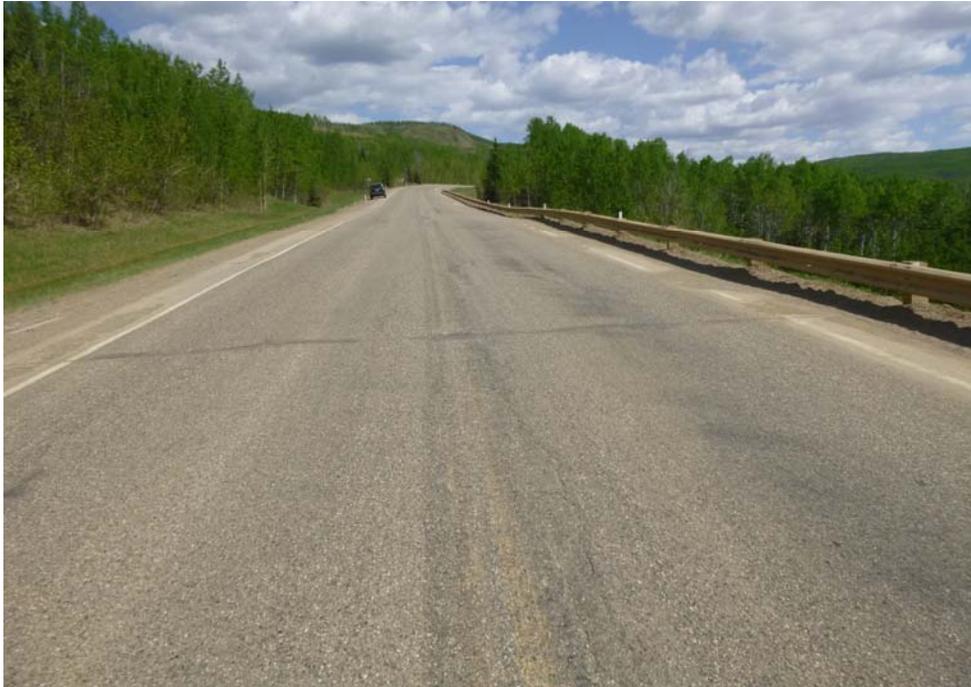
The west dip appears to be enlarging westwards, based on cracks first found in 2013 a distance of 15 m west of the west dip and which were observed to extend about 50 m west in 2017, and also a more apparent dip in the embankment in 2018. Previous cracks through the patch in the west dip were congregated in the wheel paths and did not cross, suggesting pavement fatigue, however with time the crack pattern appears to be angling semi-continuously across the highway. The cracks and the fact that the east dip was again patched in 2015, and the new/enlarged cracks and sunken shoulder at the east dip, suggests some on-going creep (which was previously reflecting through the 2008 overlay). Seepage traces in the pavement in previous years indicates a high water table.

Photo 1 – Looking east along the highway from the far west end of the site. The fall, 2017 chip seal has camouflaged the cracks. Note the west dip in the road/guardrail in the background.

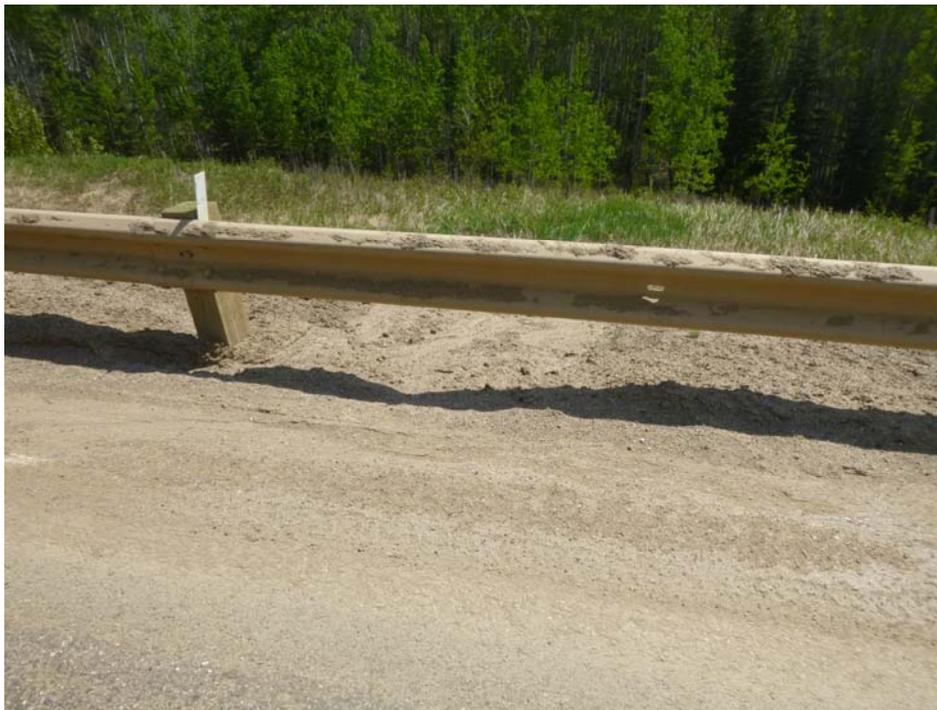
Photo 2 - Looking south at the guardrail at the west highway dip. Note the accumulated sand/gravel on the EB shoulder (~50 mm high), that channelizes runoff from the highway.

Maintenance: Clean the accumulated sand from the east highway shoulder and from underneath the guardrail for safety and to prevent formation of surface water concentration rilling. If necessary, place pitrun gravel in the runoff channel on the embankment below the guardrail.

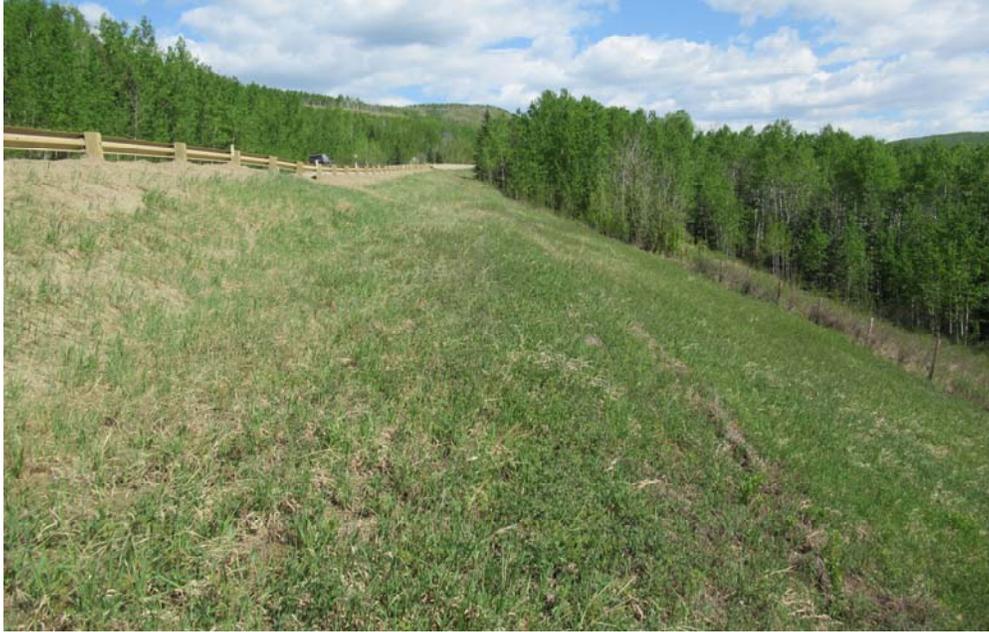
Photo 3 - Looking east along the south highway embankment, at a dip beginning to form in the embankment. Note the well grassed/vegetated sideslope. There is also a bow in the fence (not visible in the photo).

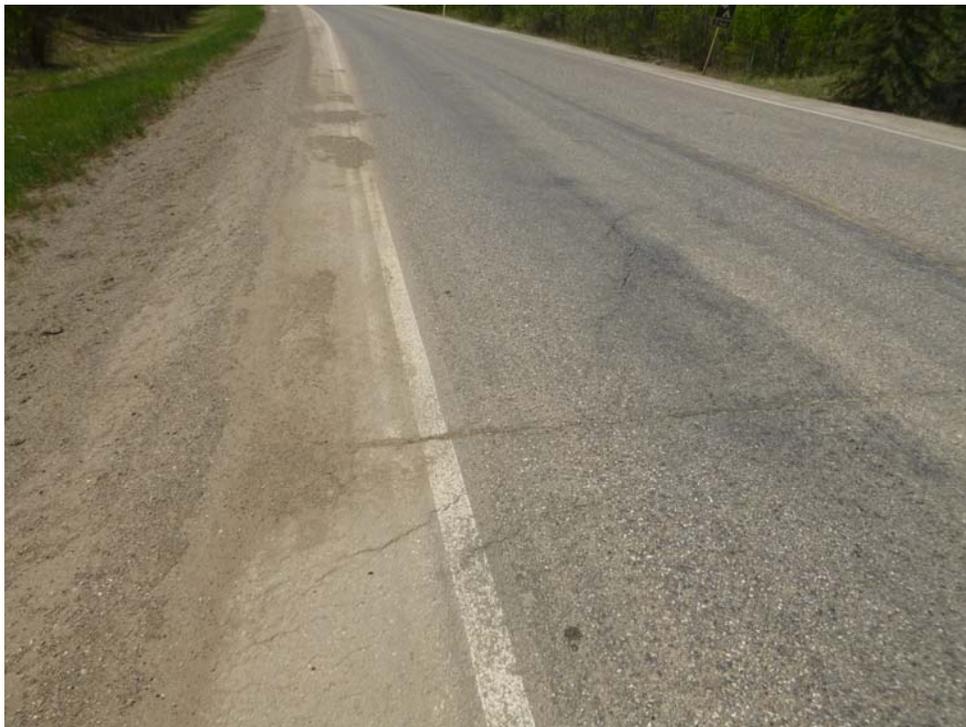
Photo 4 - Looking west at the old cracks reflecting through the chip seal, and a dip/sunken eastbound shoulder of the highway located at the east end of the site.
