**ALBERTA TRANSPORTATION
GEOHAZARD ASSESSMENT PROGRAM
PEACE REGION (GRANDE PRAIRIE DISTRICT - NORTH)
2023 INSPECTION**

Site Number	Location	Name	Hwy	km
PH022	13 km W. Cleardale	Clear River East Hill-Site 6	64:02	22.8-23.1
Legal Description		UTM Co-ordinates (NAD 83)		
S28-84-11-W6		11 N 6243933	E 334702

2023 PH022 CONTOUR PLAN

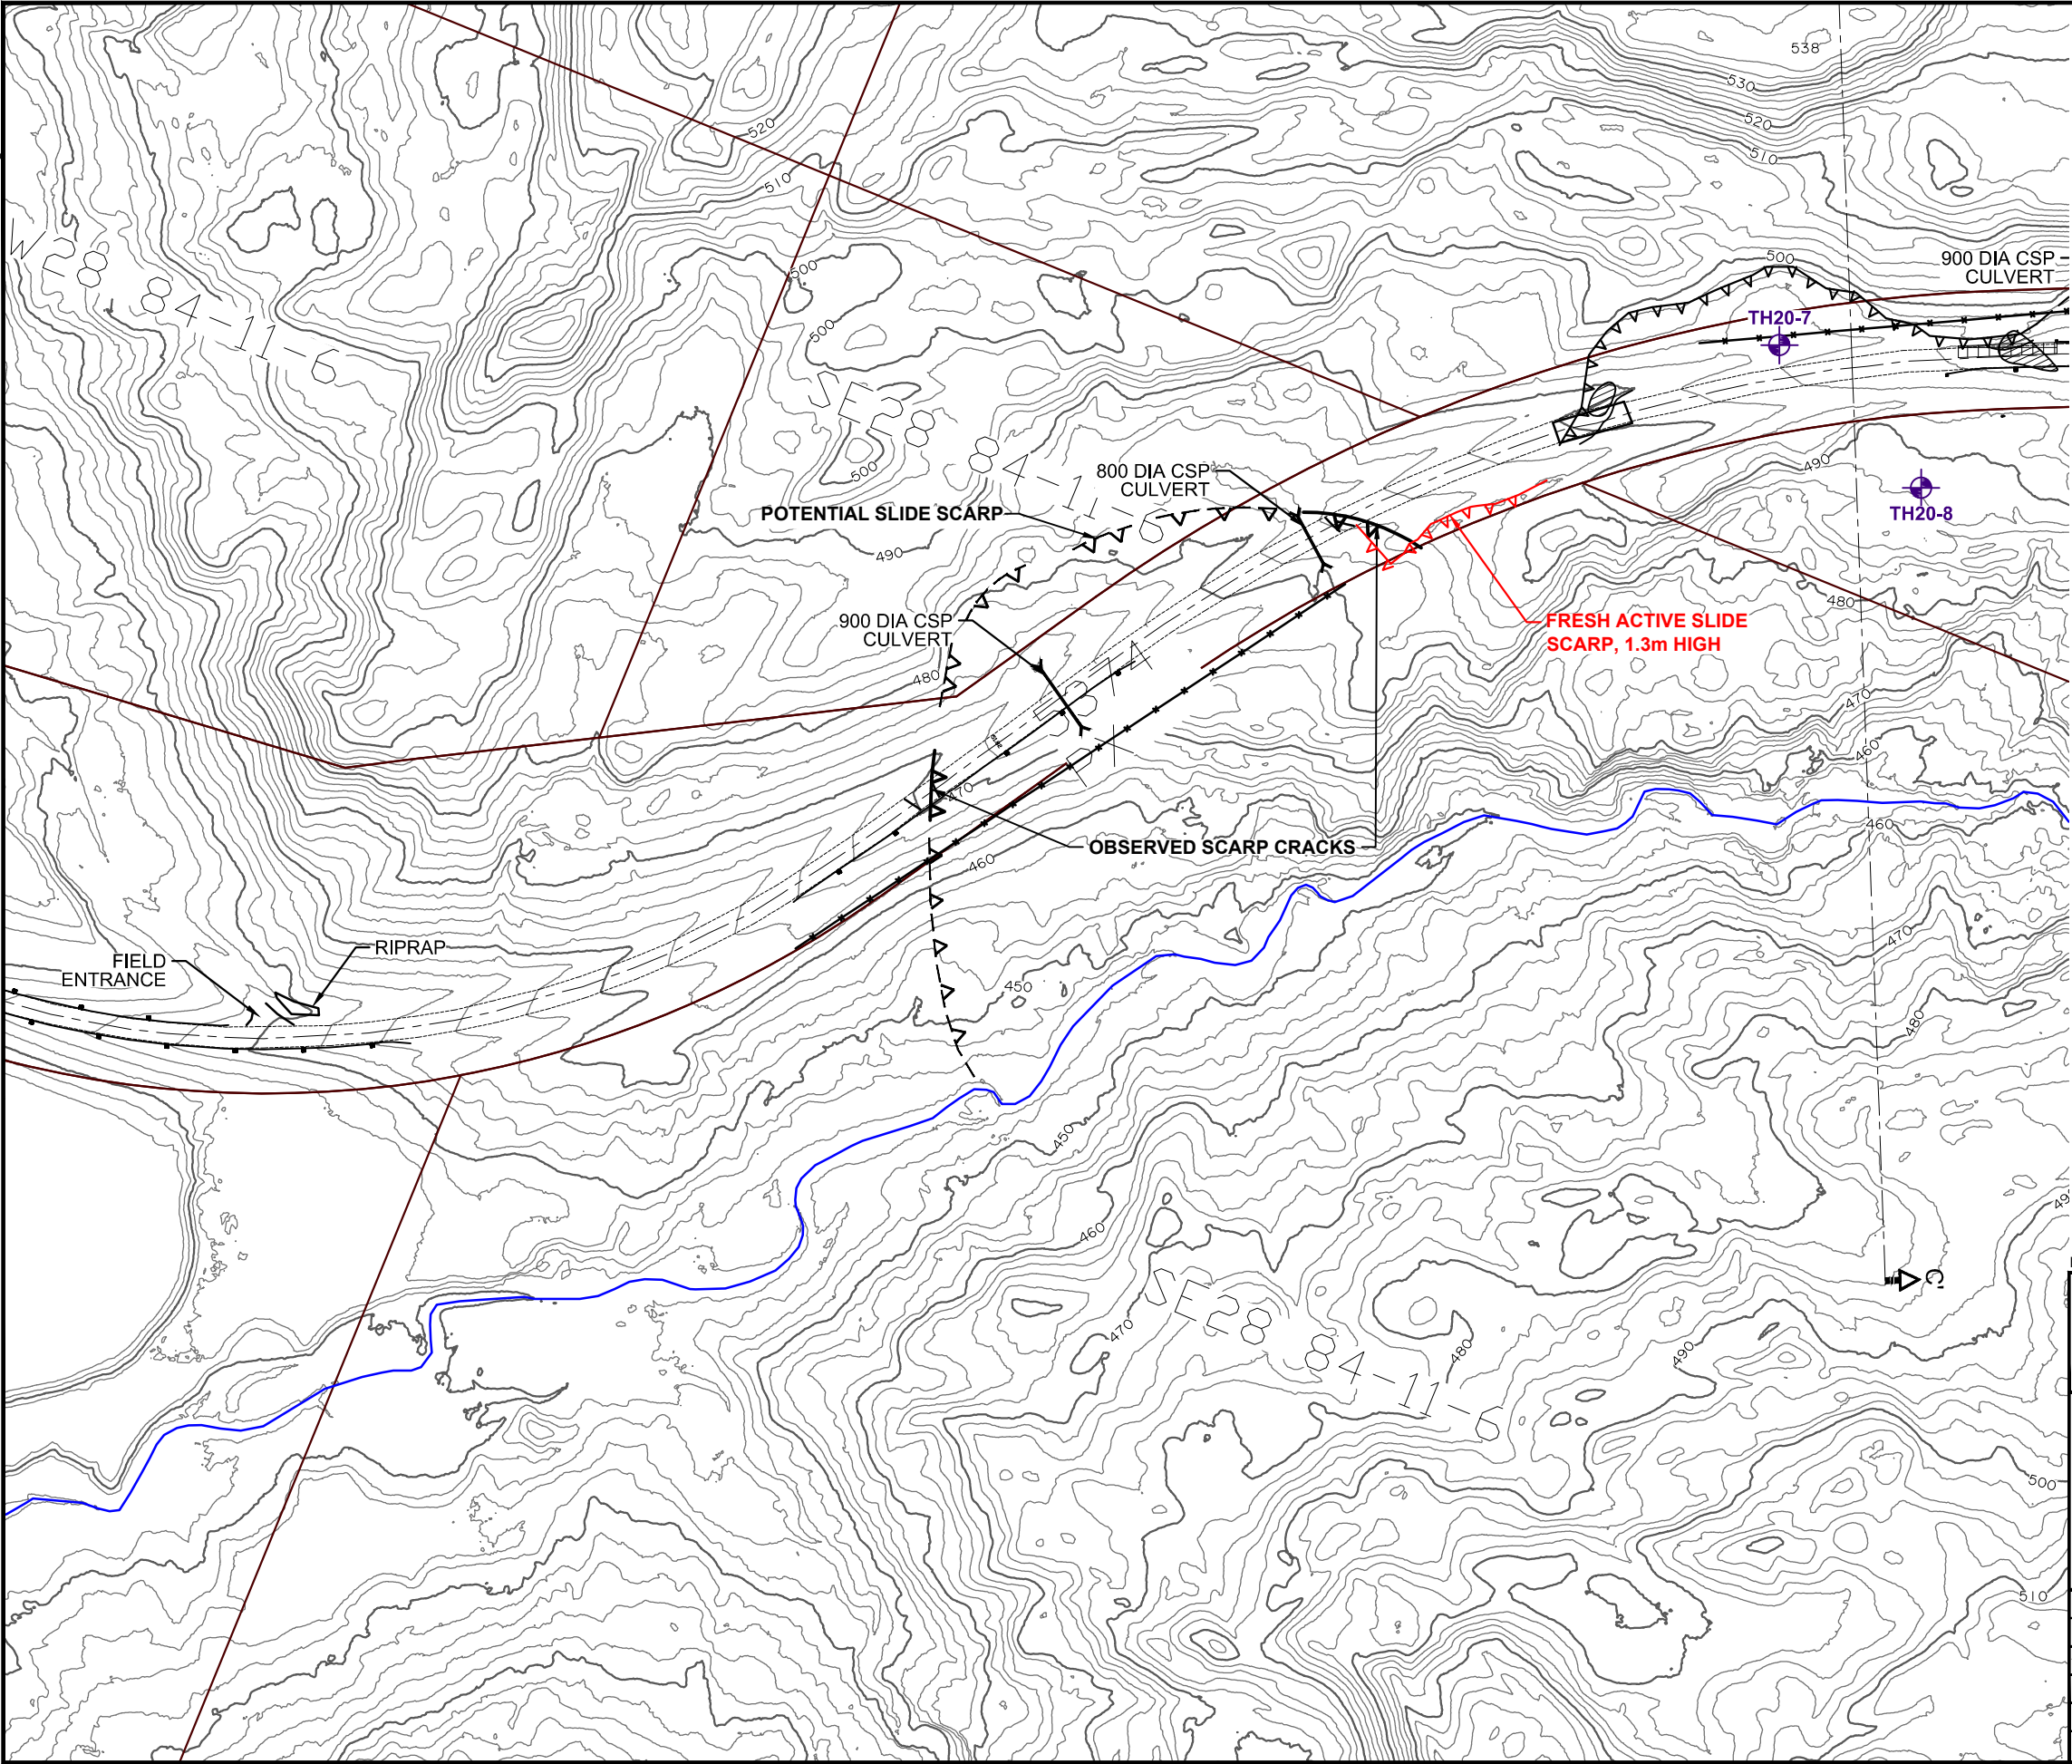
FIGURE PH022-2

Movements that were previously monitored in SI58 appear to be ongoing (but slow) based on a kink in the south guardrail, and a dip and bow in the fence on the south embankment at this location. It appears that a large slide scarp circles north of highway and joins the two observed dips spaced 200 m apart along the highway. A fresh slide scarp extension south of the highway appears to link this site with the site further east (PH023) by a continuous scarp.

The west dip appears to be enlarging westwards, based on cracks first found in 2013 a distance of 15 m west of the west dip and, which were observed to extend about 50 m west in 2017, and also an increasingly more apparent dip in the embankment with time. These cracks, and the fact that cracking

has reflected through the 2021 patched east dip, and with the fresh scarp crack observed south of the highway, in conjunction with the sunken shoulder in the pavement and south embankment at the west dip, suggest some on-going creep. Seepage traces in the pavement in previous years also indicate a high water table.

Perform a geotechnical Investigation to define the slide plane at this site, consisting of 3 test holes, each containing an SI and two Piezometers (as shown on Figure PH22-1) to depths of at least 40 m.

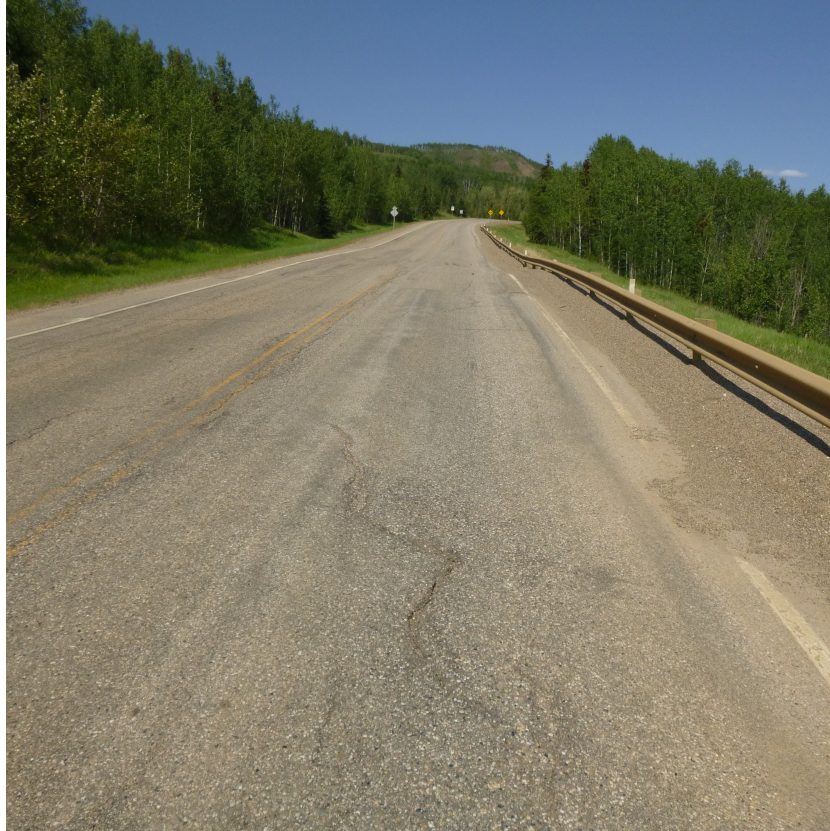
Photo 1 – Looking east along the cracked highway surface from the west end of the site. Note the west dip in the road/guardrail.

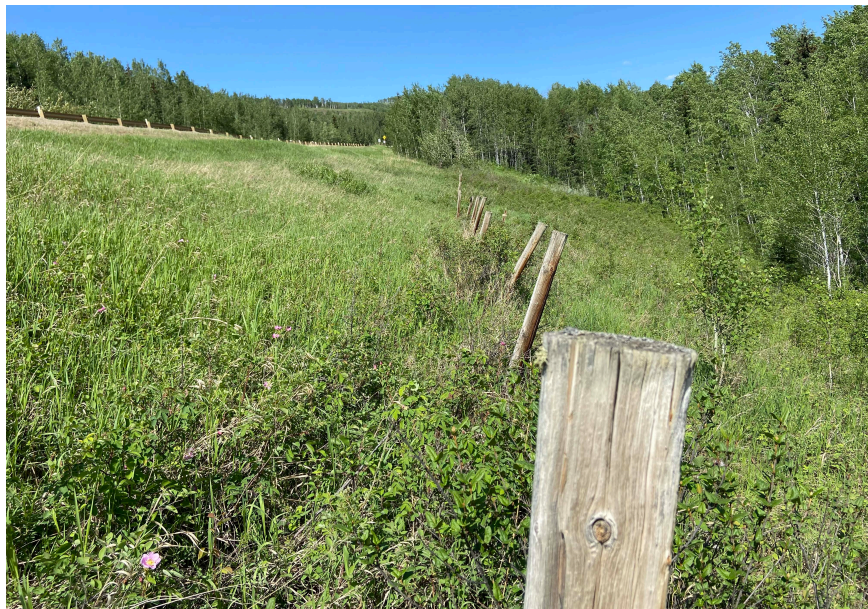
Photo 2 - Looking east along the bowed fenceline from the west end of the site.

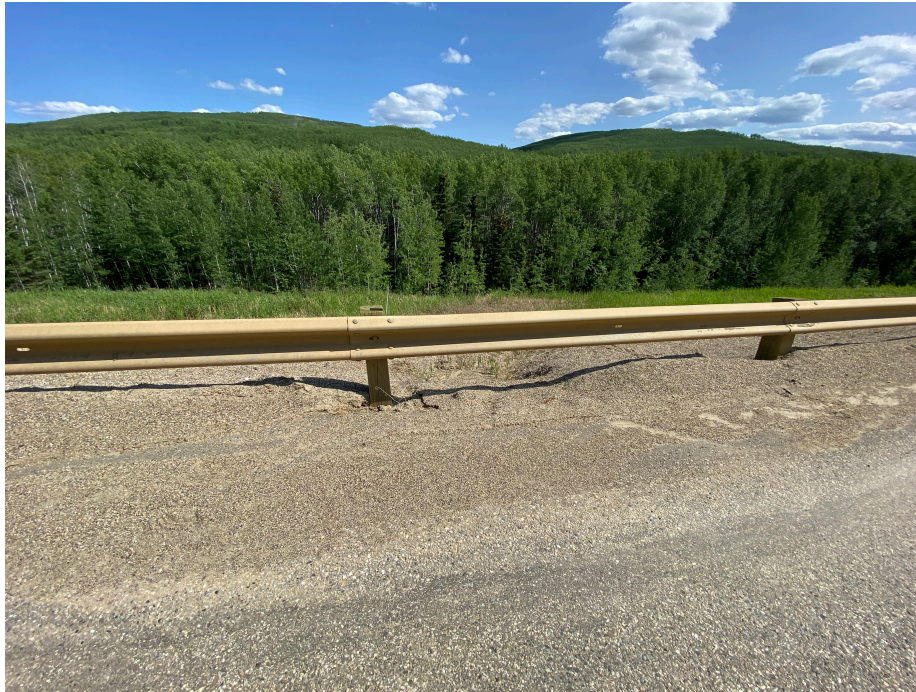
<input checked="" type="checkbox"/> Erosion	Channelized runoff from the highway along the low point in the west dip has formed an erosion rill in the EB shoulder/embankment.	<input checked="" type="checkbox"/>	<input type="checkbox"/>
<input checked="" type="checkbox"/> Seepage	Trace in OWP of WB lane east of east dip.	<input type="checkbox"/>	<input checked="" type="checkbox"/>
<input checked="" type="checkbox"/> Bridge/Culvert Distress	Two CSP culverts exist - one at the east dip, and another between the two dips.	<input type="checkbox"/>	<input checked="" type="checkbox"/>
<input type="checkbox"/> Other		<input type="checkbox"/>	<input type="checkbox"/>

Photo 3 - Looking south where channelized surface runoff flowing along the dip in the highway has breached the sand build-up underneath the south guardrail and created an erosion gully in the hwy embankment slope below.

- a) Clean the accumulated sand from the east highway shoulder and from underneath the guardrail for safety and to prevent deepening gulying caused by surface water concentration runoff.
- b) Place crushed gravel in the runoff gully channel that has formed on the embankment below the guardrail at the west dip.
- c) Monitor the pavement cracks in the two dipped areas for future subsidence/movement and progression of the circular slide scarp affecting the pavement at this location, and crack seal and patch as necessary.

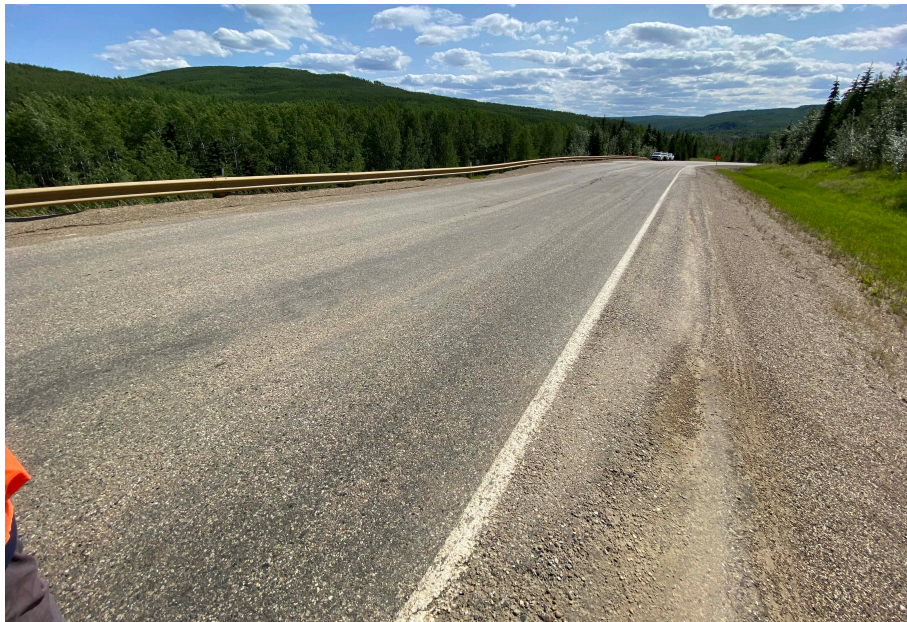
Photo 4 - Looking west at the dip/sunken highway where the slide scarp crosses the west end of the site.

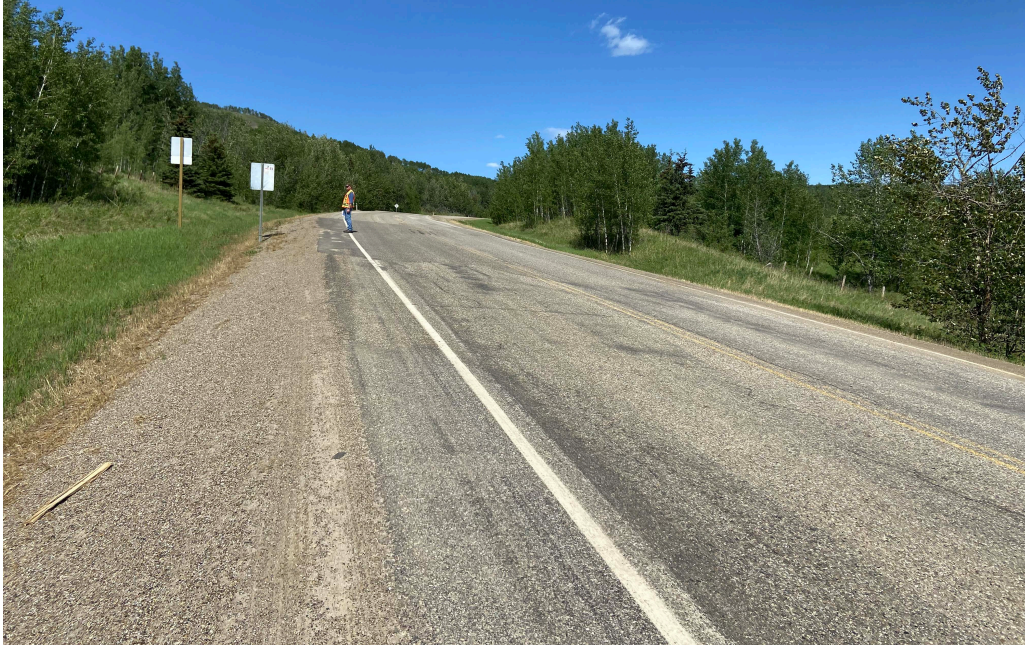
Photo 5 – Looking east where the slide scarp crosses the highway at the east end of the site and ACP patch.

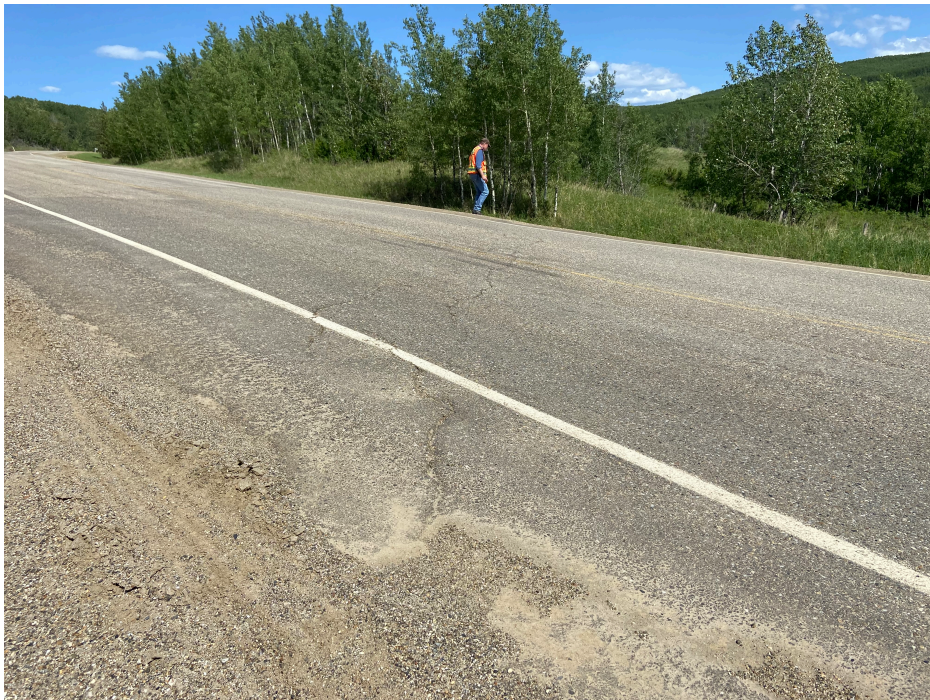
Photo 6 – Looking southeast at the scarp crack reflecting through the ACP patch placed over the east end of the site.

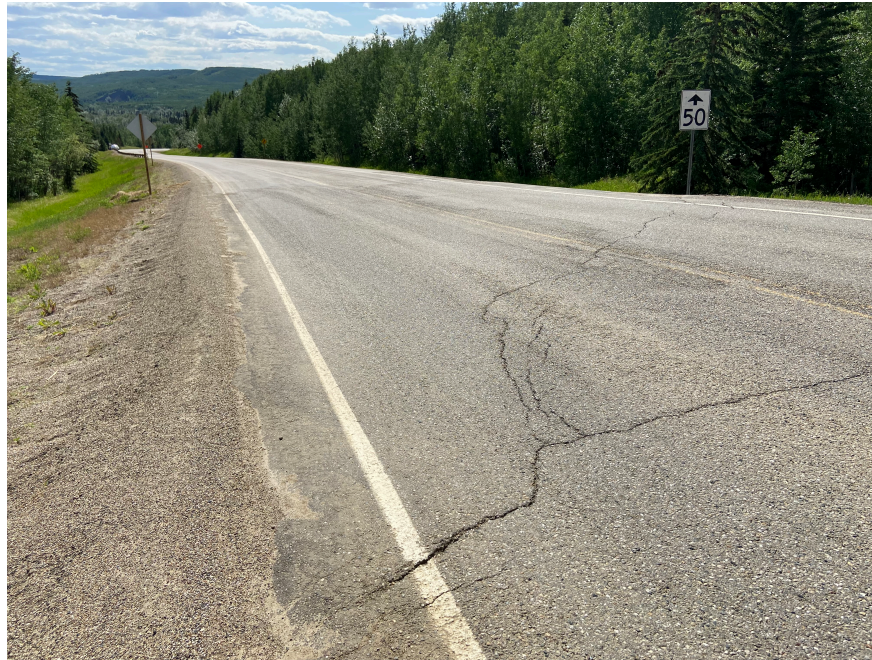
Photo 7 – Looking northwest at the same east end scarp crack as in Photo 6.

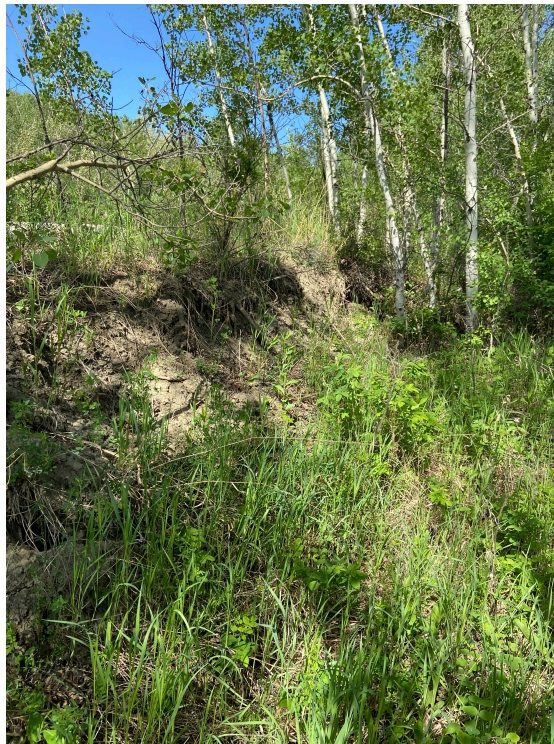
Photo 8 – Looking at the extended scarp in the bush south of the highway that links this site to PH023.
