**ALBERTA TRANSPORTATION
GEOHAZARD ASSESSMENT PROGRAM
PEACE REGION – GRANDE PRAIRIE DISTRICT - NORTH
2022 INSPECTION**

Site Number	Location	Name	Hwy	km
PH077-1 and 77-2	West of Fairview	Sites E of Hines Creek Bridge	682:02	12.5-12.8
Legal Description		UTM Co-ordinates (NAD 83)		
NE35-81-5-W6		11V N 6215000	E 396650

**PEACE REGION (GRANDE PRAIRIE DISTRICT - NORTH)
PH077-1 & PH077-2 EAST SIDE OF HINES CREEK BRIDGE
HWY 682:02, km 12.6~12.7**

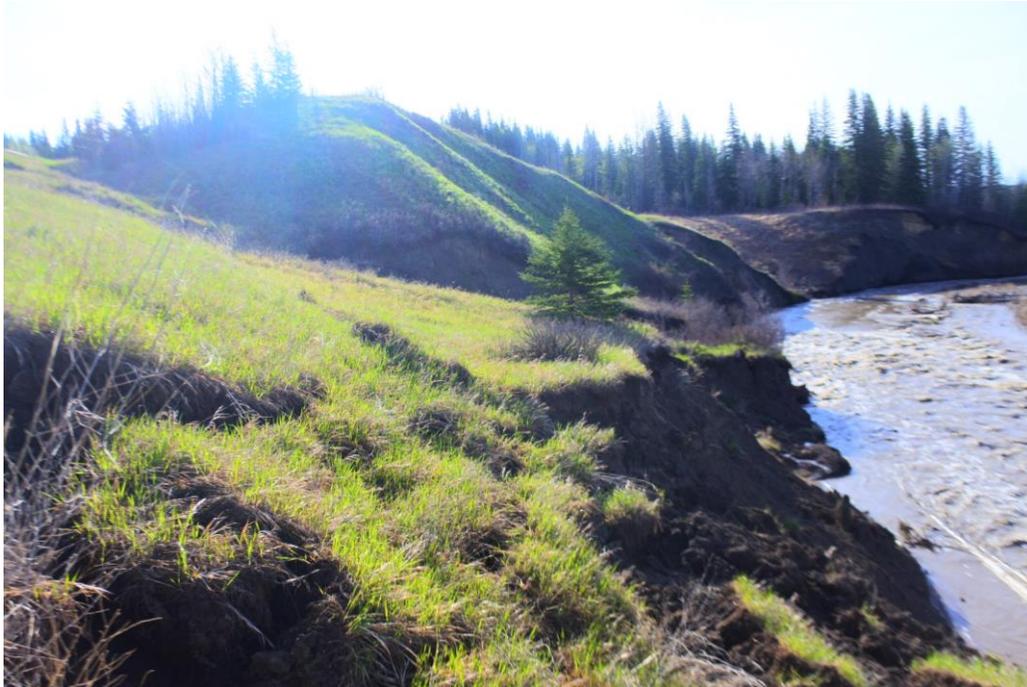
<input checked="" type="checkbox"/> Erosion	<p>At PH077-1, active erosion caused by the creek is occurring at the toe of the slope along the creek's edge.</p> <p>At PH077-2, the TRM south of the highway along the east runoff ditch where previously erosion was observed had been repaired with rip rap lining this ditch as well as placing riprap on the downstream end of the gabions; however, some of this riprap at the base was washed away by the creek.</p>	<input checked="" type="checkbox"/>	<input type="checkbox"/>
<input type="checkbox"/> Seepage		<input type="checkbox"/>	<input type="checkbox"/>
<input checked="" type="checkbox"/> Bridge/Culvert Distress	The upstream end of the 1.8 m diameter SWSP (BF75380) at PH077-2 was about 0.5 m buried with silt and debris at the drift catcher and the outlet did not appear to be visibly damaged at the time of our inspection but was somewhat buried in silt. The 2022 bridge inspection noted that there were distortions and cracks/separations within the culvert (along with low ratings) and that drift and silt should be removed from pipe and drift catcher.	<input checked="" type="checkbox"/>	<input type="checkbox"/>

Photo 1 – Looking east at Slide PH077-1 at the erosion along the north side of the Creek.

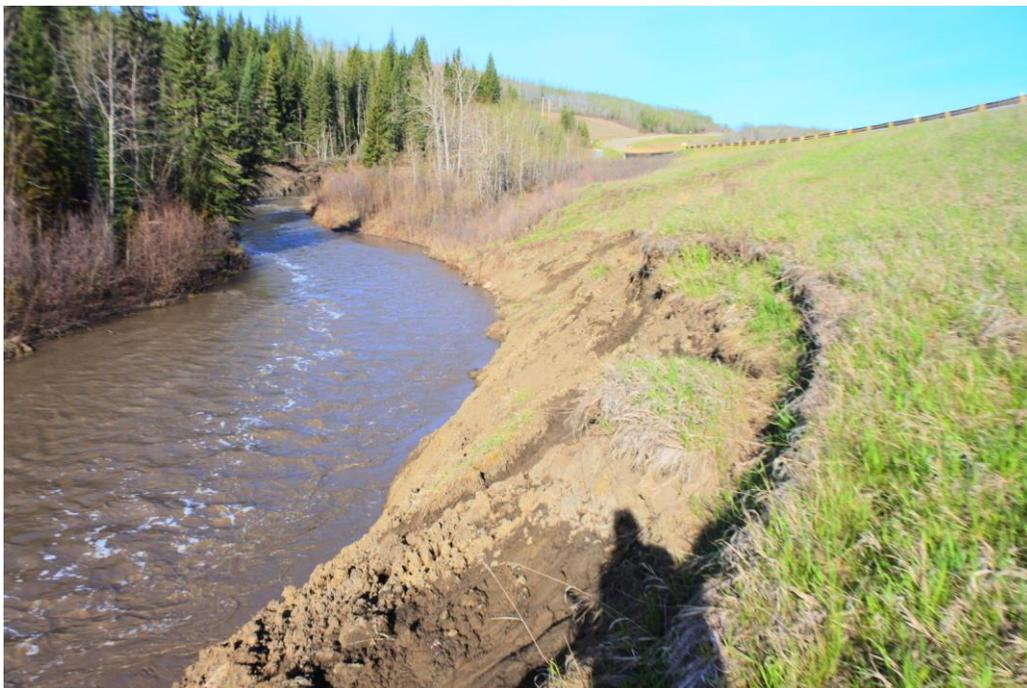
At PH077-1, the slide roughly paralleling the creek and highway is a direct result of erosion by Hines Creek and resulting soil loss along the toe of the embankment. The slope will tend to flatten with time due to loss of cohesion in the clay fill embankment material. Therefore, the slide could also gradually enlarge into the driving lanes of the highway surface, and there are already indications of this presumably starting to occur based on the existing cracks and dips in the highway. The smaller 15 m wide and larger 35 m wide slide near the east end of this site may have also been triggered by east ditch runoff erosion, and/or having a slope that is too steep for the composition material of the embankment. Ditch or surface erosion of the slope could also contribute to more rapid slope movements.

Photo 2 – Looking west at the fresh toe slumping above the creek at PH077-1 in the south highway embankment.

Medium to Long Term: A short highway re-alignment around the affected highway may be feasible. In order to meet the existing bridge (~100 m to the west), it would not be able to be a significant detour but could work if only a small portion of the highway was affected by a slide. The eroded slope should be cut back to a flatter inclination. Riprap should also be installed along the toe of the existing south embankment to mitigate future creek erosion. Rock vanes could be considered in conjunction with riprap to reduce the quantity of riprap required. Environmental approvals (DFO, AEP) for working within the confines of Hines Creek would first need to be authorized for any rock or riprap placement.

Long Term: Alternatively, due to the anticipated slide depth extending down to creek level and the embankment height (~13 m), a pile wall is feasible at this site. It would need to be a tied back pile wall (multiple anchors/pile), and a detour would be required to the north of the highway during construction. Perhaps other measures may be required in addition to the tied back pile wall, such as offloading a portion of the downstream embankment, and/or lightweight fill replacement of soil. A minimum length of 100 m of pile wall would be required to span the slide length at this site. Riprap should also be installed to mitigate creek erosion for this option.

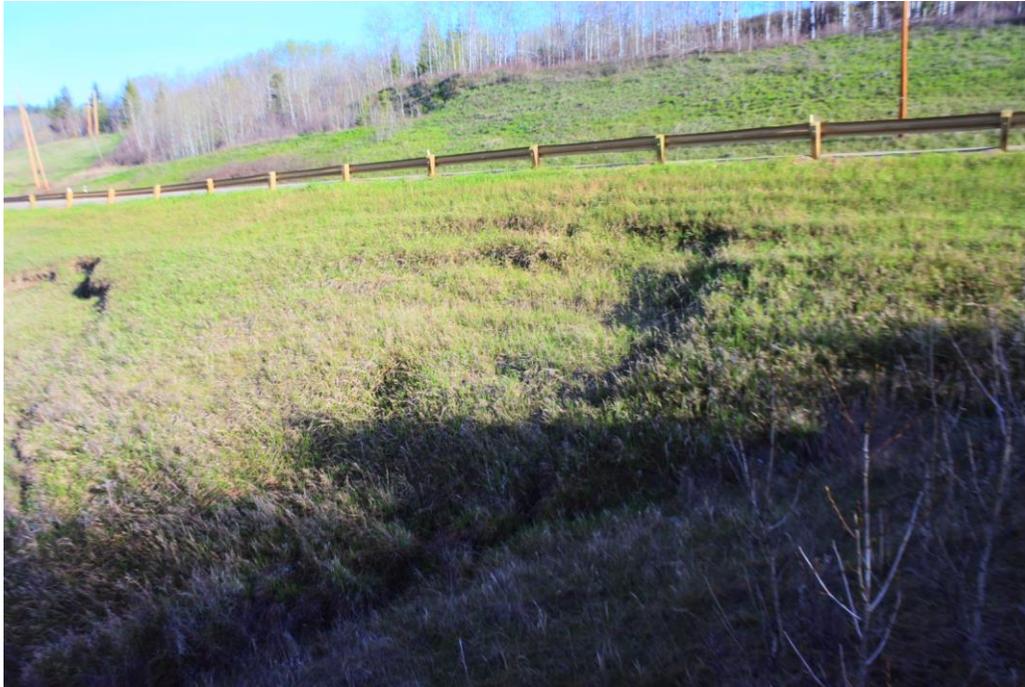
Photo 3 – Looking north upslope at the older slide scarp adjacent to the highway at PH077-1.

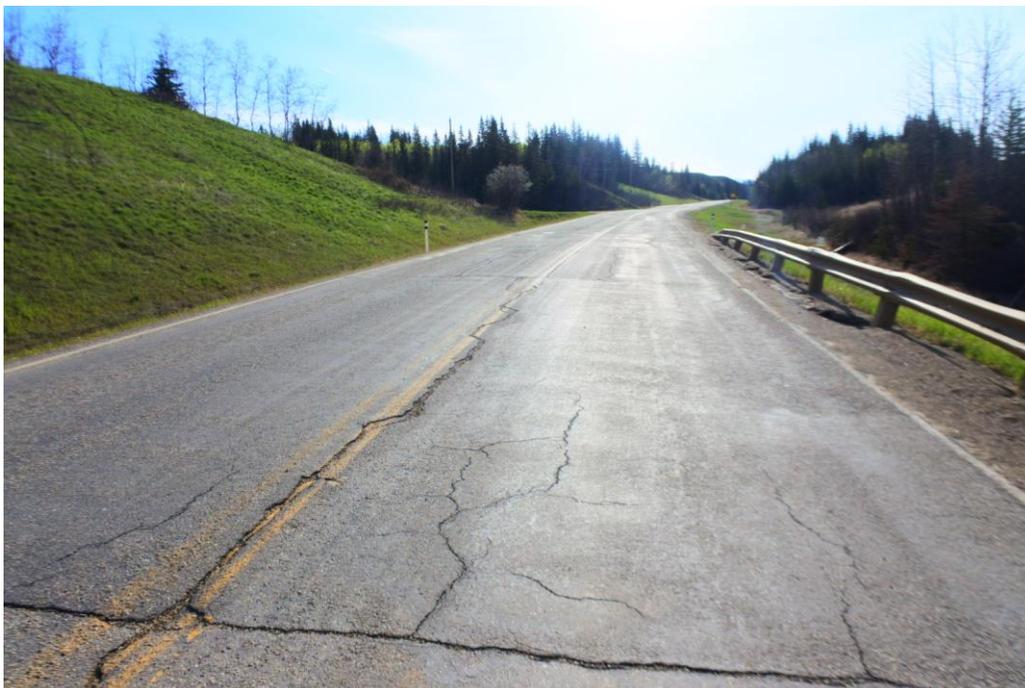
Primary Site Issue:	<p>PH077-1: Creek bank slumping caused by creek erosion continues to retrogress and has caused cracks to appear in the highway about 150 m east of the bridge. A shallow sideslope slide also exists at the east end. A newer 35 m wide slump has formed in the south embankment slope.</p> <p>PH077-2: Settlement and cracking in the highway and an active landslide through the south embankment are causing distress to the BF culvert and pavement. Channel and ditch erosion on the north embankment have created a slide around the culvert inlet which had retrogressed to near the highway.</p>		
Dimensions:	<p>PH077-1: Slide dimensions ~100 m wide along the riverbank parallel to the highway x ~30m long. New slump is ~ 35 m wide and ~20 m long.</p> <p>PH077-2: South embankment slide ~40 m wide x 75 m long extending to river. North embankment slope slide ~40 m wide x ~40 m. Erosion ~30 m long in the ditch TRM's, plus ~25 m of upstream channel erosion in front of the culvert inlet.</p>

Photo 4 - Looking east along the highway at the crack/dip in the highway above the Slide at PH077-1.

In the short term, regular monitoring of these sites should be undertaken for enlargement. If any of the slides encroach into the shoulders of the highway, barricades should be erected and enhanced with warning signage until highway repairs are undertaken. A temporary detour upslope (to the north of the highway) may also be required depending on the extent of the highway affected.

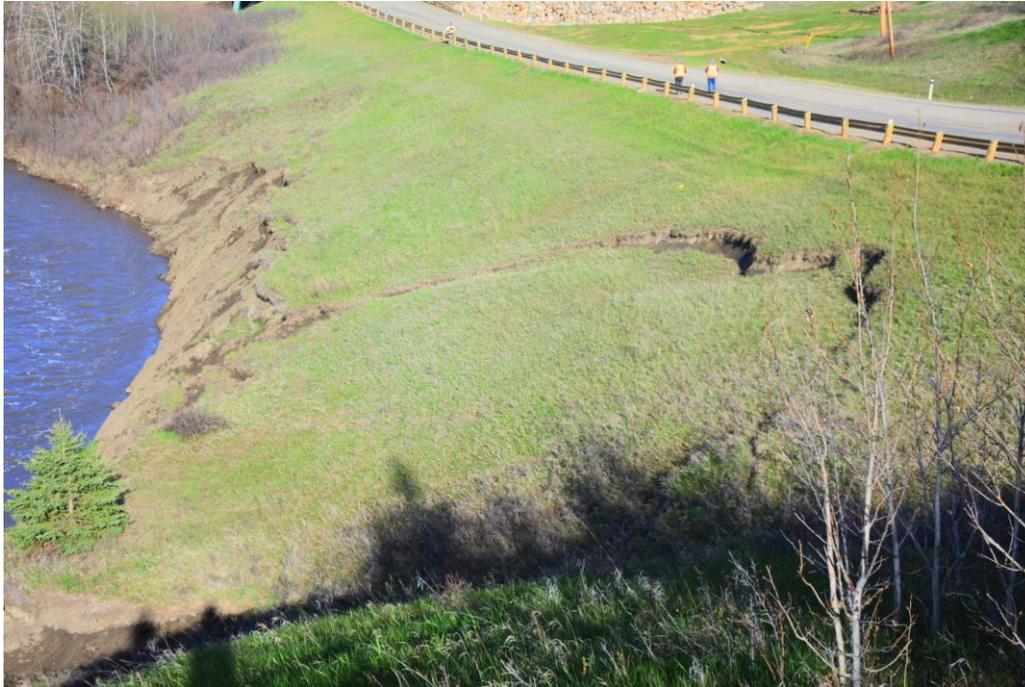
Photo 5 - Looking west at new slump that developed west of the knob hill.

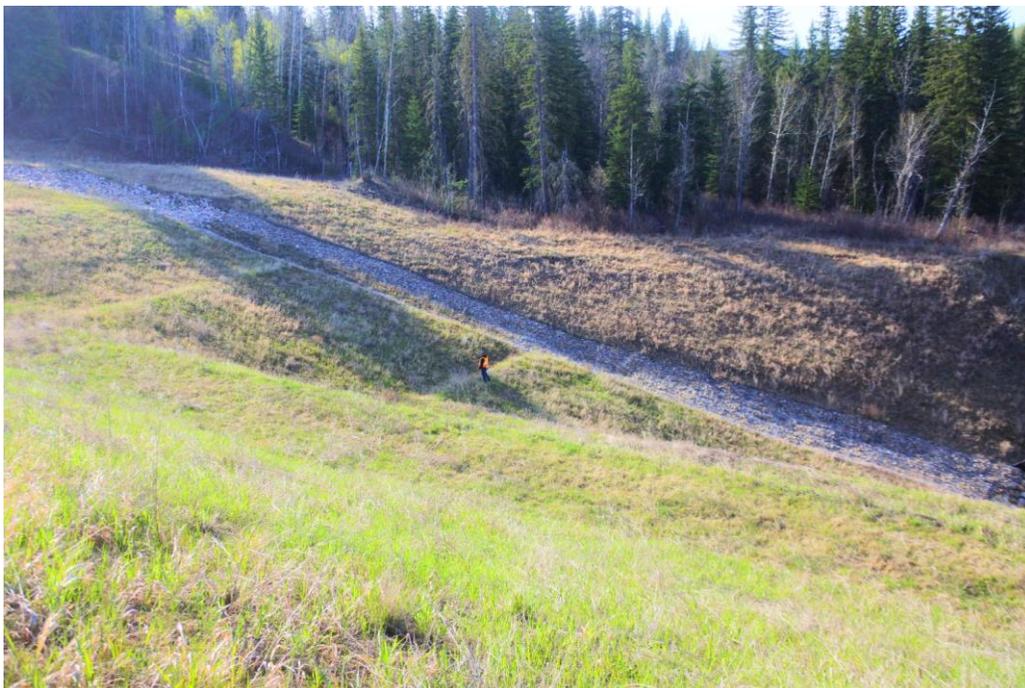
Photo 6 – Looking east at riprap swale into the gabion mattress channel of PH077-2.

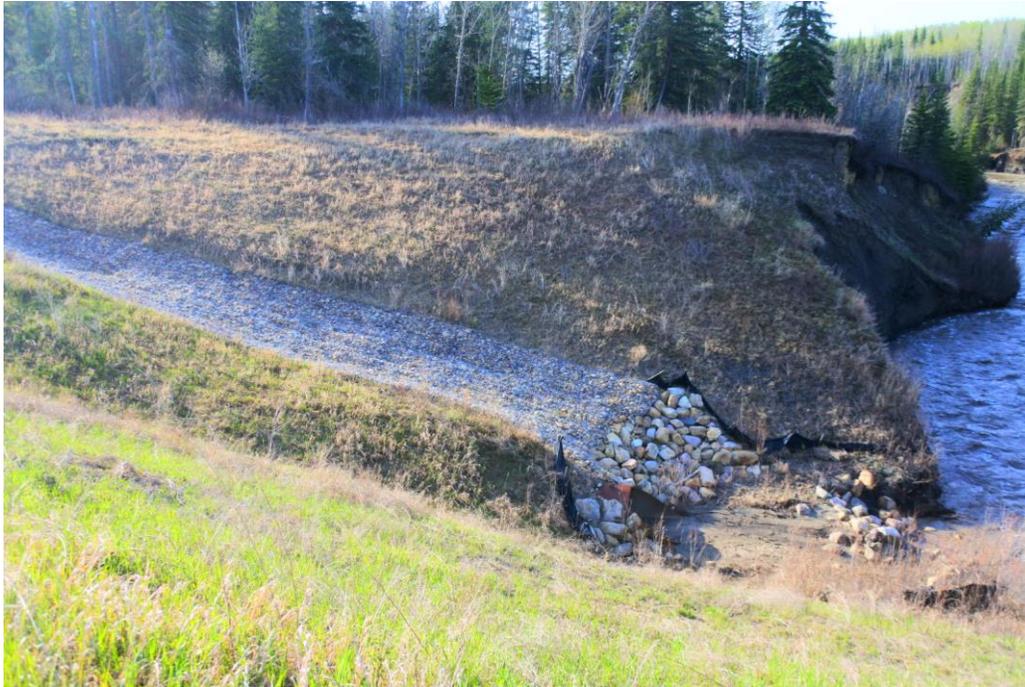
Photo 7 - Looking east at the southeast ditch drainage channel of PH077-2, Hines Creek.

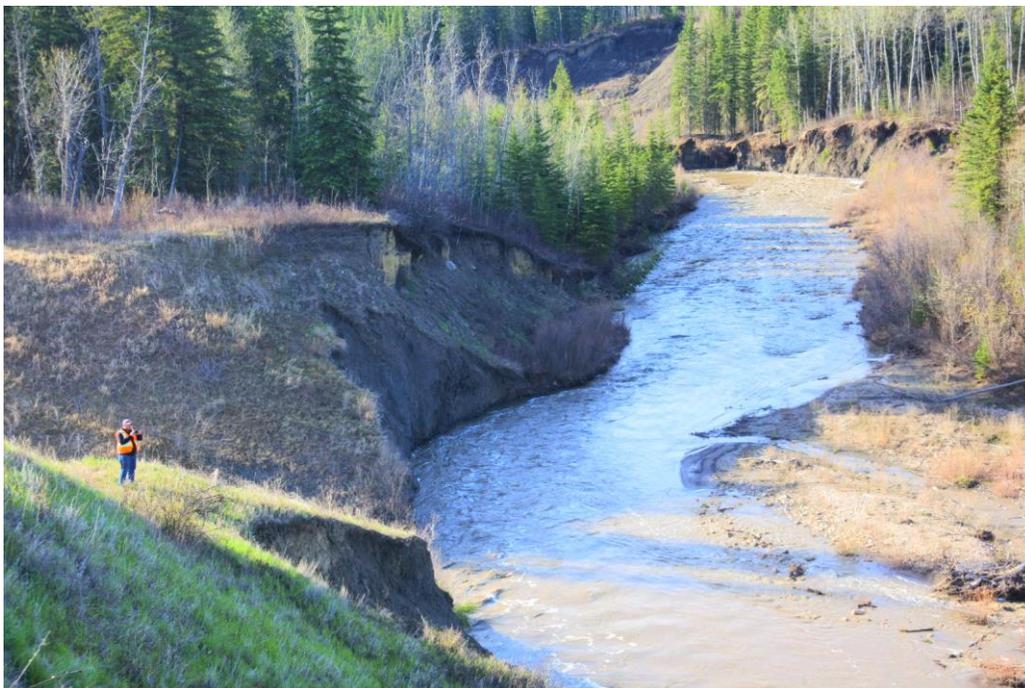
Photo 8 - Looking southeast at the river bank slumping near the culvert outlet area of PH077-2.

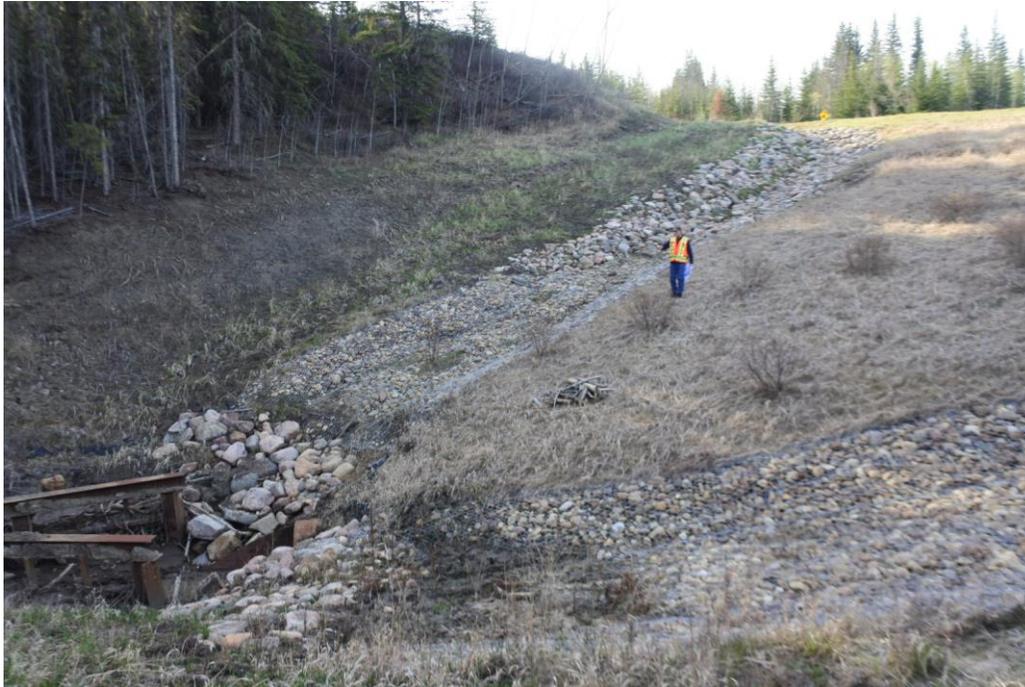
Photo 9 – Looking south at the northeast ditch crotch of the north embankment of PH077-2. In 2021 the riprap protection had been extended further upslope.

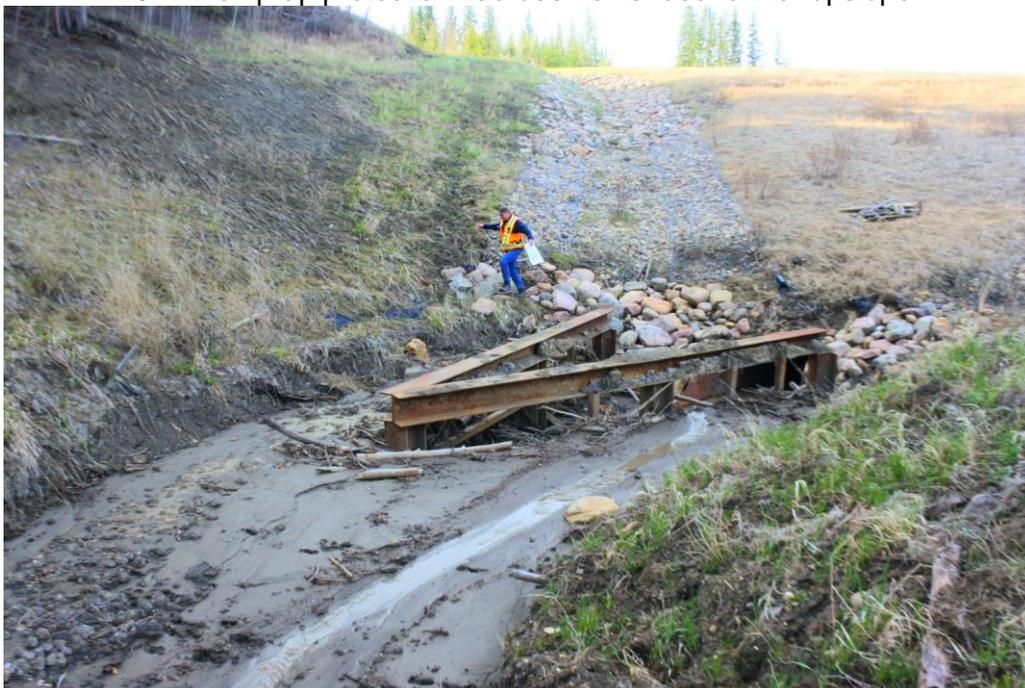
Photo 10 – Looking south at the culvert inlet area of the north embankment of PH077-2. The trash rack and culvert inlet were half full of debris and silt.

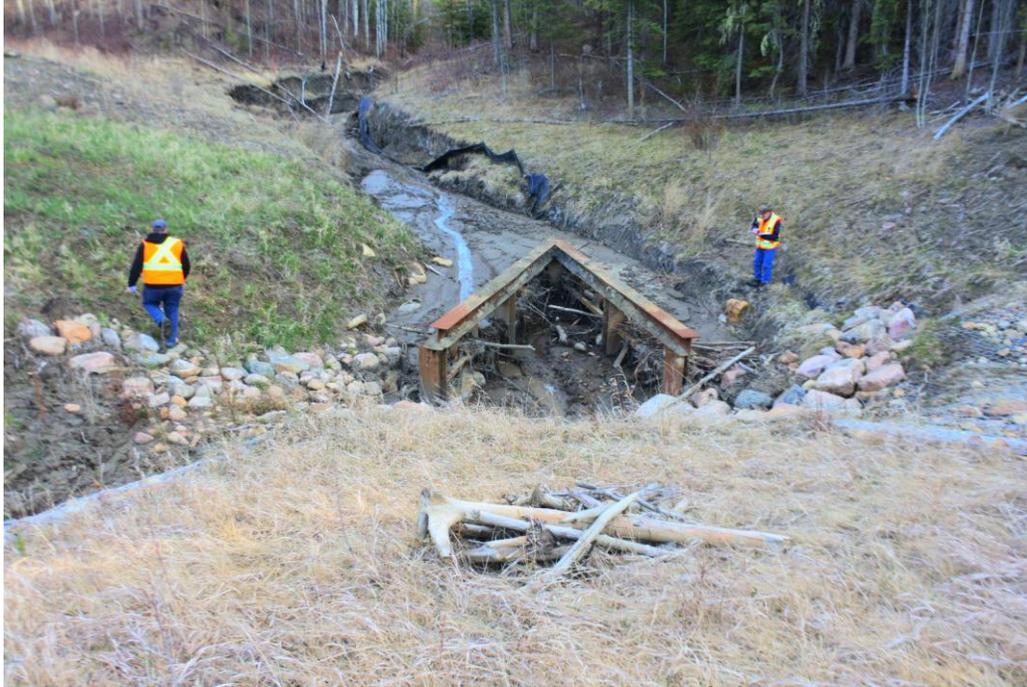
Photo 11 - Looking north along the infilled channel leading into the culvert inlet north of the highway at PH077-2.

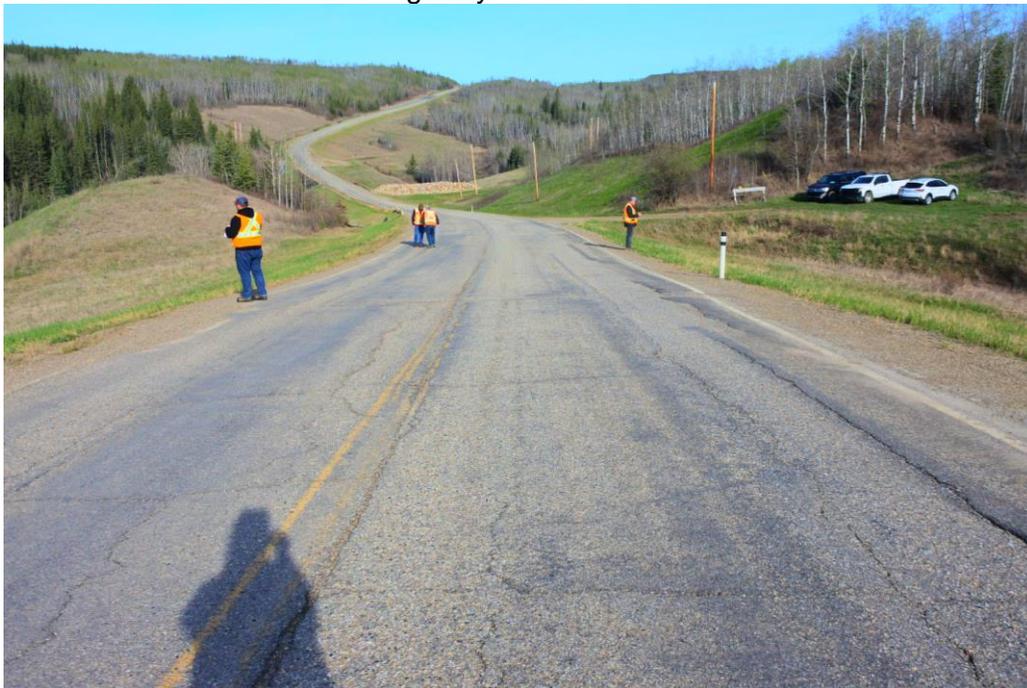
At PH077-2, cracks and a noticeable dip exist across a 40 m length of the highway overtop the SWSP culvert, with another dip existing further east. Same condition in 2022.		
<input checked="" type="checkbox"/> Slope Movement	<p>At PH077-1: The Creek has eroded the toe of the south embankment, and a slide scarp has developed parallel to the highway and is as close as 8 m from the pavement, additional sloughing was observed in 2022 along the creek bank. At the east end, there is an overgrown 15 m wide shallow side slope slide with a 0.4 m high scarp, 0.6 m high toe push and is 3.6 m from the guardrail. To the west of this shallow slide a new 35 m wide side slope slide developed and the backscarp is 6.2 m away from the guardrail.</p> <p>At PH077-2: A landslide has developed through the south embankment and has deformed the culvert. There is a 0.4 m high scarp located 4.6 m from the white shoulder line. North of the highway, a 1.5 m wide graben crack with a 0.2 m drop has developed above the erosion near the culvert inlet, and which has developed into a slide that previously retrogressed back towards the highway. The riverbank is also locally slumping upstream and downstream of the culvert outlet</p>	<input checked="" type="checkbox"/>	<input checked="" type="checkbox"/>

Settlement observed overtop of the culvert at Site 2, in the form of dips and cracks in the highway could be the result of embankment fill settlement but might also be an indication that the slide movement will eventually retrogress towards the highway or has already.

Photo 12 - Looking west along the highway across PH077-2. Note the settlement and cracking in the highway.

Long Term: A potential long-term solution is a highway re-alignment to the north, done in conjunction with the re-alignment for Site 1, before meeting the existing bridge over Hines Creek. A re-alignment could allow some flattening of the south slope leading down to the creek. For this option, the top section of the culvert might need to be re-profiled to remain within the embankment fill and the inlet end of the pipe would need to be extended to allow a shift and flattening of the north embankment slope. The damaged pieces of the pipe will need to be repaired. Some shear piles might also be needed in the south slope. It is understood that AT are also considering replacing the culvert with a shorter pipe that exits the upper part of the slope and then bringing the discharge down the slope in an armoured drop structure. The costs of the drop structure would need to be weighed against the costs of repairing/replacing the longer SWSP culvert.

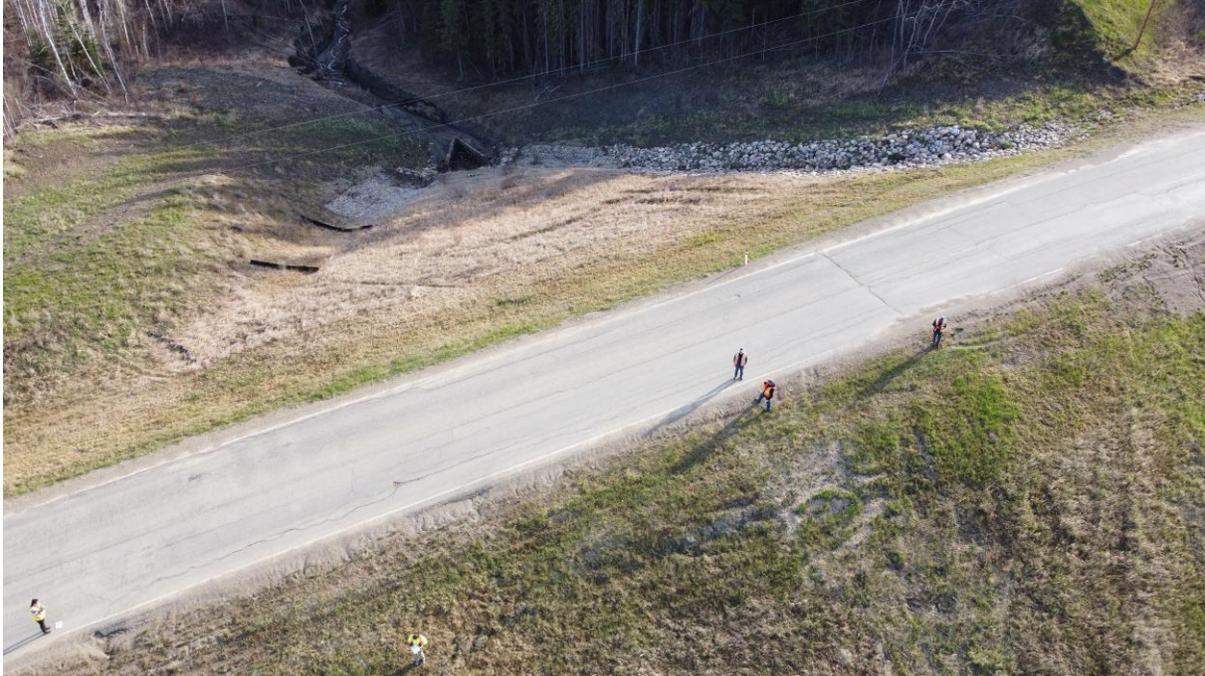
Photo 13 - Looking north from drone at infilled channel leading into the culvert inlet north of the highway at PH077-2.

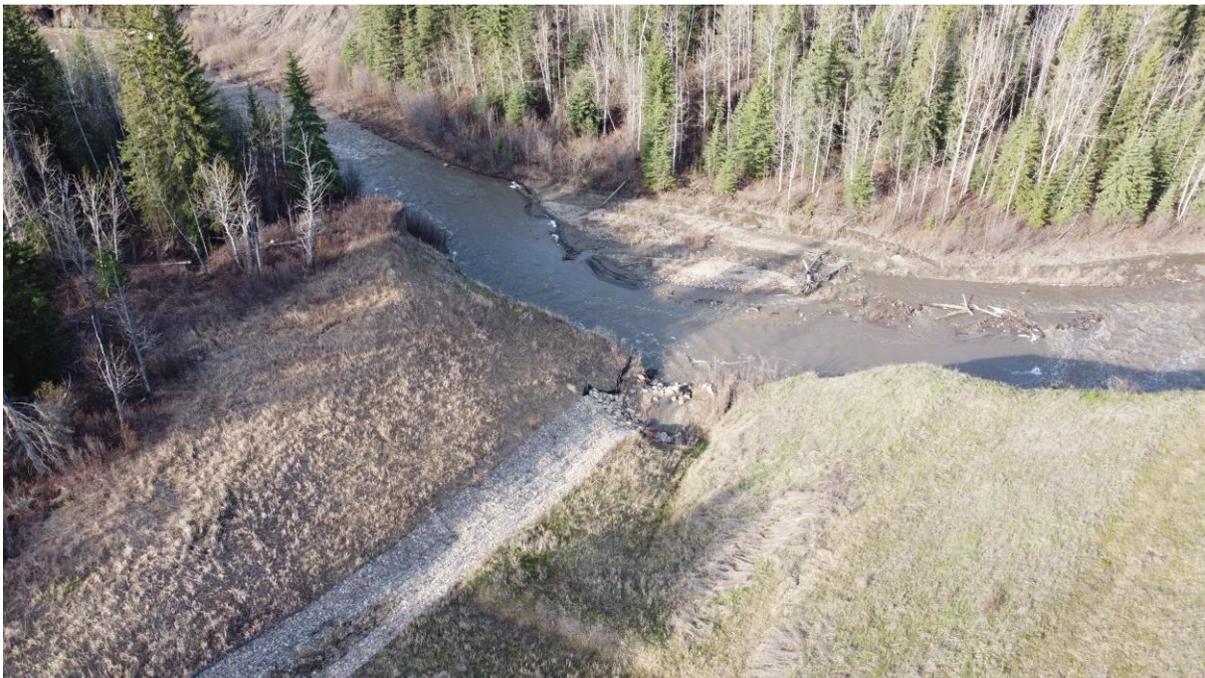
Photo 14 - Looking south from drone at creek, gabion mattress and culvert outlet.

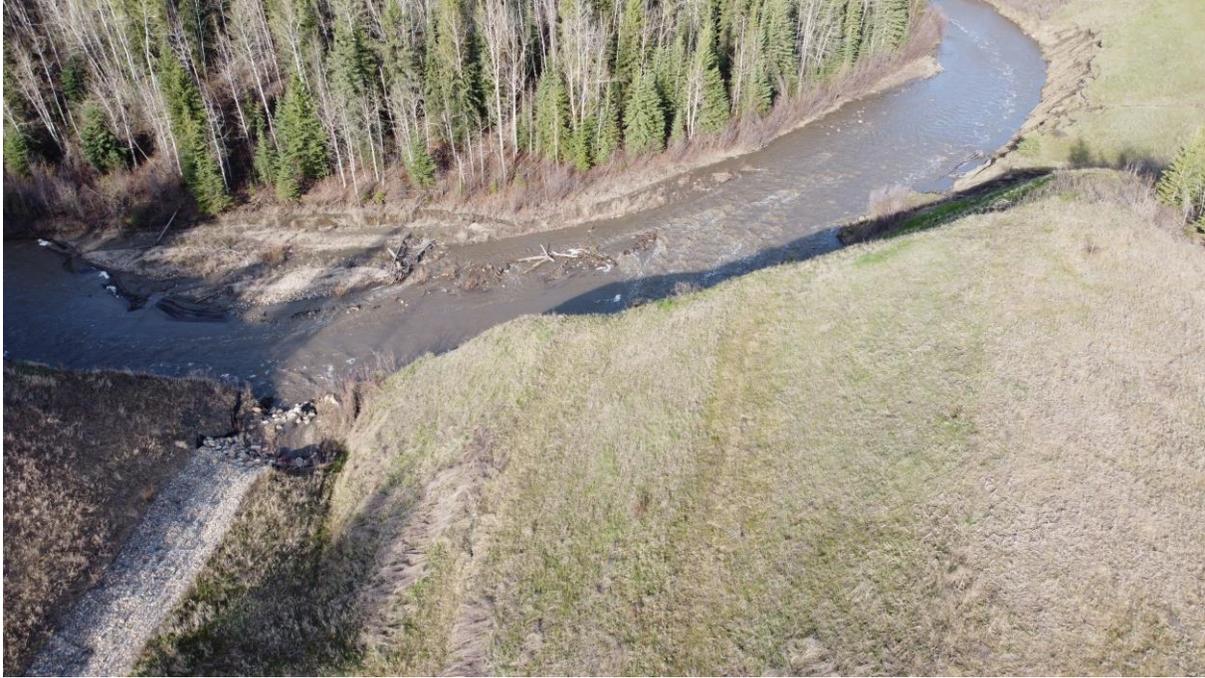
Photo 15 - Looking south from drone at creek and erosion.
