**THURBER** ENGINEERING LTD.

August 4, 2022

**ALBERTA TRANSPORTATION GRMP (CON0022165)  
PEACE REGION (GRANDE PRAIRIE DISTRICT – NORTH)  
INSTRUMENTATION MONITORING RESULTS – SPRING 2022**

**SITE GP024: HWY 725:02, HAMELIN CREEK**

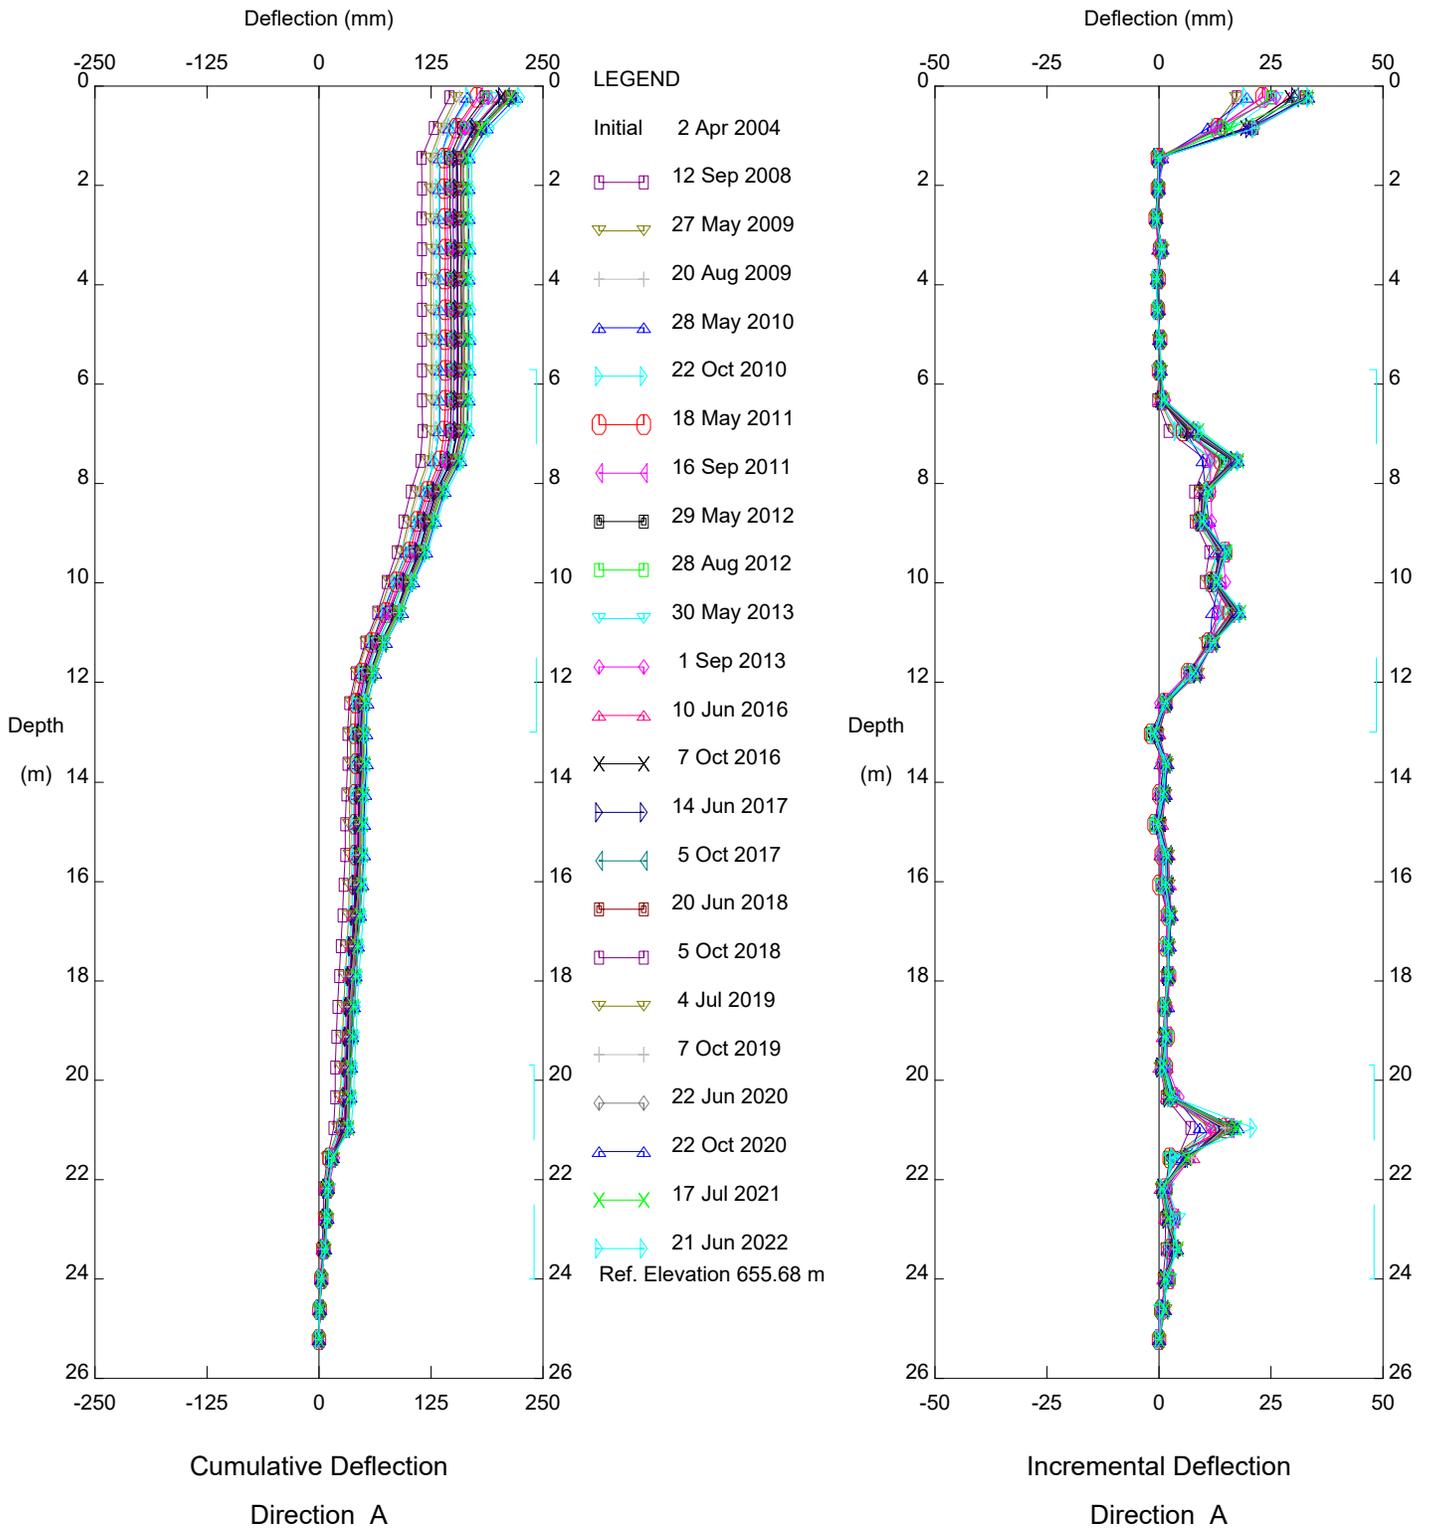
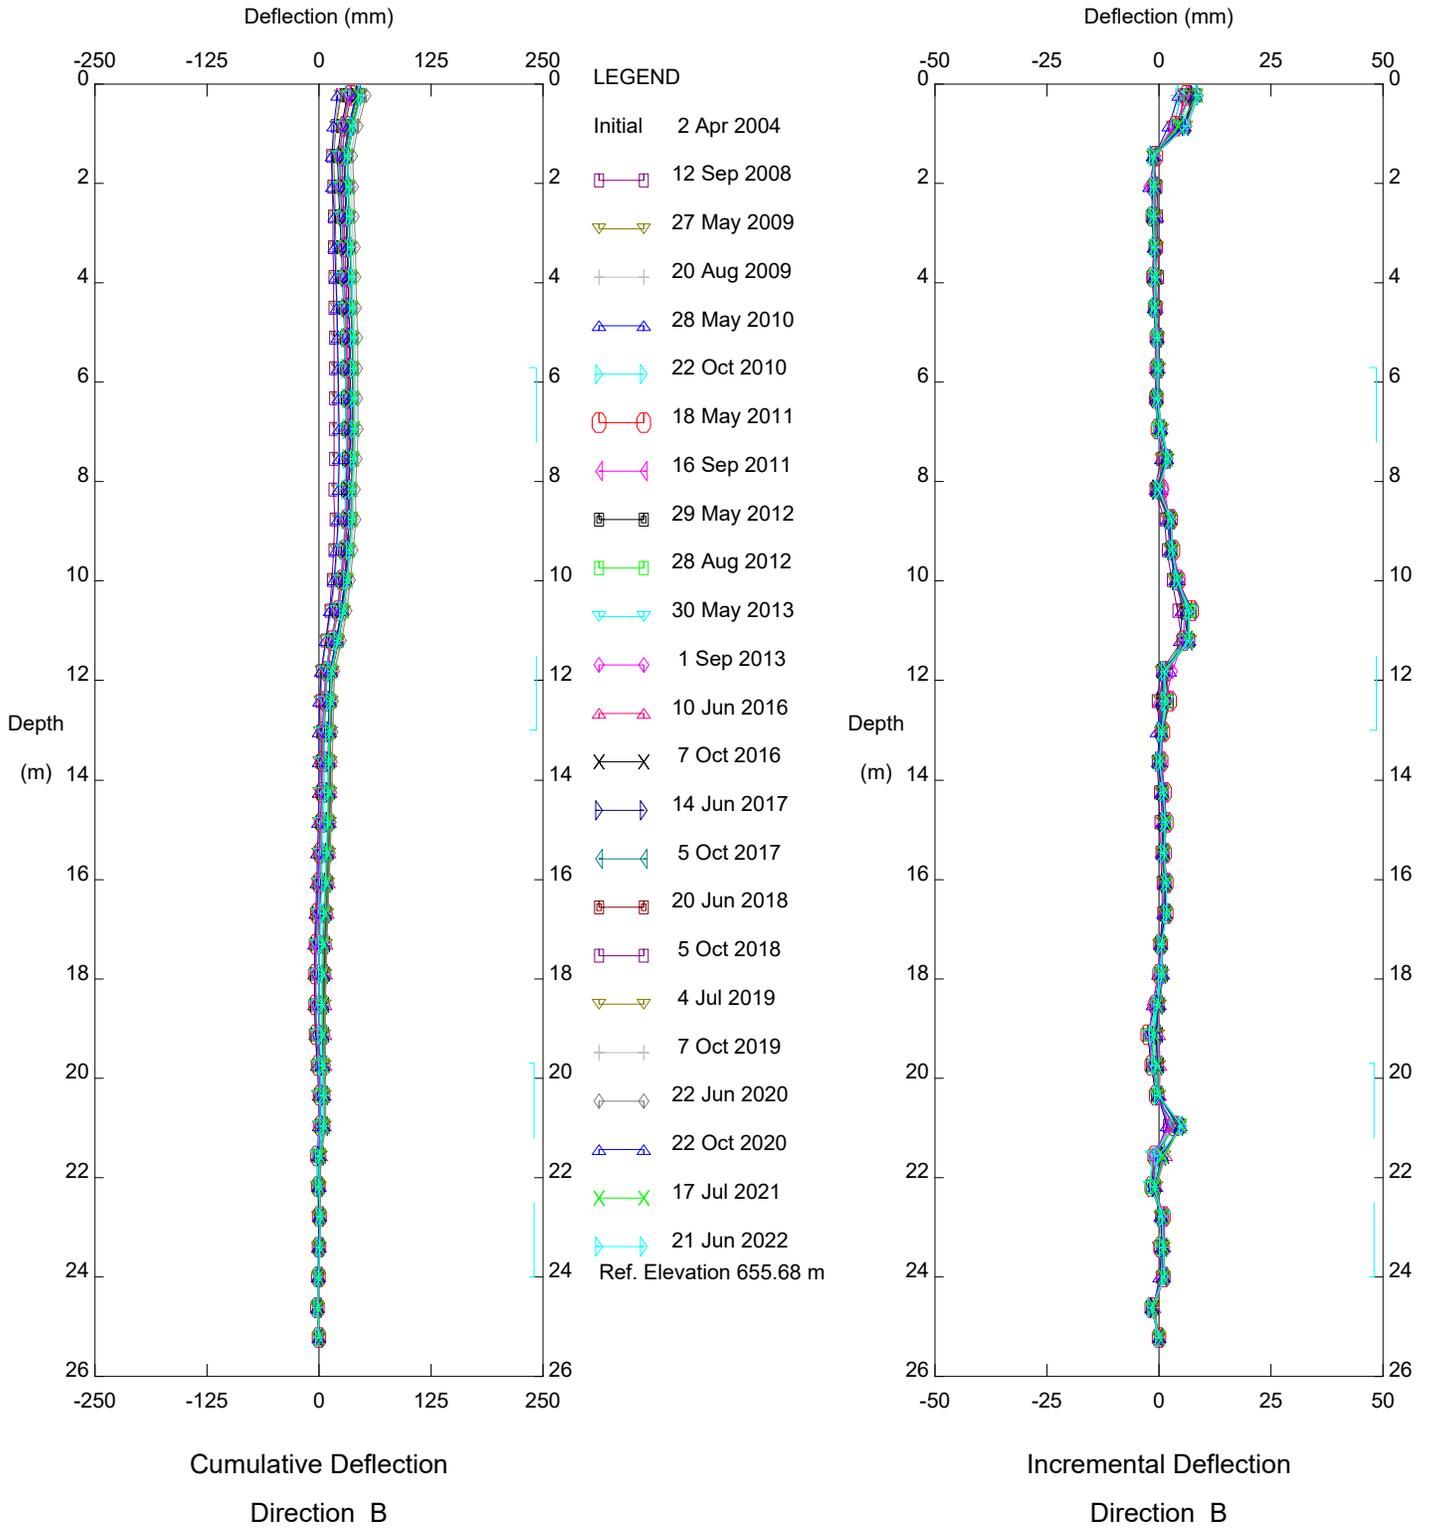
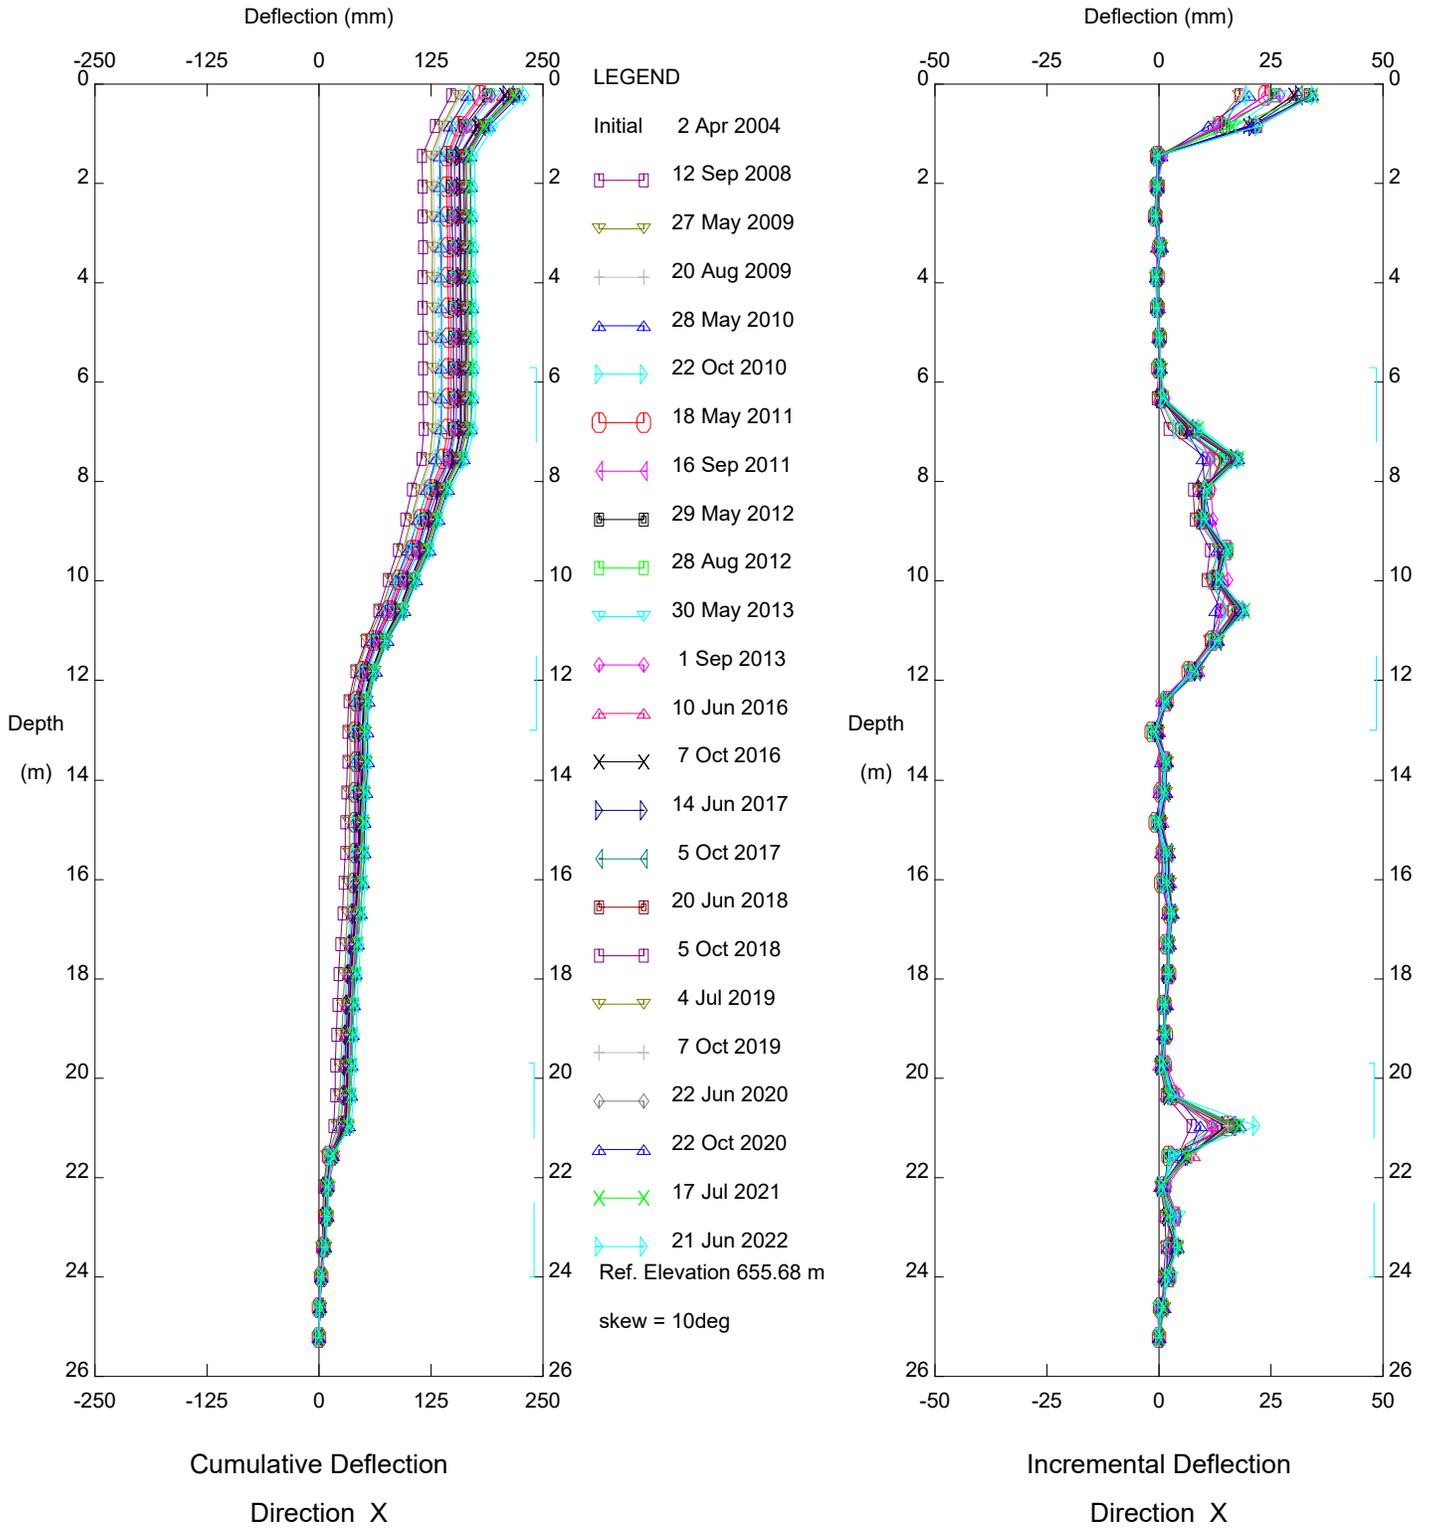
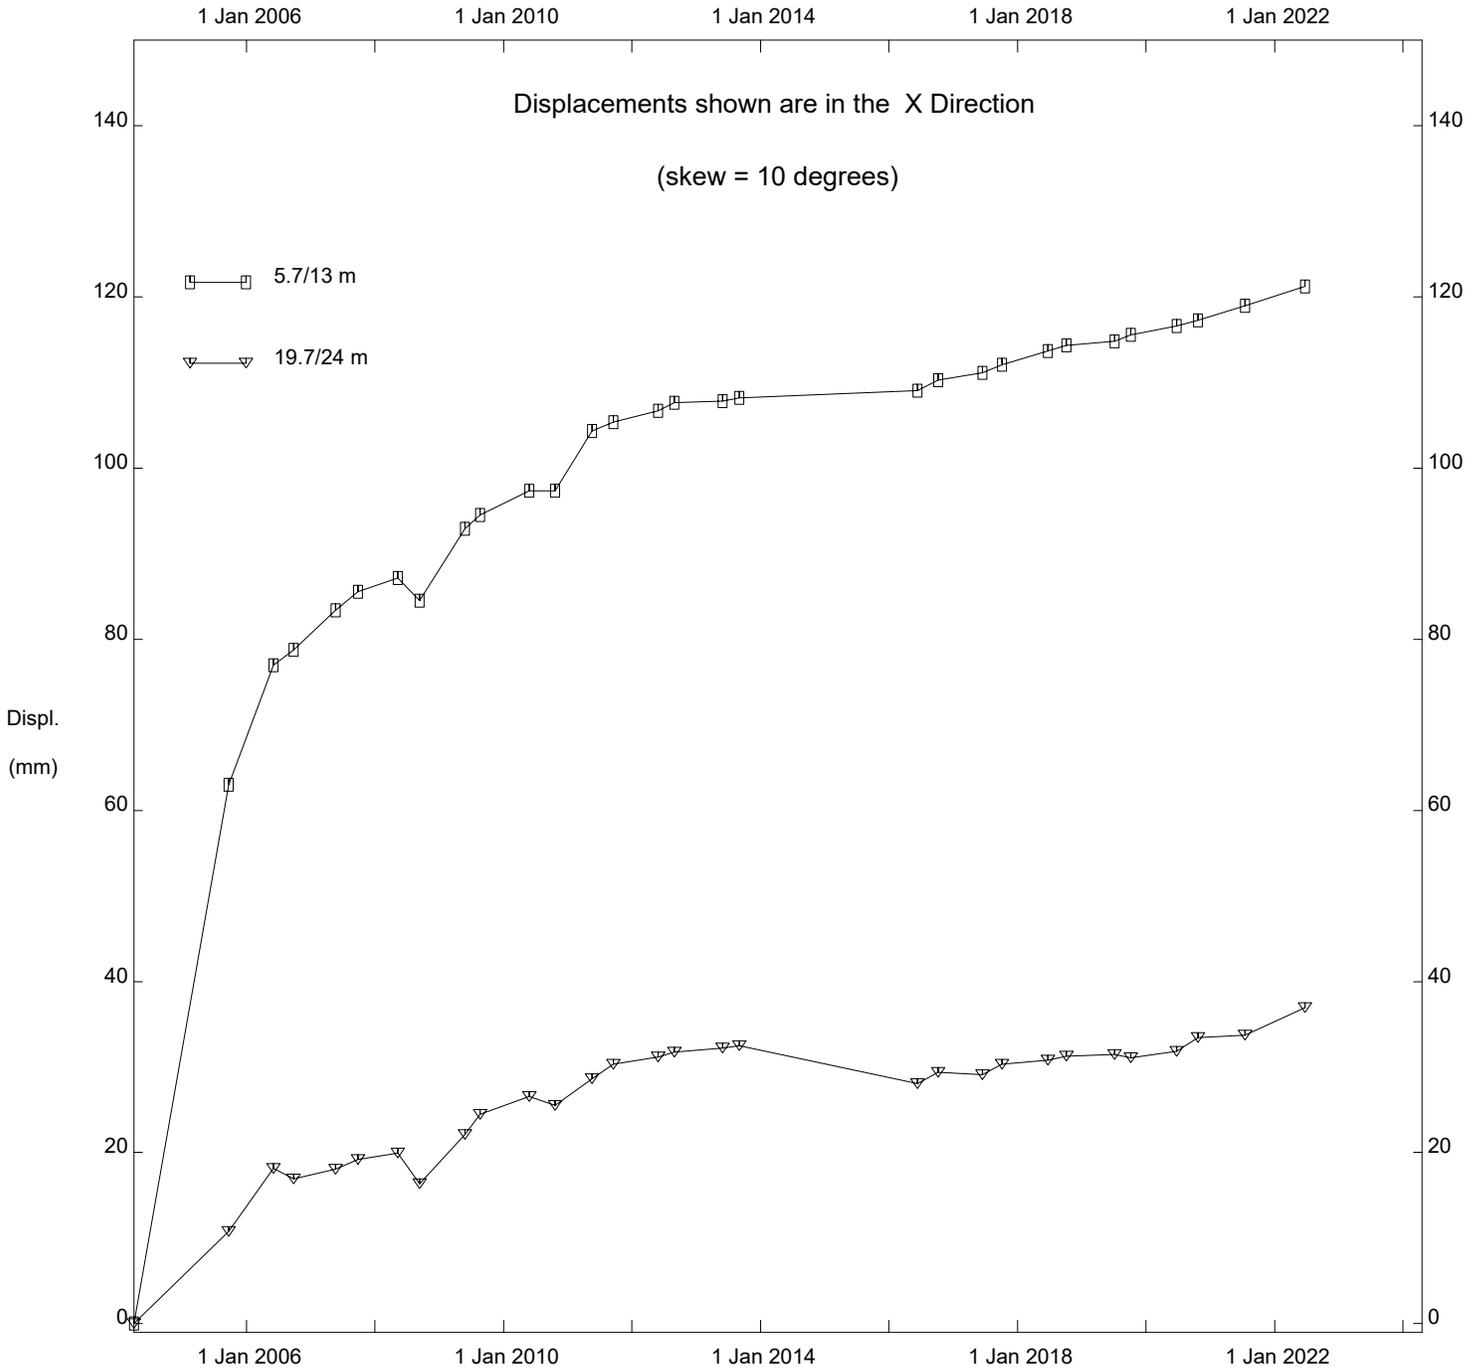
GP024 Hamelin Creek, Inclinometer HC04-3

Slope inclinometer HC04-3 showed rates of movement of 2.4 mm/yr and 3.5 mm/yr over 5.7 m to 13.0 m depth and 19.7 m to 24.0 m depth, respectively, since the spring of 2021 readings. SI06-08 showed a rate of movement of 0.7 mm/yr over 2.8 m to 5.2 m depth since the spring of 2021 readings.

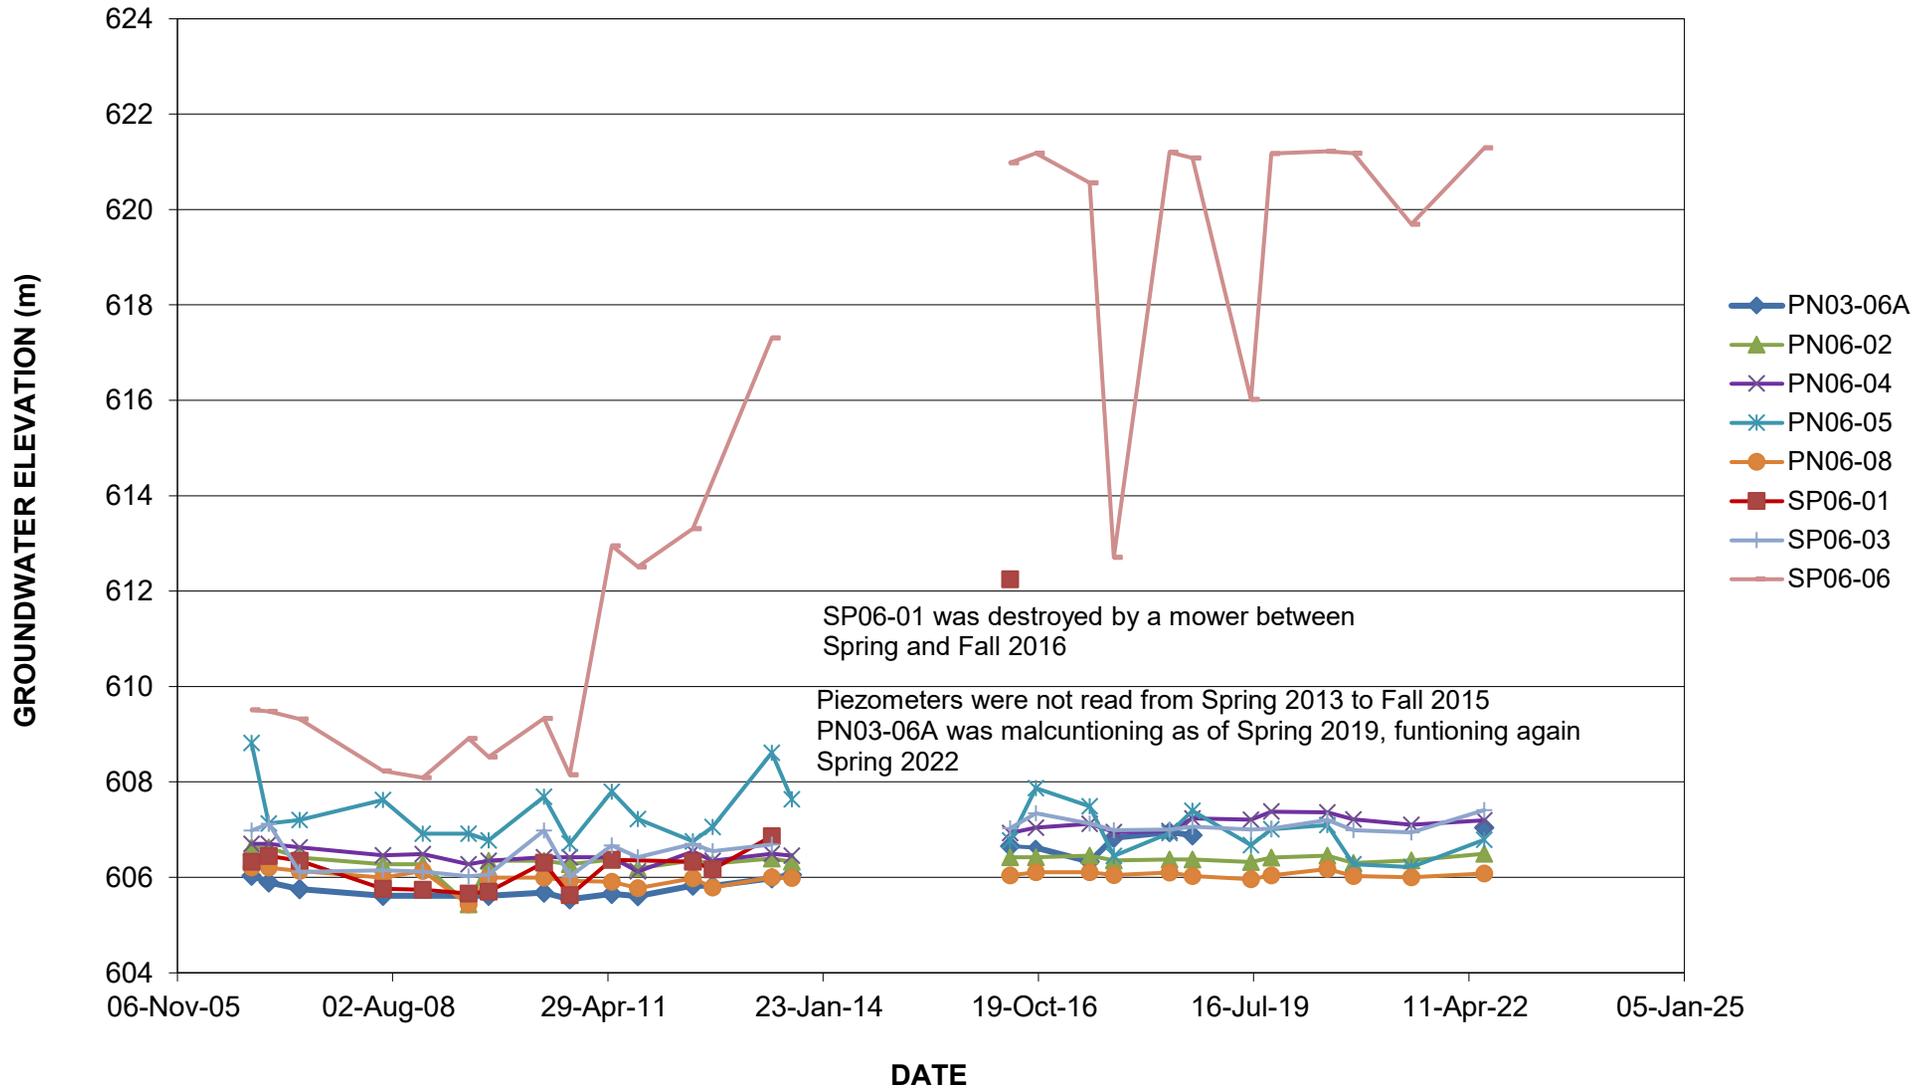
**FIGURE GP024-1**  
**PIEZOMETRIC ELEVATIONS FOR HWY 725:02, HAMELIN CREEK**

All of the pneumatic piezometers showed increases in measured groundwater levels since the spring of 2021 readings, ranging from an increase of 0.08 m in PN06-08 to an increase of 0.57 m in PN06-05. PN03-06A showed an increase in groundwater level of 0.16 m since the previous reading of this instrument in the fall of 2018, and the current groundwater level is the highest ever measured for this instrument. Pneumatic piezometer results are summarized in Table GP024-2 above and are plotted in Figures GP024-1 (by elevation) and GP024-2 (by depth) in Appendix A.

Standpipe piezometers SP06-03 and SP06-06 showed increases in groundwater levels of 0.47 m and 1.60 m, respectively, since the spring of 2021 readings. The current groundwater levels in the standpipes are the highest measured in the instruments since they were initialized. Standpipe piezometer results are summarized in Table GP024-3 above and are plotted in Figures GP024-1 (by elevation) and GP024-2 (by depth) in Appendix A.
