SITE INSPECTION FORM

SITE NUMBER AND NAME: GP020-II Backslope Slump North of Grande Cache		HIGHWAY & KM: 40:34, 35.998	PREVIOUS INSPECTION DATE: June 13, 2022	INSPECTION DATE: June 10, 2024
LEGAL DESCRIPTION: NE 32-56-08-W6M	NAD 83 COORDINATES: UTM Northing Easting 11 5973303 358690		RISK ASSESSMENT: PF: 10 CF: 3 TOTAL: 30	
AVERAGE ANNUAL DAILY TRAFFIC (AADT): 1,480 (north) 1,720 (south) (Reference No. 70000103, 2023) 1,450 (north) 1,480 (south) (Reference No. 70000104, 2023)			CONTRACT MAINTENANCE AREA (CMA): 504

PROJECT
PEACE REGION (GRANDE PRAIRIE DISTRICT-SOUTH)
GEOHAZARD RISK MANAGEMENT PROGRAM

TITLE
Site Plan
GP020-II - Backslope Slump North of Grande Cache
Hwy 40:34, km 35.998

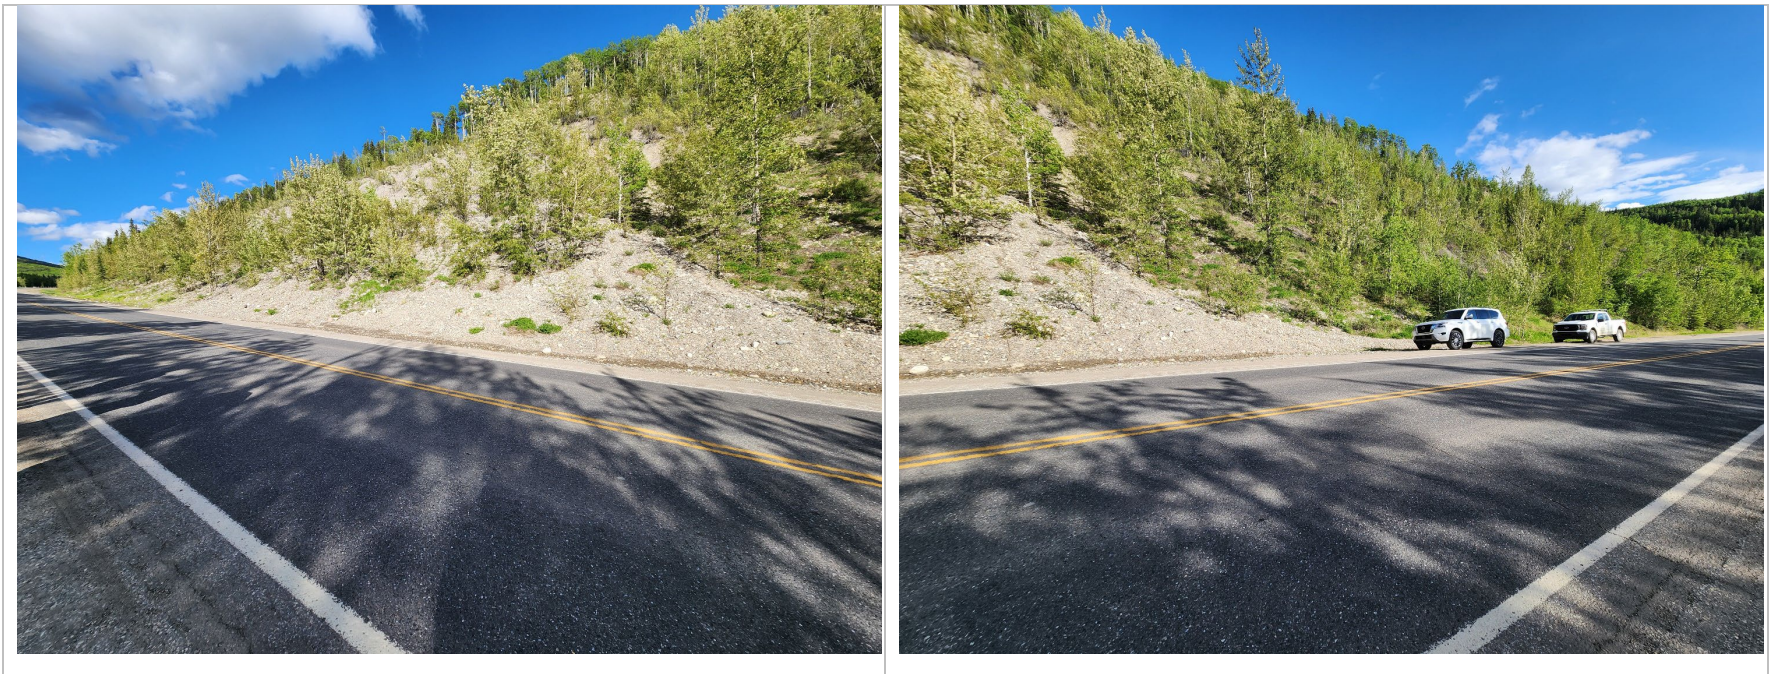
ITEM	CONDITION EXISTS		DESCRIPTION AND LOCATION	NOTICABLE CHANGE FROM LAST INSPECTION	
	YES	NO		YES	NO
Pavement Distress		X	None observed at time of 2024 inspection (Photo 1).		X
Slope Movement	X		Some ongoing surface slumping on east backslope. Some material being deposited into east highway ditch.		X
Erosion	X		Ongoing rill and gully erosion on east backslope (Photo 1). Seepage, surface water runoff, precipitation, weathering, and freeze thaw eroding backslope materials, which are gravelly. Material being deposited into east highway ditch (Photo 2).	X	
Seepage	X		Seepage along east backslope.		X
Culvert Distress		X	No culverts observed by KCB.		X

Photo 1 Pavement surface and backslope on east side of Hwy 40:34. Note areas of poor vegetation, exposed gravelly material, and gully and rill erosion on backslope. Photo taken June 10, 2024, facing northeast and southeast, respectively.

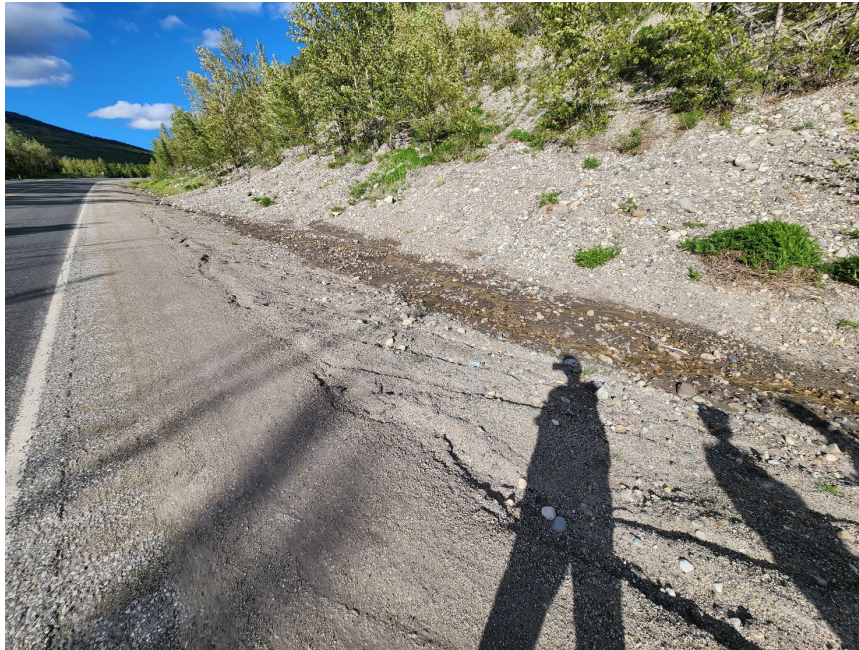
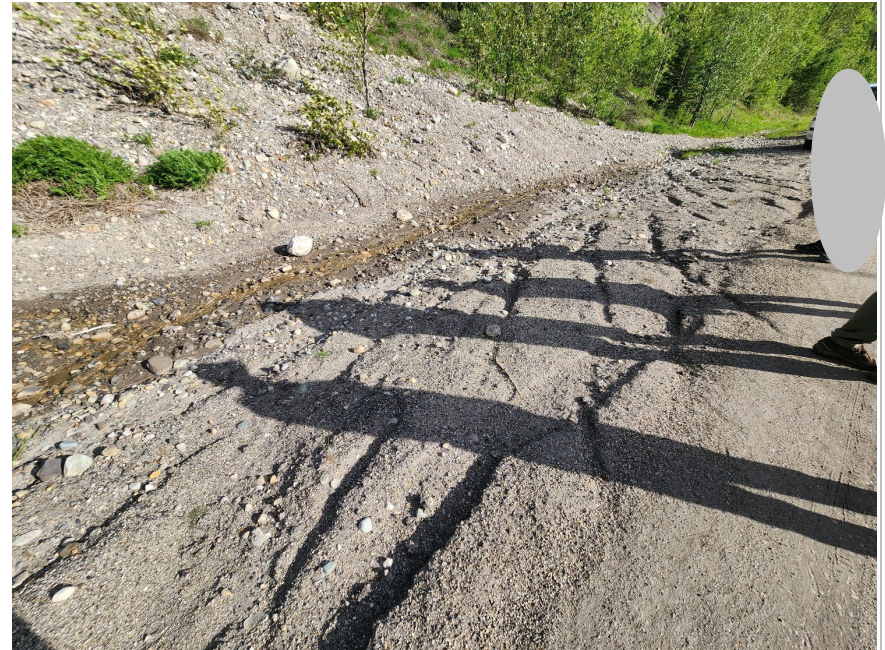
Earthflows, erosion, and gravity movement of particles likely occurring in response to seepage, surface water runoff flowing over crest of slope onto backslope, precipitation infiltrating into slope softening slope materials, weathering, and freeze thaw. Rate of occurrence and volume of earthflows and erosion likely to increase in response to freshet and/or periods of prolonged and/or heavy rainfall.

Photo 2 **Water flowing in ditch at toe of backslope on east side of Hwy 40:34. Photo taken June 10, 2024, facing northeast and southeast, respectively.**

- A diversion ditch could be constructed at the crest of the east backslope to divert surface water runoff away from crest of the mudflow area. However, review of 2022 unmanned-aerial-vehicle (UAV) flight imagery indicates construction of a diversion ditch may not be practical due to lack of access and topography.
- Most material being deposited in east highway ditch appears to slow ditch flows and not block them completely (ditch is wide and shallow). Icing problems in ditch reported in winter of 2021/2022. Water currently flowing in ditch to southwest. Continue to clean ditch to maintain earthflow storage volume (i.e., keep ditch as wide and deep as possible to retain material within the ditch) and reduce the potential for material reaching the highway.
