**ALBERTA TRANSPORTATION  
GEOHAZARD ASSESSMENT PROGRAM  
PEACE REGION – GRANDE PRAIRIE DISTRICT  
2020 INSPECTION**

<b>Site Number</b>	<b>Location</b>	<b>Name</b>	<b>Hwy</b>	<b>km</b>
GP41	Grande Cache	East Hwy Ditch Erosion	40:34	32.4
<b>Legal Description</b>		<b>UTM Co-ordinates (NAD 83)</b>		
SE4-57-8-W6		11U N 5,973,920	E 360,760

<b>Date</b>	<b>PF</b>	<b>CF</b>	<b>Total</b>
<b>Previous Inspection:</b>	May 22, 2019	10	3	30 (Erosion Risk Scale)
<b>Current Inspection:</b>	May 25, 2020	11	4	44 (Erosion Risk Scale)
<b>Road AADT:</b>	1,540	<b>Year:</b>		2019
<b>Inspected By:</b>	Don Proudfoot, Nicole Wilder (Thurber) Ed Szmata, Rishi Adhikari (AT)			
<b>Report Attachments:</b>	<input checked="" type="checkbox"/> Photographs <input checked="" type="checkbox"/> Plans <input type="checkbox"/> Maintenance Items

**MAY 25, 2020 INSPECTION PLAN**

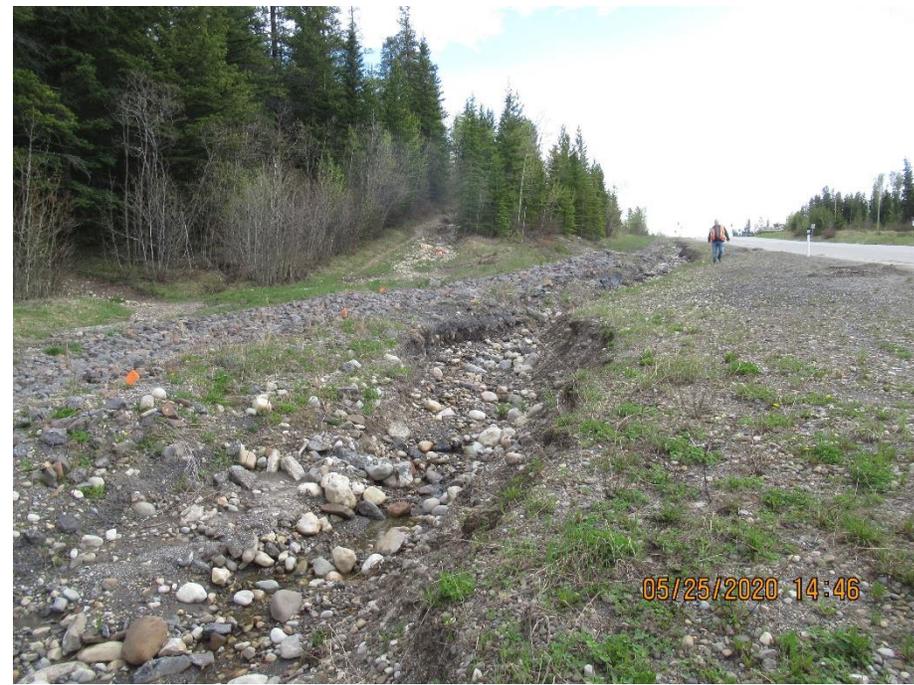
**Photo 1.**  
Looking south from  
the north end of the  
erosion gully.

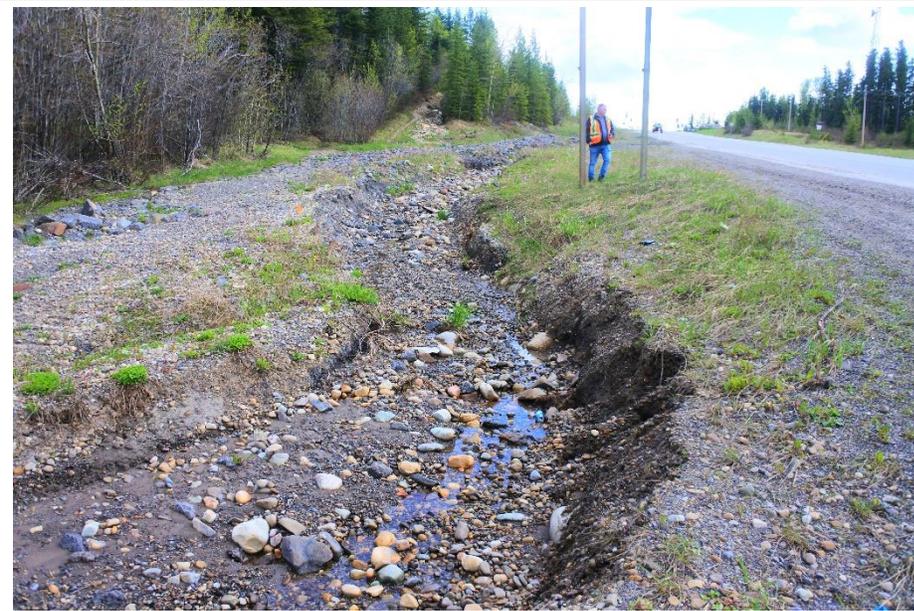
**Photo 2.**  
Looking south at  
further eroded gully in  
ditch.

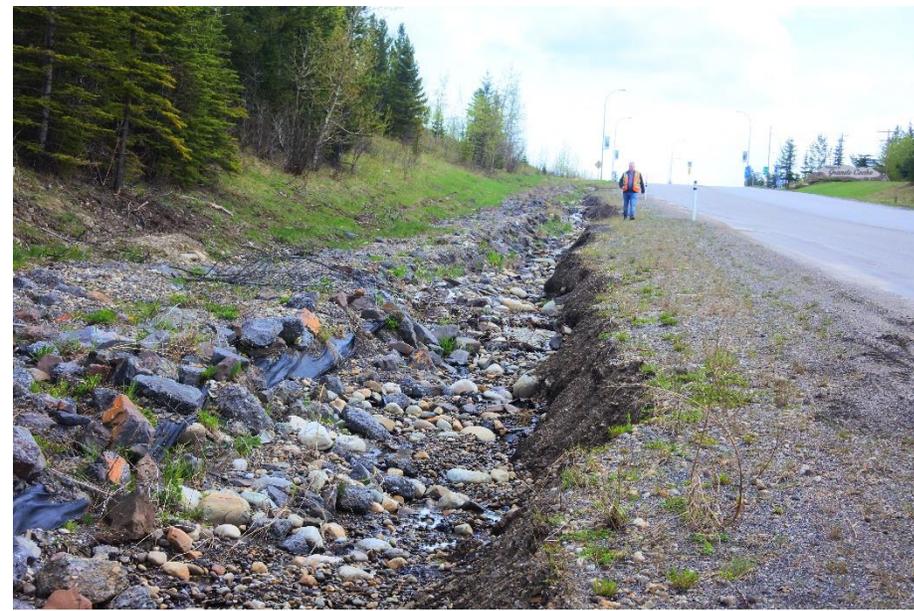
**Photo 3.**  
Looking south at a runoff erosion gully that enters the east highway ditch near the north end which has eroded the ditch

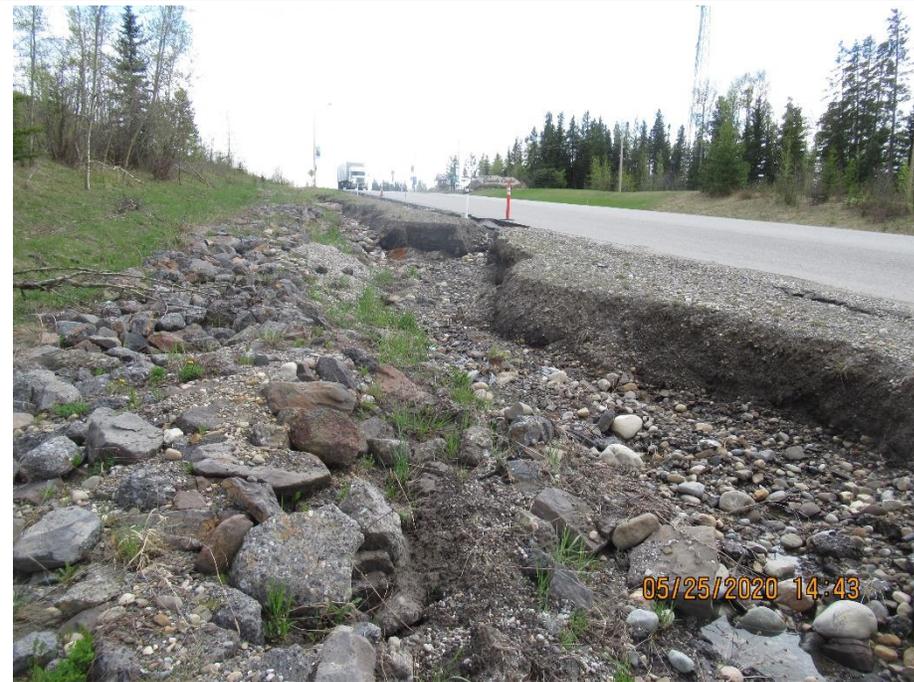
**Photo 4.**  
Looking south where deepest portion of the erosion gully in the east ditch is and is now encroaching into the roadway.

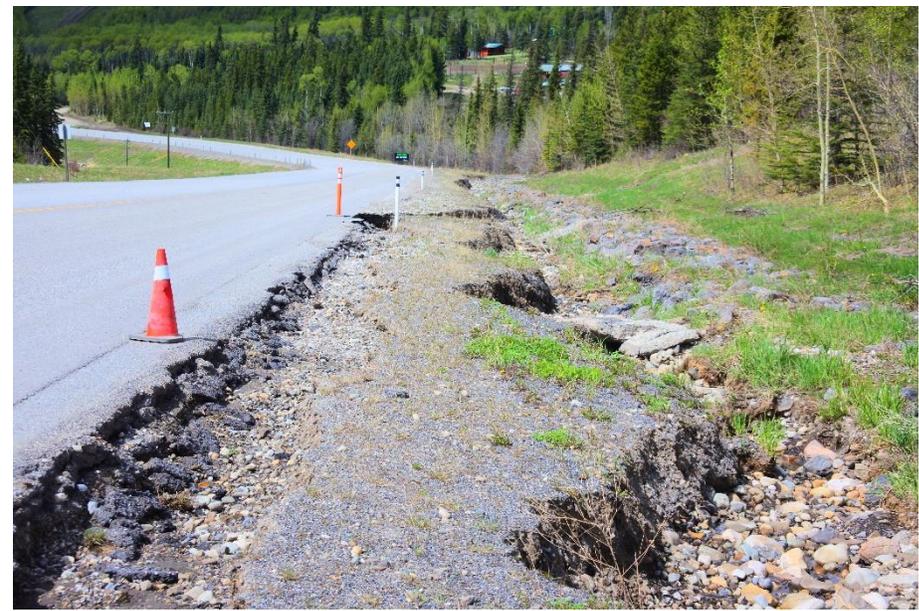
The highway has now been affected by the erosion in several locations, (Photo 5 & 6). The erosion has encroached into the edge of the pavement and will continue eroding it away and may lead to partial lane closure if it isn't dealt with soon. There is a new erosion gully that has formed near the south end of the site which begins adjacent to the highway pavement as shown on Photo 11 and extends north as shown on Photo 5 and 6.

**Photo 5.**  
Looking north along the erosion gully further south where the erosion is up to 1.2 m deep and cutting into the highway now.

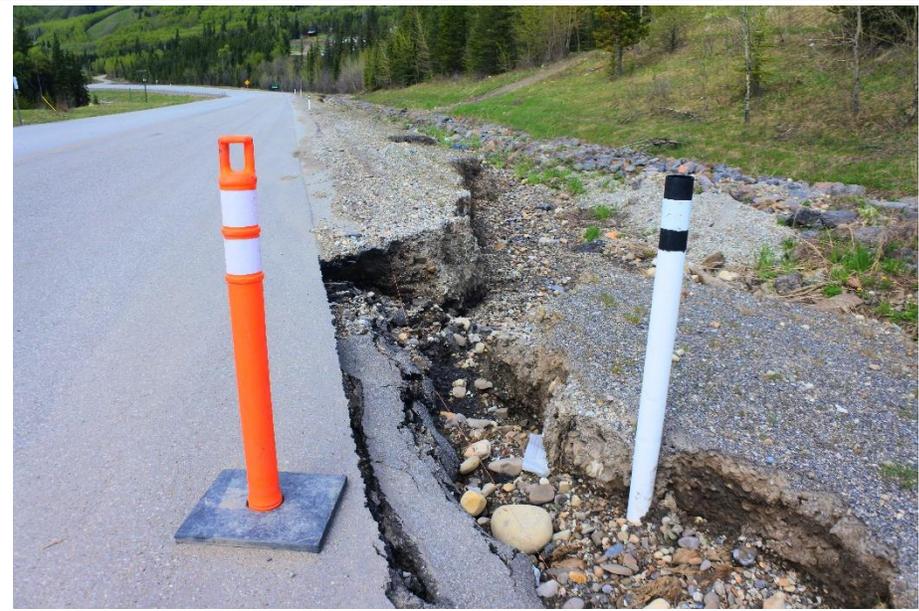
**Photo 6.**  
Looking north along the erosion gully where the erosion has gotten closer to the roadway.

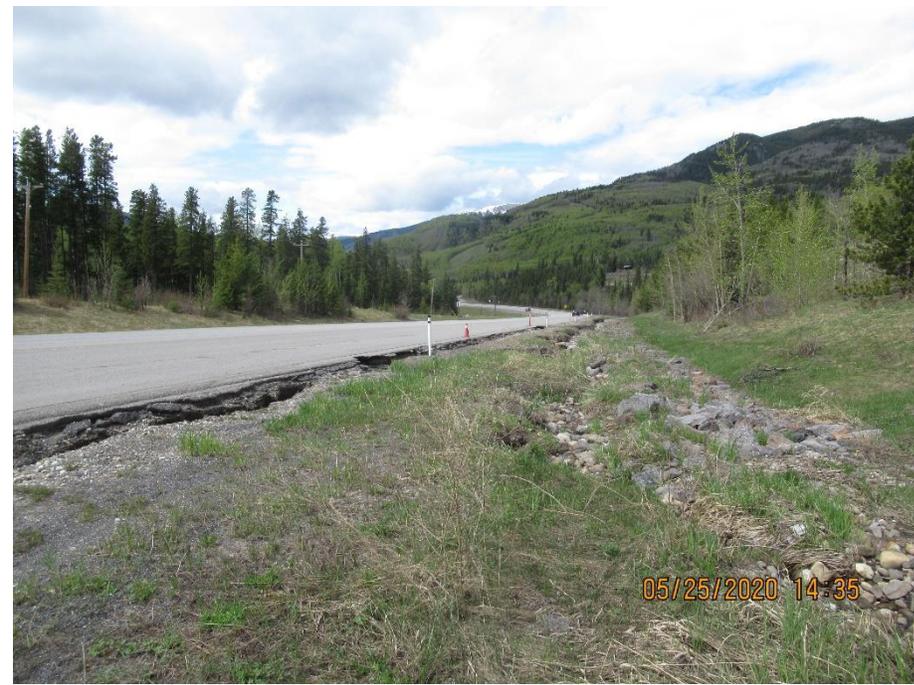
**Photo 7.**  
Looking north along the erosion gully from the start of the riprap in the east ditch.

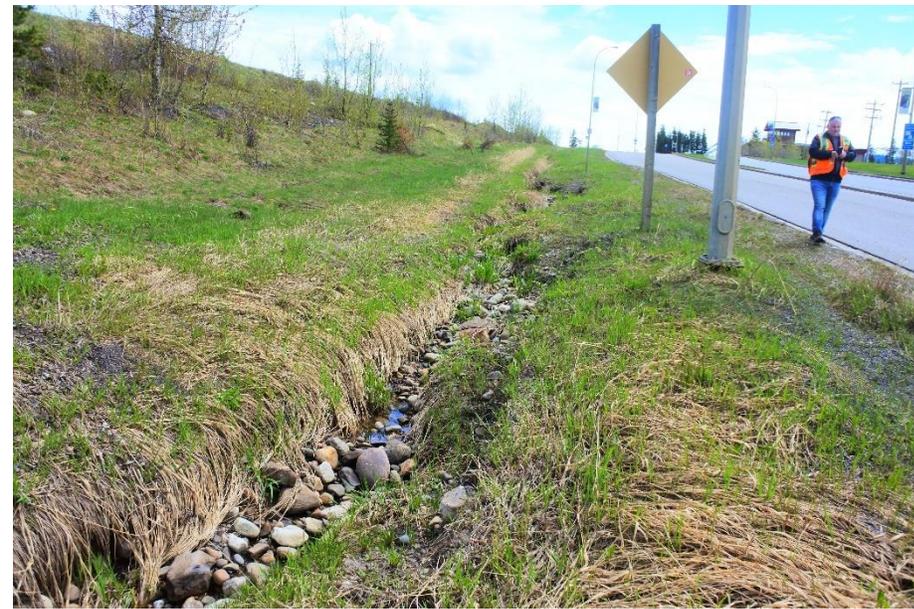
**Photo 8.**  
Looking south along the erosion gully just south of where the riprap lined channel starts.

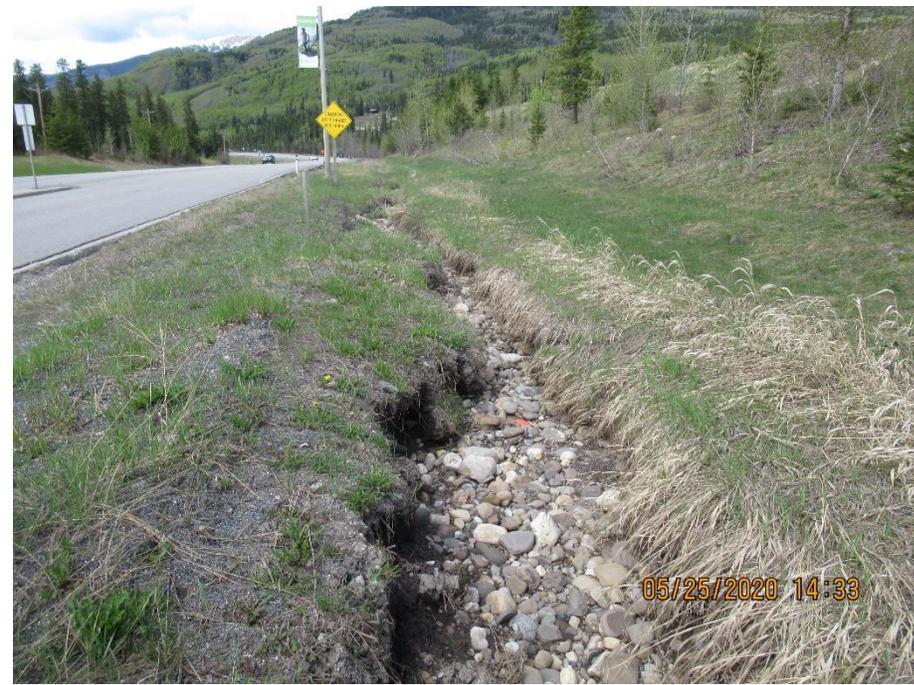
**Photo 9.**  
Looking north along the erosion gully formed in a grassed ditch, south of where the riprap starts.

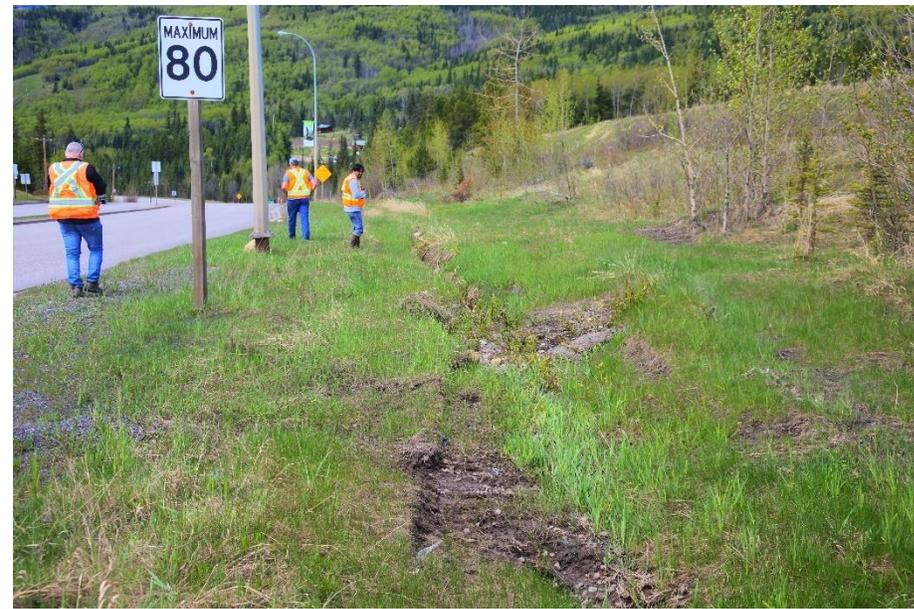
**Photo 10.**  
Looking north from the beginning of the erosion gully in the grassed ditch (near the south end).

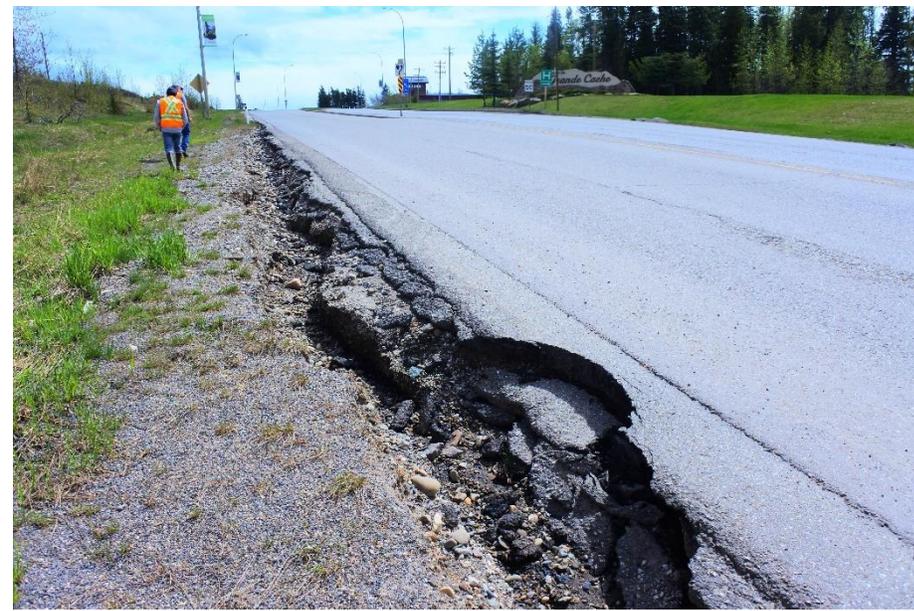
**Photo 11.**  
Looking south at new erosion that runs near highway pavement.

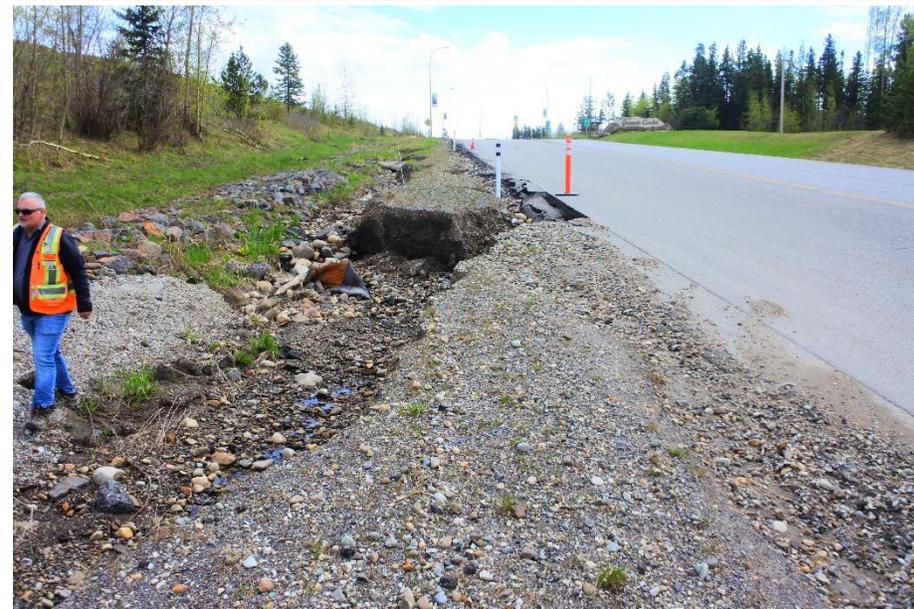
**Photo 12.**  
Looking south where a second channel of erosion exists and has cut into the roadway.
