ALBERTA TRANSPORTATION GEOHAZARD ASSESSMENT PROGRAM PEACE REGION – GRANDE PRAIRIE DISTRICT 2019 CALL OUT

THURBER ENGINEERING LTD.

Site Number	Location			Na	ame		Hwy	km		
GP06B	N of Grand	N of Grande Cache		Tear Drop Slides			40:36	21.8		
Legal Description)					nates (NAD 8				
NW30-58-7-W6 11U N 5,990,745 E 366,610										
			Date		PF	CF	Tota	al		
Previous Inspection:		J	une 8, 2019		9	4				
Current Inspection			uly 12, 2019		14	5 70				
Road AADT:	-		900			Year: 2018				
		Bar	arry Meays, Nicole Wilder (Thurber)							
		Ed	Ed Szmata, Dwayne Lowen (AT)							
Report Attachments:			Photograph	ance Items						
Primary Site Issue:		Landslide in a 20 m high, 2H:1V highway embankment fill.								
			About 190 m wide along highway, by ~40 m long from highway down							
Dimensions:			to toe.							
Date of any rem	ediation:									
Maintenance:			Crack Sealing and Patching. SB lane closed to traffic on July 12, 2019 due to ongoing rapid landslide movements. Gravel added to west shoulder and traffic lights currently in place to manage traffic on one lane of open roadway

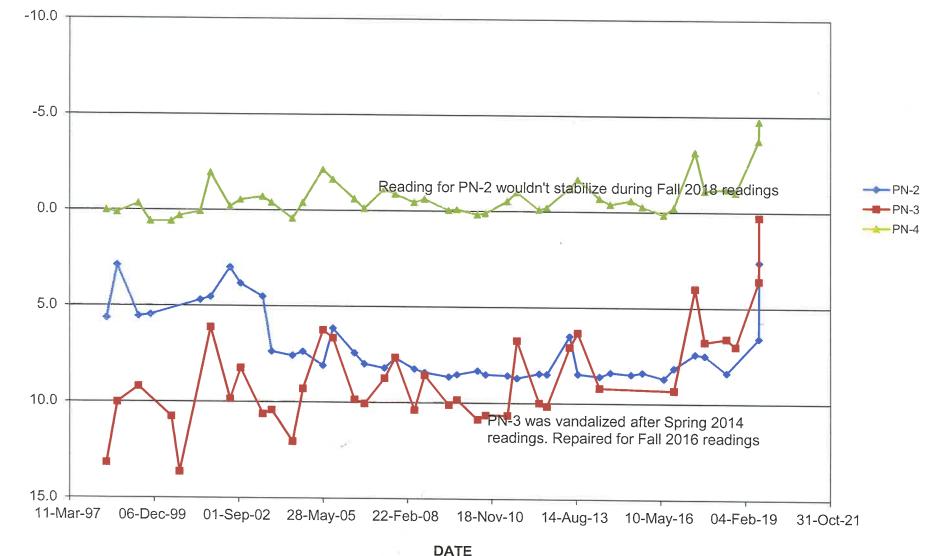
FIGURE GP006B-1-1 PIEZOMETER DATA FOR SHEEP CREEK RR TRACK EMBANKMENT

Piezometer PN-4, which had indicated pore pressures of 1 m to 3 m above ground surface over the last year, had recently shown an increase to 3.7 m above ground surface (July 8) and 4.7 m above ground surface (July 12). PN-3 and PN-2 also indicated increased pore water pressures on July 12 to about 0.3 m BGS and 2.3 m BGS, respectively. The latest readings are shown on the attached cross-sections figure, while all of the historic pore pressure readings are charted on the attached chart.					
There are also 3 relatively small embankment slumps downslope of the highway surface further south of the scarp crack and backslope scarp. These slumps were anticipated to be separate, shallow fit instabilities caused by previous groundwater seepage and have self-healed due to lack of activity, but they (especially the south one) may possibly be linked and form part of the larger slide in the pavement A trace of seepage was observed from the scarp crack in the highway during a previous inspection however no seepage was observed either from the pavement surface or the steep downslope highway embankment during this Call Out visit.

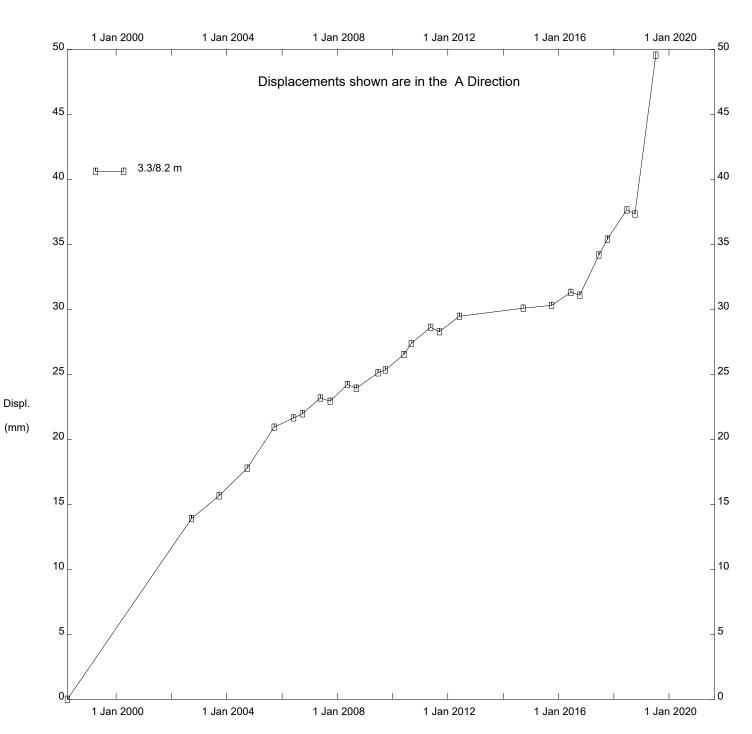
GP006B-1 Sheep Creek Embankment, Inclinometer SI-02

recorded. The depth of movement is shown between 3 to 8 m at the downslope (east) shoulder in SI-2 near the center of the slide (see attached), with the most recent recorded movement that had increased to 16 mm/yr (July 8, 2019). Also, there are no operational instruments downslope of the road shoulder to identify the shape/depth of the slide. This adds some uncertainty to the size/shape/extent of the slide affecting the highway.

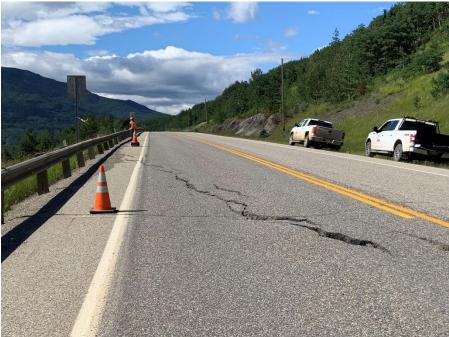
Photo 1 – Looking south along the northbound lane at the south end of the fresh, wider, pavement crack. There is an old dip/crack in the highway northbound lane about 40 m further south (visible in the background) which was basically unchanged.

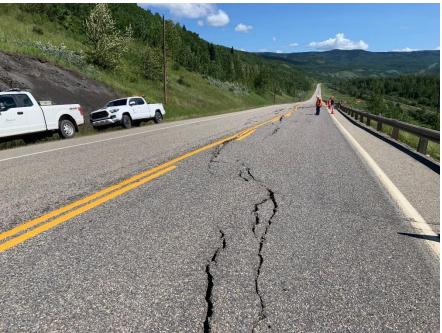
Photo 2 – Looking north at the fresh crack from the same spot as Photo 1.

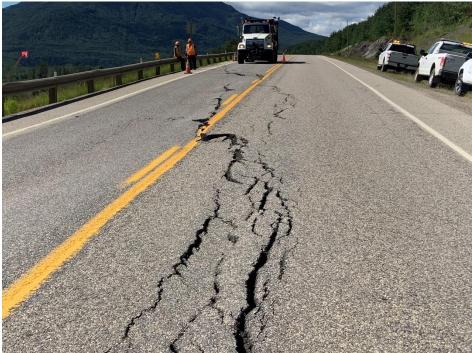
Photo 3 – Looking south at the fresh cracking about 40 m north of the south end of this crack.

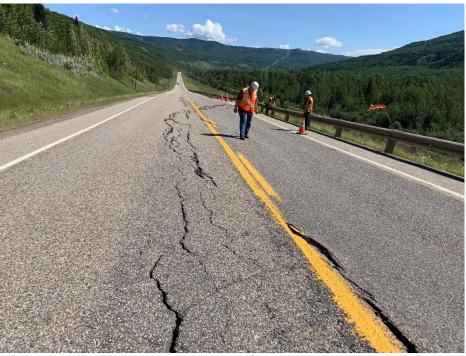
Photo 4 – Looking north at the crack from the same spot as Photo 3.

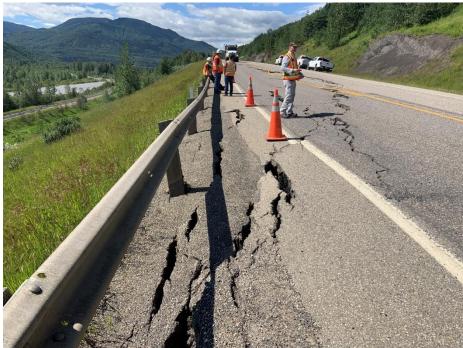
Photo 5 – Looking south along the east guardrail at the cracking, and the central dipped area on the east side of the crack, where it approaches the east shoulder.

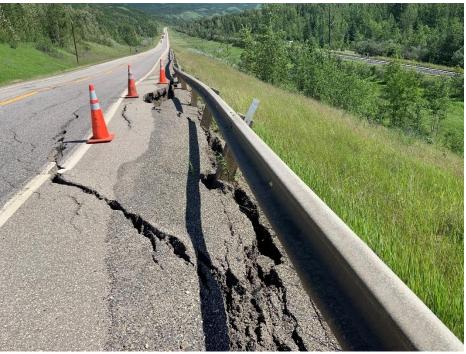
Photo 6 – Looking north along the east guardrail at the crack from the same spot as Photo 5. Note the north dip in the NB lane beyond the last traffic cone.

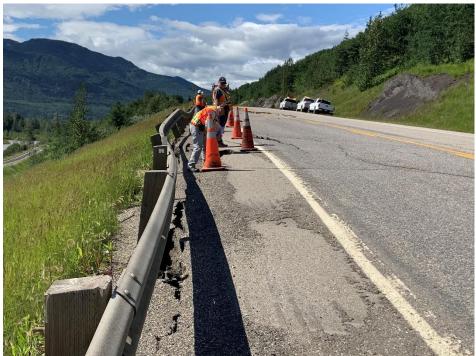
Photo 7 – Looking south from the north dip. Note the bent guardrail at this location.

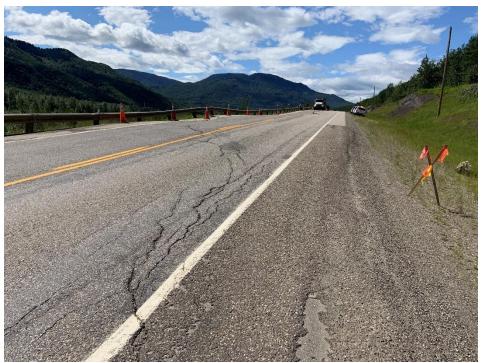
Photo 8 - Looking south along the west edge of the highway at the crack around the north dip

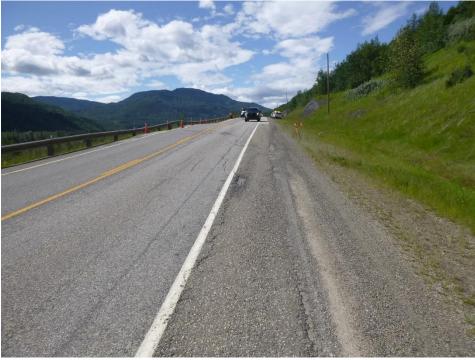
Photo 9 – Looking south from near the north end of the fresher crack.

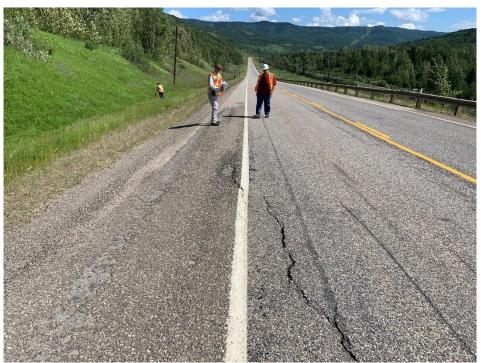
Photo 10 – Looking north at the end of the crack where it exits the west edge of the highway.

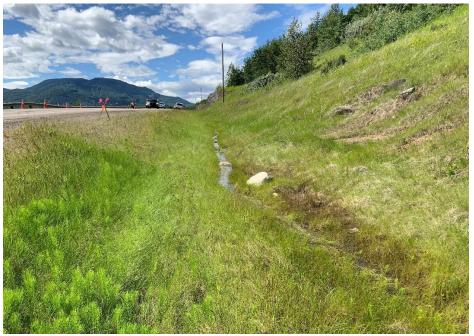
Photo 11 – Looking south along the west ditch from the north end of the pavement crack. Note the substantial ditch water flowing northwards, and the north seepage area from the west cut backslope directly above the white stone in the ditch.

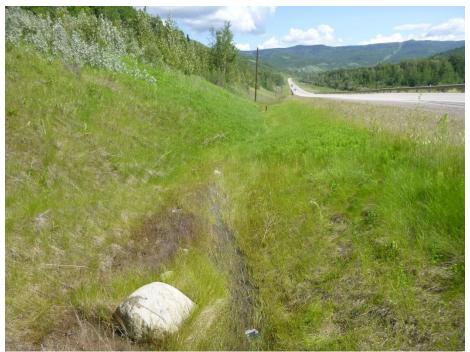
Photo 12 – Looking north along the west ditch from the white stone, with SI-4 in the background.

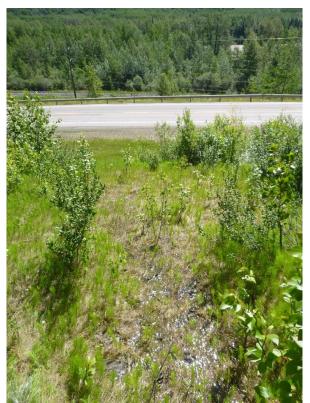
Photo 13 – Looking east towards the hwy at heavy seepage from the scarp area on the west cut backslope at the north end of the cracked area.

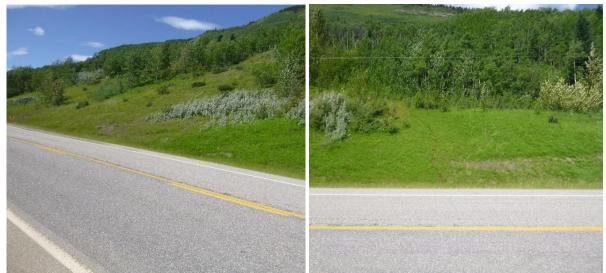
Photo 14 – Looking southwest at the north seepage/scarp area on the west cut backslope. Note SI-4 in the west ditch.

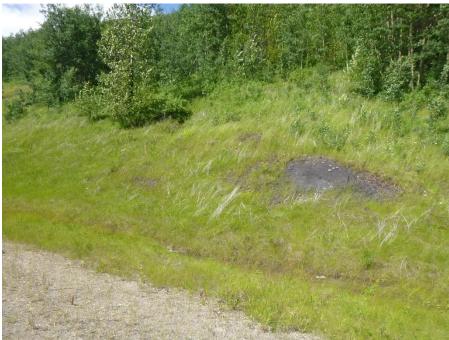
Photo 15 – Looking west at the south seepage area in the backslope above the west ditch, just south of the bedrock exposure.

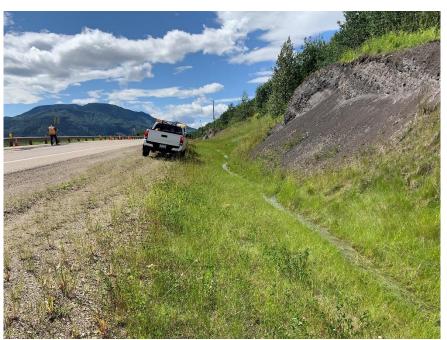
Photo 16 – Looking south along the west ditch near the center of the cracked pavement site. Note the bedrock exposure above the ditch. The seepage area identified in Photo 15 is just south of this exposure in front of the trucks. Note the steady ditch flow along the ditch.

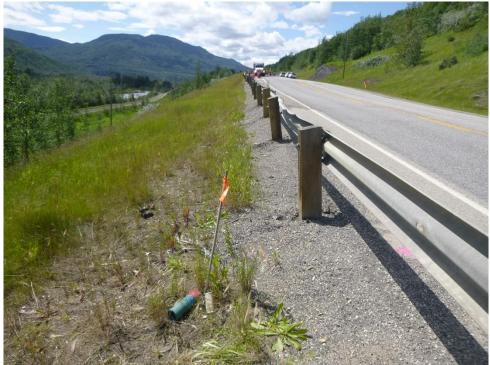
Photo 17 – Looking south along the east side of the guardrail from SI-3 at the north end of the site.

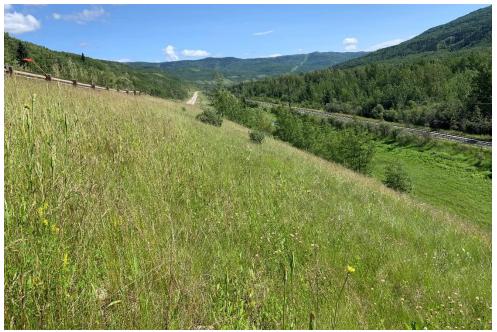
Photo 18 – Looking north along the east embankment sideslope, from the south end of the site.

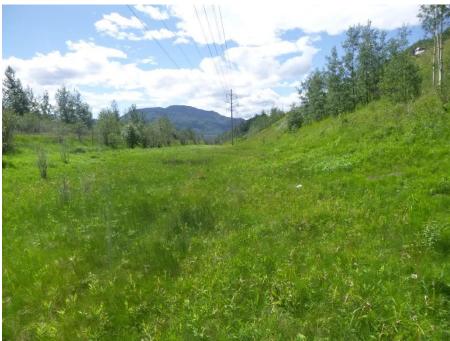
Photo 19 – Looking south along the embankment toe from the north end of the site. Note the overhead power line and railway track embankment on the left, where an underground gas line also runs between them.

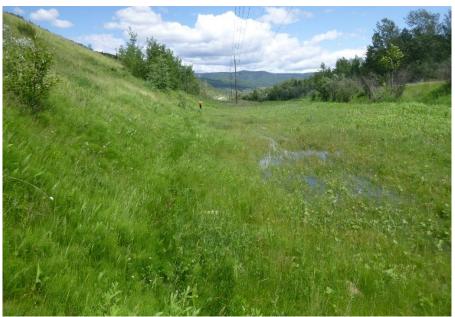
Photo 20 – Looking north along the embankment toe from near the south end of the site. Note the standing water all along this flat area outside the highway embankment toe.

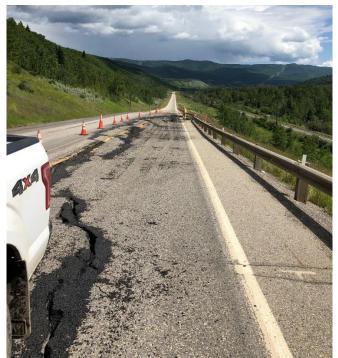
The slide affecting the pavement is probably the result of an overly steep (2H:1V) fill, aggravated by seasonal rises in the groundwater table and surface infiltration. The slide is now moving very rapidly, based on the information above, and the most recent crack sealing/patching tore apart within a few days (see Photos 21 and 22). The significant amount of rain over the last month has resulted in a big increase to the water table level that is likely the main cause of the high rate of landslide movements that are currently occurring.

Photo 21 – Looking north along the highway from near the south end of the slide on July 17, 2019 (5 days after cold mix crack sealing).
