November 30, 2022

CON0022166 Peace Region (Grande Prairie District – South) GRMP Instrumentation Monitoring Site GP008; H40:36, km 16.365 Road Surface Slumping (2.5 km North of McIntyre Mine) Section C – 2022 Fall Readings

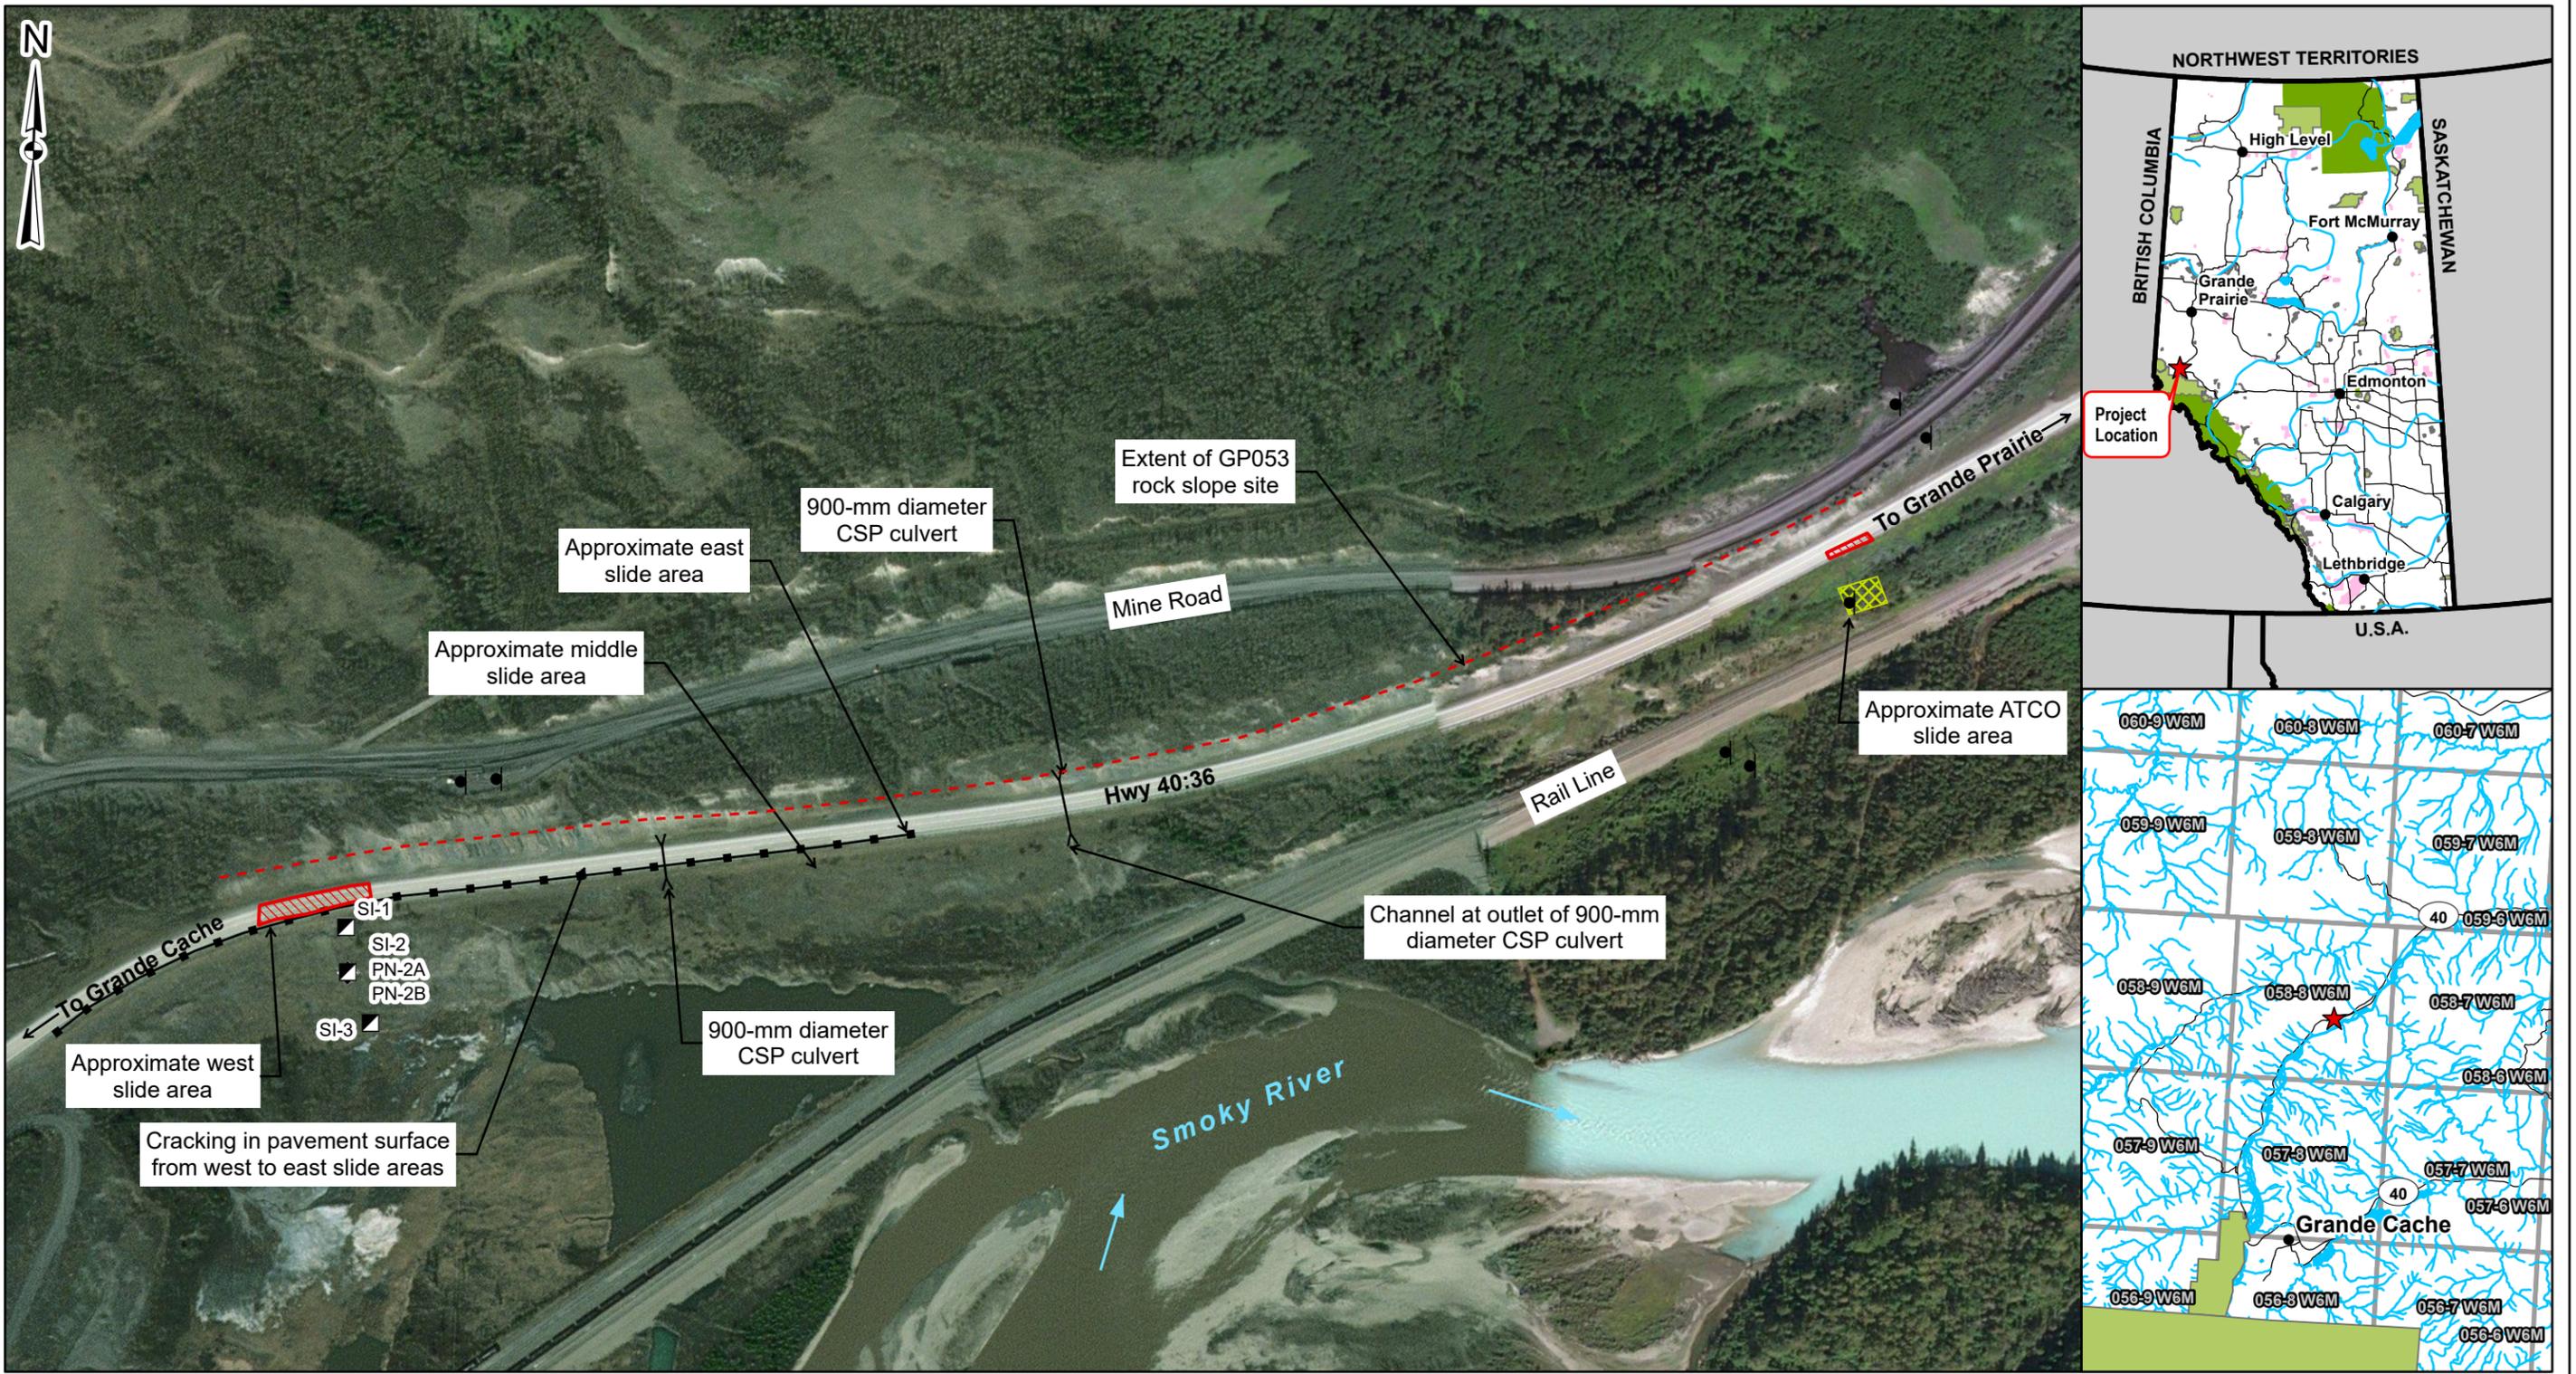
PROJECT	PEACE REGION (GRANDE PRAIRIE DISTRICT-SOUTH) GEOHAZARD RISK MANAGEMENT PROGRAM	
TITLE	Site Plan GP008 - Road Surface Slumping (2.5 km North of McIntyre Mine) Hwy 40:36, km 16.365 and 17.139	
SCALE	PROJECT No.	FIG No.
1:4,000	A05116A01	1

The geohazard at the GP008 site consists of three landslides in a possible mine-waste fill/dump below Hwy 40:36:

- the west/south slide, which cuts diagonally across the highway;
- the middle slide, which is confined to the northbound lane and shoulder; and
- the east/north slide, which encompasses both lanes.

AT has noted that cracking usually reflects through pavement patches at the site very quickly. It is noted that the existing SIs are installed at the west slide area only and movements recorded in them may not be reflective of movements occurring at the middle or east/north slide areas where no instruments are installed.

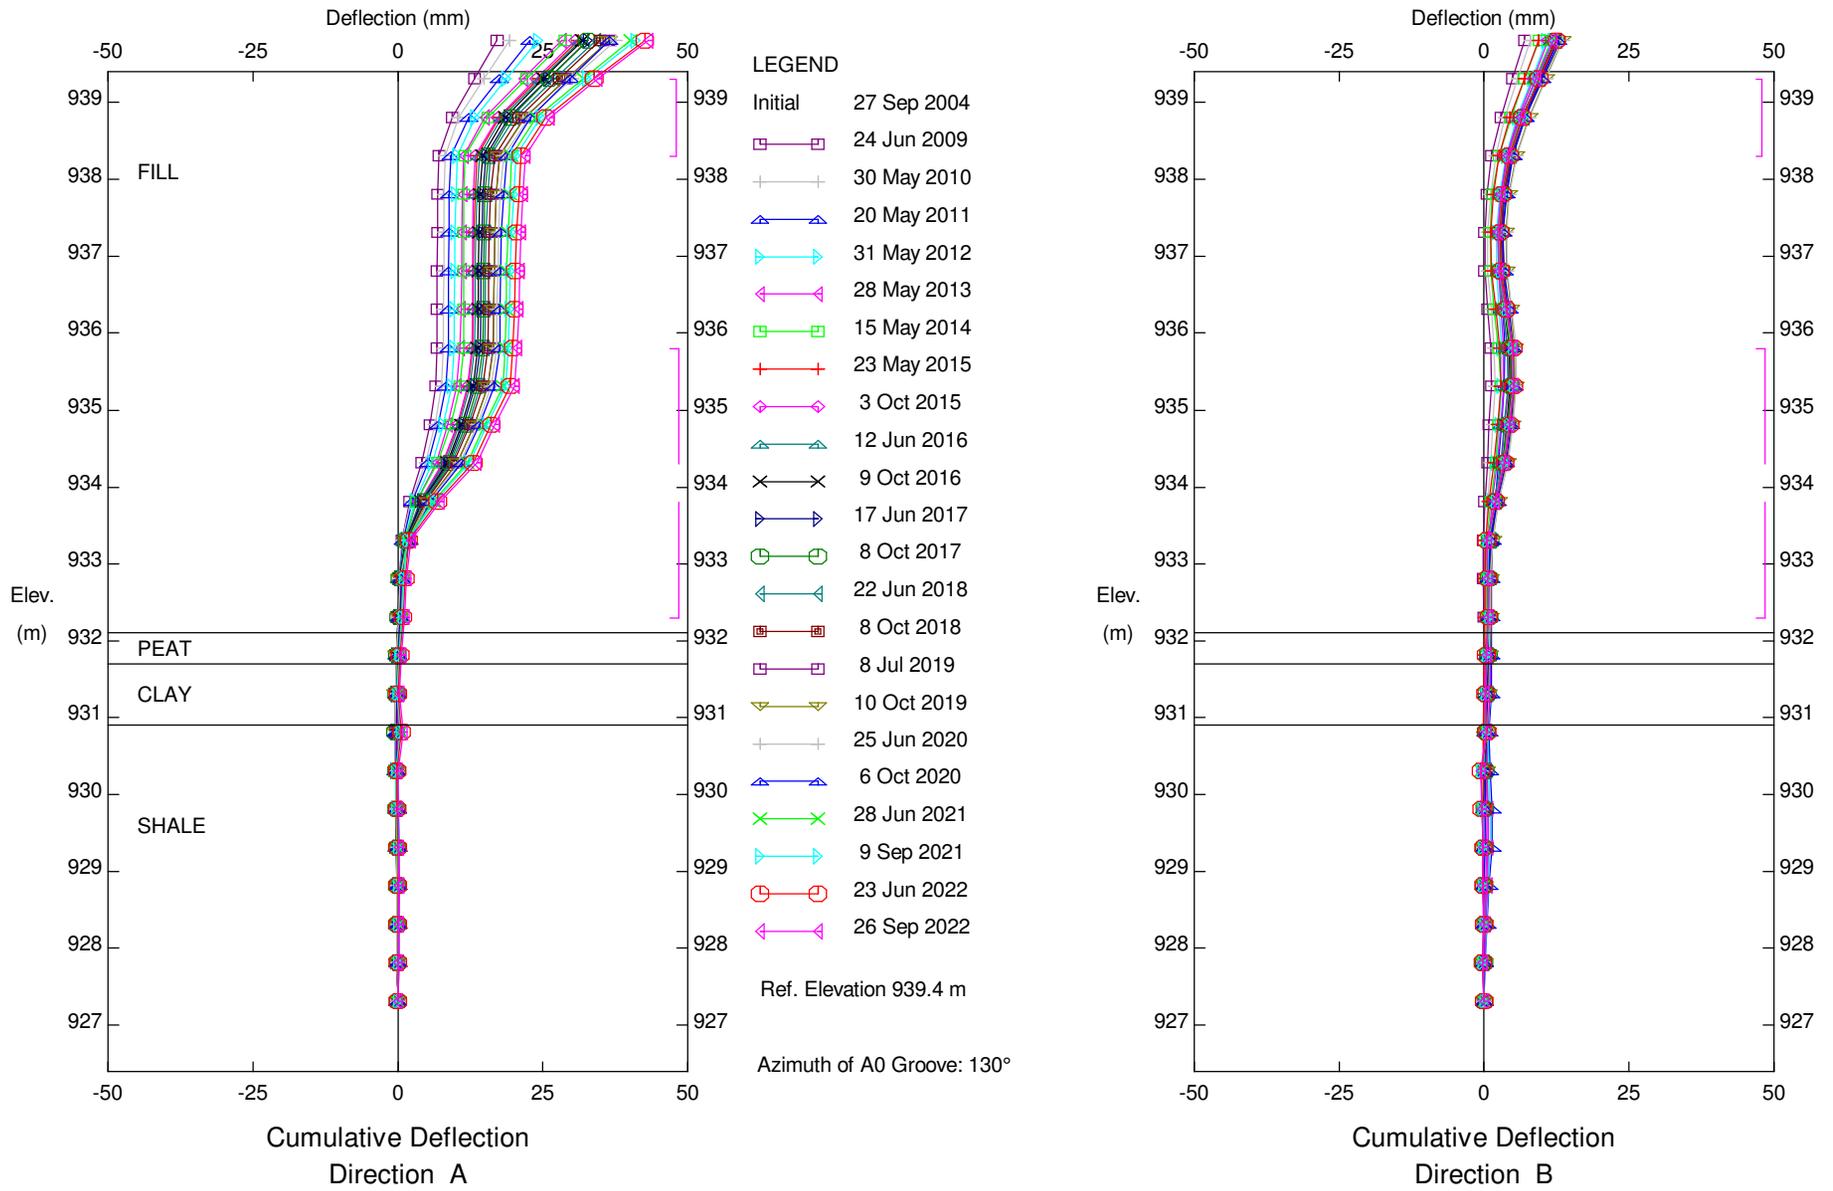
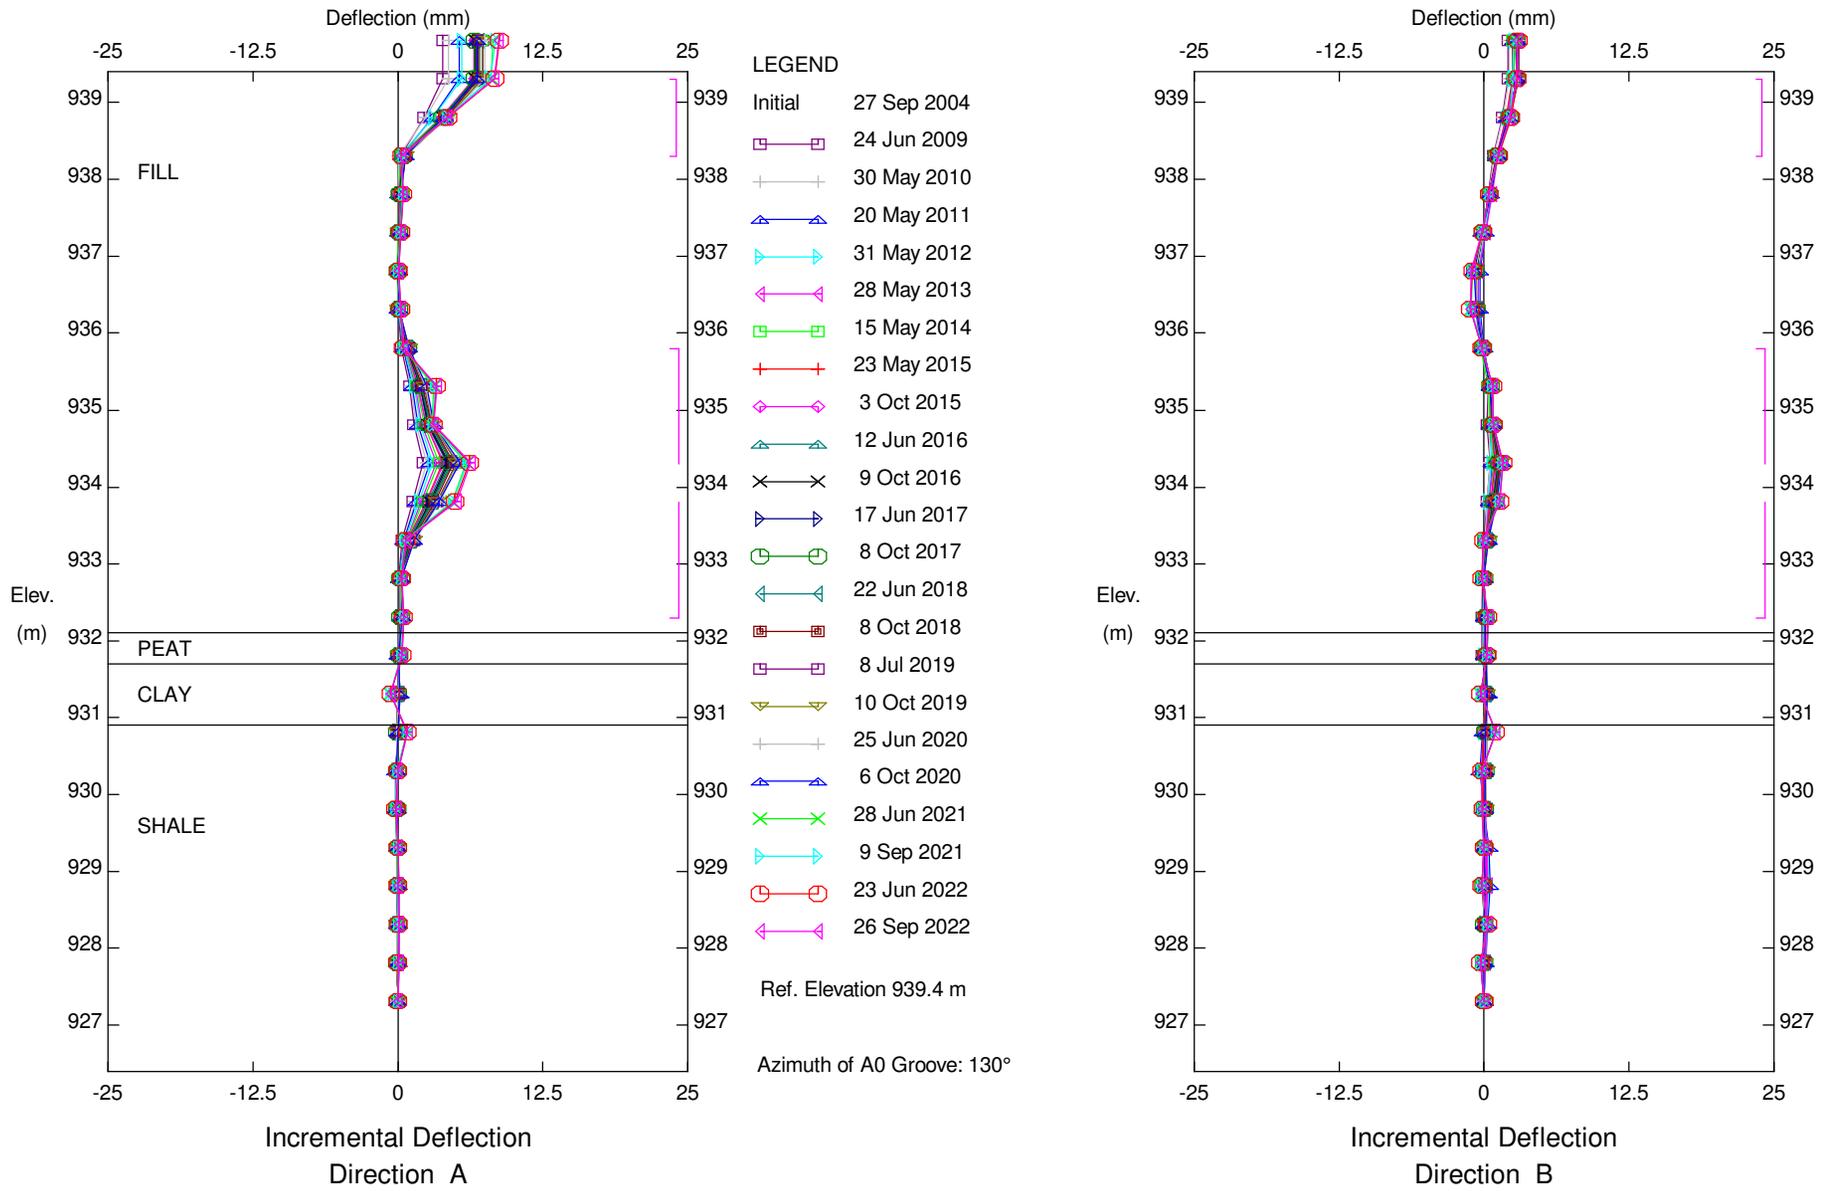
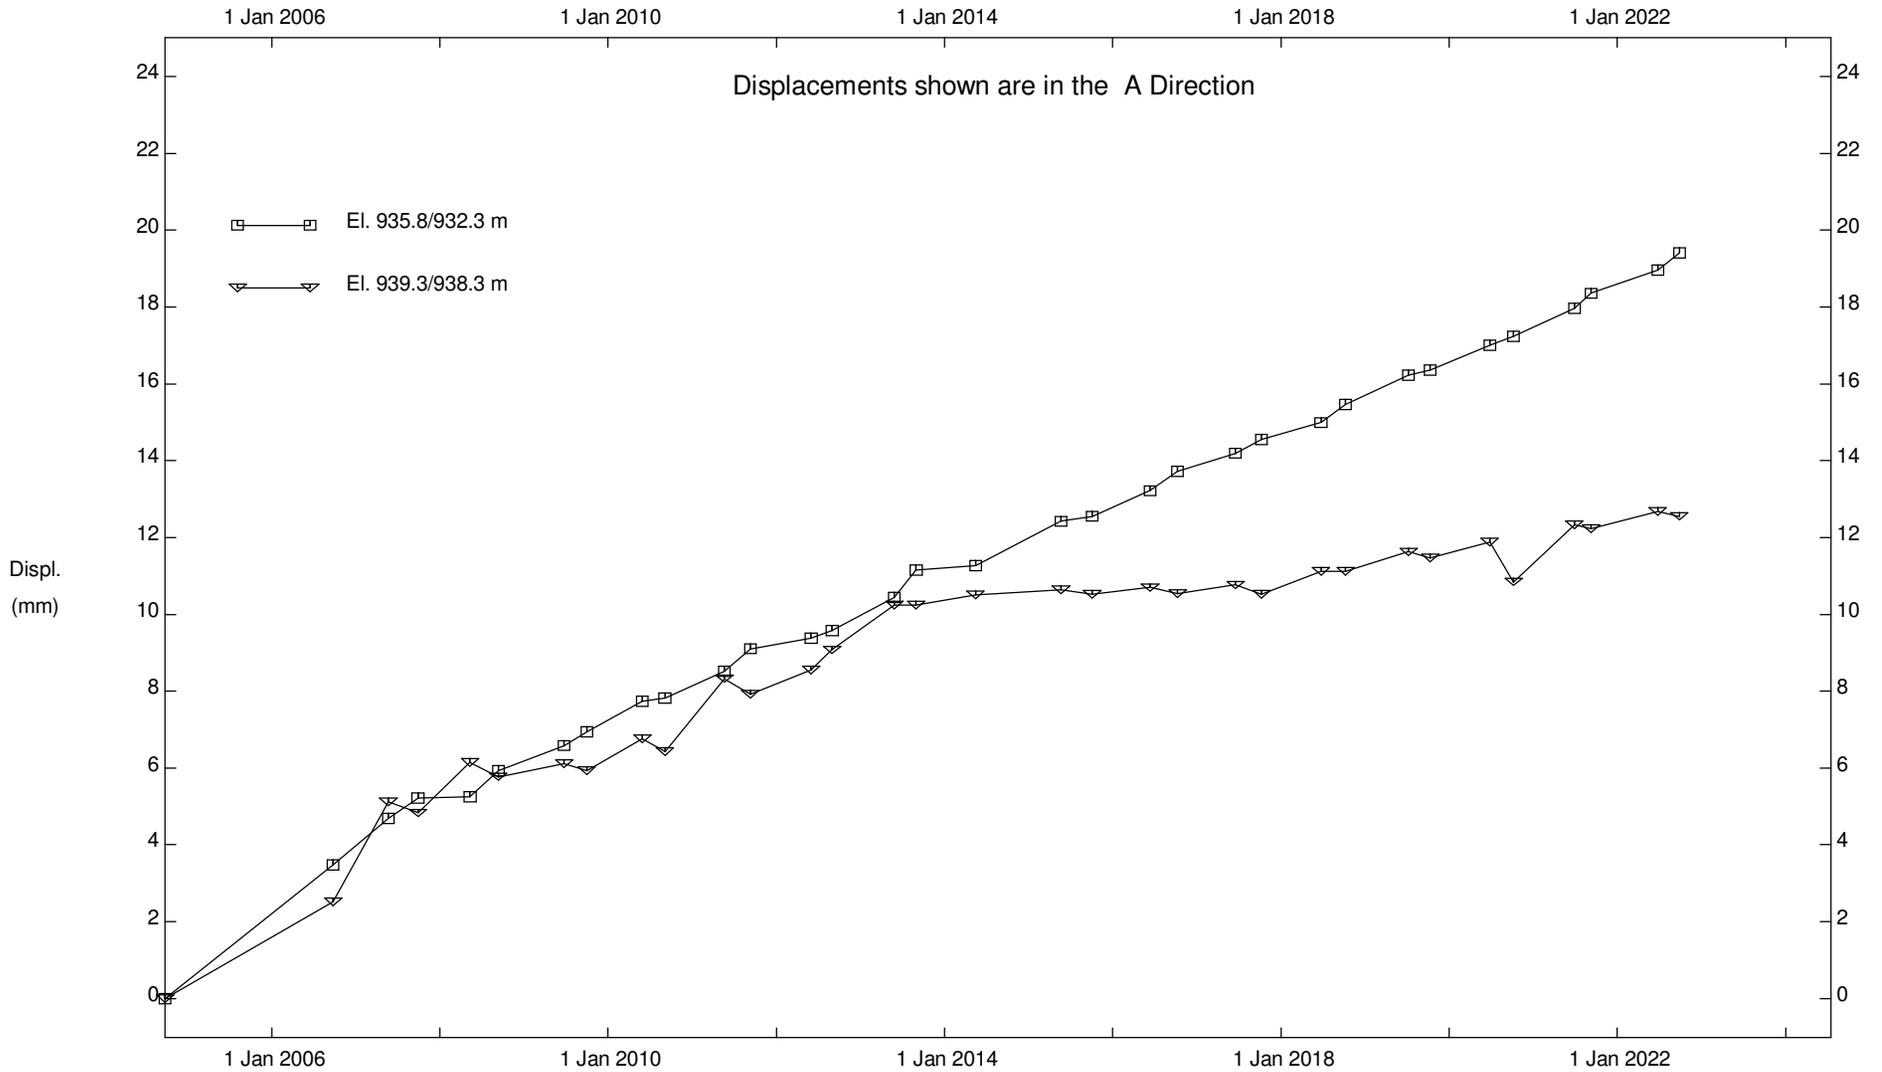
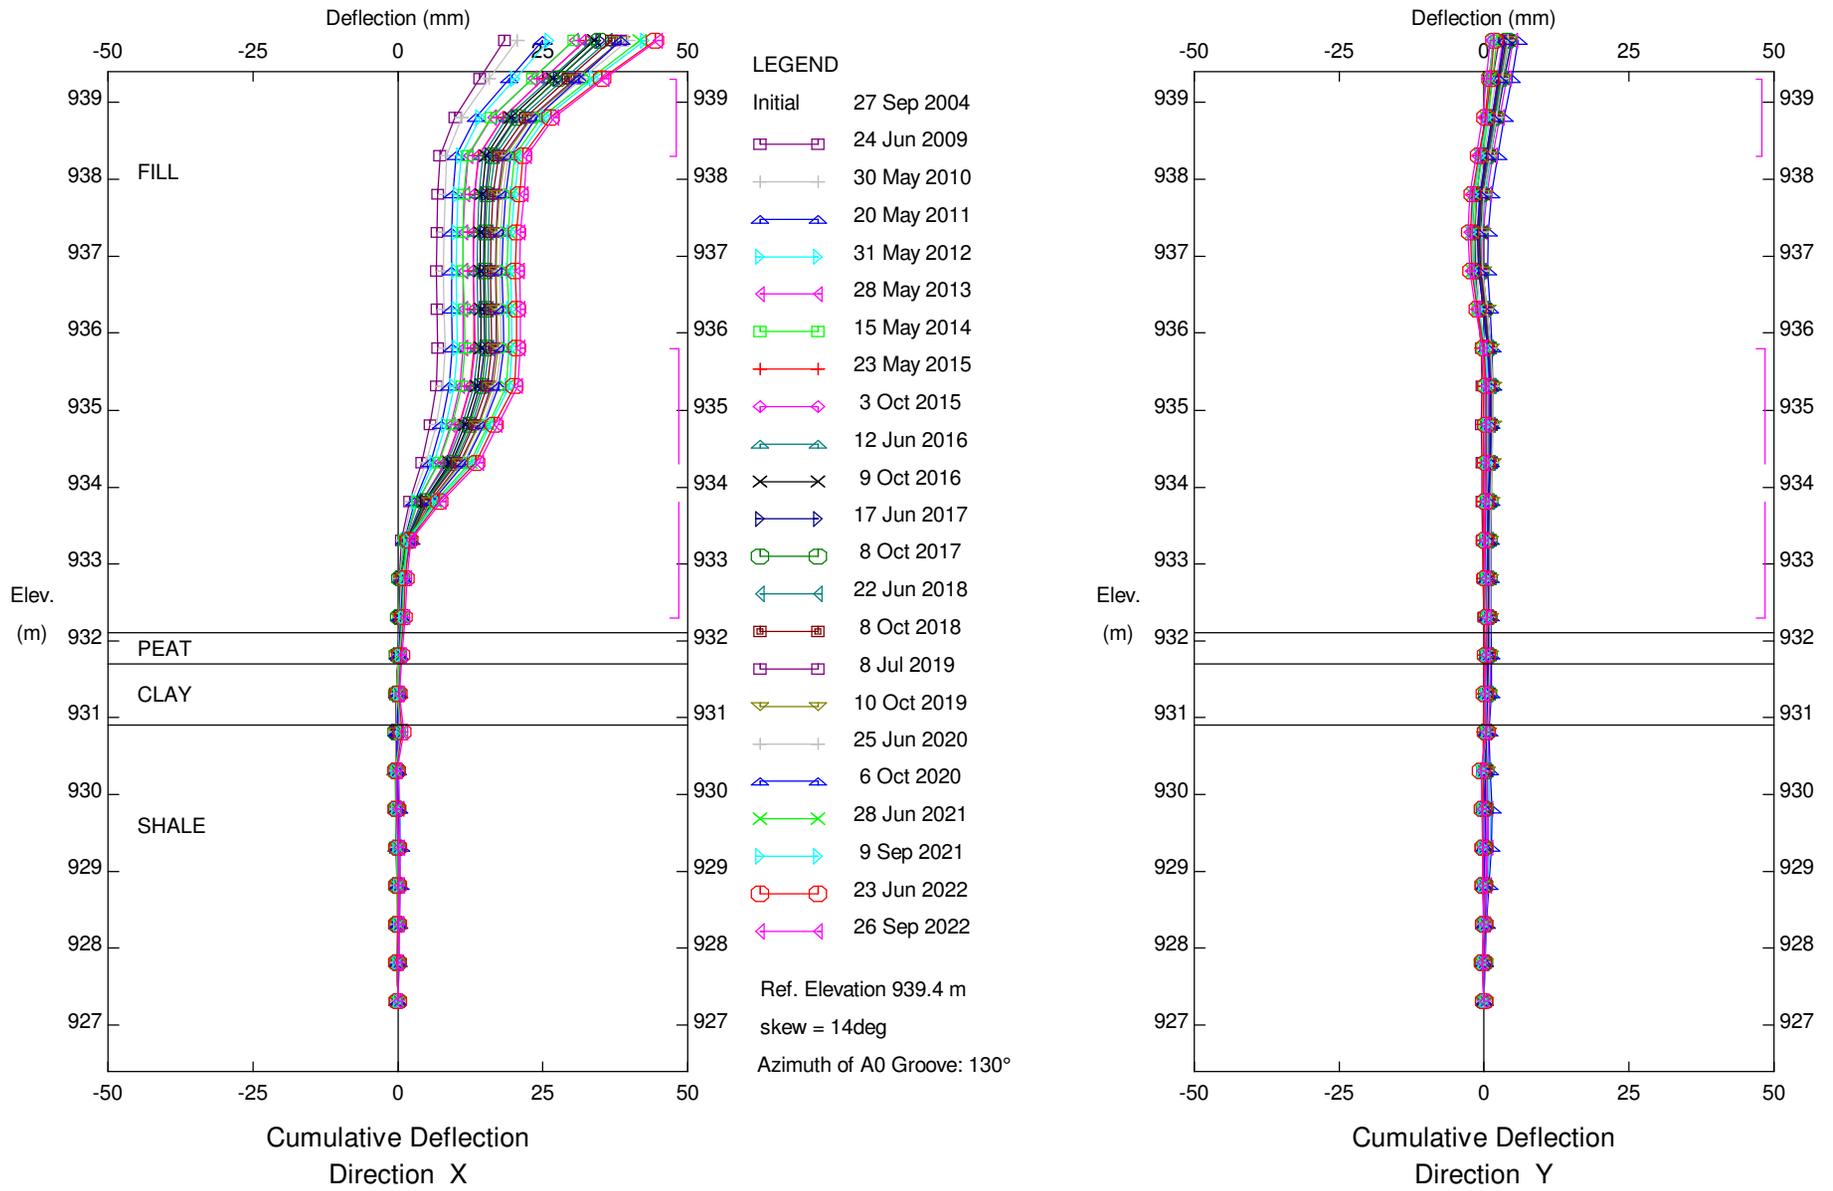
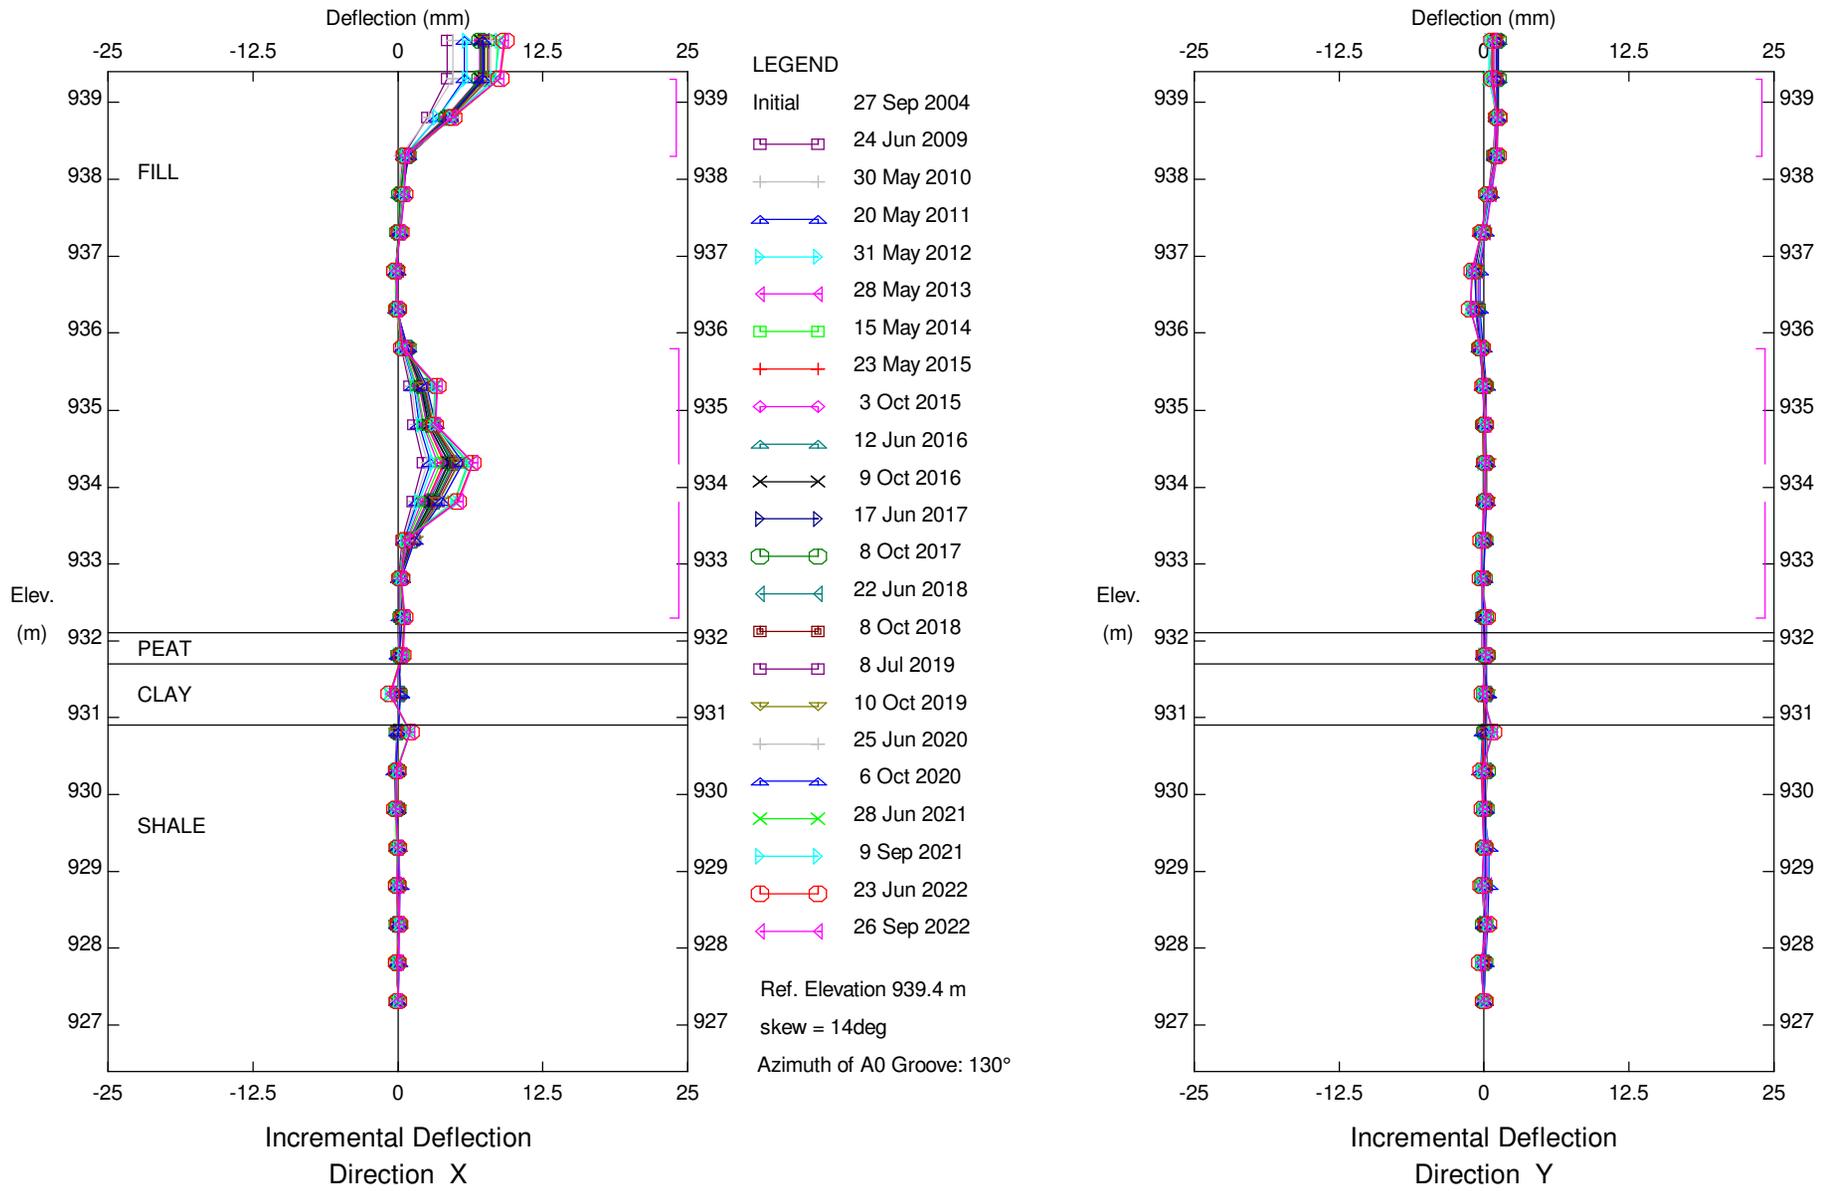
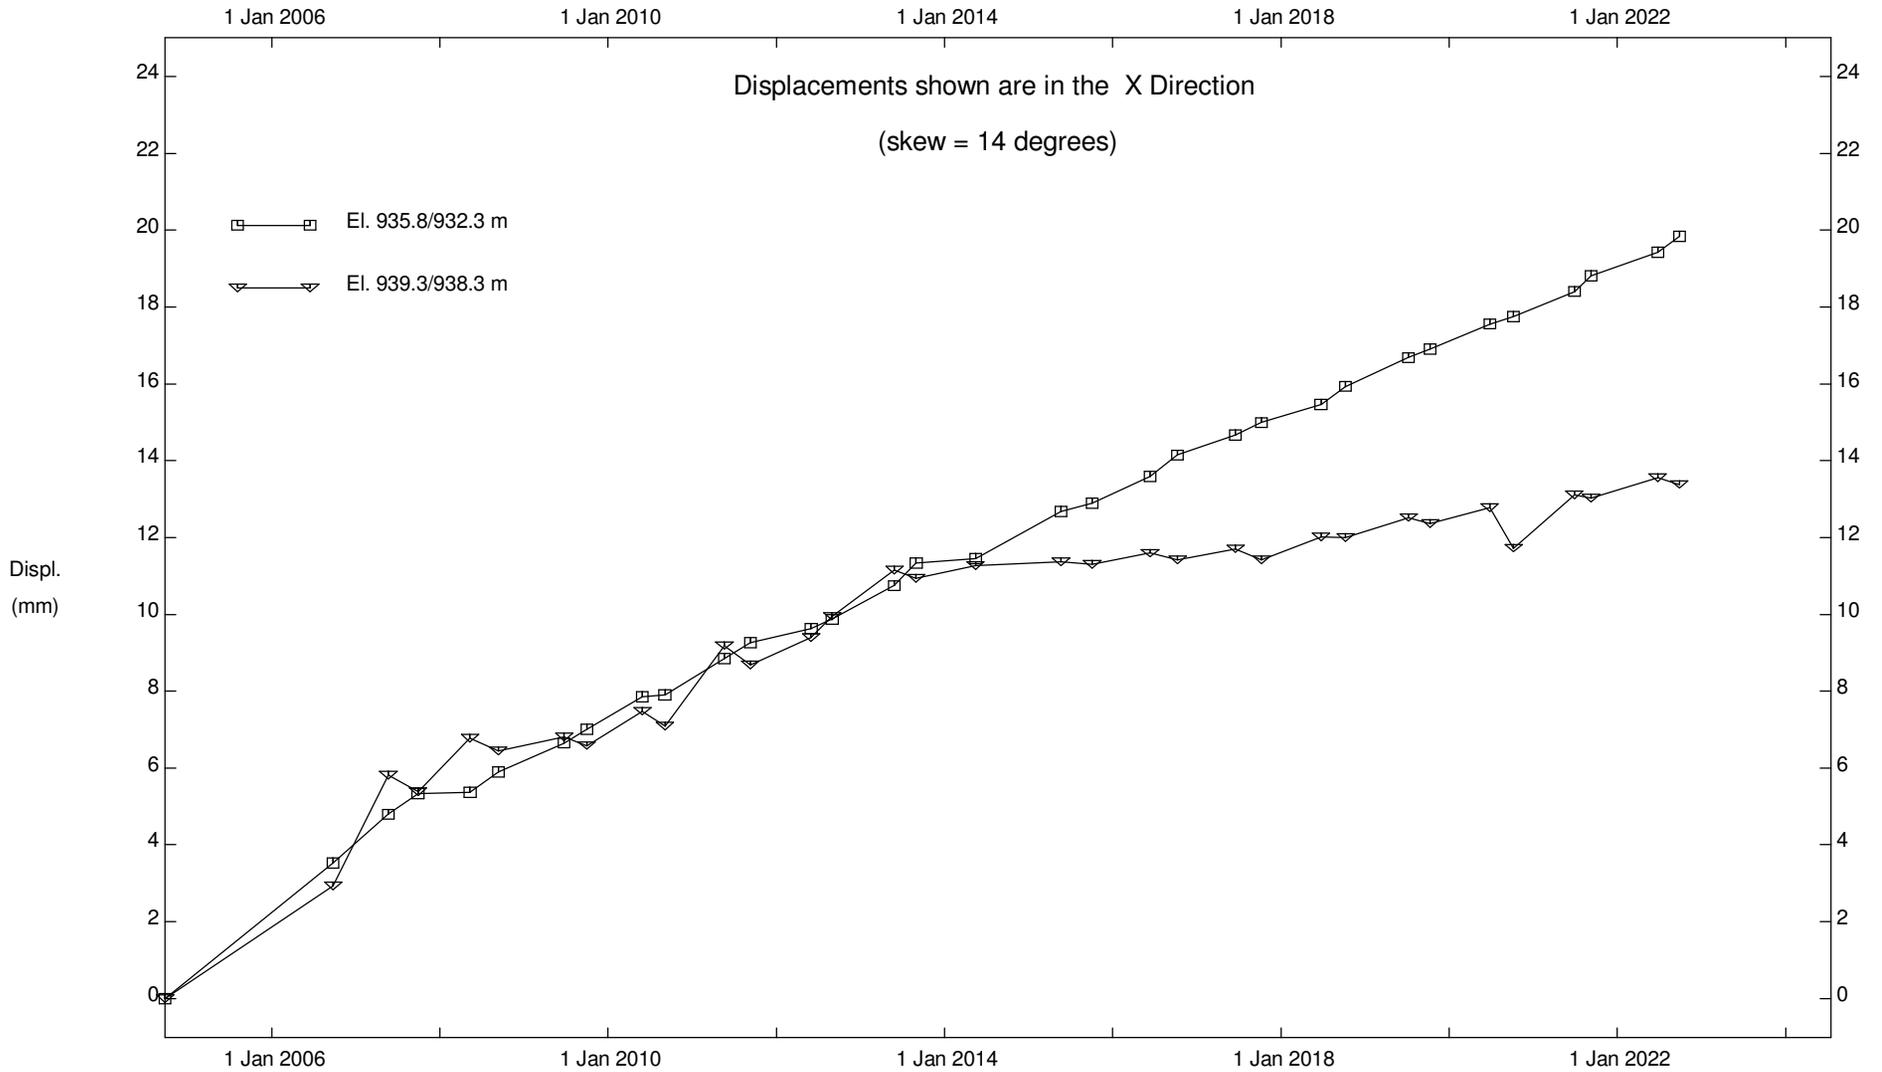
GP008; H40:36, Road Surface Slumping, Inclinometer SI-1
 Alberta Transportation

- SI-1 from ground surface to an approximate depth of 1.1 m below ground surface, and from approximately 3.6 m to 7.1 m below ground surface;
- SI-2 from ground surface to an approximate depth of 2.1 m below ground surface, and from approximately 2.1 m to 4.1 m below ground surface; and
- SI-3 from an approximate depth of 1.2 m to 2.1 m below ground surface with most the movement being recorded since May 2015.

Although a peat layer was identified in the SI data plots, the distributed shearing movements recorded in SI-1 appear to be in the lower portion of the fill, above the peat layer. The peat layer is the most likely cause of the movement and the SI data points may be shifted upwards due to soil logging or SI stick up issues. Alternatively, there could be a loose zone of fine-grained segregated material near the base of the fill that is straining under embankment load. Observations of the fill surface during the 2021 Section B Inspection indicated that the fill material is likely mine waste that could have been end-dumped in thick lifts (with minimal compaction) before or as part of highway construction. Movements recorded in SI-2 and SI-3 are well above the peat layer, indicating that straining of the embankment along a segregated fine-grained layer in the mine-waste fill is more likely.
