November 30, 2022

CON0022166 Peace Region (Grande Prairie District – South) GRMP Instrumentation Monitoring Site GP008; H40:36, km 16.365 Road Surface Slumping (2.5 km North of McIntyre Mine) Section C – 2022 Fall Readings

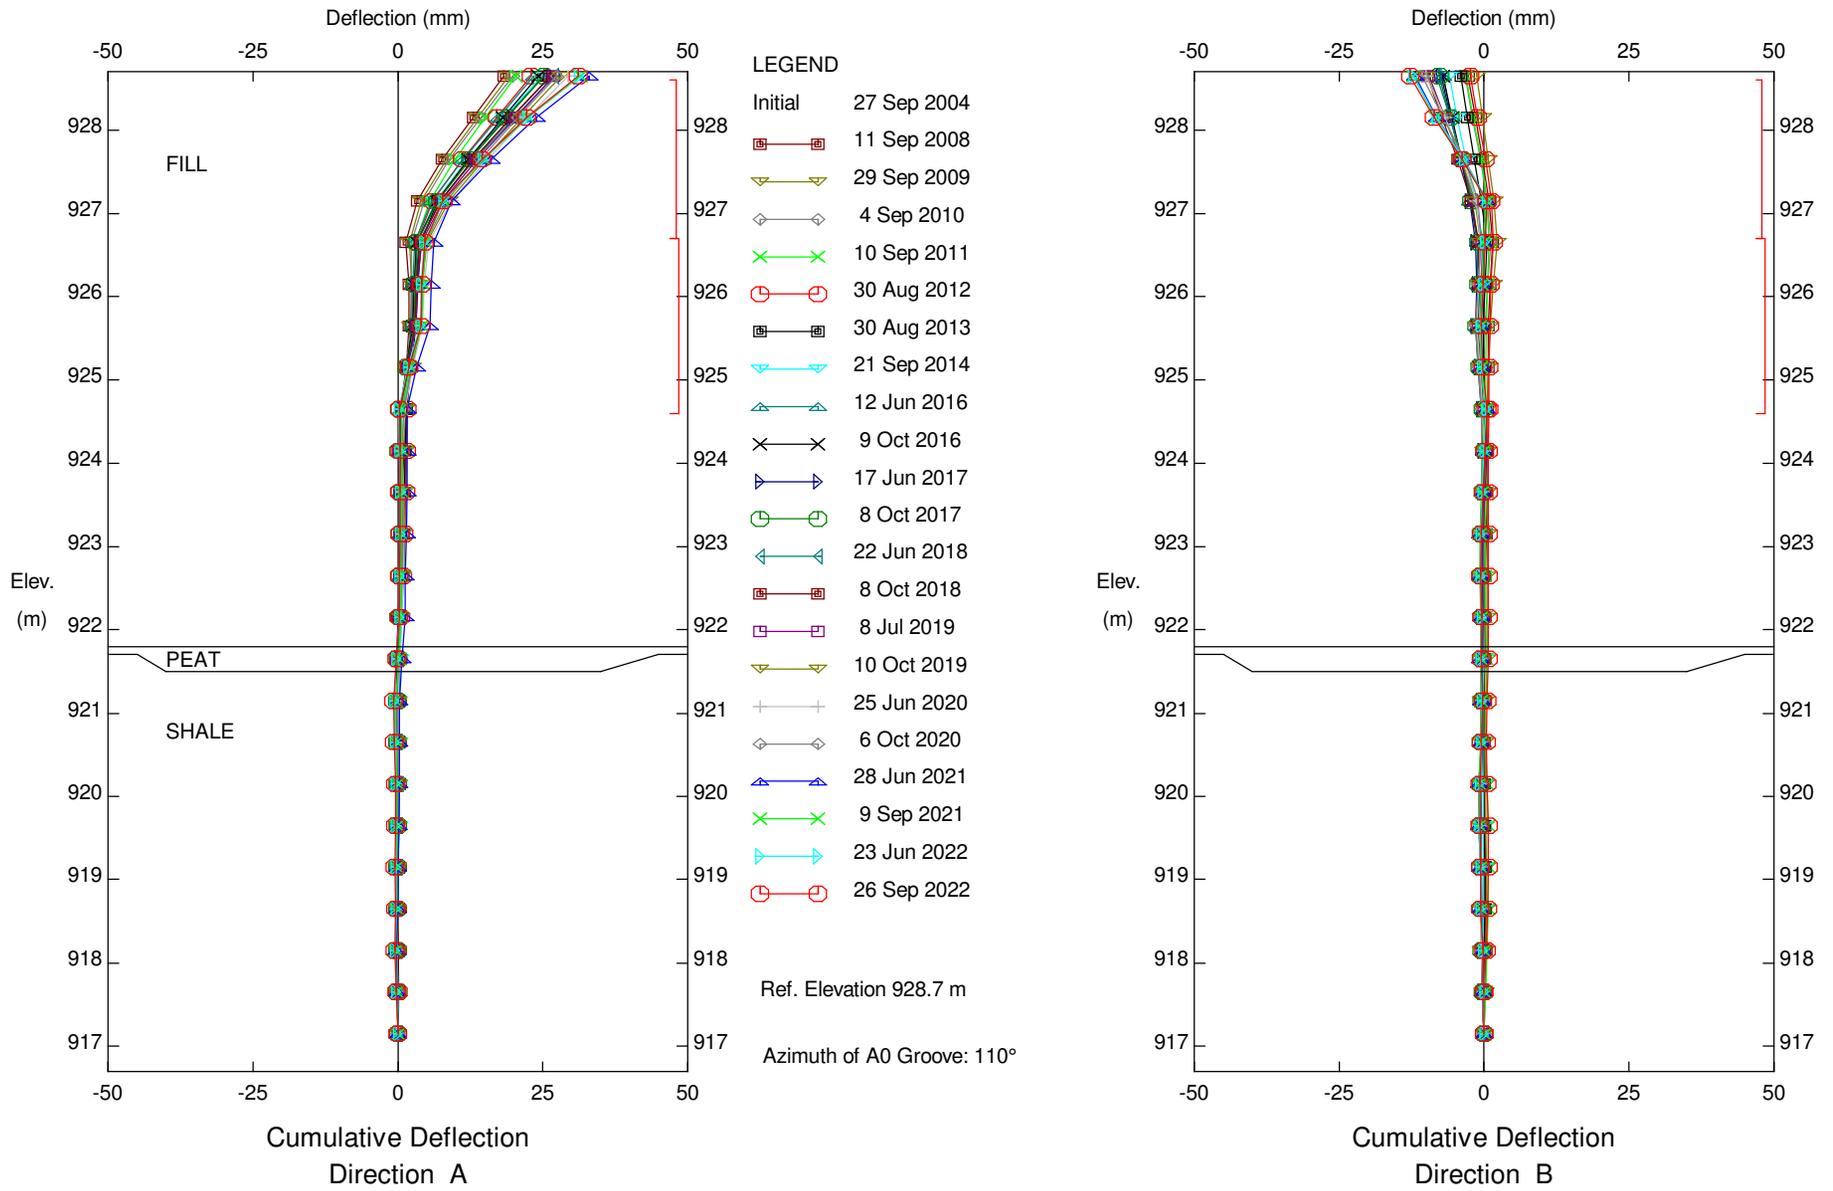
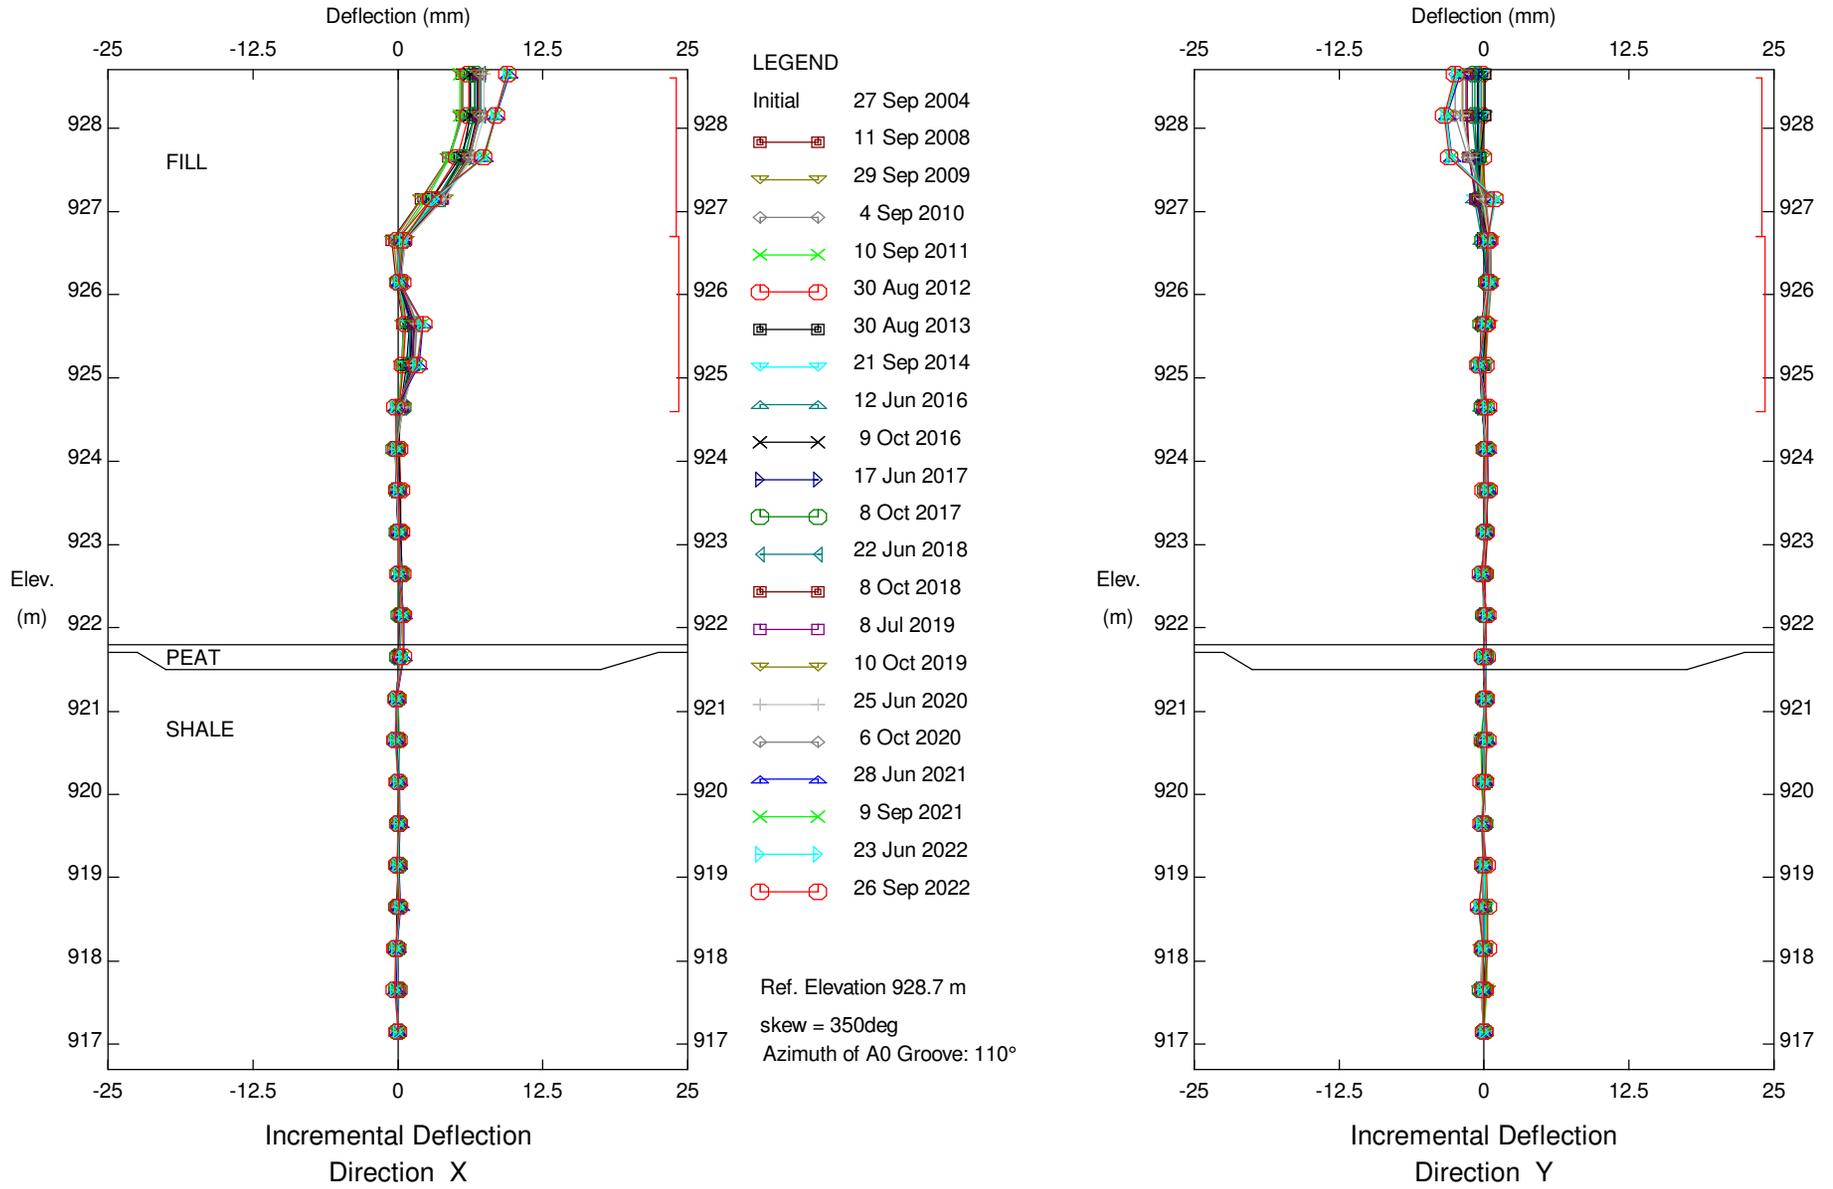
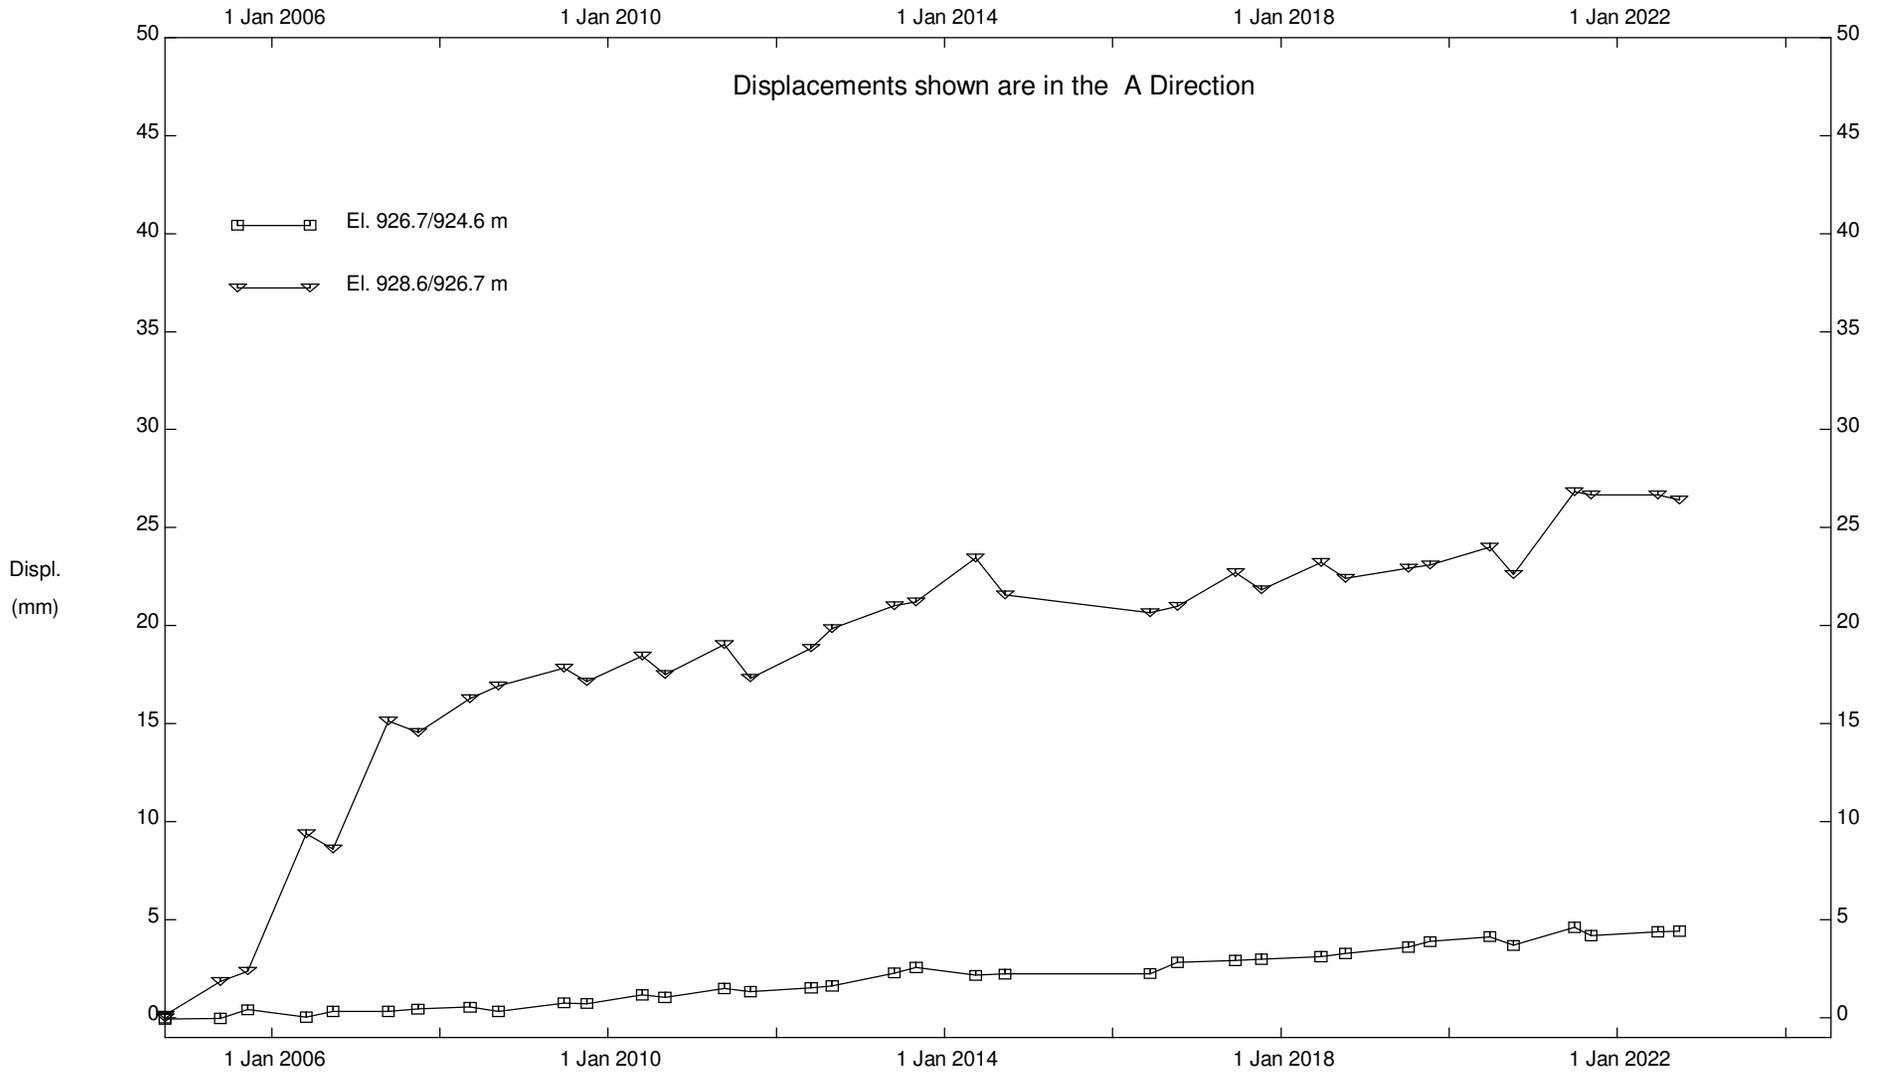
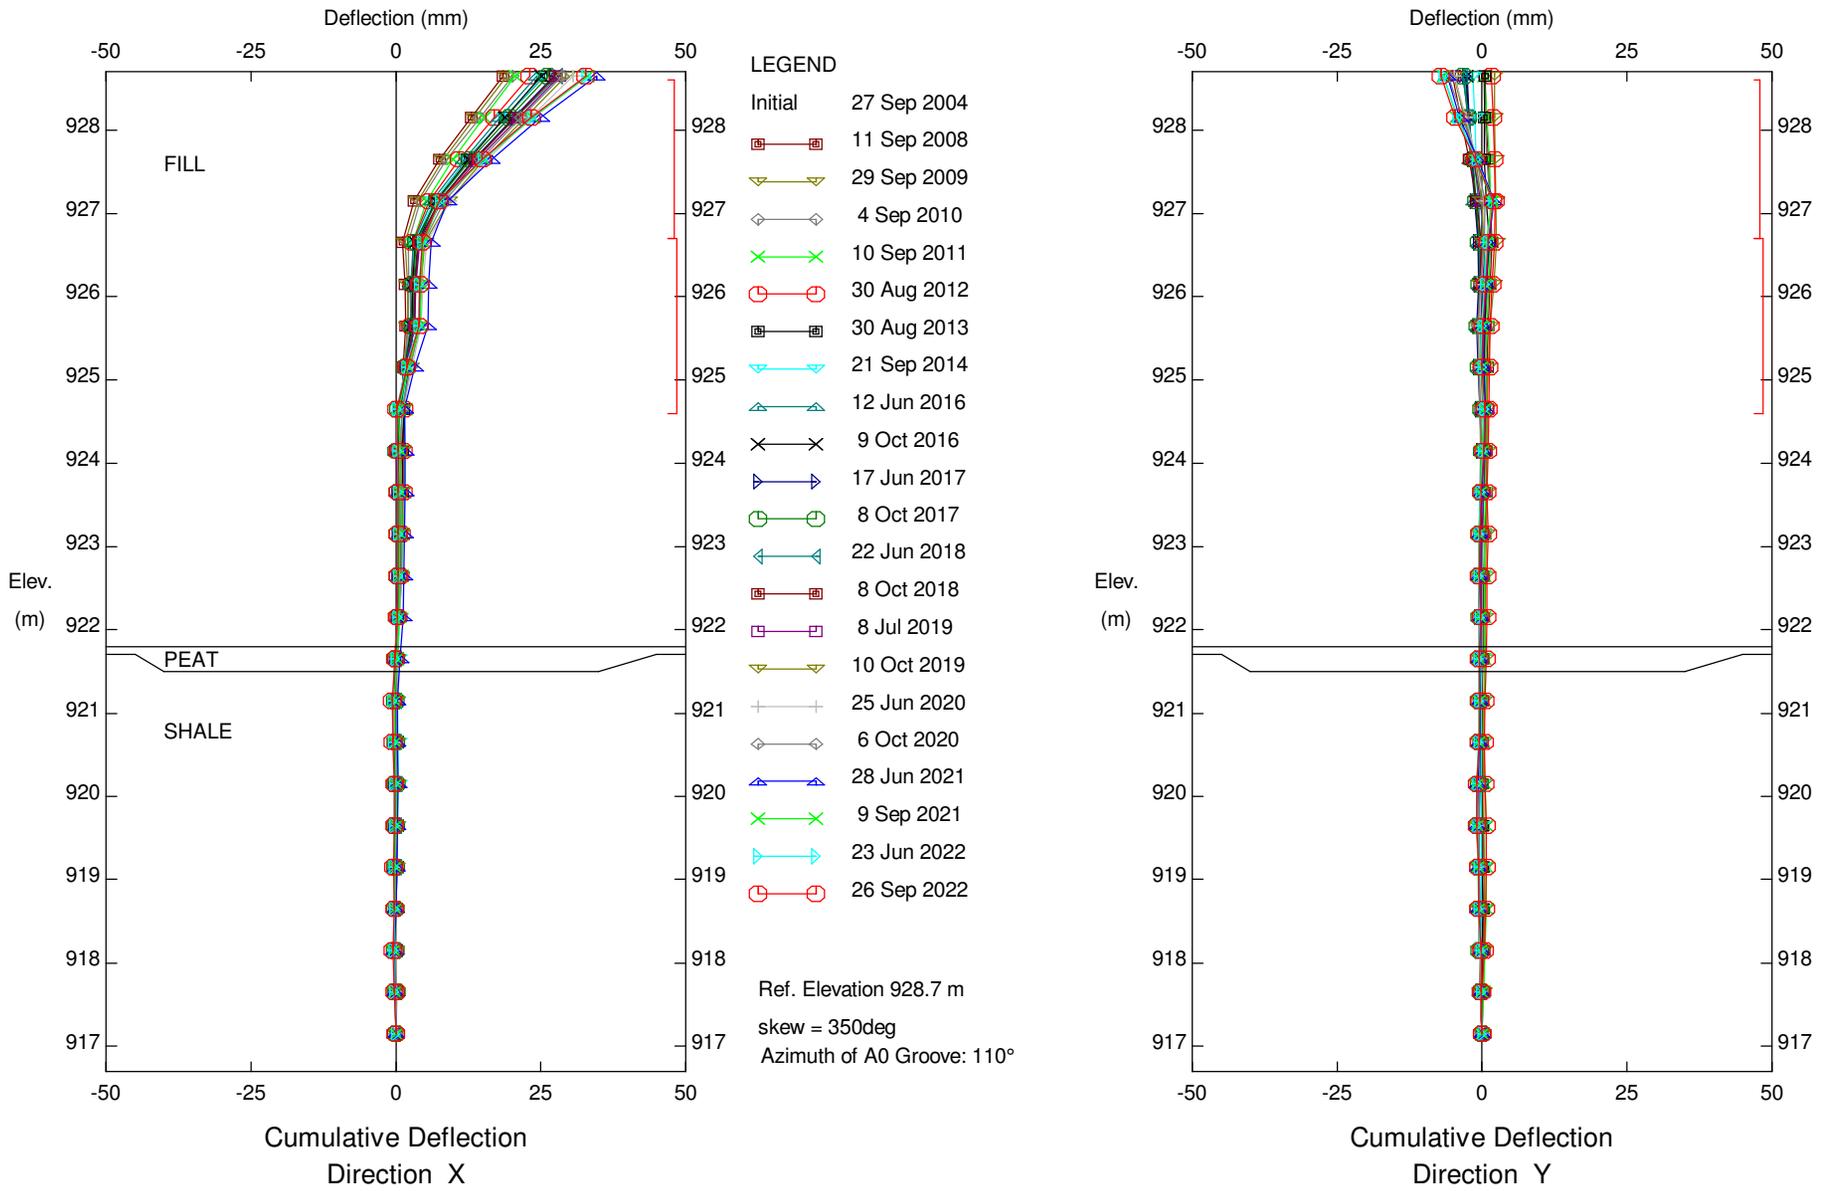
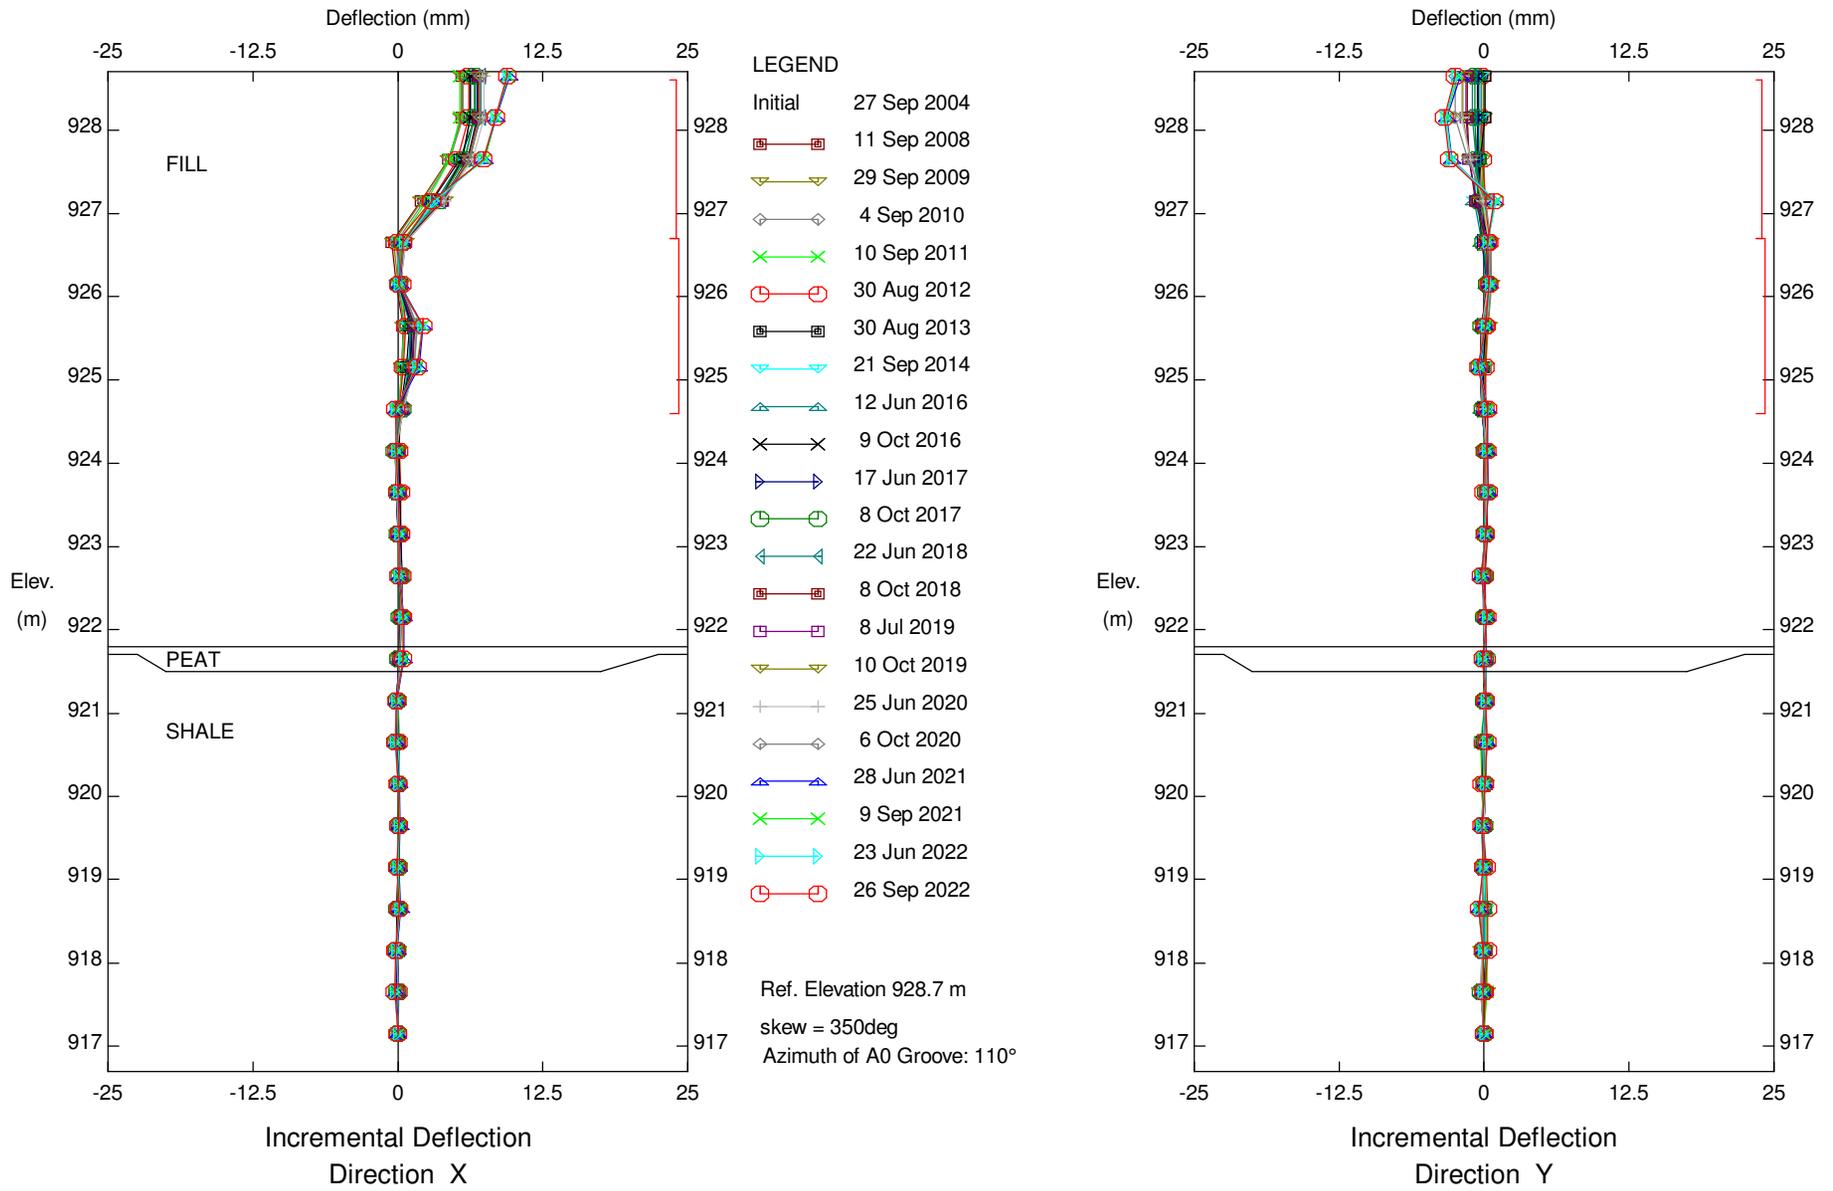
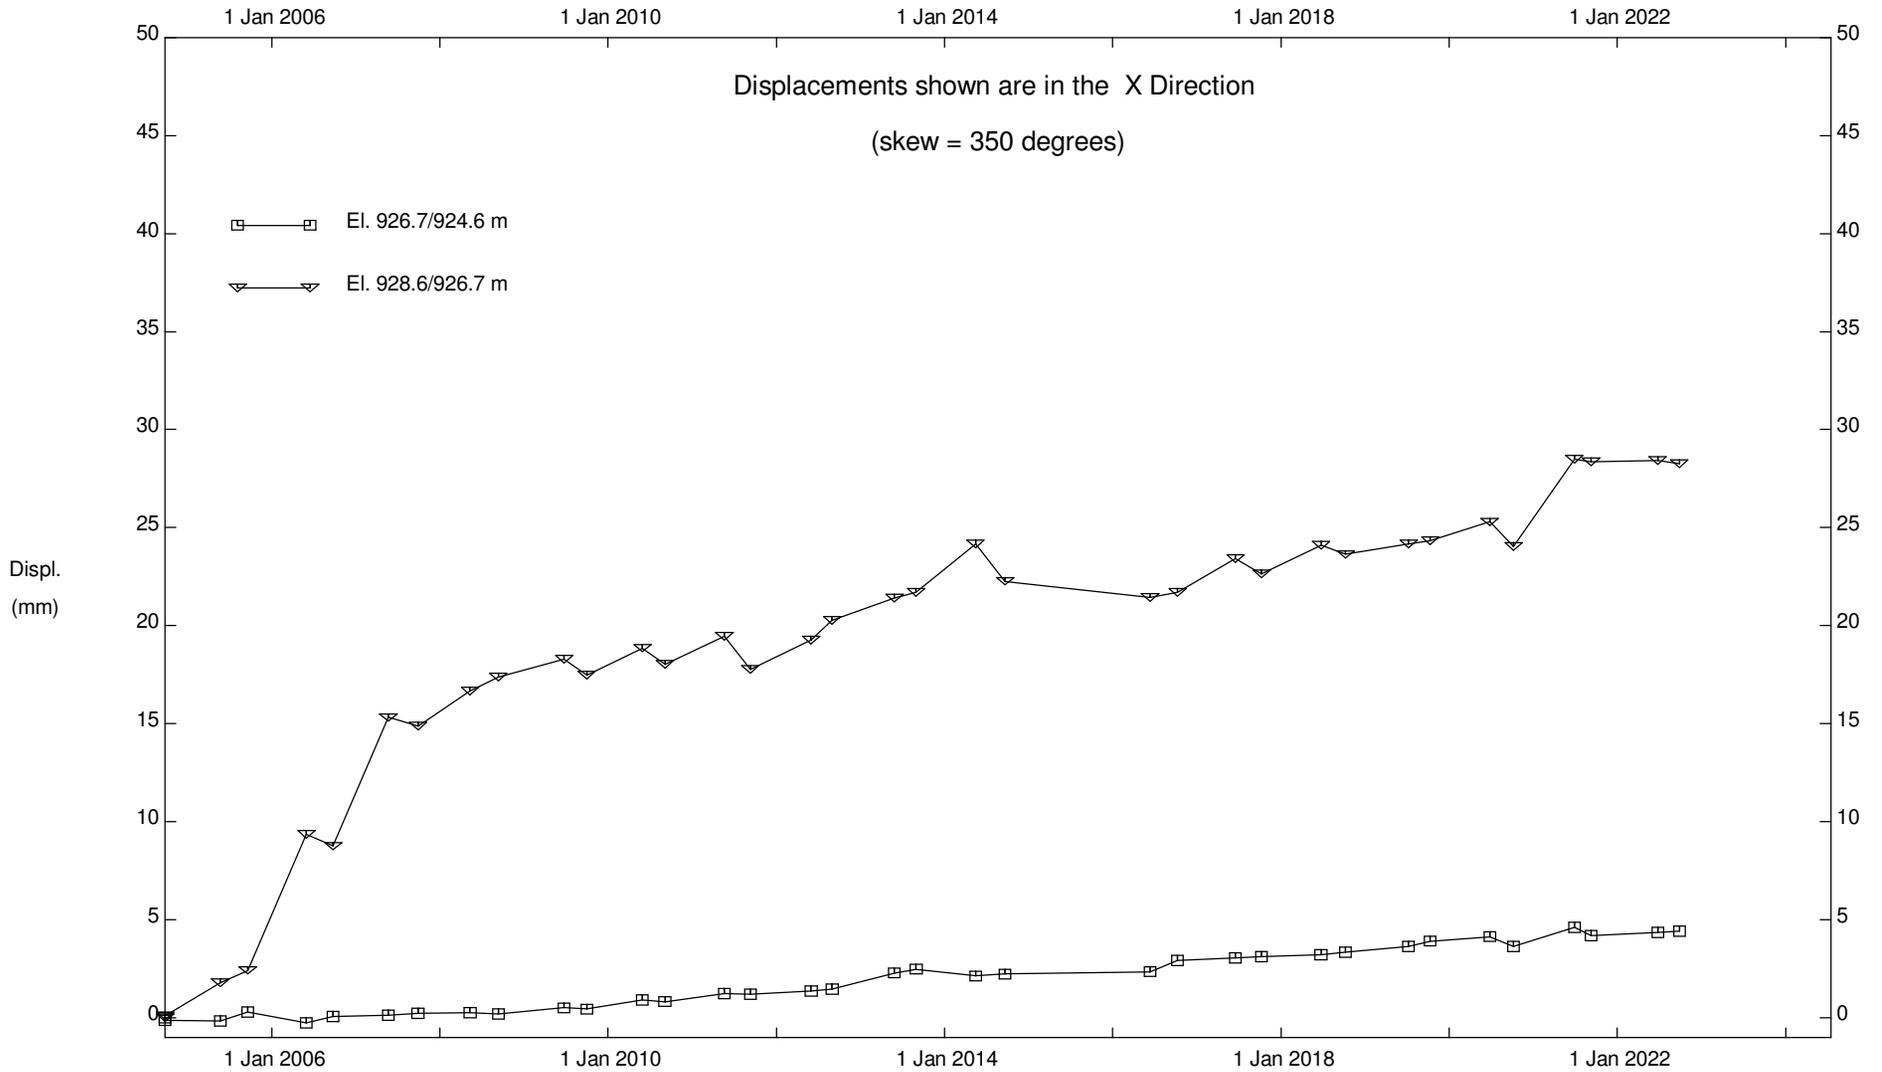
GP008; H40:36, Road Surface Slumping, Inclinator SI-2
Alberta Transportation

- SI-1 from ground surface to an approximate depth of 1.1 m below ground surface, and from approximately 3.6 m to 7.1 m below ground surface;
- SI-2 from ground surface to an approximate depth of 2.1 m below ground surface, and from approximately 2.1 m to 4.1 m below ground surface; and
- SI-3 from an approximate depth of 1.2 m to 2.1 m below ground surface with most the movement being recorded since May 2015.

Since the instruments were installed in 2007, the rate of movement being recorded in SI-1, SI-2, and SI-3 in the fill has been slow (less than 2 mm/year), except for increased movement (up to approximately 6 mm/year) recorded in the X-direction of SI-2 in early 2006 and 2021. In 2021, the increased rate of movement recorded in SI-2 was likely a result of the SI reading equipment being changed when KCB took over the instrument readings. Since 2021, the movement rates are once again slow (less than 2 mm/year).
