November 30, 2022

CON0022166 Peace Region (Grande Prairie District – South) GRMP Instrumentation Monitoring Site GP008; H40:36, km 16.365 Road Surface Slumping (2.5 km North of McIntyre Mine) Section C – 2022 Fall Readings

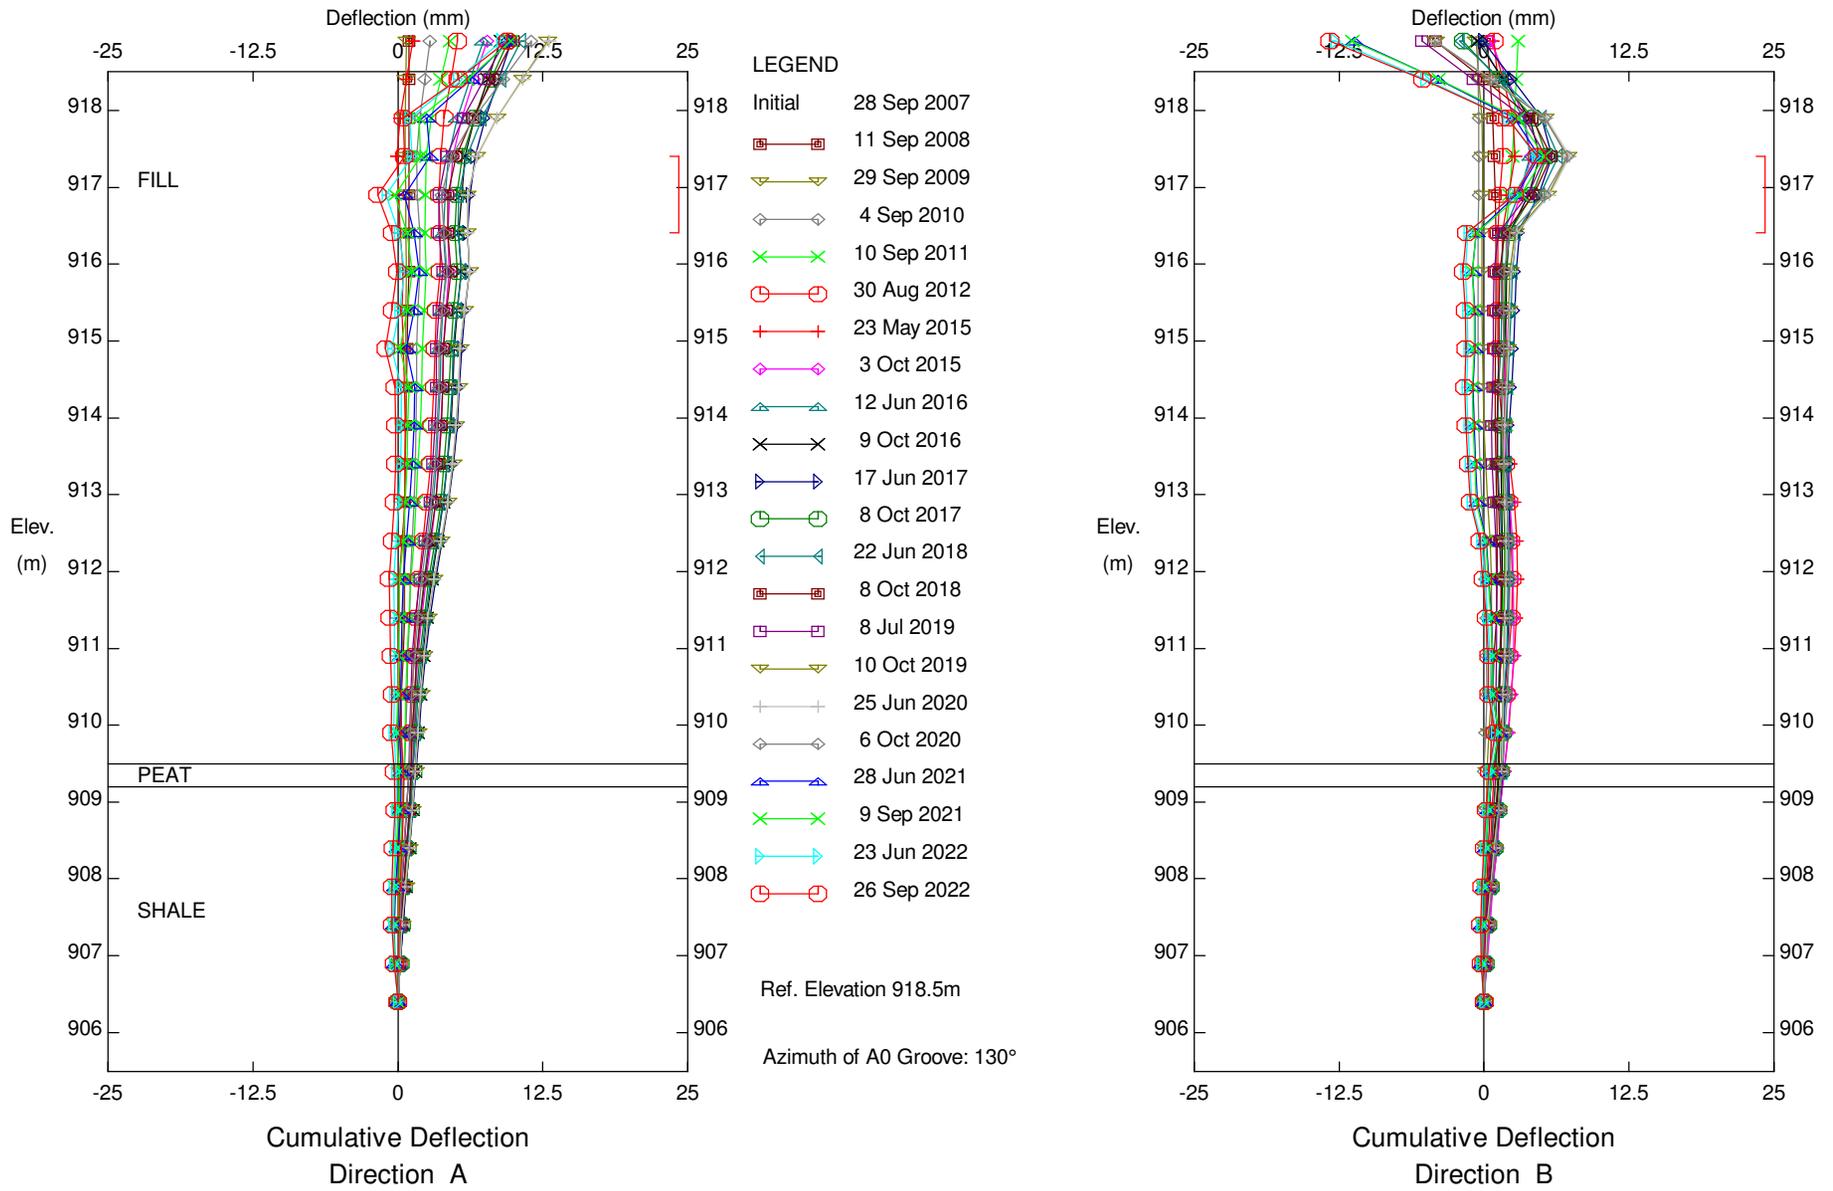
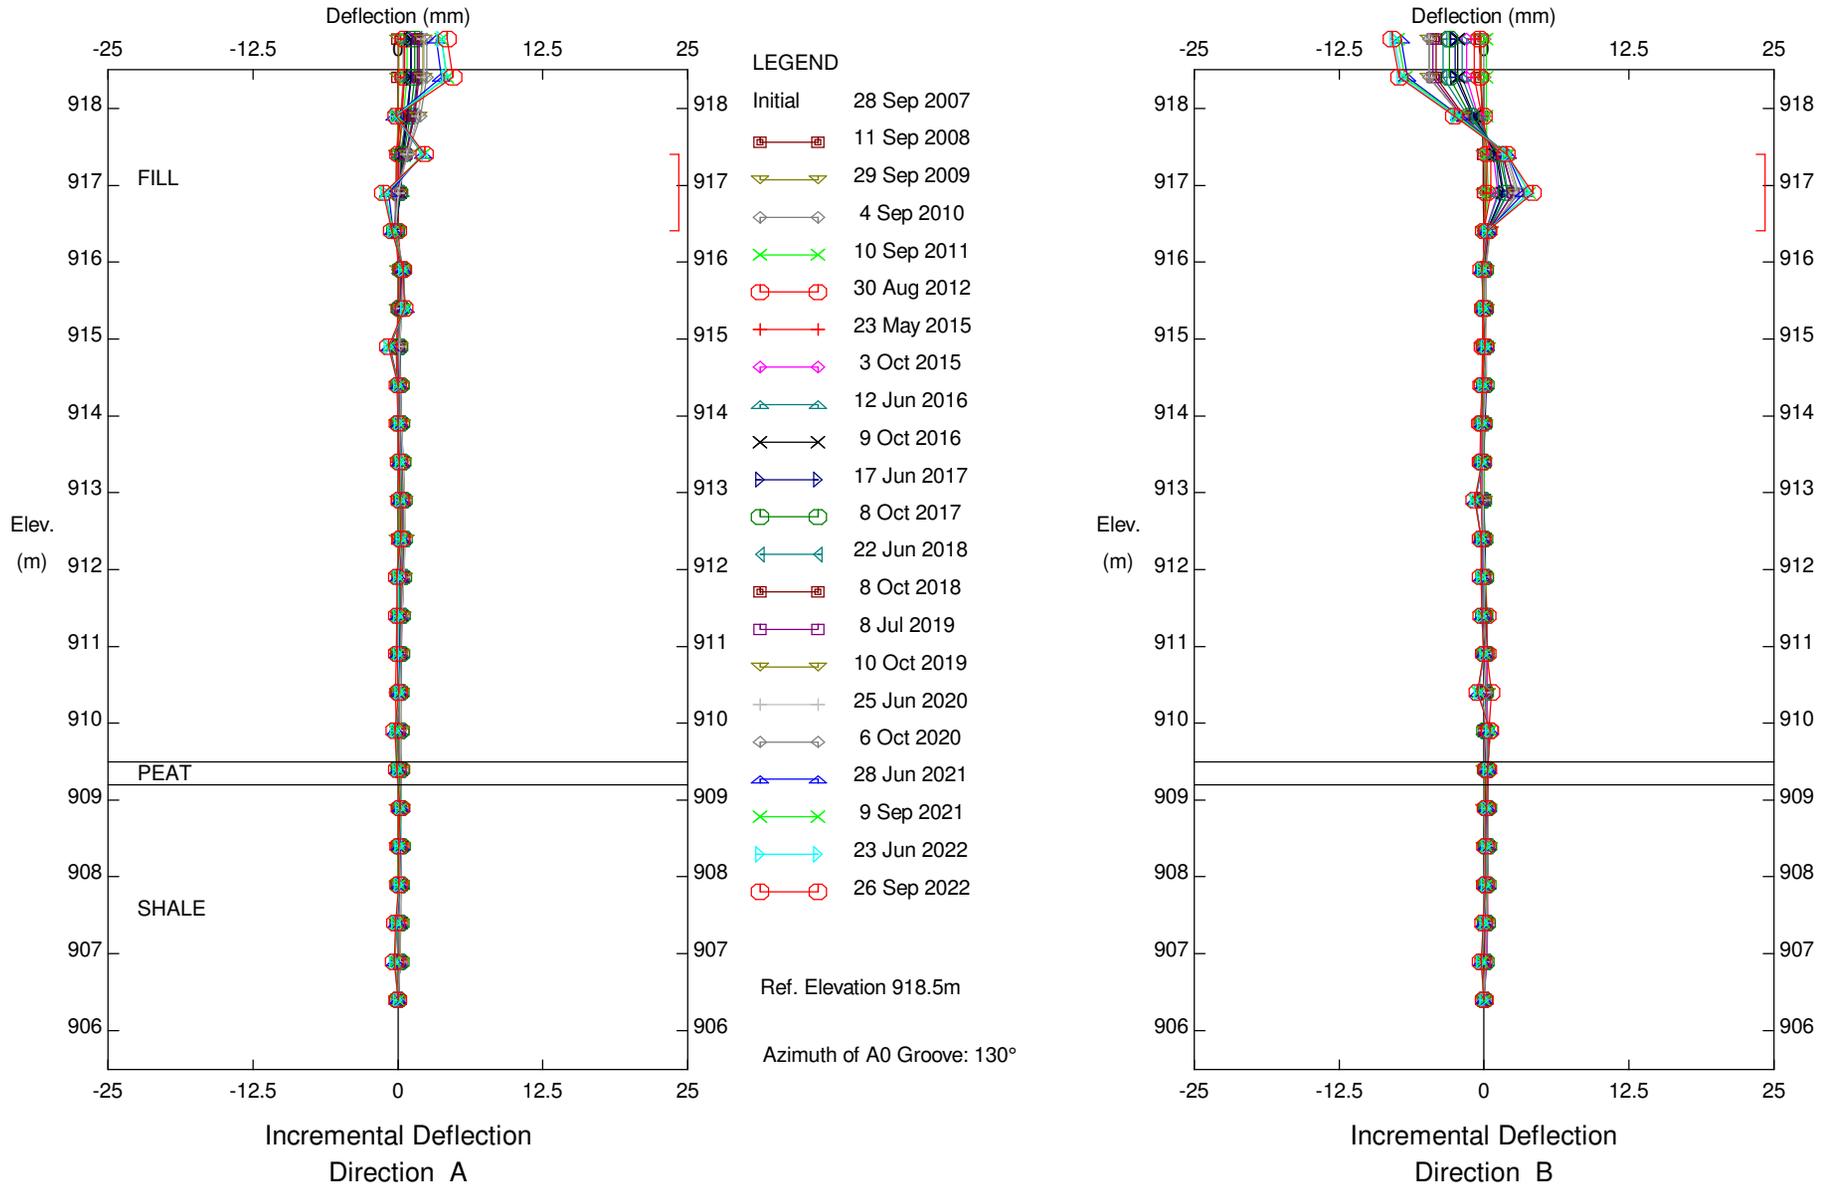
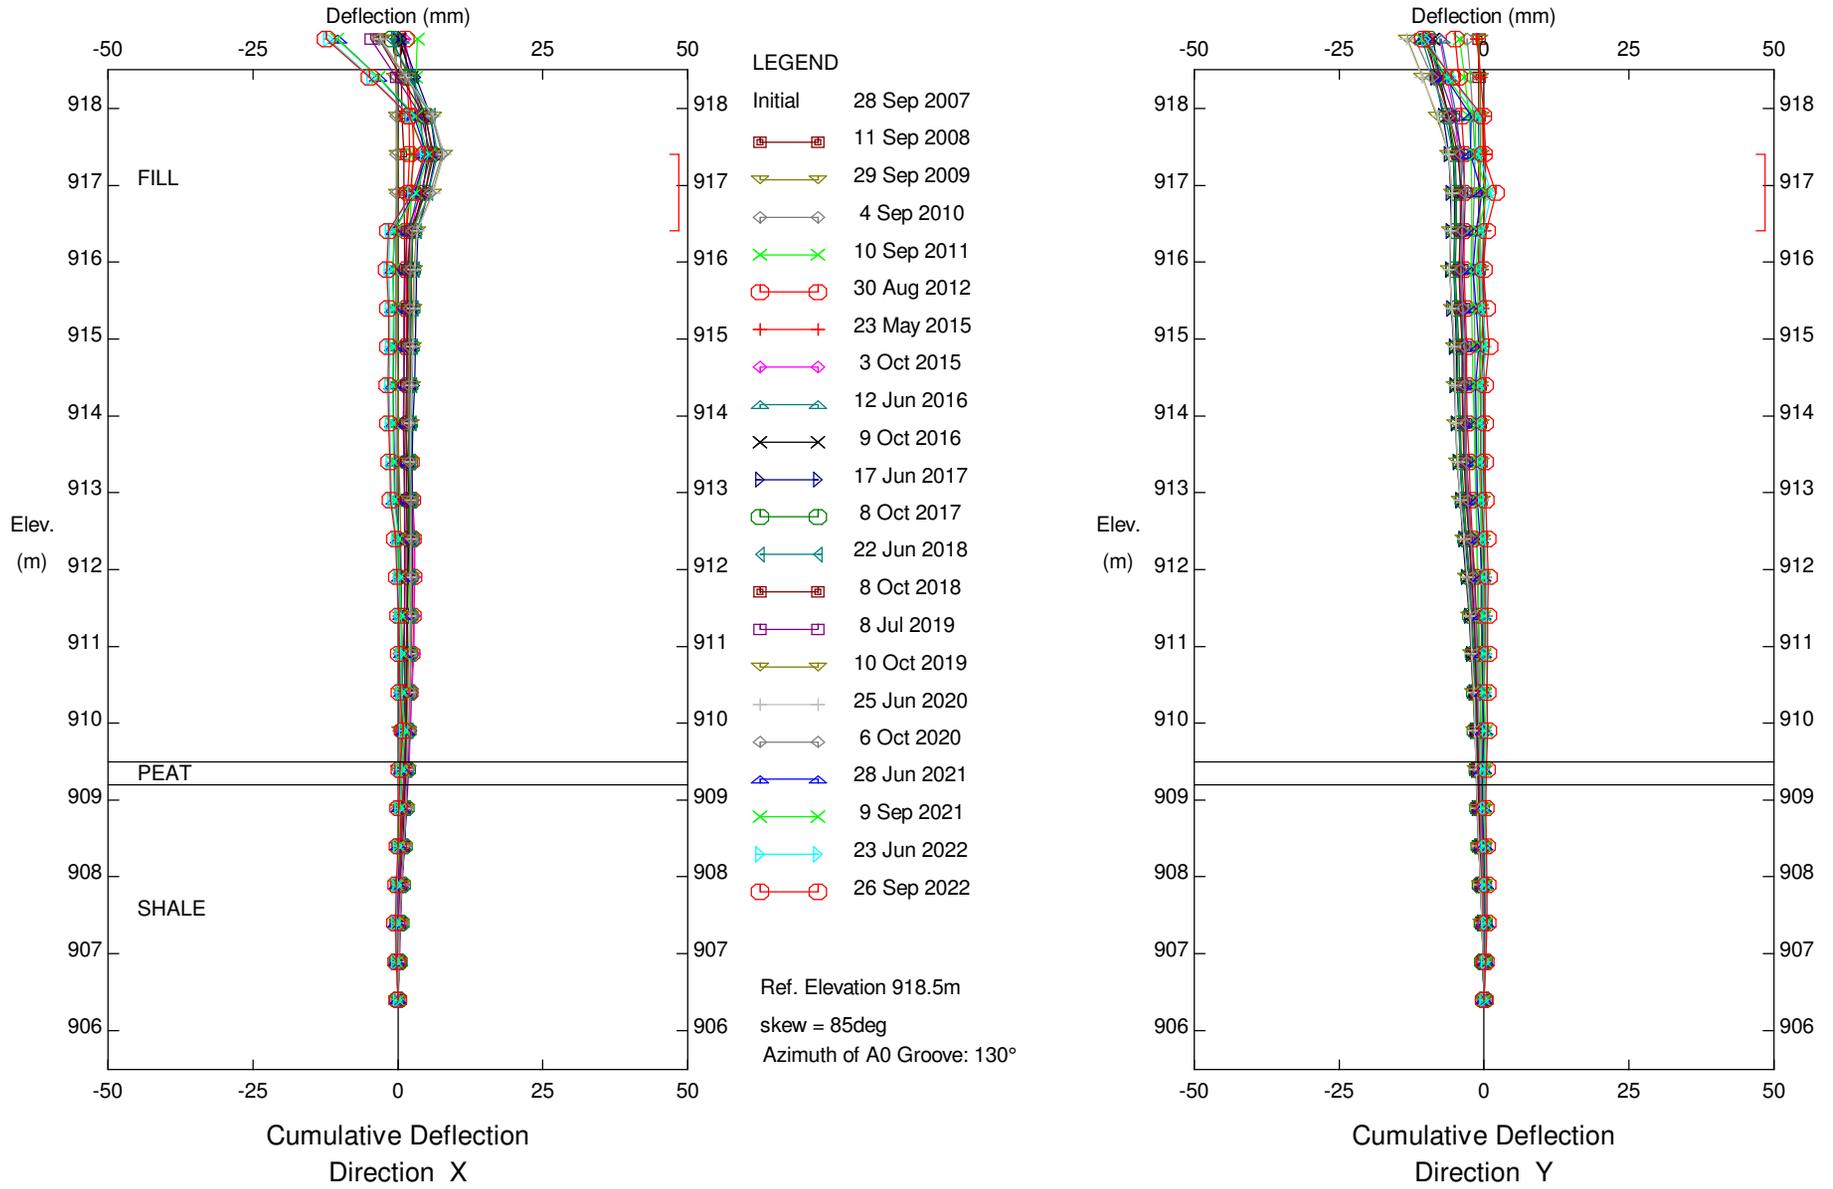
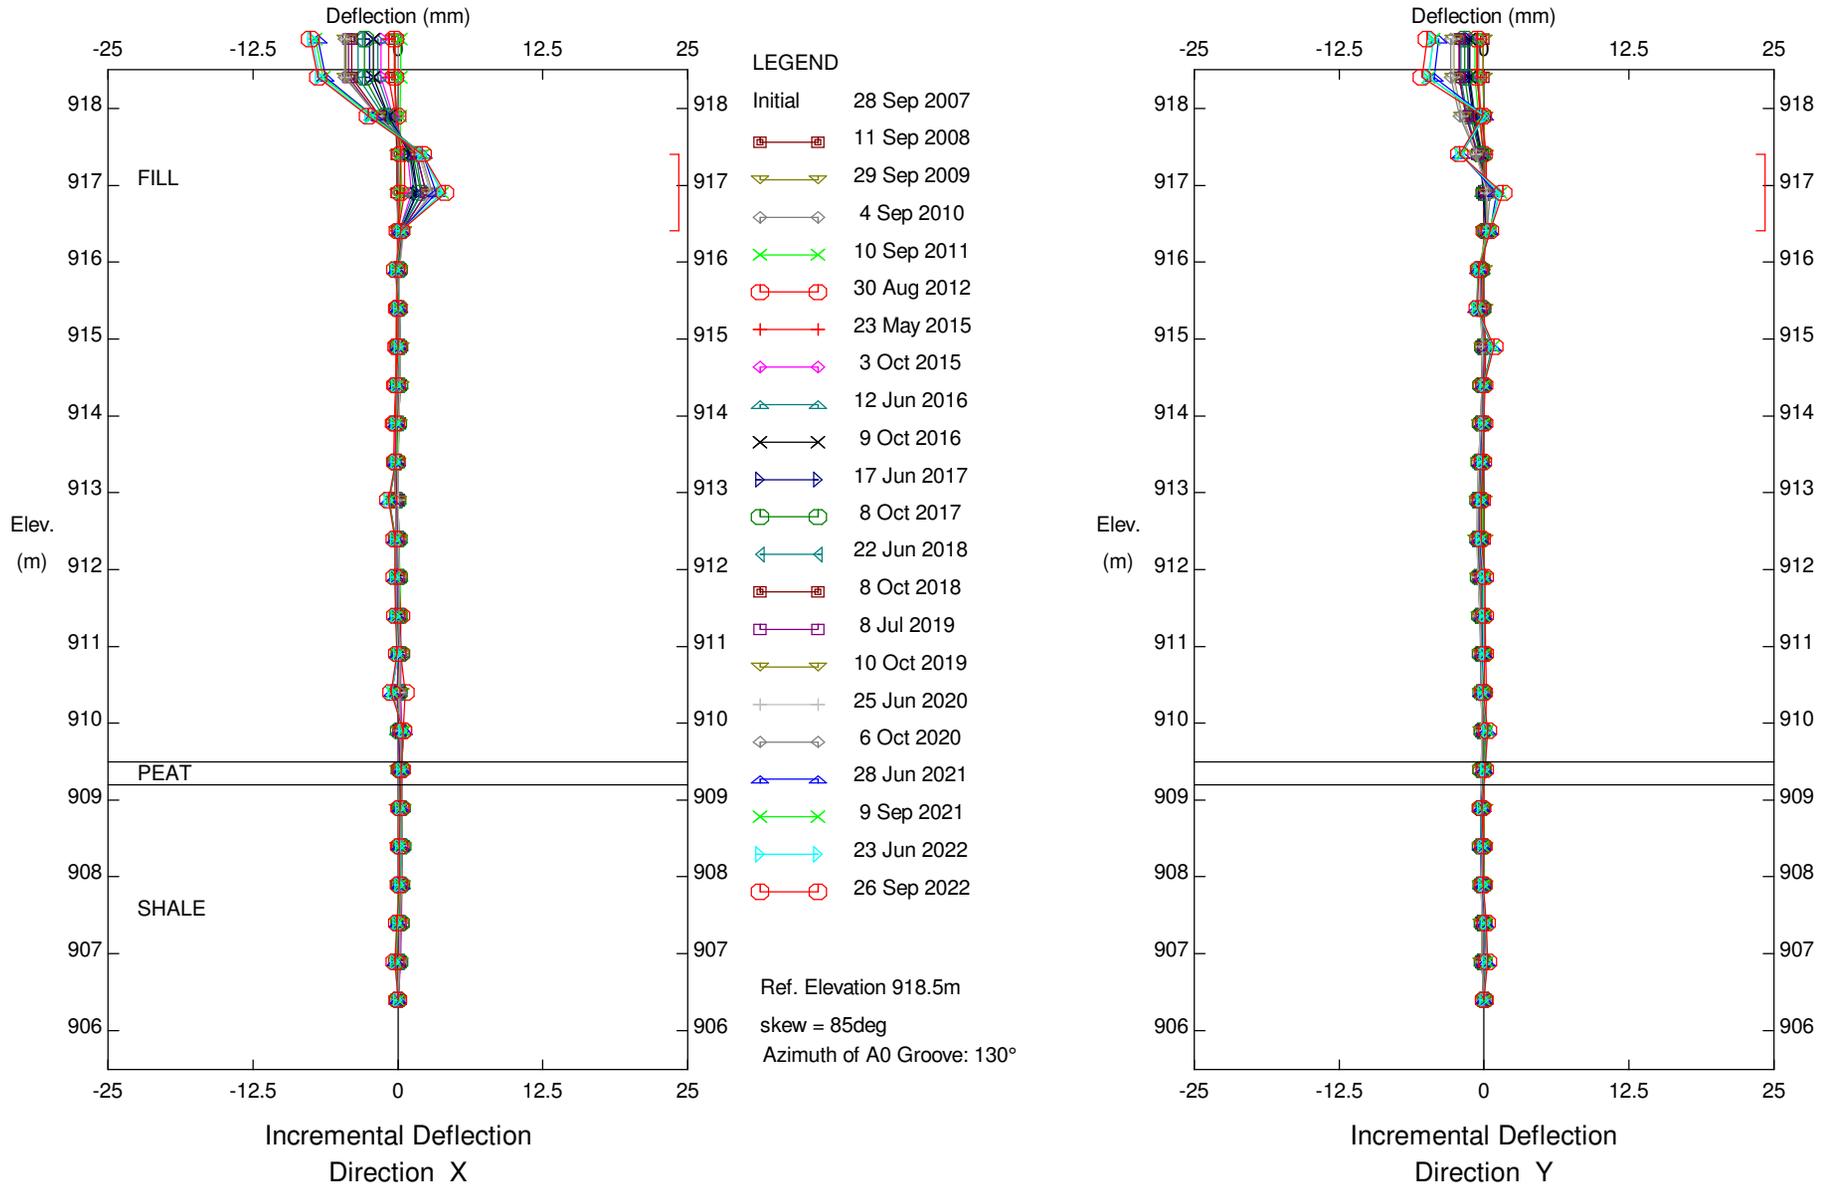
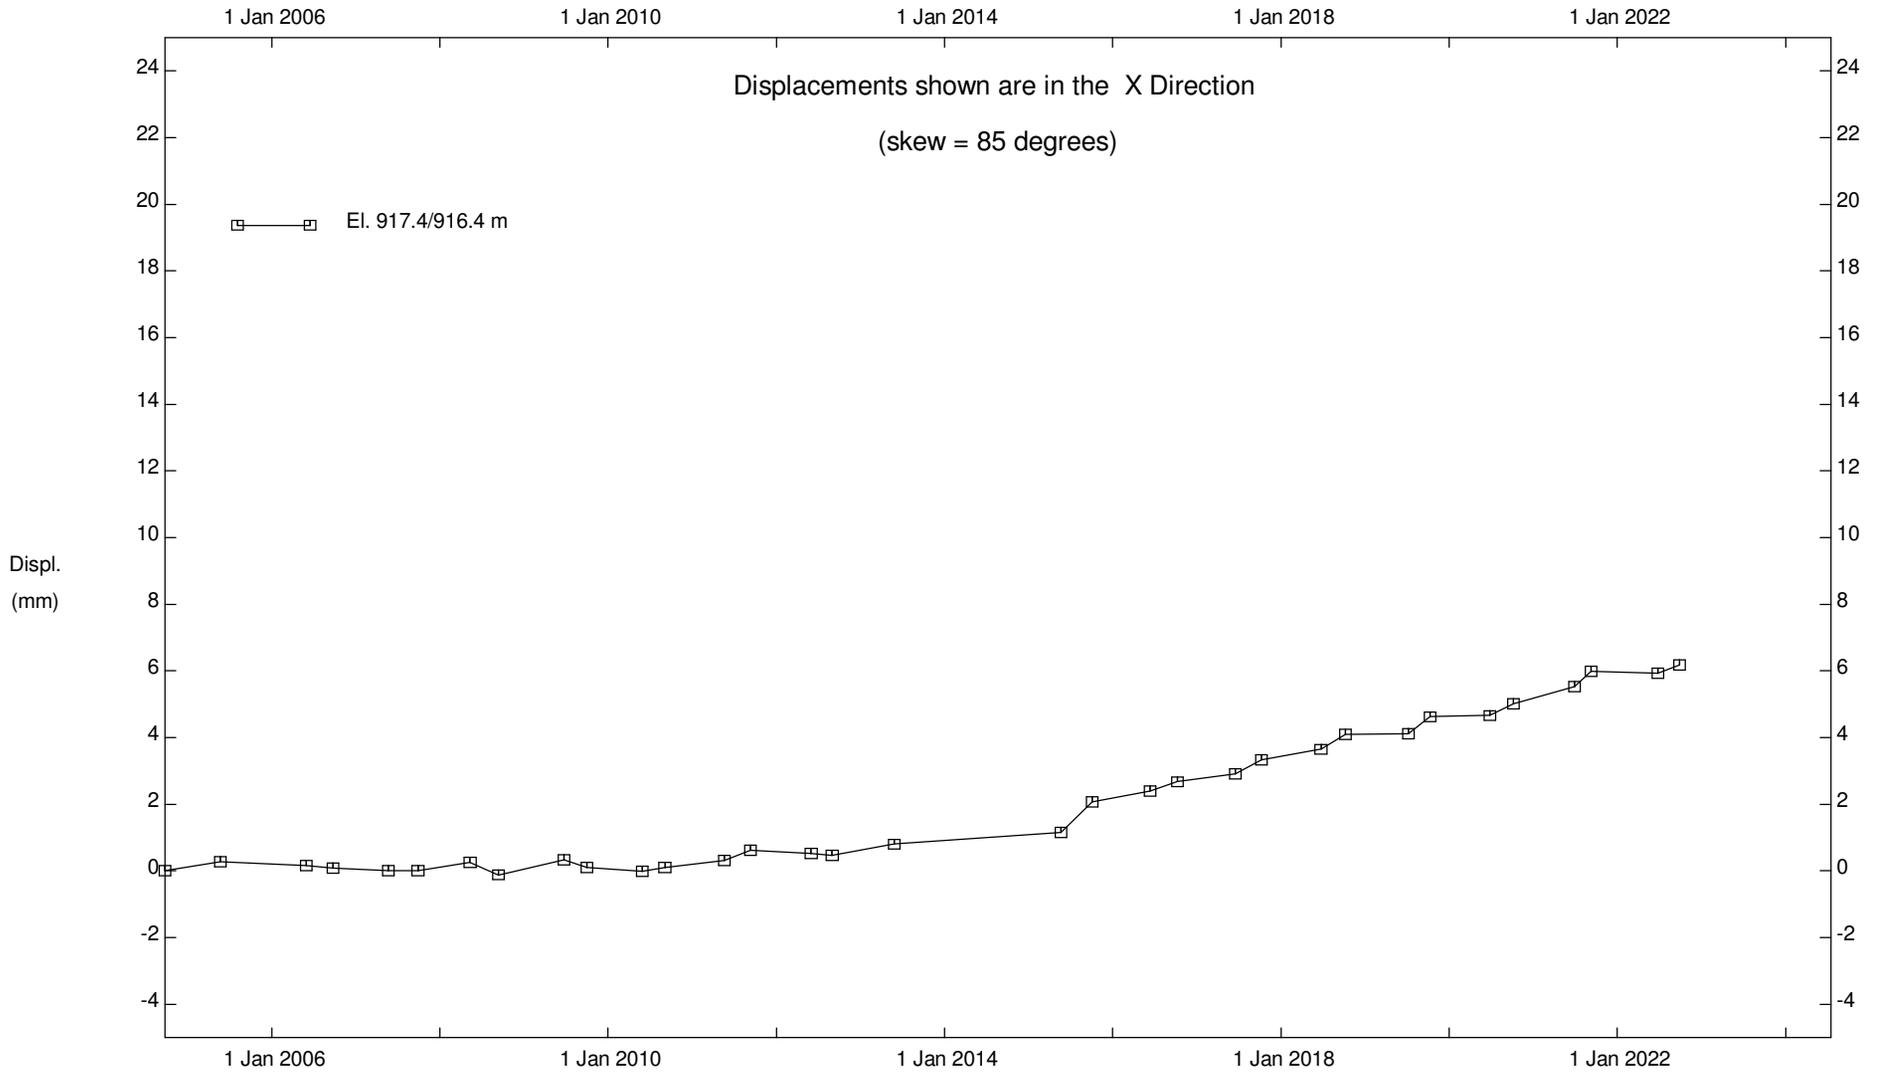
GP008; H40:36, Road Surface Slumping, Inclinometer SI-3
Alberta Transportation

- SI-1 from ground surface to an approximate depth of 1.1 m below ground surface, and from approximately 3.6 m to 7.1 m below ground surface;
- SI-2 from ground surface to an approximate depth of 2.1 m below ground surface, and from approximately 2.1 m to 4.1 m below ground surface; and
- SI-3 from an approximate depth of 1.2 m to 2.1 m below ground surface with most the movement being recorded since May 2015.

SI-1 and SI-2 (located near the top of the slope and mid-slope, respectively) are recording movement to the southeast. However, SI-3 (located near the toe of the slope) is recording movement more towards the southwest. This could indicate that the movement pattern for the highway embankment is complicated and difficult to assess, given that the highway embankment was constructed in thick lifts with minimal compaction.

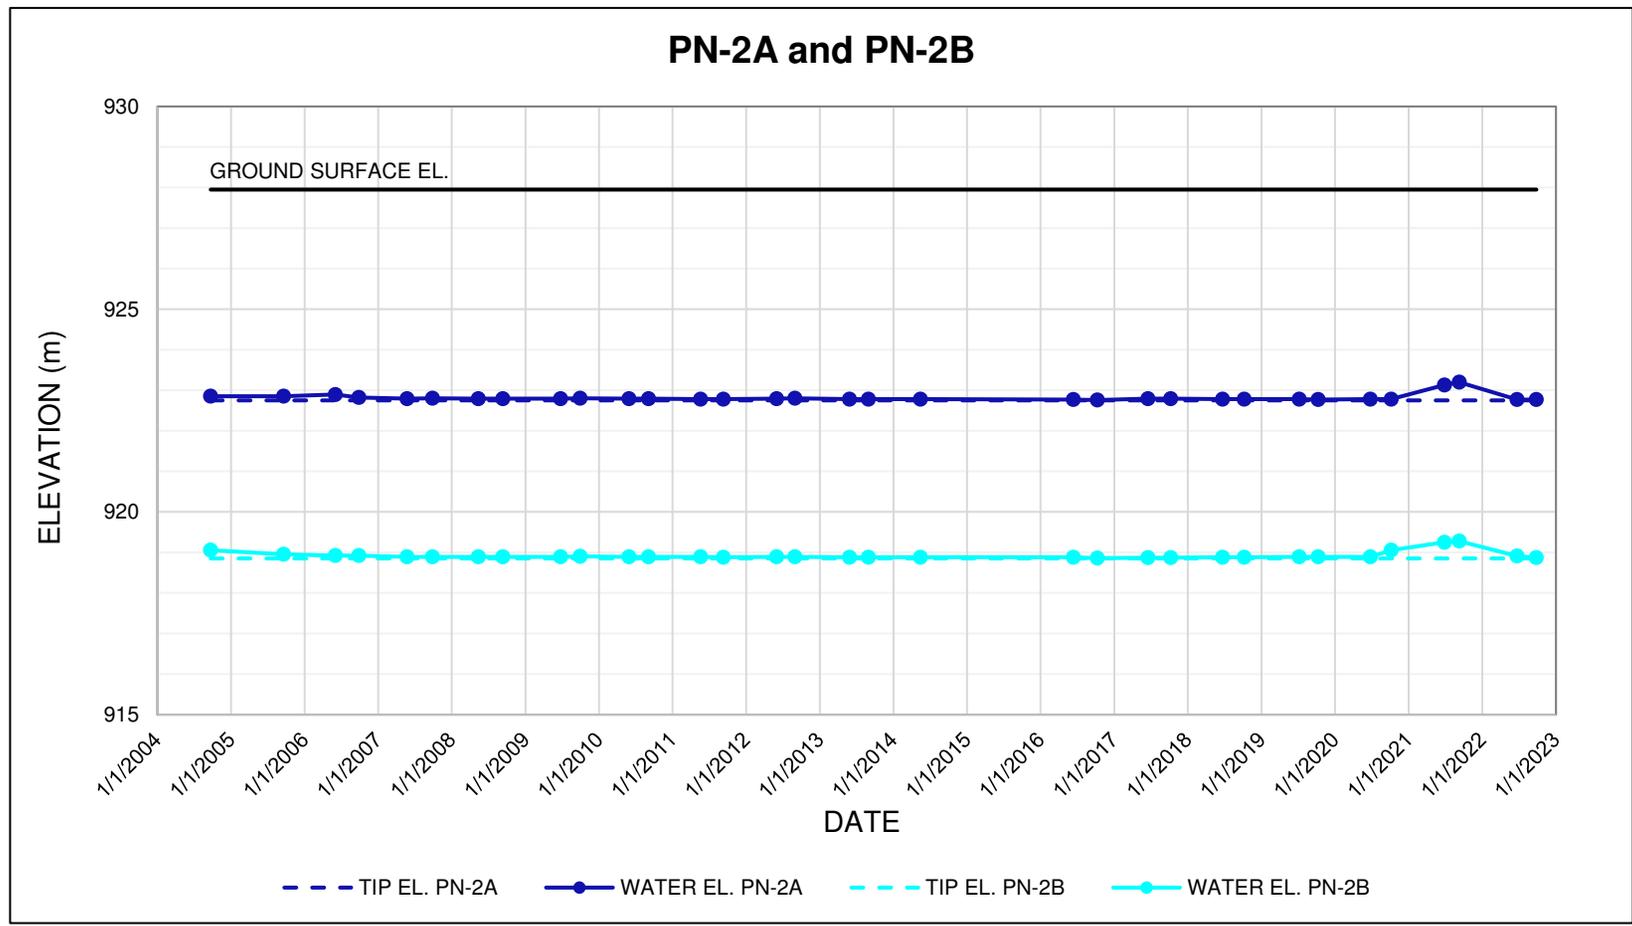
PROJECT PEACE REGION (GRANDE PRAIRIE DISTRICT - SOUTH) GEOHAZARD RISK MANAGEMENT PROGRAM		
	TITLE Piezometer Data GP008 - Road Surface Slumping (2.5 km North of McIntyre Mine) Hwy 40:36, km 16.365

Since the instruments were installed in 2004, water levels recorded in PN-2A and PN-2B have been near tip elevation (i.e., the instruments have been dry), except during the spring and fall 2021 readings when water levels increased to 0.2 m and 0.4 m above tip elevation, respectively. The spring and fall 2022 readings indicate the instruments are dry again.
