**ALBERTA TRANSPORTATION
GEOHAZARD ASSESSMENT PROGRAM
PEACE REGION – GRANDE PRAIRIE DISTRICT
2020 INSPECTION**

Site Number	Location	Name	Hwy	km
GP38	NW of Grande Cache	2.0 km N of Kakwa River Bridge	40:38	25.9
Legal Description		UTM Co-ordinates (NAD 83)		
SE8-63-4-W6		11U N 6,033,120	E 398,445

2020 INSPECTION PLAN

DWG No. 13353-GP38-1

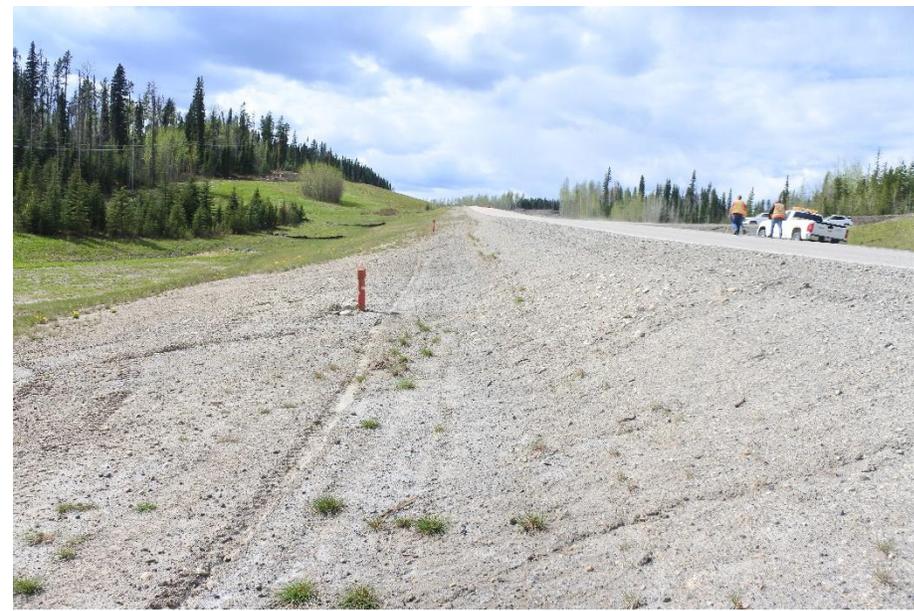
Photo 1.
Looking north
towards the
highway and SIs.

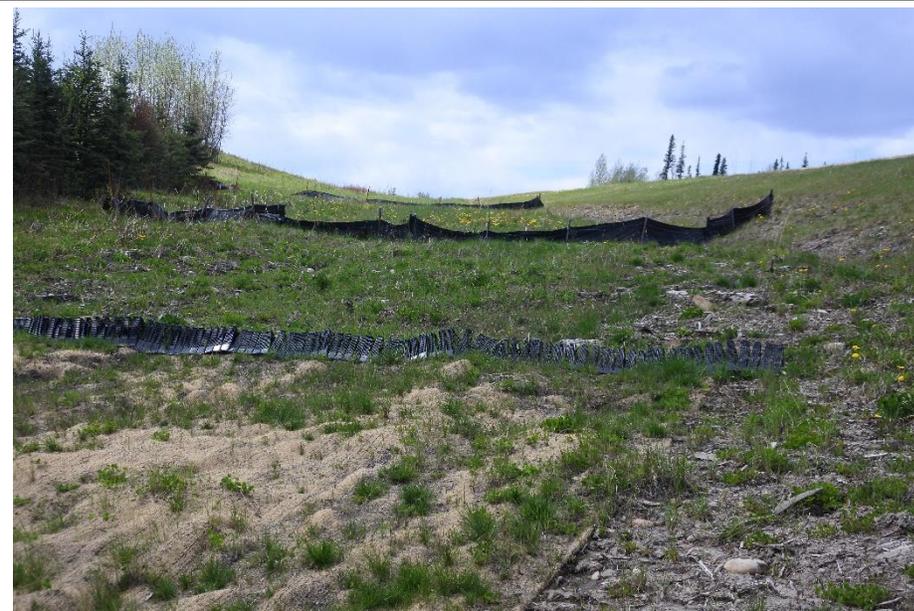
Photo 2.
Looking north
along the west ditch
at erosion control soil
covering and silt
fencing.

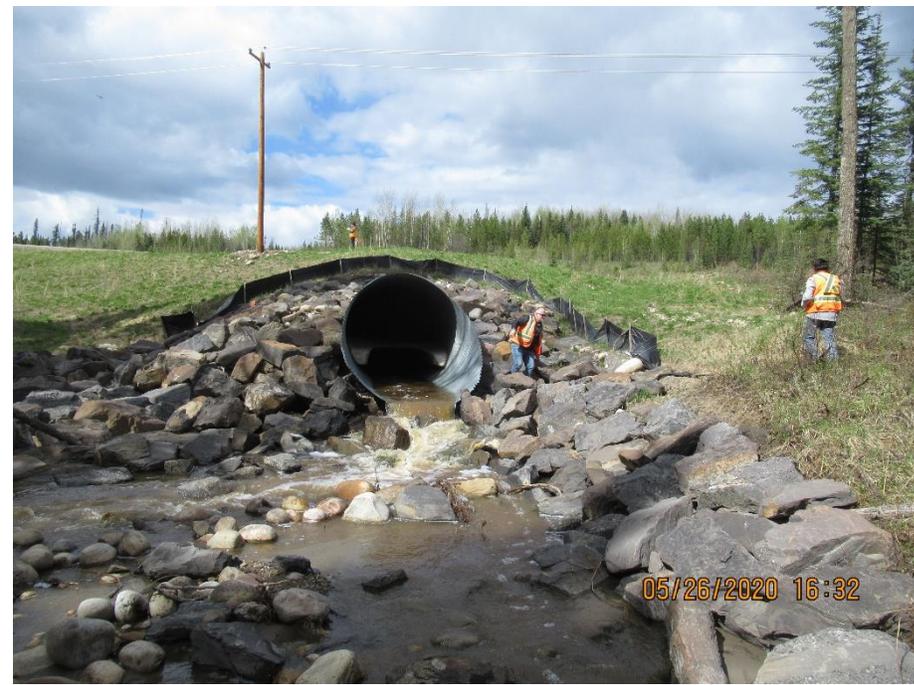
The previous 2.5 m diameter CSP culvert was replaced with a 2.43 m diameter SPCSP culvert on the north side of this slide area, crossing beneath the highway in a northeast to southwest direction. The previous culvert did not have any identifiable distress during past inspections; however, the outfall from this culvert had a 1.5 m drop over 7 m distance which contributed to erosion of the creek banks. There was work performed at the culvert outlet and further upslope along the west highway ditch in the winter/spring of 2016. This work reportedly consisted of grading, erosion control soil covering, riprap placement around/above the outlet, and installation of a subdrain.

Photo 3.
Looking north at
the 2.43 m
diameter SPCSP
outlet and riprap.

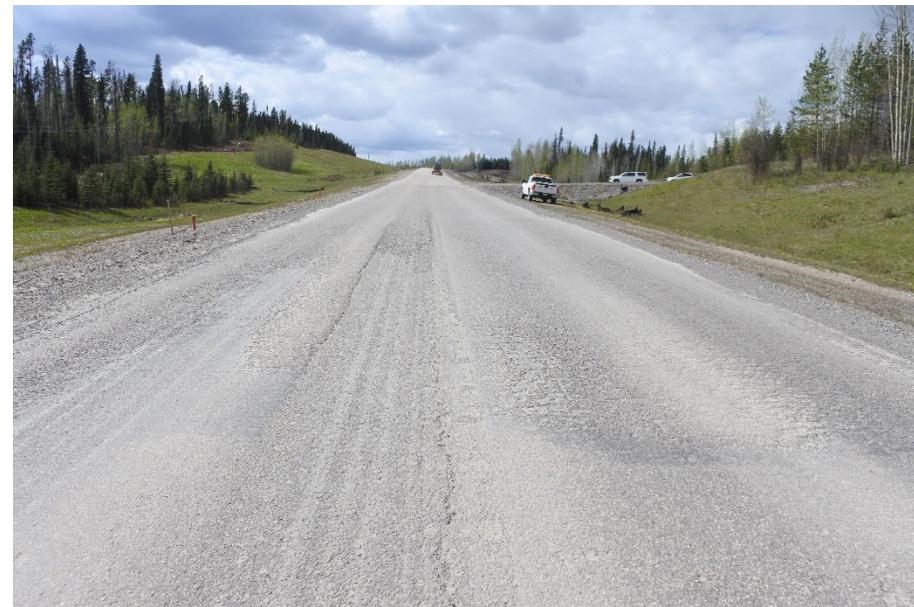
There are hairline cracks projecting through the ACP patch since the repair of the landslide in similar locations to previously observed which were in similar condition in 2020. This is evidence that the landslide may have been adjusting to the new fill placement from the toe berm construction; however, it appears that the movement has been slowing down.

Photo 4.
Looking north along
the highway at
where patch had
been placed.

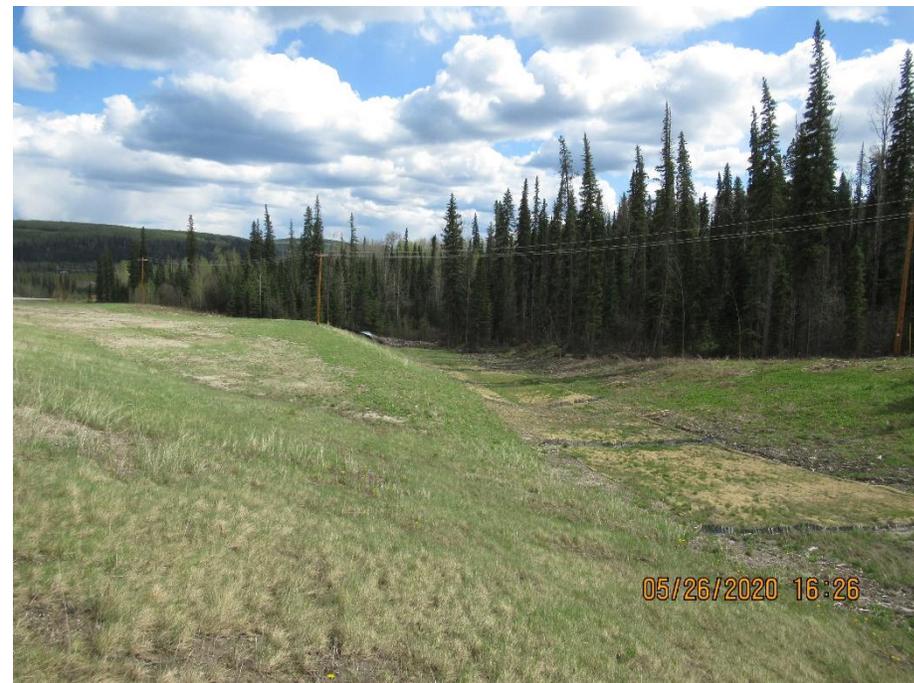
Photo 5.
Looking southeast
at swale and toe
berm.

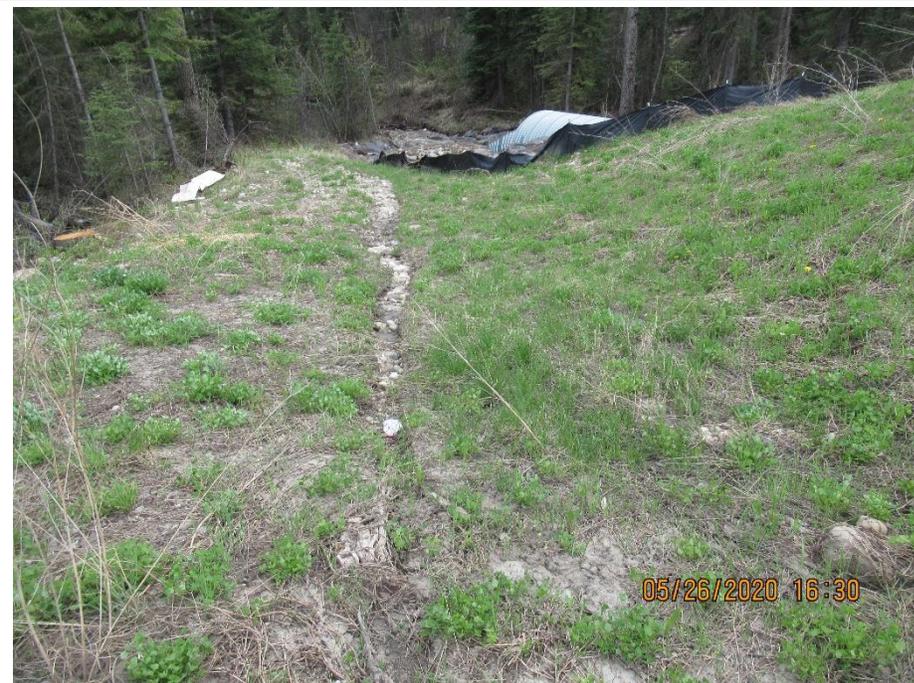
After the repair construction was completed in 2018, minor erosion was noted along the west edge of the swale and beside and below coconut mat just south of the culvert outlet. The erosion is likely from the excessive rain and surface runoff flow that occurred in 2019 as this erosion was in fairly similar condition in 2020. Ground seepage was observed from springs along the west side of the swale making the ground very soft. The areas that have been broadcast seeded now show grass growth.

Photo 6.
Looking southwest
at where minor
erosion has
occurred beneath
coconut matting.

In the short term, the site should be monitored every one to two years to ensure the toe berm functions properly and that large increases landslide movement do not occur. The minor erosion observed should be monitored and if these areas worsen then they should be removed and replaced with compacted clay fill and erosion control matting. The area near where the springs are located may need further drainage measures to drain to the creek.

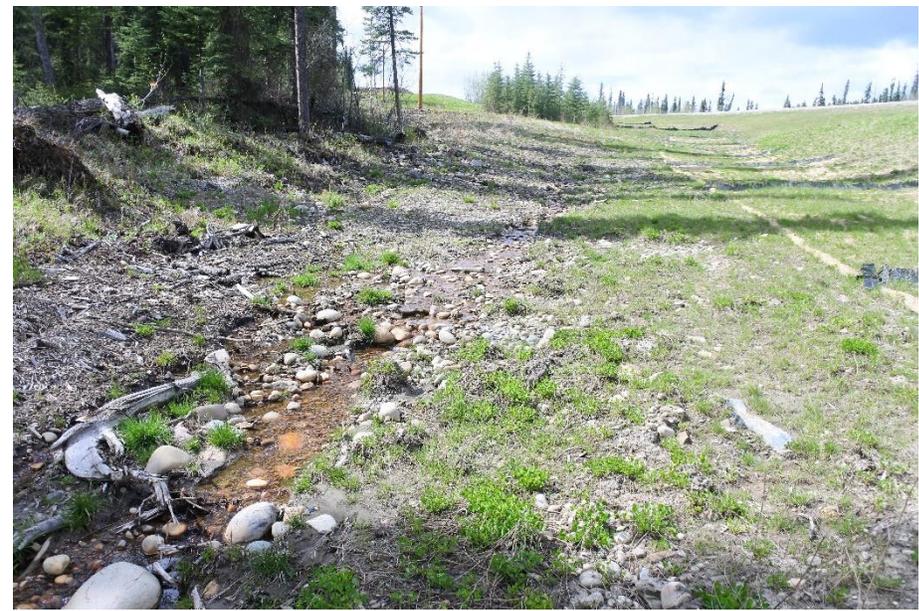
Photo 7.
Looking northwest towards swale where there are several springs and ground seepage runs parallel to outside west edge of swale.

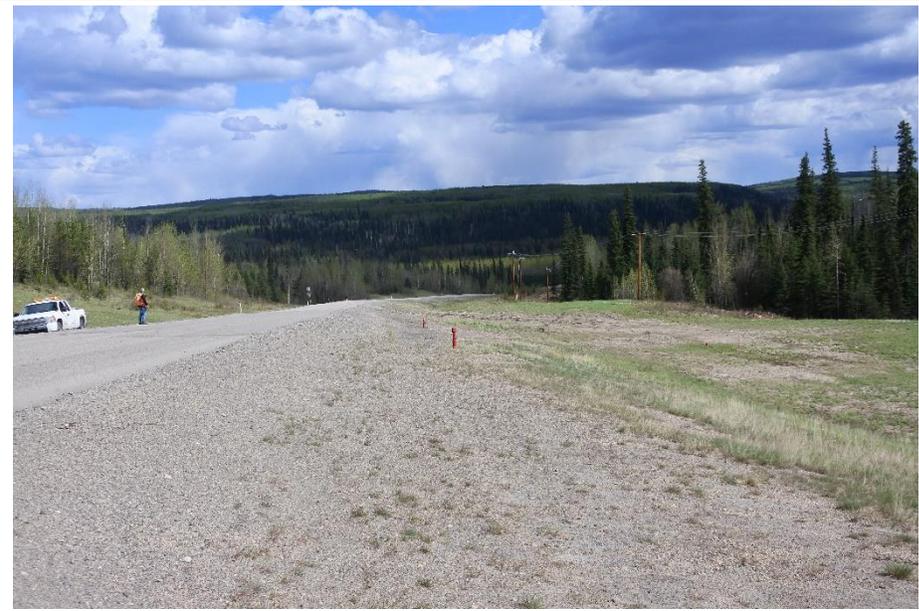
Photo 8.
Looking southeast along the highway SBL towards the buried 2.43 m diameter SPCSP culvert.

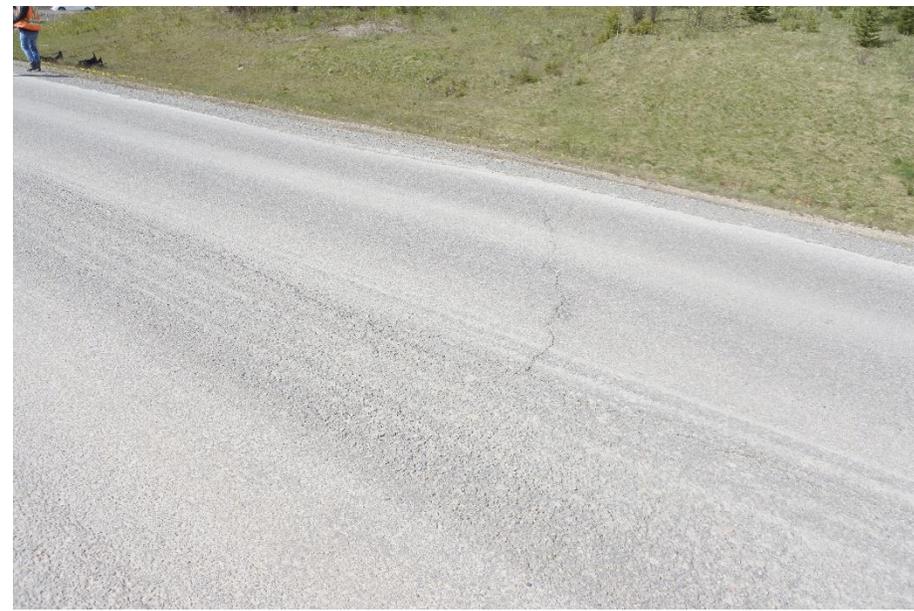
Photo 9.
Looking north at diagonal crack that has reflected through the new asphalt patch.

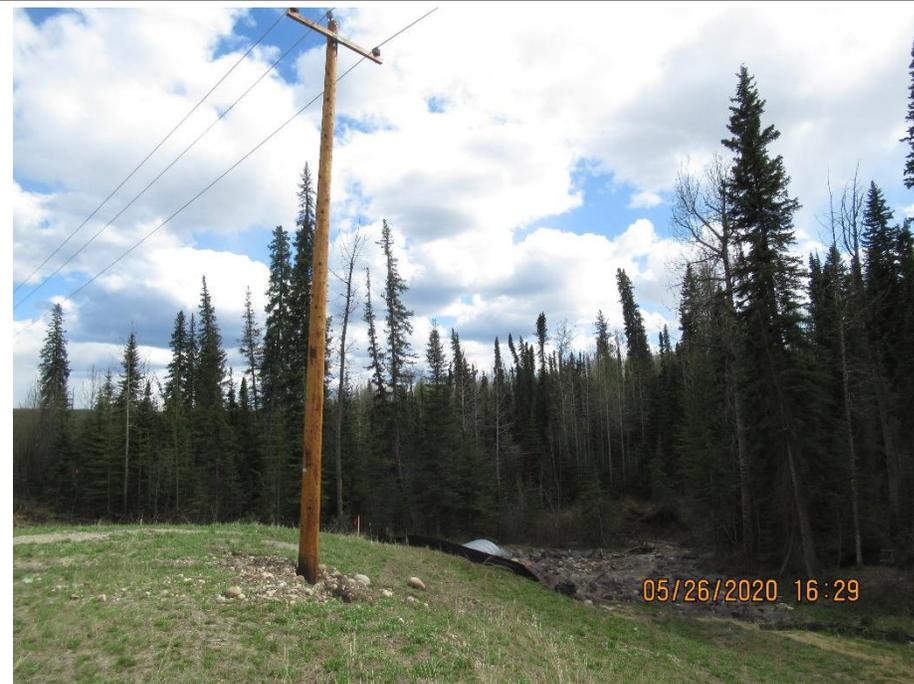
Photo 10.
Looking southeast at new power pole that was installed on toe berm near culvert alignment.
