SITE INSPECTION FORM

SITE NUMBER AND NAME: GP001 Slide 5.0 km South of Wapiti River Bridge (Wapiti Hill)		HIGHWAY & KM: 40:42, 25.393	PREVIOUS INSPECTION DATE: June 14, 2017	INSPECTION DATE: June 15, 2022
LEGAL DESCRIPTION: NE 18-70-05-W6M	NAD 83 COORDINATES: UTM Northing Easting 11 6103632 388701		RISK ASSESSMENT: PF: 8 CF: 4 TOTAL: 32	
AVERAGE ANNUAL DAILY TRAFFIC (AADT): 4320 (north) & 4180 (south) (Reference No. 990228, 2021)			CONTRACT MAINTENANCE AREA (CMA): 504

PRIMARY SITE ISSUE: Deep-seated landslide located along south/west valley slope of Wapiti River. Hwy 40:42 fill placed in a side-hill arrangement across a large, old slide area. Slide movements affecting both lanes of highway.

**PEACE REGION
(GRANDE PRAIRIE DISTRICT – SOUTH) GRMP**

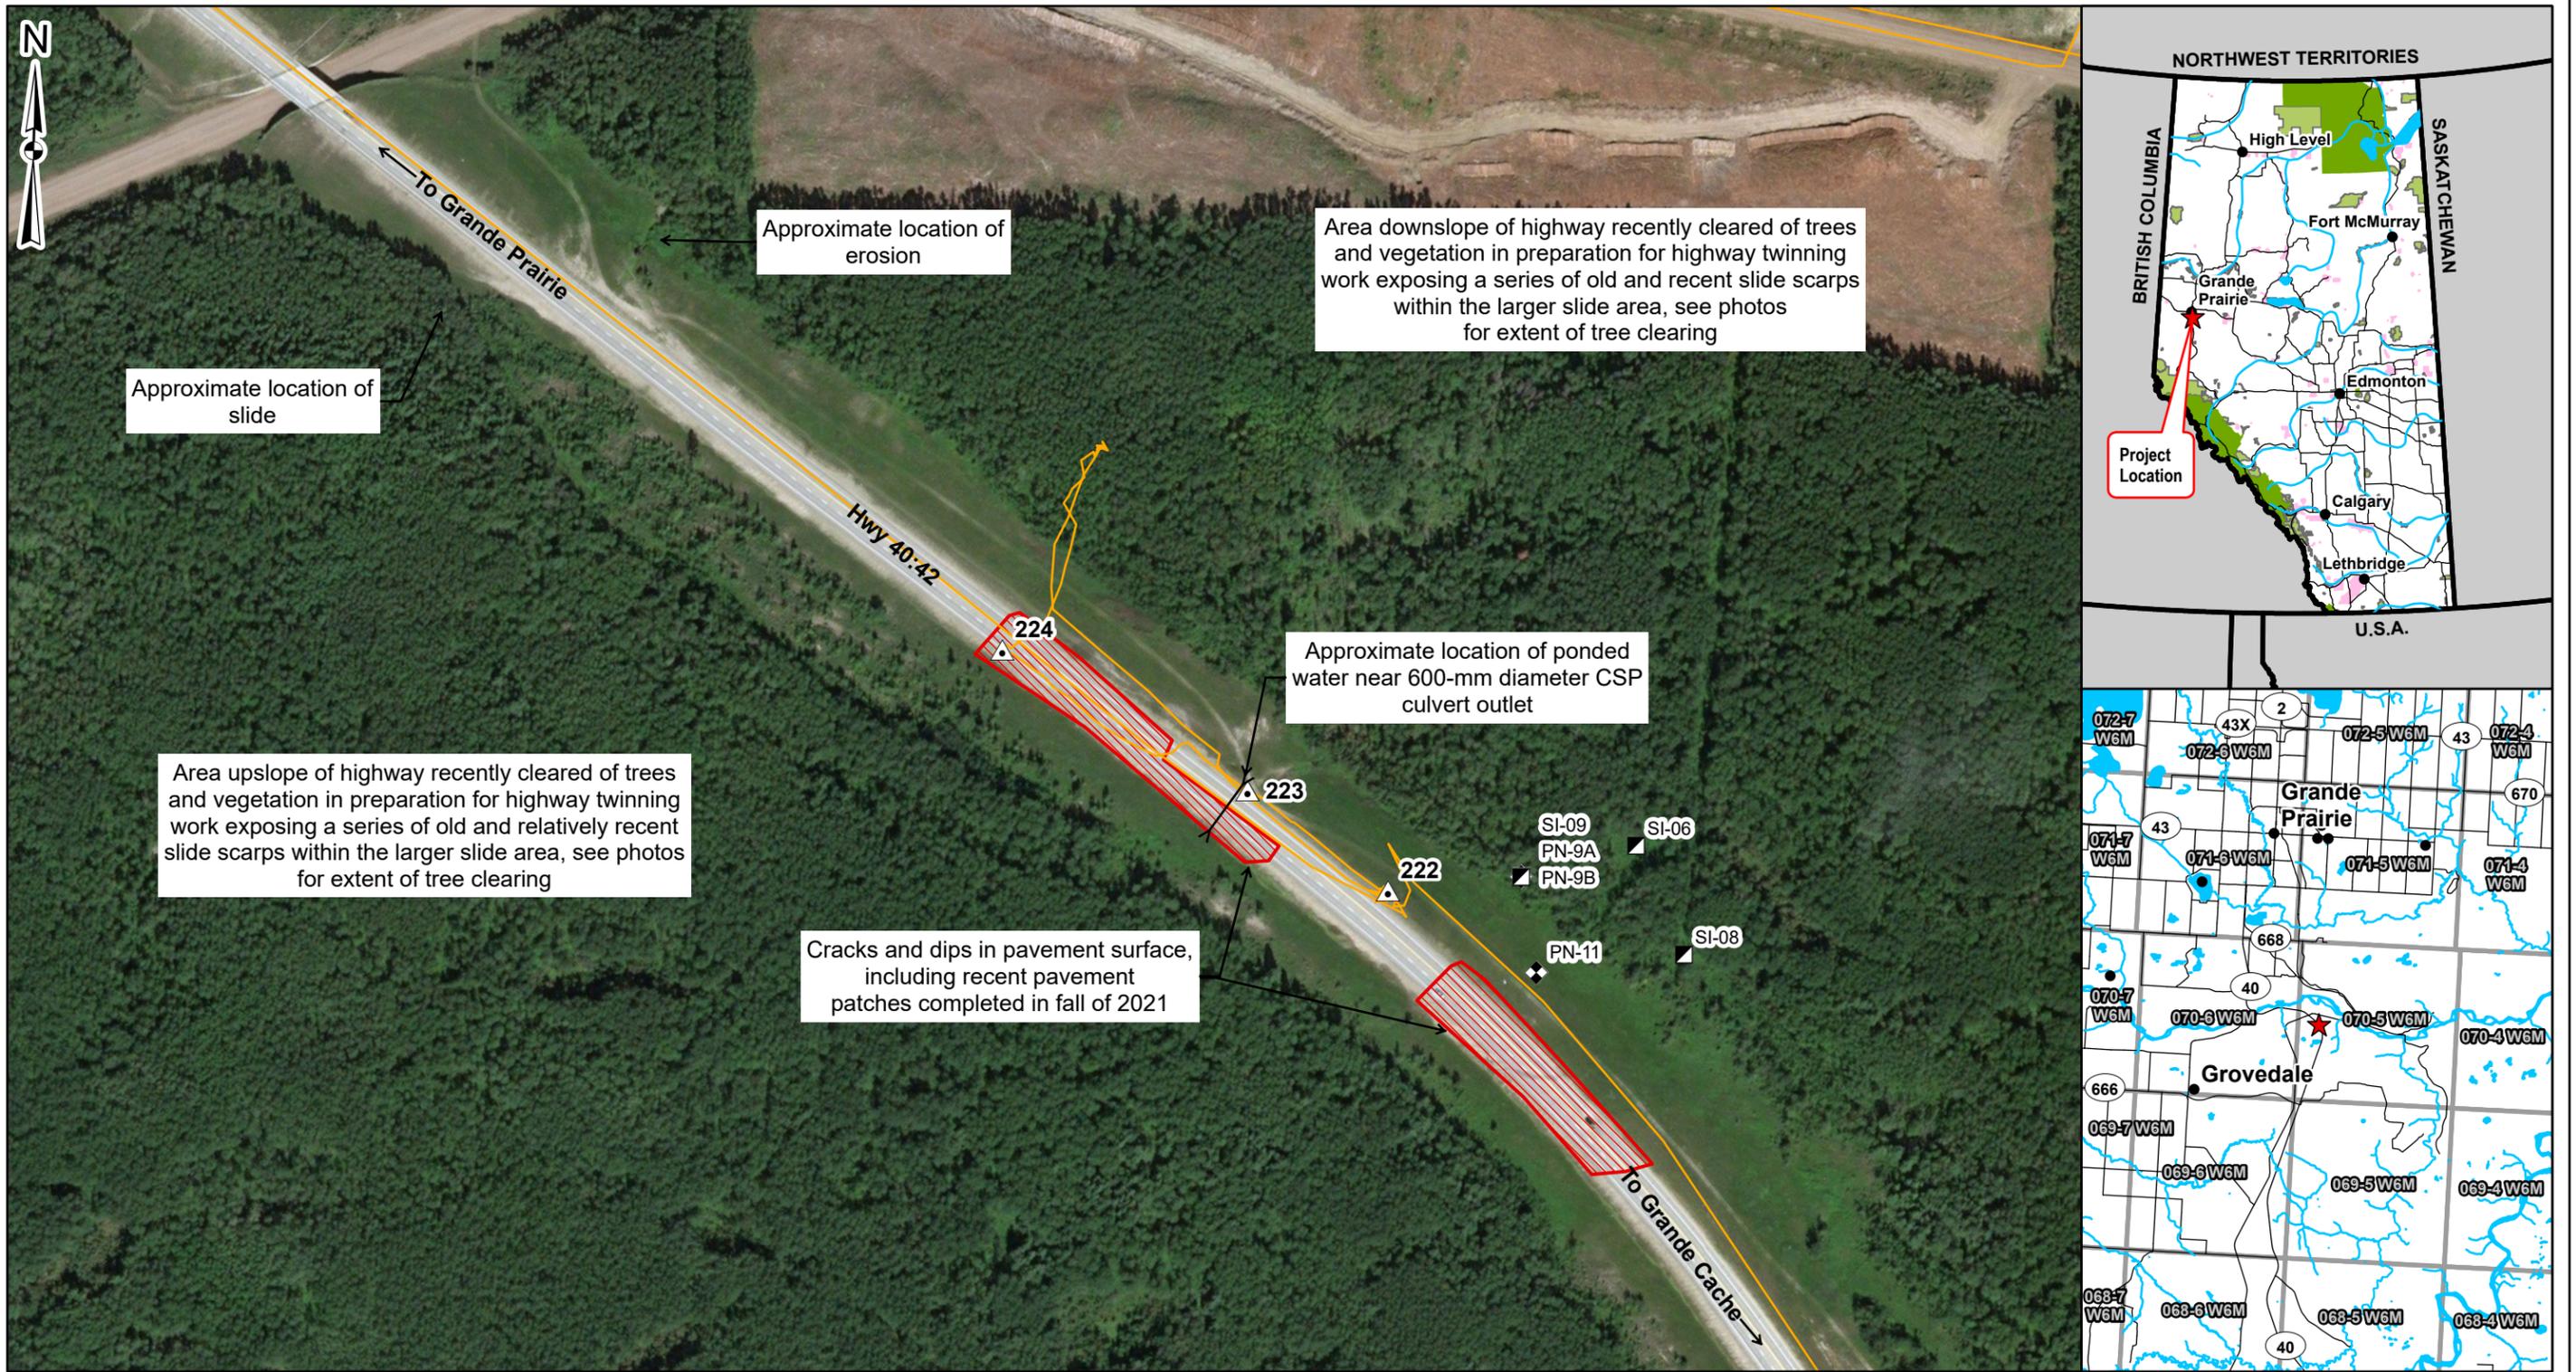
PROJECT	PEACE REGION (GRANDE PRAIRIE DISTRICT-SOUTH) GEOHAZARD RISK MANAGEMENT PROGRAM	
TITLE	Site Plan GP001 - Slide 5.0 km South of Wapiti River Bridge Hwy 40:42, km 25.393	
SCALE	PROJECT No.	FIG No.
1:3,000	A05116A01	1

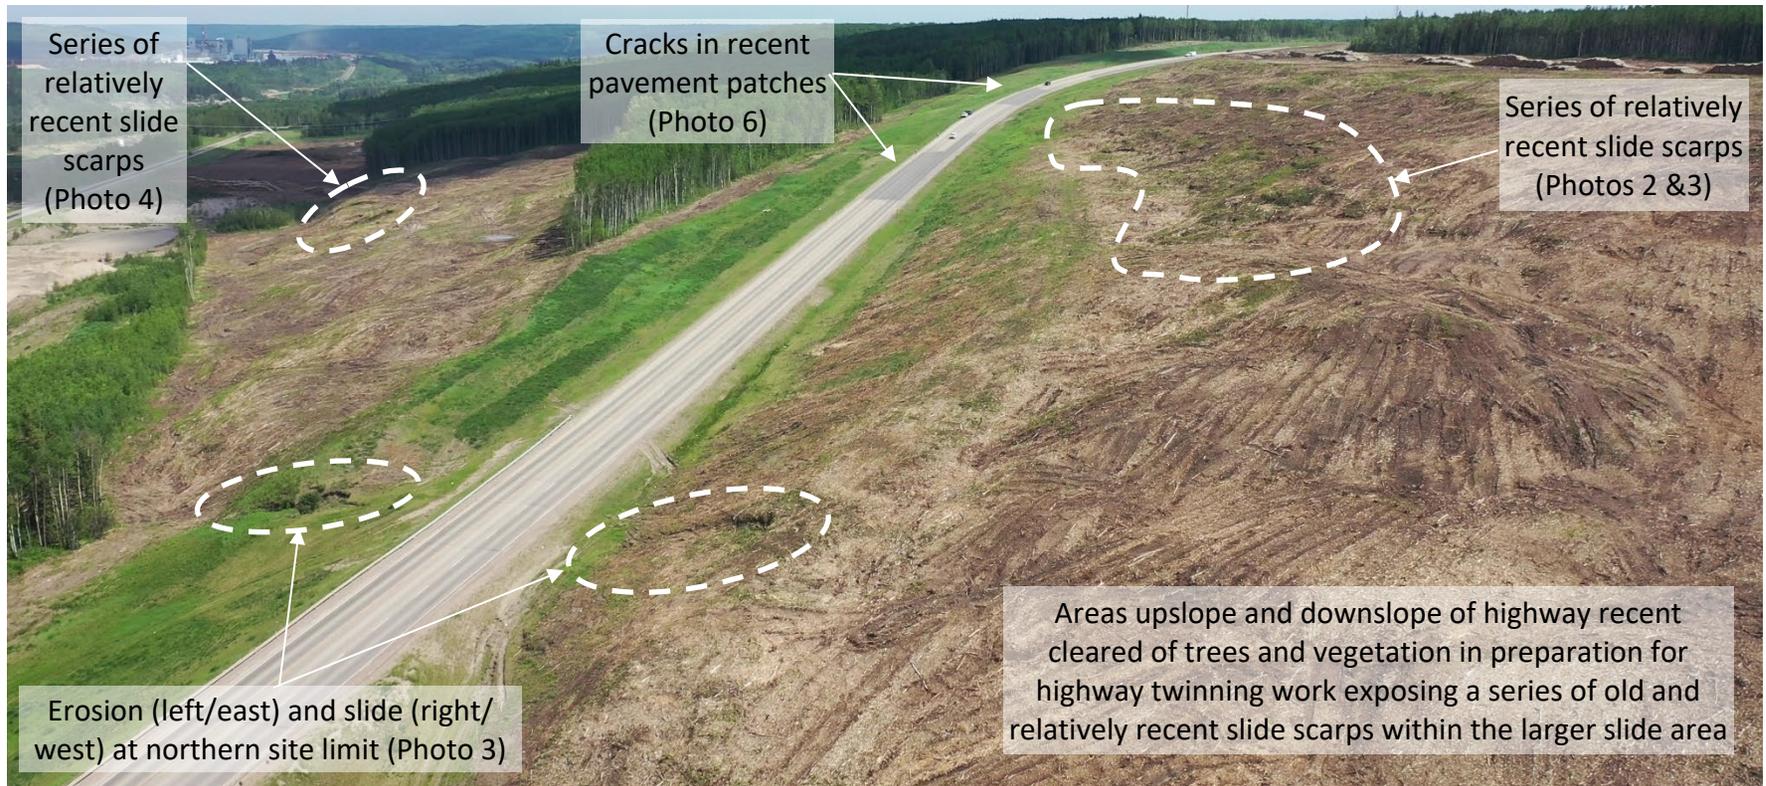
Photo 1 Overview of GP001 site on Hwy 40:42. Photo taken June 15, 2022, with unmanned aerial vehicle (UAV) facing southeast.

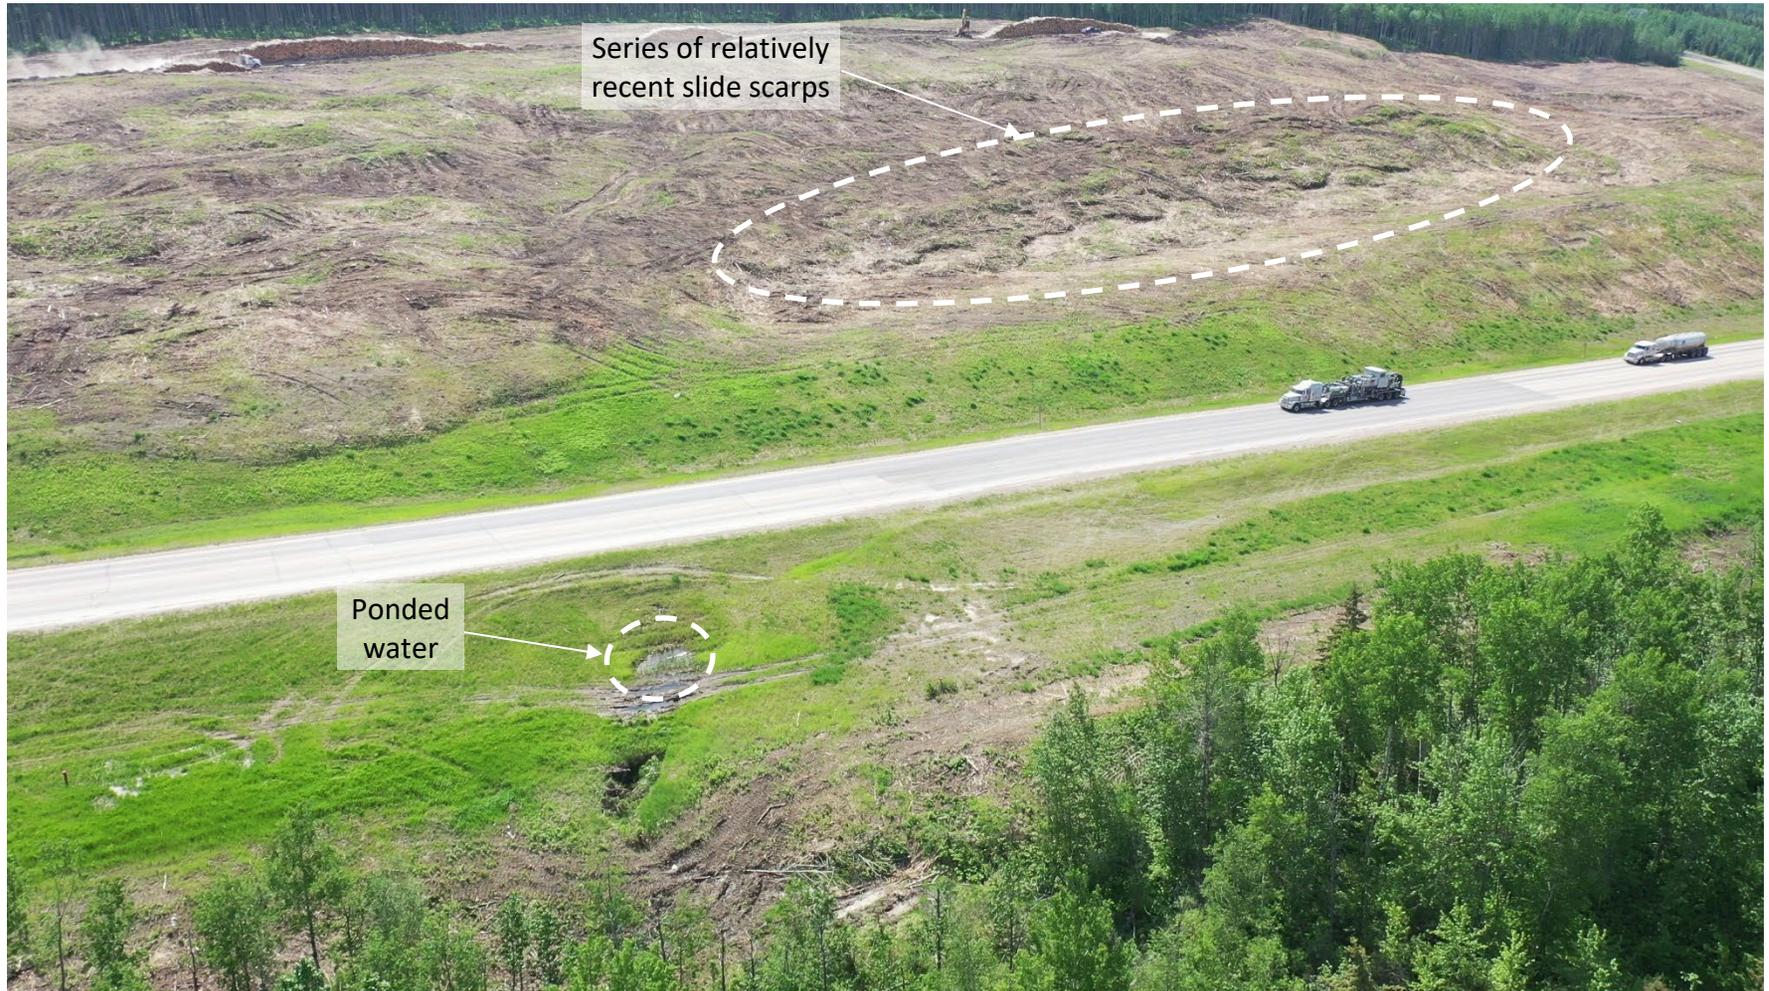
COMMENTS
Slope upslope and downslope of highway is landslide terrain.
Areas upslope and downslope of highway recently cleared of trees and vegetation in preparation for highway twinning work exposing a series of old and relatively recent slide scarps within the larger slide area.

Recently cleared areas upslope and downslope of highway will be susceptible to erosion. Increased water infiltration into these areas may also trigger additional slide movements, which may impact pavement surface.

Photo 2 Area upslope of Hwy 40:42 recently cleared of trees and vegetation exposing a series of old and relatively recent slide scarps (circled in white) within the larger slide area. Water ponded (circled in white) downstream of highway near culvert outlet and WP223. Photo taken June 15, 2022, with UAV facing west.

- Continue to monitor site. Monitor for signs of increased slide activity and changes in hydrology upslope and downslope of highway due to trees and vegetation being cleared.
- Continue to patch highway as needed to maintain pavement surface.

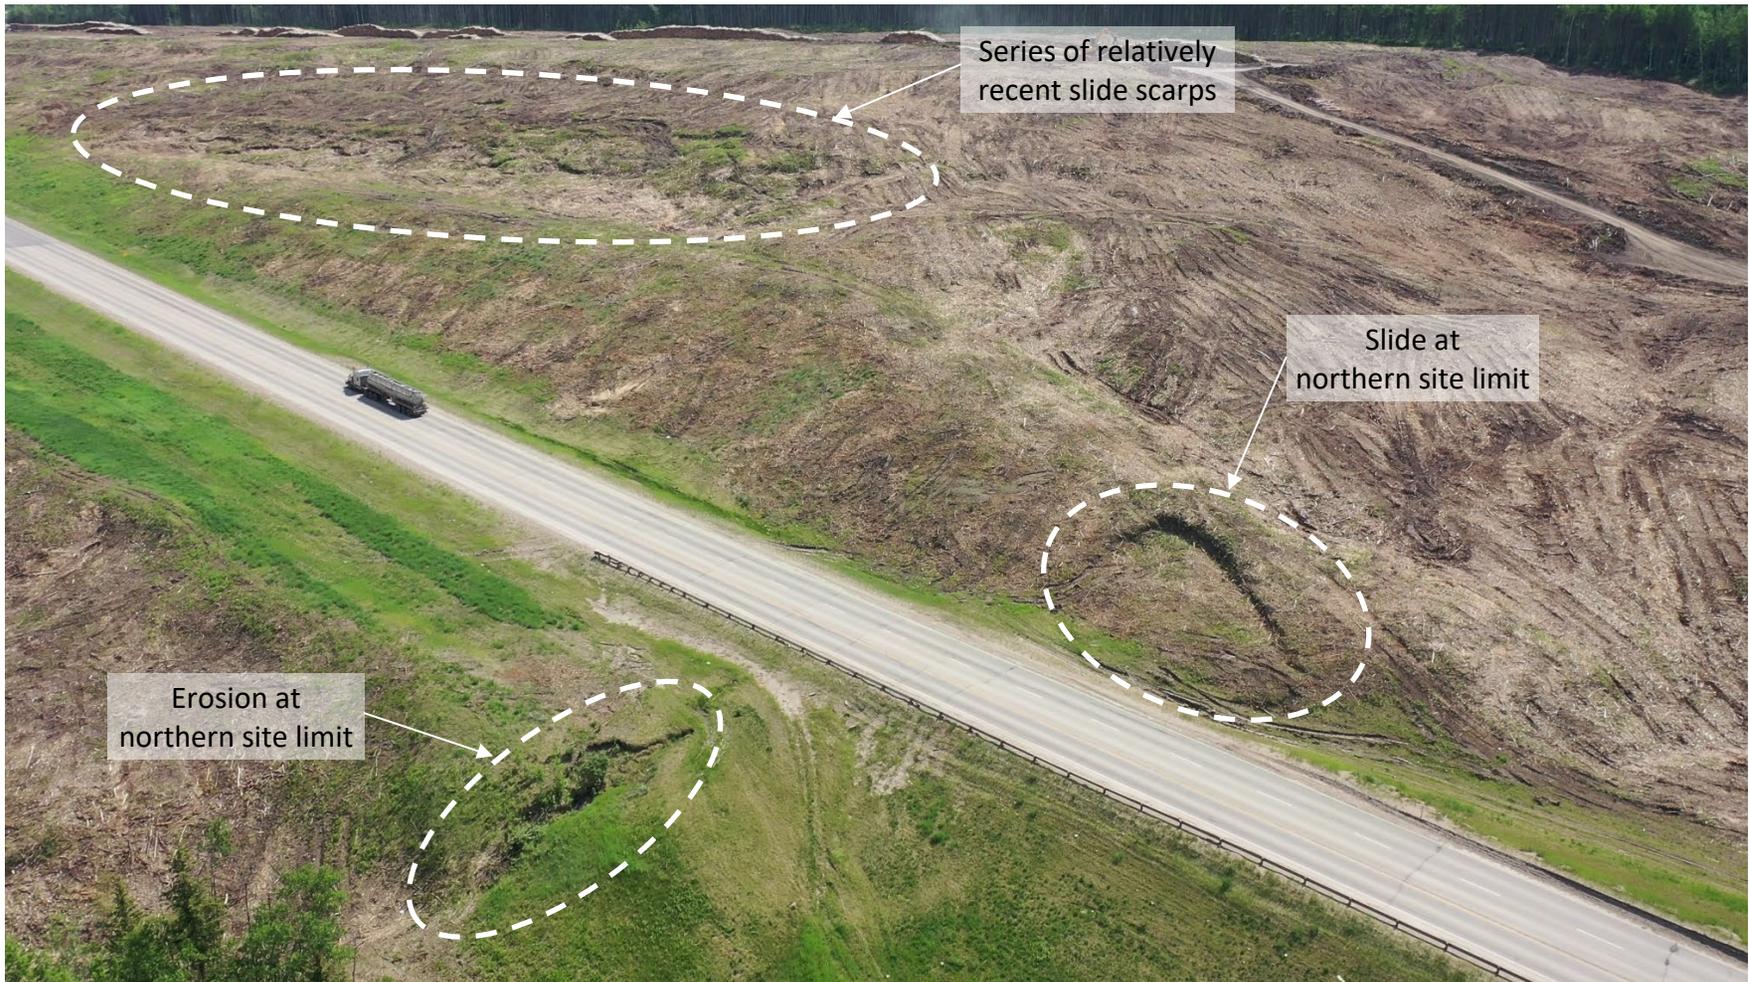
Slide and erosion observed on north and south side of highway, respectively, at northern site limit just before bridge. At the time of the 2022 inspection neither was affecting the pavement surface of the highway.

Photo 3 Erosion and slide (circled in white) at northern site limit just before bridge. Photo taken June 15, 2022, with UAV facing south.

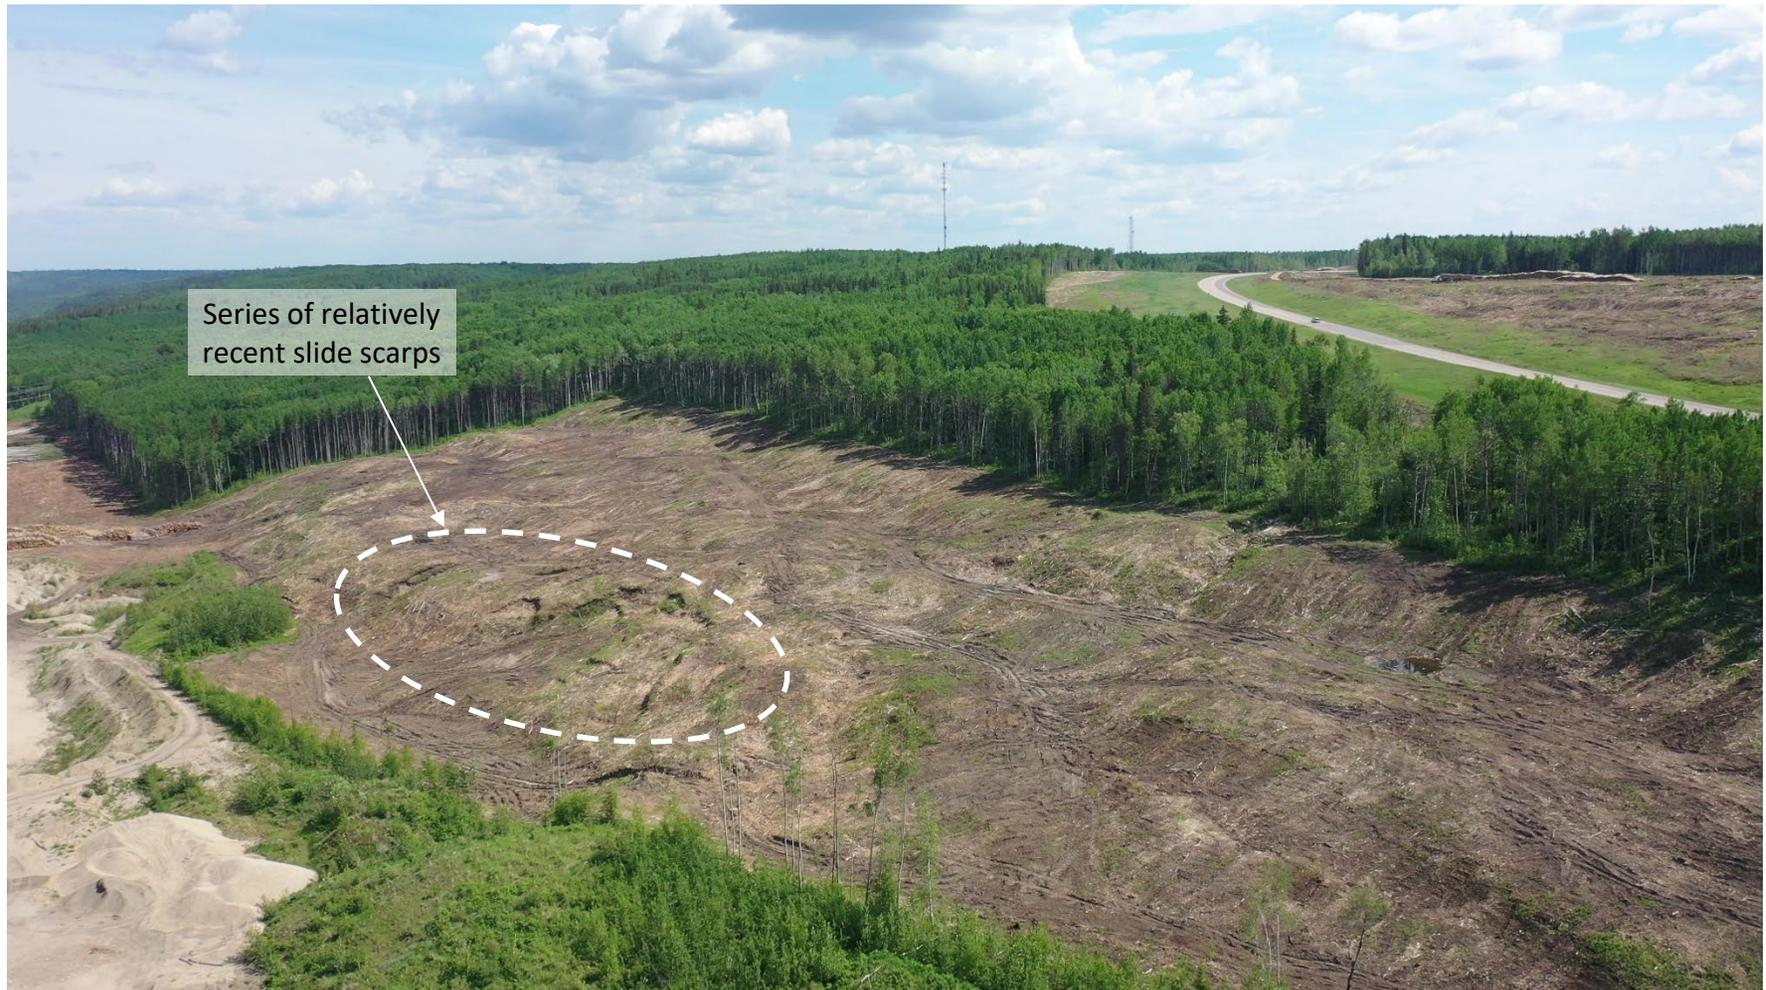
Photo 4 Area downslope of Hwy 40:42 recently cleared of trees and vegetation exposing a series of old and relatively recent slide scarps (circled in white) within the larger slide area. Photo taken June 15, 2022, with UAV facing southeast.

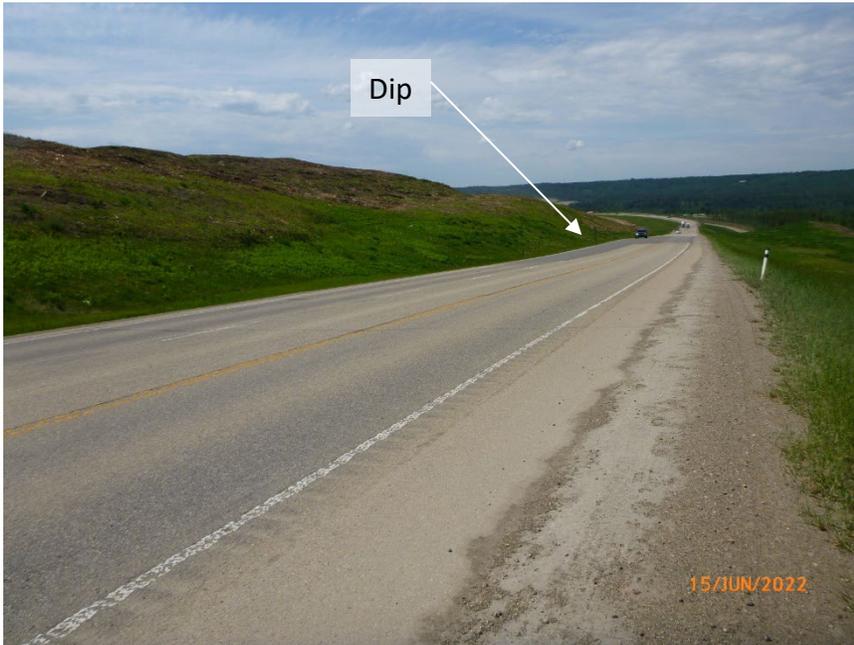
ITEM	CONDITION EXISTS		DESCRIPTION AND LOCATION	NOTICABLE CHANGE FROM LAST INSPECTION	
	YES	NO		YES	NO
Pavement Distress	X		Cracks and dips in pavement surface, including recent pavement patches completed in fall of 2021 (WP224 at north extent of north patch).	X	
Slope Movement	X		Cracking in recent pavement patches indicates ongoing slide movements.	X	
Erosion		X	None observed at time of 2022 inspection.		X
Seepage	X		Wet subgrade conditions previously observed during construction. Water ponded downslope of highway near culvert outlet and WP223.		X
Culvert Distress			Culvert not inspected.

Photo 5 Dip in pavement surface of Hwy 40:42. Photo taken June 15, 2022, facing northwest.

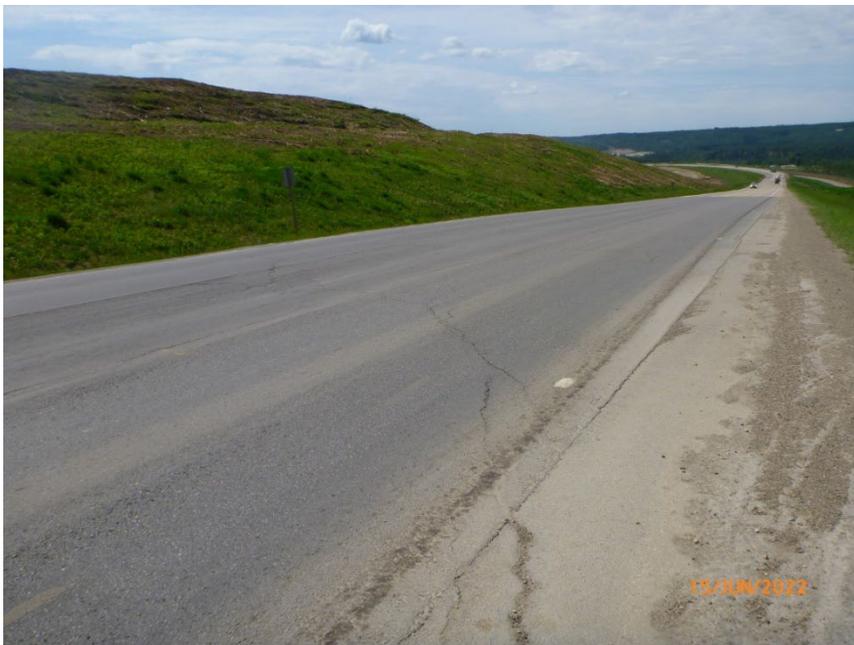
Photo 6 Cracking in recent pavement patch of Hwy 40:42 completed in fall of 2021. Photo taken June 15, 2022, facing northwest.
