<b>SITE NUMBER AND NAME:</b> GP052 Puskwaskau River Slide		<b>HIGHWAY &amp; KM:</b> 736:02, 27.011	<b>PREVIOUS INSPECTION DATE:</b> May 30, 2020	<b>INSPECTION DATE:</b> July 19, 2021
<b>LEGAL DESCRIPTION:</b> NW 26-74-01-W6M	<b>NAD 83 COORDINATES:</b> UTM Northing Easting 11 6144232 434495		<b>RISK ASSESSMENT:</b> 1: PF: 10 CF: 4 TOTAL: 40 2: PF: 11 CF: 6 TOTAL: 66	
<b>AVERAGE ANNUAL DAILY TRAFFIC (AADT):</b> 130 (north) & 140 (south) (Reference No. 70000833)			<b>CONTRACT MAINTENANCE AREA (CMA):</b> 504

PROJECT GRANDE PRAIRIE SOUTH REGION GEOHAZARD RISK MANAGEMENT PROGRAM		
TITLE Site Plan GP052 Puskwaskau River Slide Hwy 736:02, km 27.011		
SCALE 1:1,750	PROJECT No. A05116A01	FIG No. 1

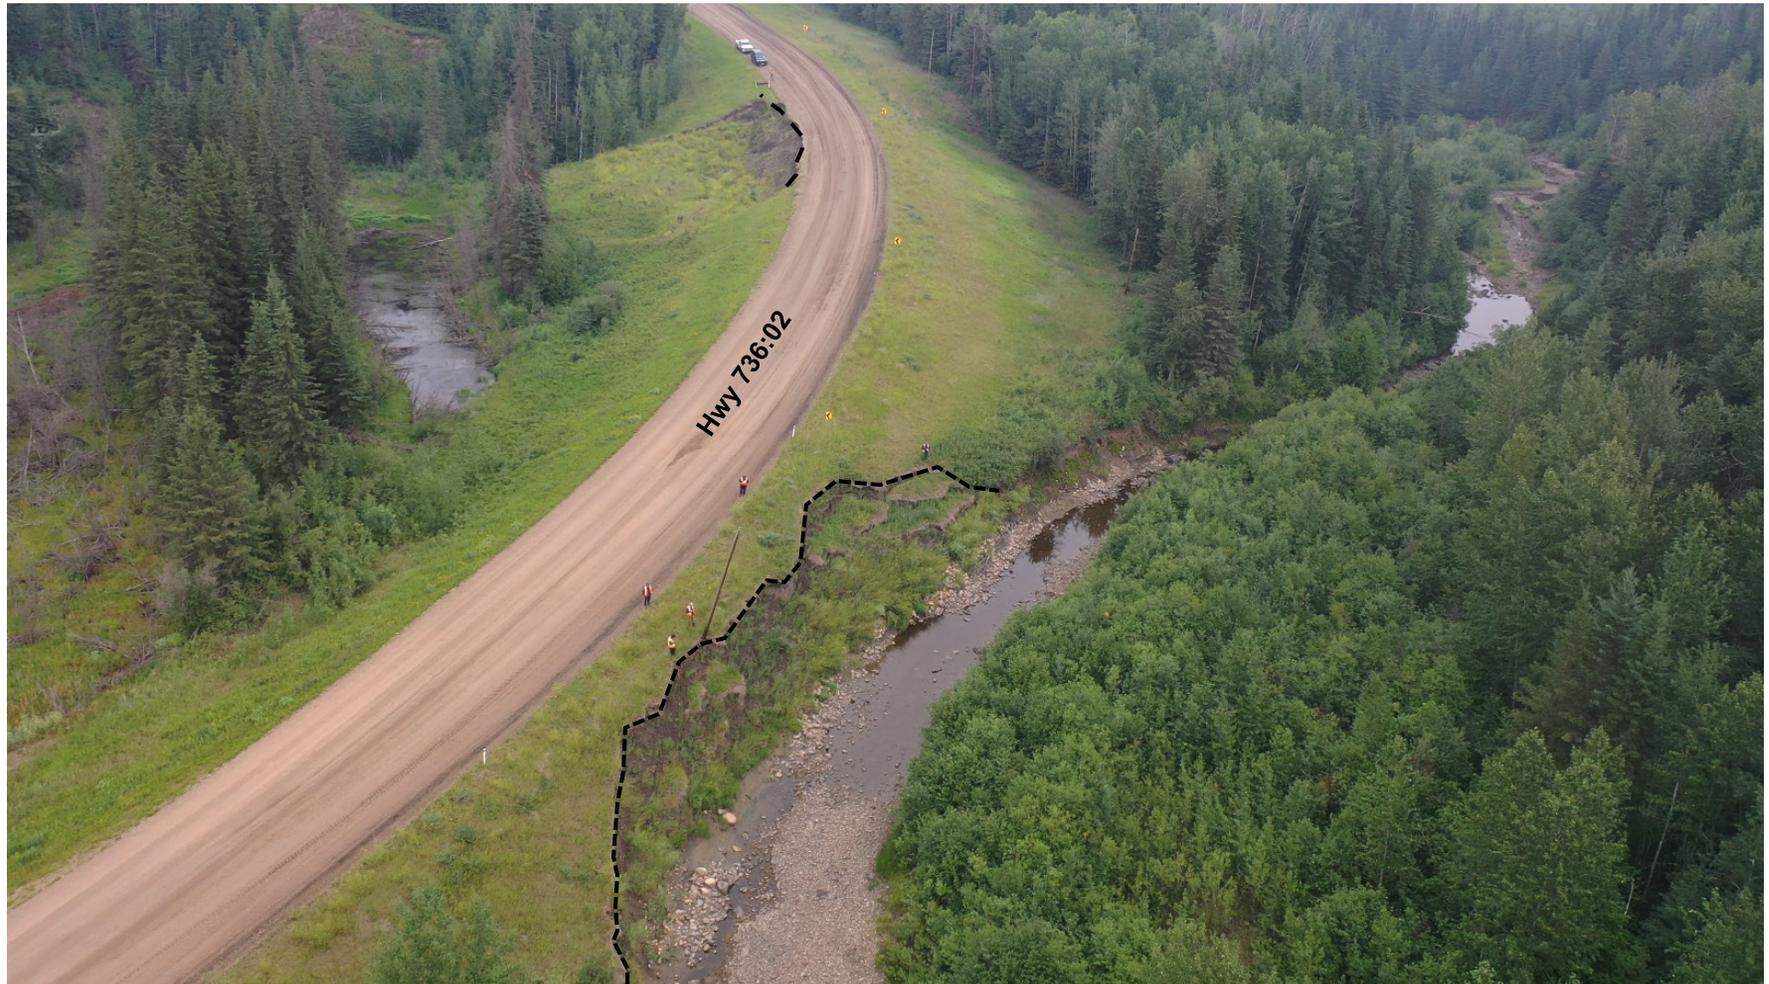
**Photo 1** Overview of the GP052 site, showing the slide (40 m long and 10 m in height) and erosion extents (50 m long and 6 m in height). Photo taken July 19, 2021 facing north.

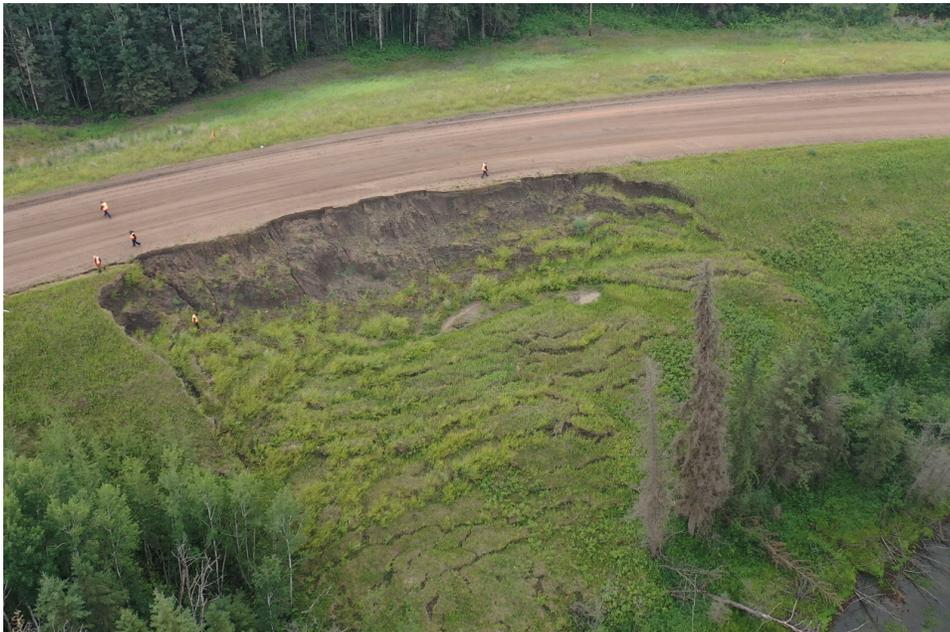
**Photo 2** The slide on the east (southbound) side of Hwy 736 is approximately 40 m long, 10 m tall, and a near vertical backscarp of 1.5 m. Photo taken July 19, 2021 facing east.

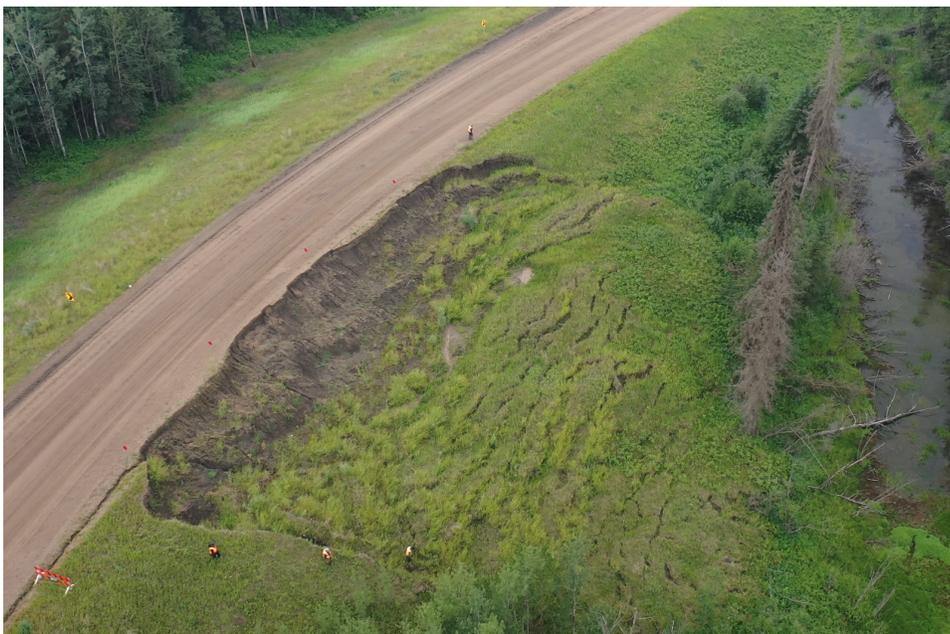
**Photo 4** Hazard markers have been installed in the shoulder of the road. Note cracking behind head scarp of embankment slope failure indicating retrogression of slide. Photo taken July 19, 2021 facing south.

<b>COMMENTS</b>
<u>Embankment Slope Slide</u>
<ul style="list-style-type: none"> <li>- Head scarp of slide has retrogressed onto the shoulder of the gravel-surfaced highway. T-bar mounted hazard markers have been placed. Slide retrogression will occur and is on the verge of undermining one of the hazard markers. Ground cracking parallel to the head scarp located between 1 and 3 m in behind the head scarp. Slide appears to be expanding to the left</li> <li>- Appears to be a rotational or transitional-rotational type failure. Slide mass is disturbed and quite wet due to poor drainage on disturbed slide mass.</li> <li>- Wetland area (oxbow lake) at toe of embankment slide.</li> <li>- Short term actions – continue to monitor site, maintain hazard markers, consider more visible and substantial delineator candles and/or wooden barricades</li> </ul>

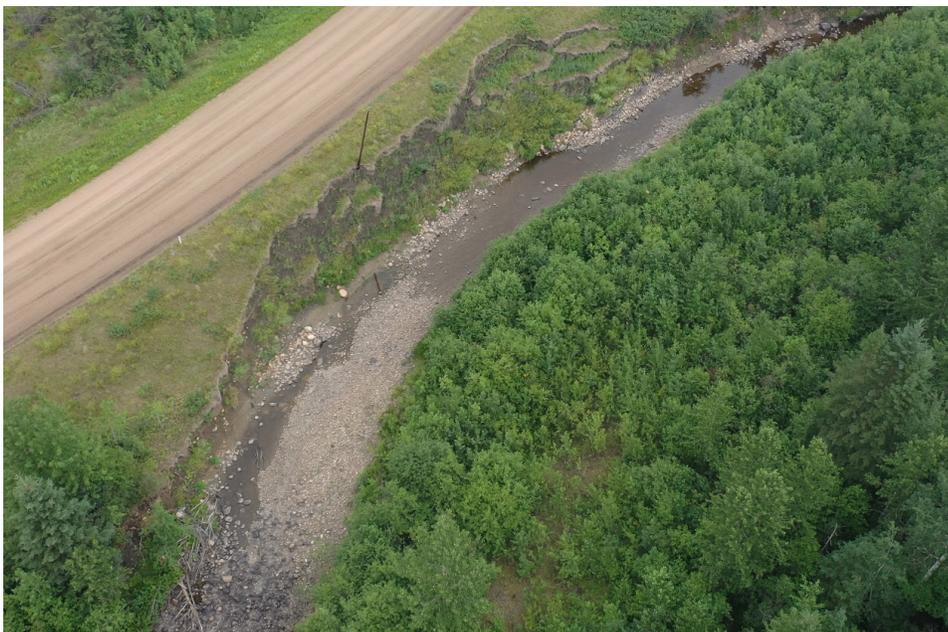
**Photo 6** The erosion on the east (northbound) side of Highway 736 is approximately 2.5 m from the edge of the highway and is beginning to impact a power pole. Photo taken July 19, 2021 facing south.
