**PEACE REGION – SWAN HILLS
GEOHAZARD RISK ASSESSMENT
SITE INSPECTION FORM**

SITE NUMBER SH 26	SITE NAME Gunns Creek North Embankment Failure	HIGHWAY & KM HWY 2A:54	PREVIOUS INSPECTION DATE 04 July 2014	INSPECTION DATE 24 June 2015
LEGAL DESCRIPTION LSD 16-34-76-14 W5M	NAD 83 UTM COORDINATES N 6146169 E 500409	PREVIOUS RISK ASSESSMENT		
		PF: 12	CF: 4	TOTAL: 48
		CURRENT RISK ASSESSMENT		
		PF: 12	CF: 4	TOTAL: 48

SH26: HWY 2A:54
GUNNS CREEK NORTH EMBANKMENT FAILURE
~9km EAST OF HWY 49 JUNCTION
SITE PLAN

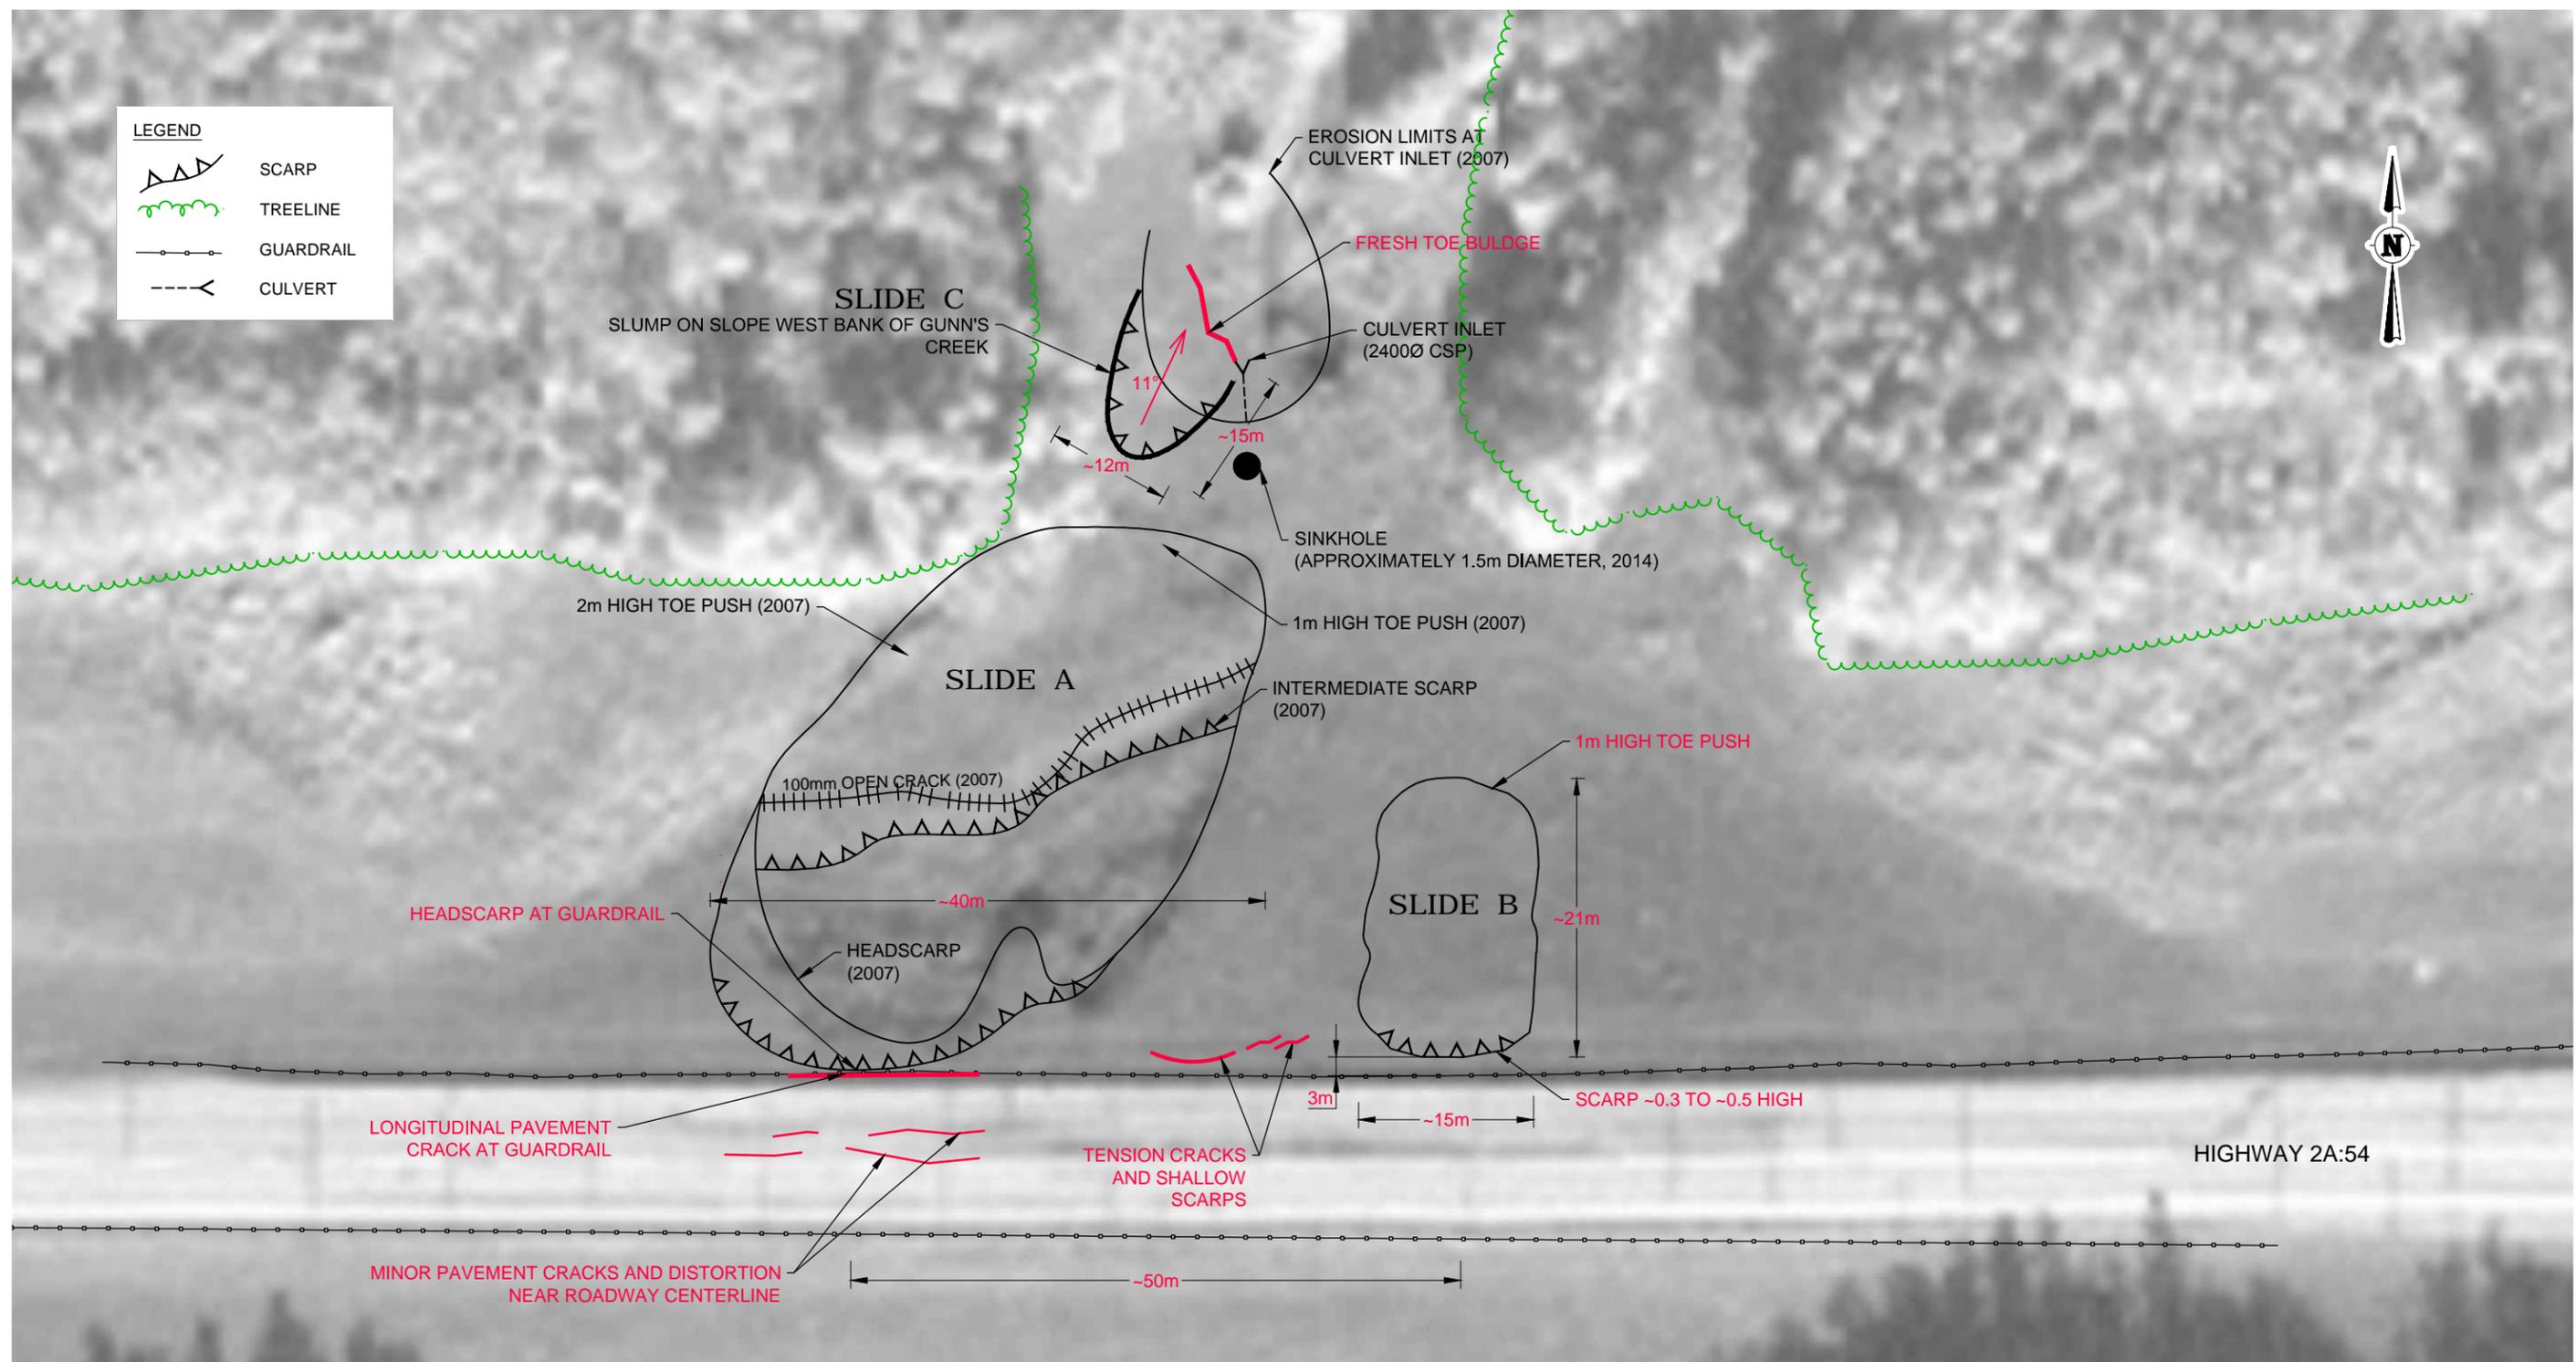
FIGURE 1

- NOTES:
- 2007 ANNOTATIONS BASED ON HAND SKETCH BY THURBER ENGINEERING LTD. DATED JUNE, 2007. PROVIDED BY ALBERTA TRANSPORTATION.
 - FEATURE LOCATIONS ARE APPROXIMATE.
 - PREVIOUS OBSERVATIONS SHOWN IN BLACK.
 - JUNE 24, 2015 OBSERVATIONS SHOWN IN RED.

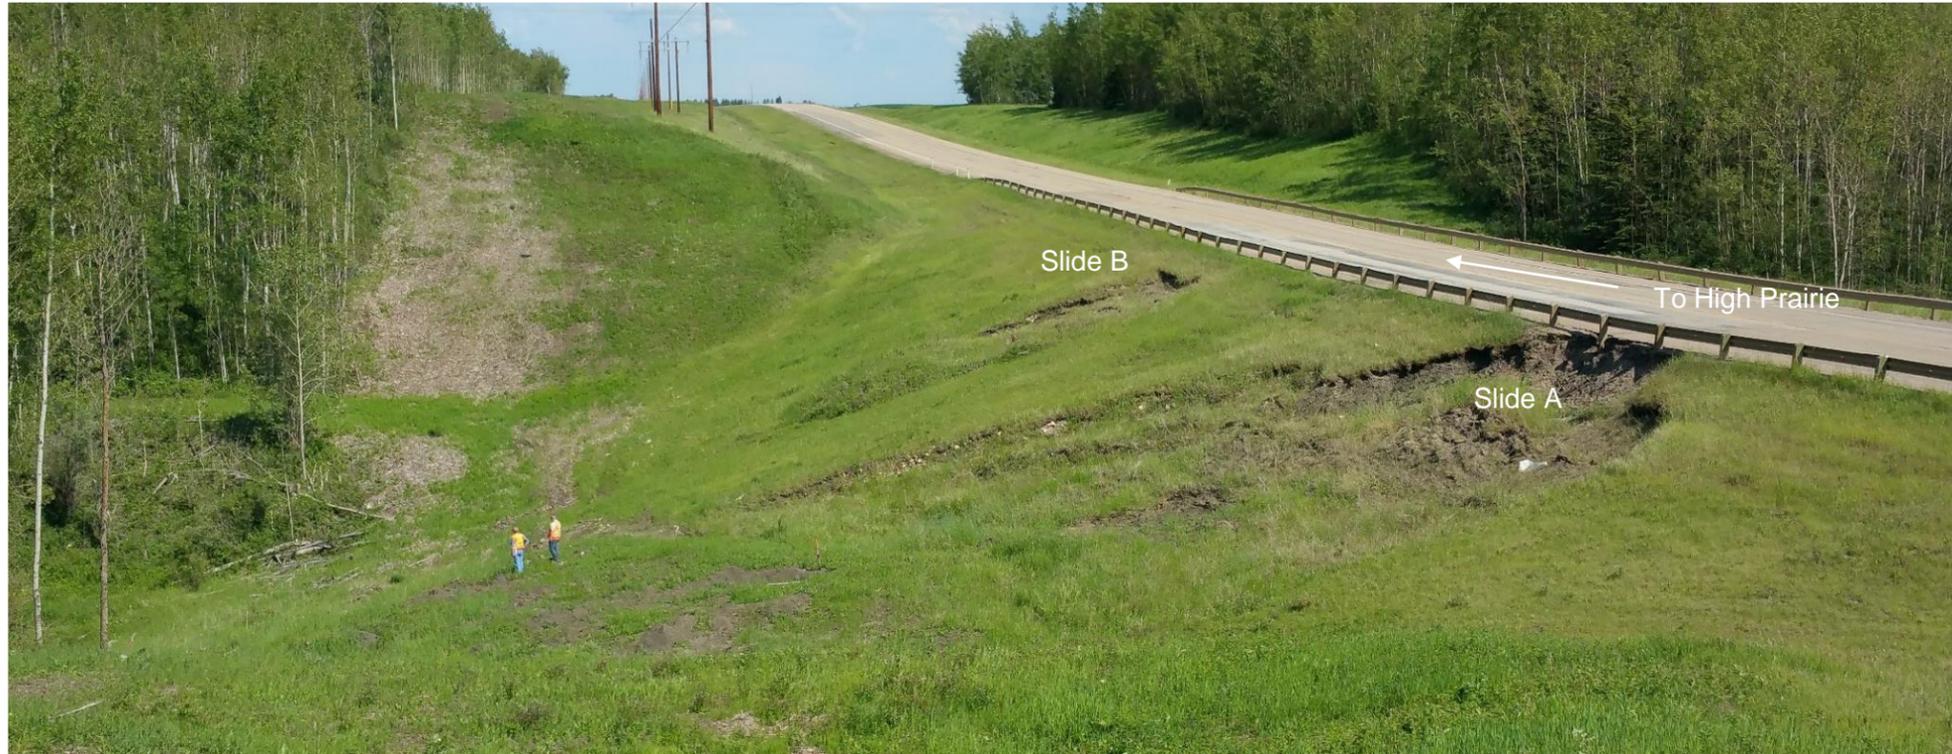
Continued retrogression and toe bulging of the Slide A and Slide B was observed during the 2015 inspection (Photos 1 to 3). At the headscarp of Slide A, the pavement edge was exposed and had started to detach from the roadway. The shallow failure (Slide C) on the north embankment of Gunns Creek had continued to slump towards the creek between 2014 and 2015 (Photo 4). The three slides will be repaired in 2015.

Photo 1: (looking east)
Overall view of Slides A and B from western approach

Remedial measures for this site are currently undergoing engineering as part of the Flood Mitigation work. Amec Foster Wheeler submitted a detailed design report in July 2015. The remedial measures will consist of excavation of the failed slope materials at Slides A, B and C, installation of drainage measures at Slide A and B, and reconstruction of the slopes. Construction is scheduled to start later in 2015. Inspection of the site should be continued following construction to evaluate the effectiveness of the remedial measures.

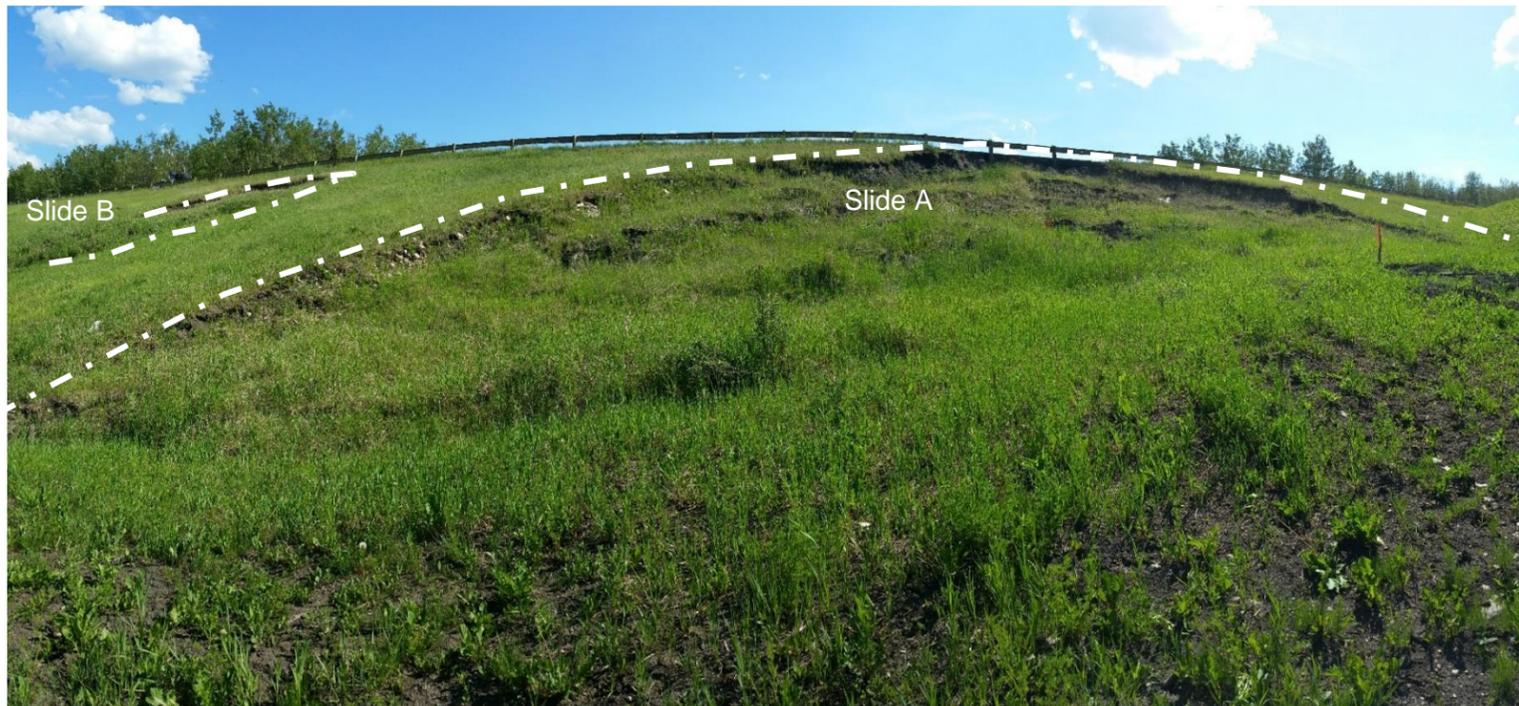
Photo 2: (looking south)
Slumped mass of Slide A.

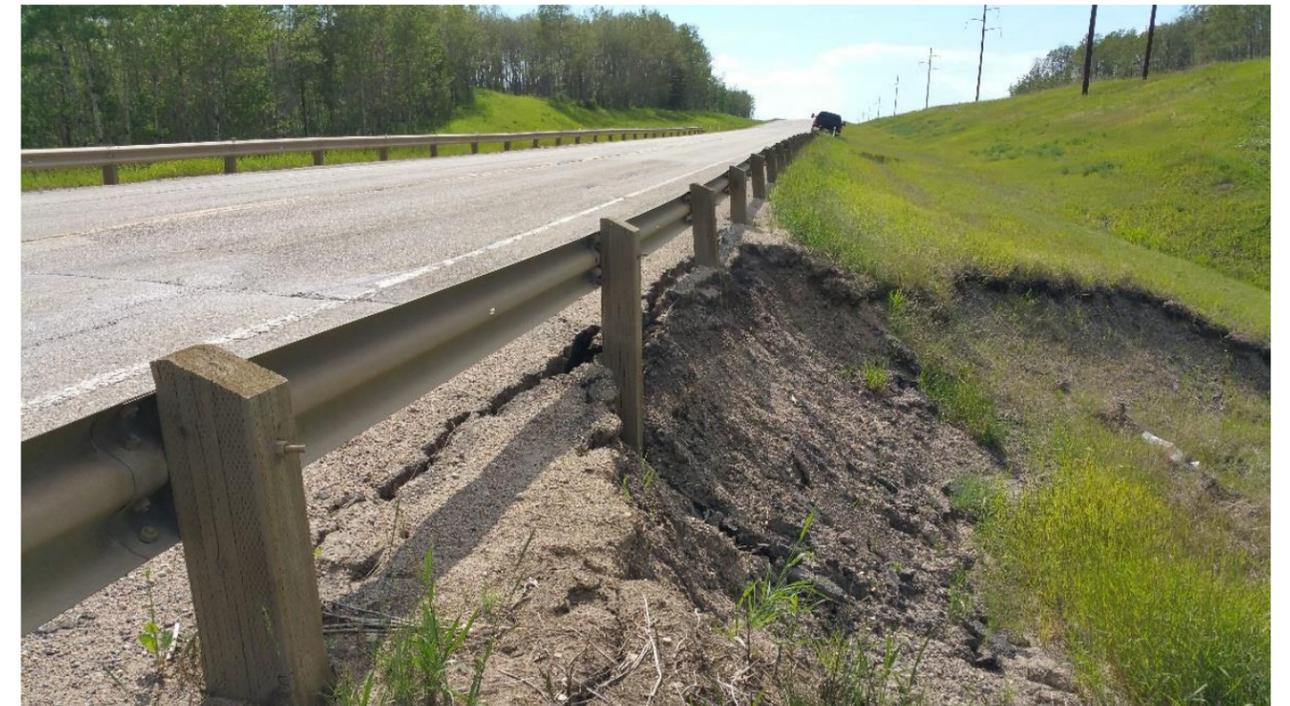
ITEM	CONDITION EXISTS		DESCRIPTION AND LOCATION	NOTICABLE CHANGE FROM LAST INSPECTION		
	YES	NO		YES	NO	SEE COMMENTS
PAVEMENT DISTRESS	X		The headscarp of Slide A has retrogressed to the guardrail and into the pavement. A slight vertical sag in the guardrail at the headscarp of Slide A (see Photo 3). Some minor pavement cracking and deformation was noted near the centerline of the roadway (see Figure 1).	X		X
SLOPE MOVEMENT	X		Bowl shaped slope failure approximately 40 m by 40 m in plan (Slide A). Bowl shaped slope failure approximately 15 m wide by 21 m long (Slide B) and tension cracking and shallow scarps between Slide A and B. Shallow failure beyond the toe of the north embankment on west bank of Gunns Creek, approximately 12 m wide by 15 m long. (Slide C)	X		X
EROSION	X		Erosion and slumping of east and west banks of Gunns Creek adjacent to the culvert inlet. Sinkhole immediately upslope and adjacent to the culvert inlet approximately 1.5 m in diameter. Minor erosion of the south bank of Gunns Creek near the culvert outlet.	X		X

Photo 3: (looking west)
Exposed headscarp of Slide A. Tension cracking near the headscarp of Slide A adjacent to guardrail. Note the slight sag in the guardrail.

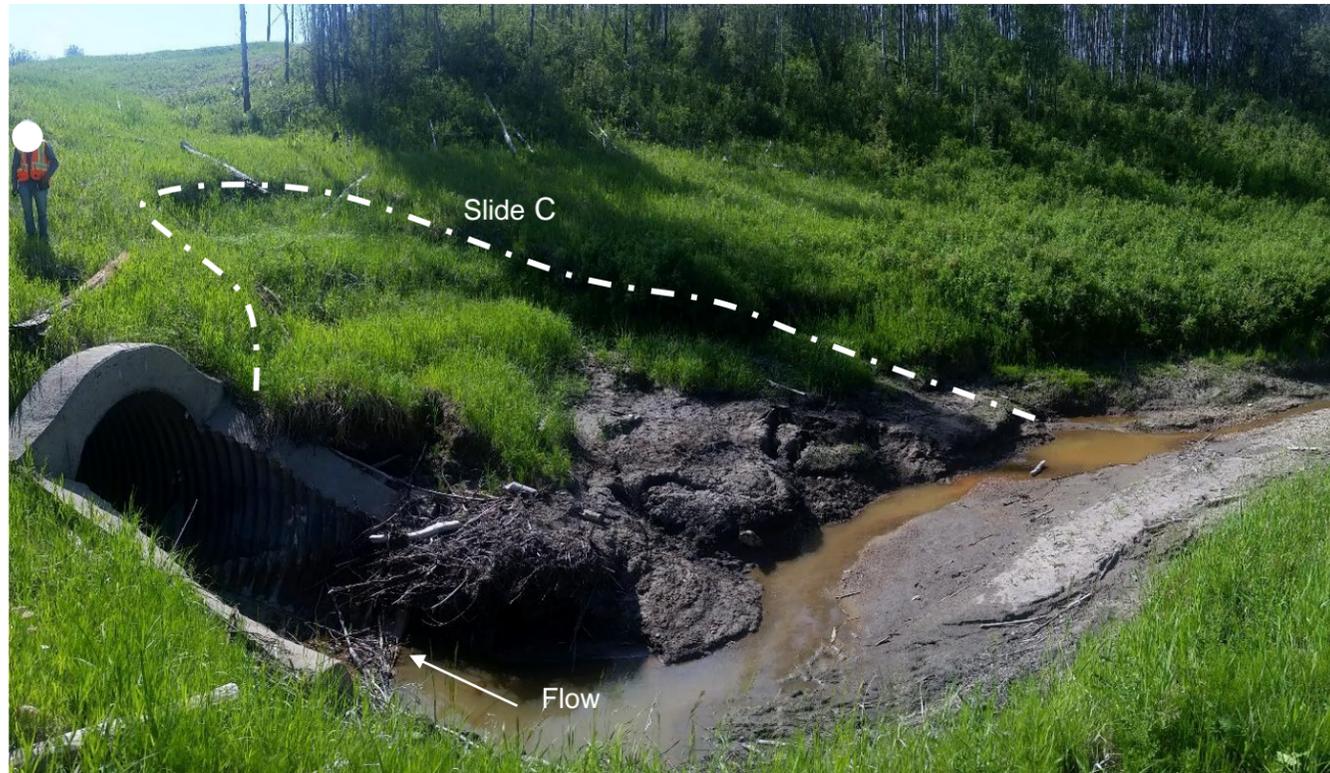
Photo 4: (looking west)
Shallow slumping (Slide C) on west bank of Gunns Creek. Fresh toe bulge apparent.

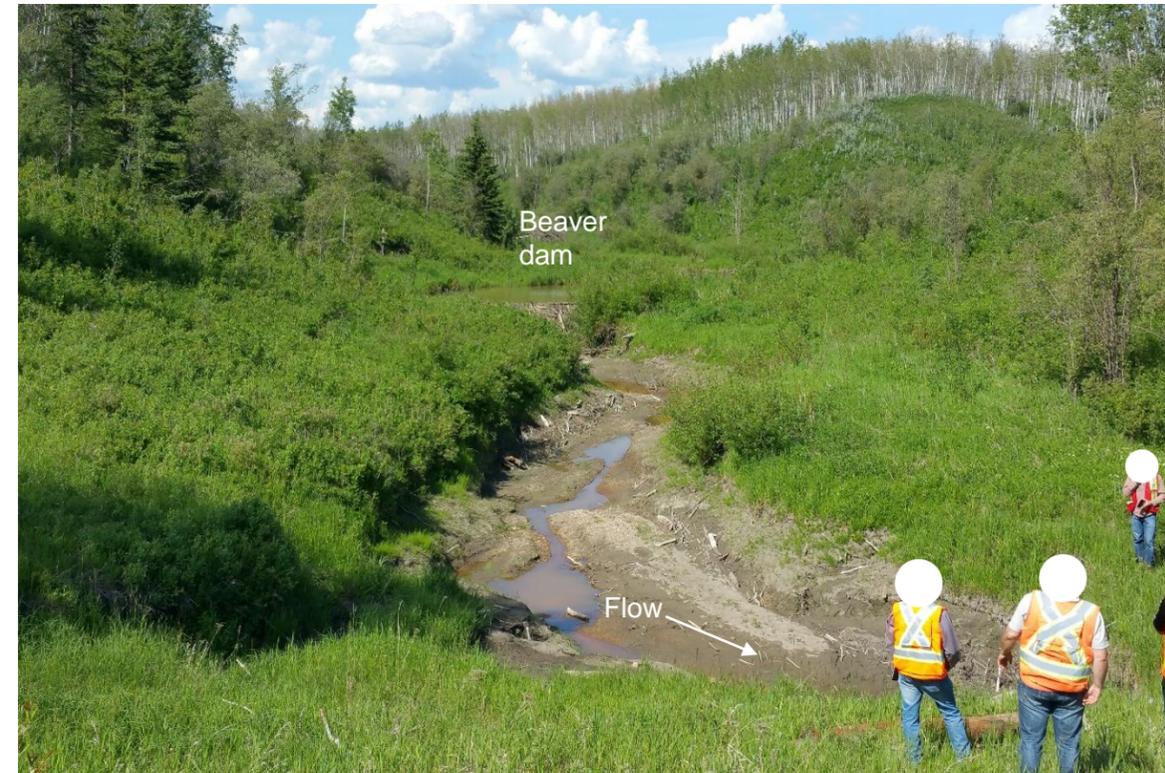
Photo 5: (looking north)
Erosion of east and west banks of Gunns Creek adjacent to the culvert inlet. Note beaver dam in background.

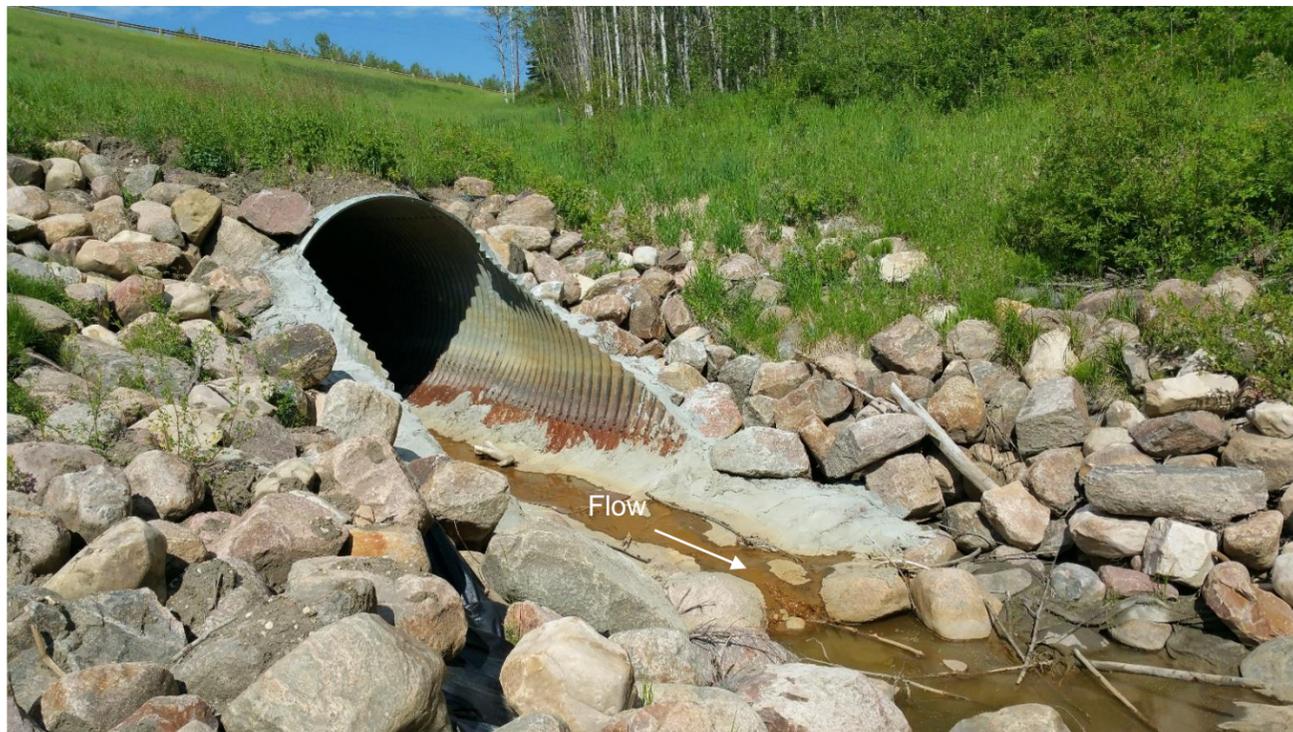
Photo 6: (looking northeast)
Geotextile and riprap placed around culvert outlet between 2013 and 2014 inspections. No discernible displacement of riprap has occurred since the 2014 inspection.

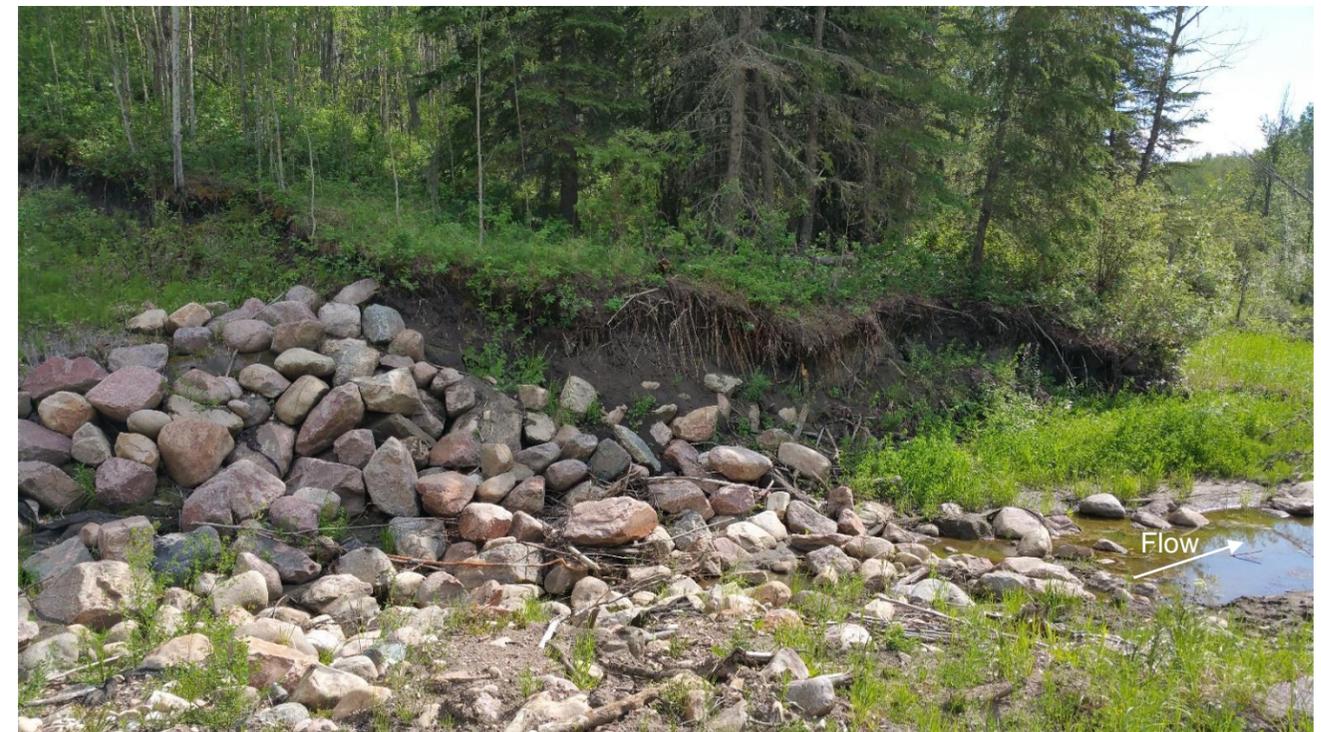
The south embankment (expired Site SH15) was also visited at the time of the 2015 inspection. Minor erosion of the south bank of Gunns Creek near the culvert outlet was observed during the 2014 and 2015 inspections (Photos 7 and 8). Following the addition of rip rap between the 2013 and 2014 inspections, erosion has decreased and no significant changes were observed between the 2014 and 2015 inspections.

Photo 7: (looking south)
Erosion near culvert outlet at south embankment.
