**PEACE REGION – SWAN HILLS
GEOHAZARD RISK ASSESSMENT
SITE INSPECTION FORM**

SITE NUMBER SH 27A	SITE NAME Judy Creek Ditch Erosion	HIGHWAY & KM HWY 32:12 KM 48.1	PREVIOUS INSPECTION DATE 02 July 2014	INSPECTION DATE 24 June 2015
LEGAL DESCRIPTION LSD 06-15-64-10-W5M	UTM NAD 84 COORDINATES N 6044314 E 601633	PREVIOUS RISK ASSESSMENT		
		PF: 12	CF: 3	TOTAL: 36
		CURRENT RISK ASSESSMENT		
		PF: 12	CF: 3	TOTAL: 36

**GEOHAZARD ASSESSMENT
 PEACE REGION (SWAN HILLS)**

**SH27A DITCH EROSION NEAR JUDY CREEK
 HIGHWAY 33:12, KM 48.1
 SITE LOCATION, PLAN AND CROSS-SECTION**

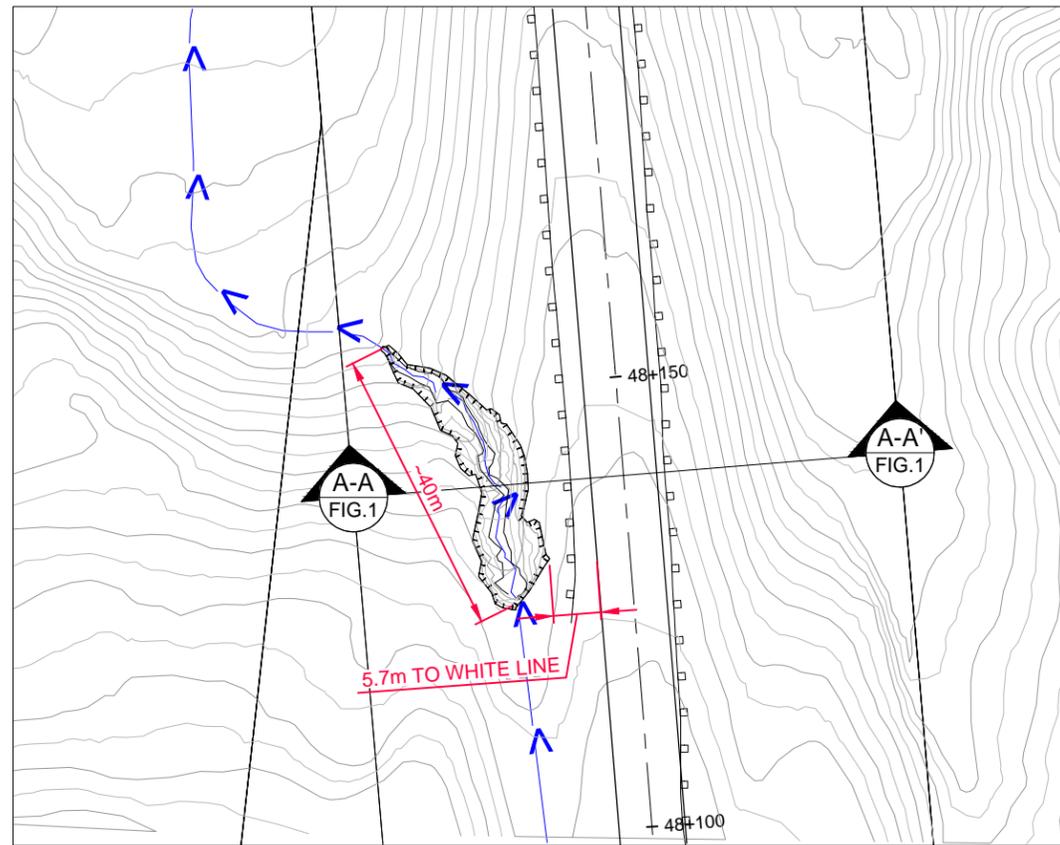
SITE PLAN

- APPROXIMATE DIMENSIONS:**
- See plan attached
 - Erosion gully extended ~20 m along the fall of the slope of the ditch to the north, parallel to the road, and then turned to the northwest and extended a further 20 m along the fall of the slope to the northwest;
 - At its start, the erosion gully has formed a vertical drop. In 2014, the erosion gully was ~2.5 m deep and 8 m wide near the start of the gully;
 - The erosion gully was ~5.7 m from the white line on the west side of the highway at its closest location.

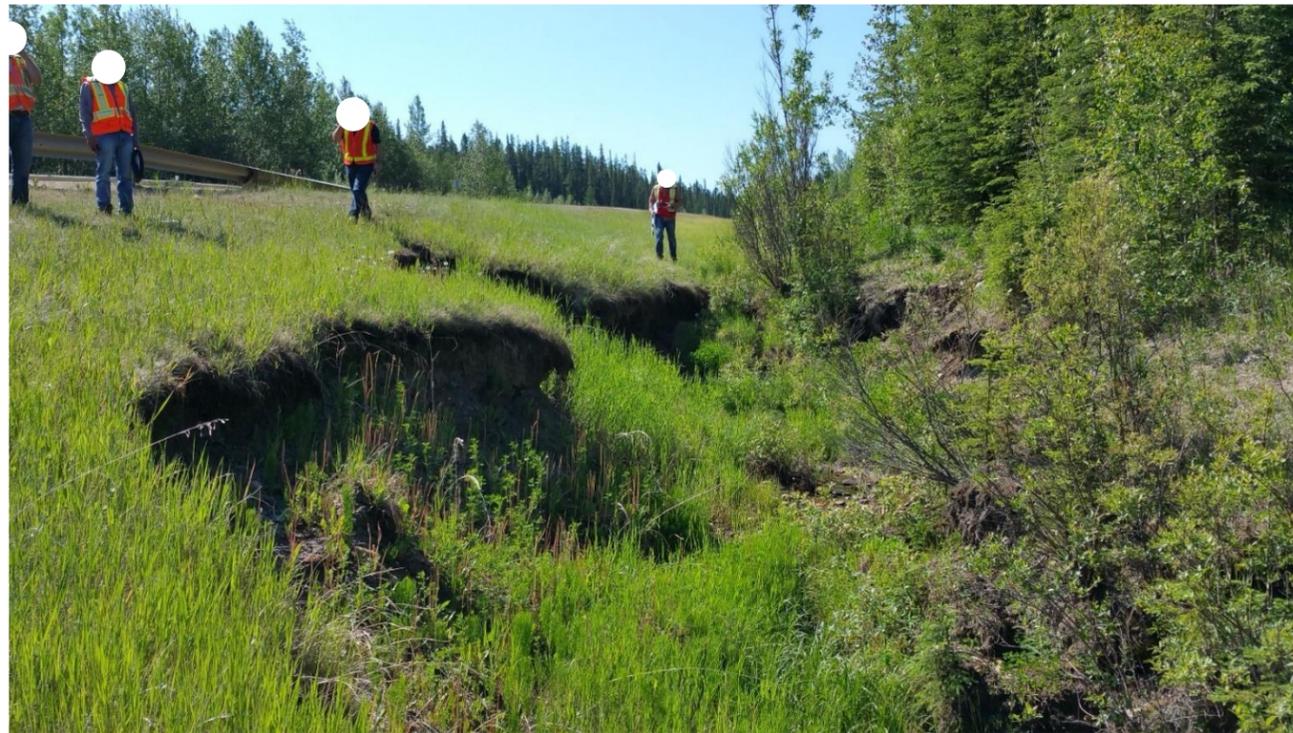
Erosion gully in the west ditch along Highway 32:12 (Photos 1 to 3). Retrogression and widening of the erosion gully could undermine the highway. An underground fibre optic cable has been exposed by the gully in 2013.

The soils within the gully are considered highly erodible and although there has been no impact to the highway, the erosion is expected to continue and could accelerate during high ditch flow. Although the likelihood of sudden and total closure of the highway at this location is considered relatively small under normal ditch flow conditions, the rate of retrogression, widening and down cutting of the gully would be greater under high flow conditions which would increase the risk of undermining the highway.

Photo 1: (looking south)
Erosion and slumping in west ditch of Highway 32. Erosion gully was approximately ~5.7 m from the white line of the highway.

Designs works to repair the erosion gully were completed in summer 2015 with construction expected to commence later in 2015 under the High Water Mitigation Works for the Swan Hills Region. The design consists of installing a perforated sub-drain, reconstructing the ditch grade with compact granular material, and armouring the gully with riprap. For further details, refer to the design documents in Part F of the site binder.

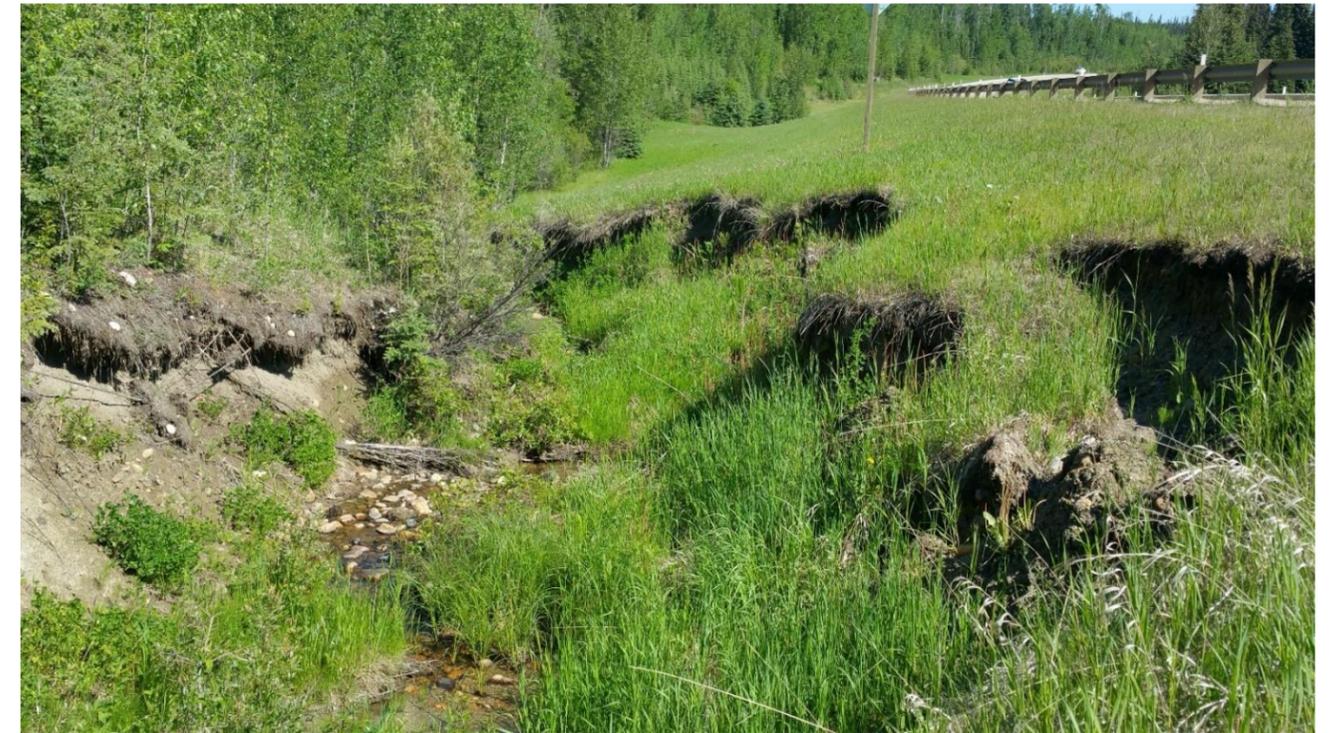
Photo 2: (looking north)
Note depth of erosion gully and erosion of highway embankment fill.

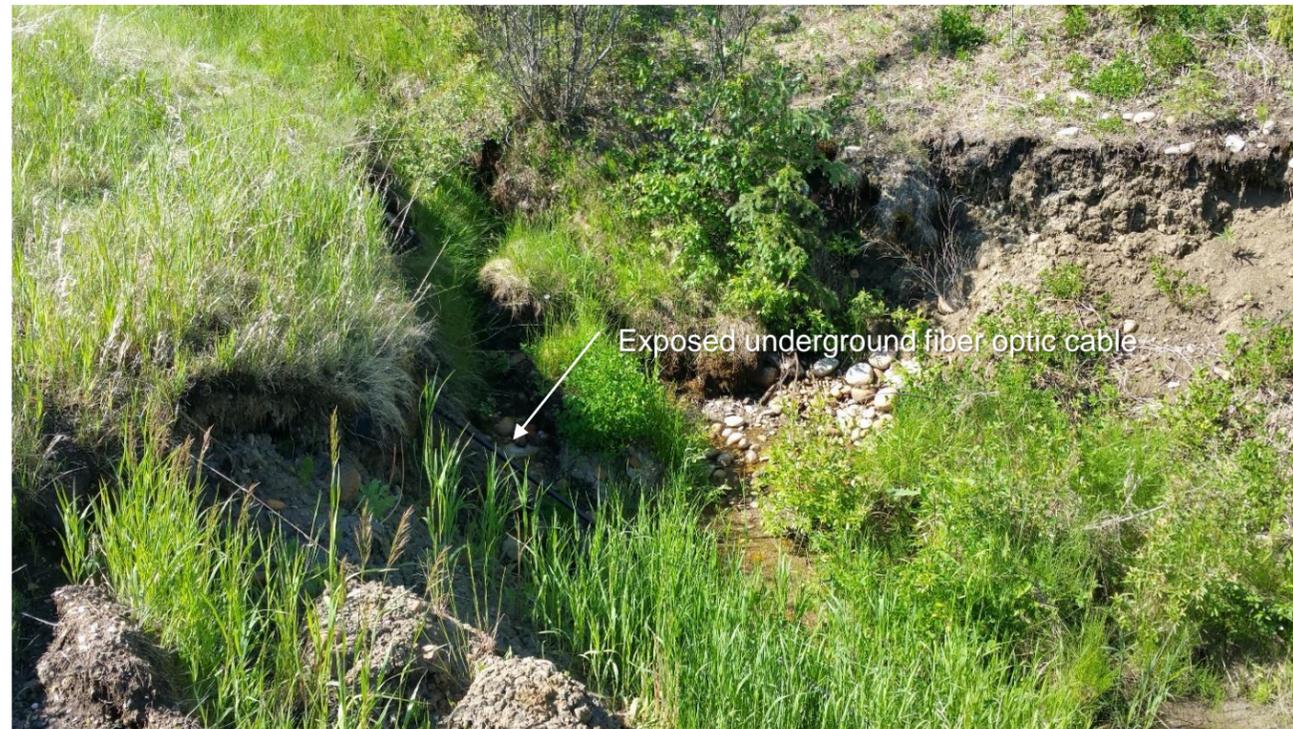
Photo 3: (looking east)
Note depth of erosion gully, erosion of highway embankment fill, and exposed cable.
