GEOHAZARD ASSESSMENT PROGRAM

PEACE RIVER / HIGH LEVEL AREA

2014 INSPECTION

Site Number	Location	Name	Hwy	km
PH68	North of Town of Peace River	Bogey and Double Bogey Landslides	743:02	Approx. 3.6
Legal Description		UTM Co-ordinates		
12-84-22-5		11V N 6235659	E 478510

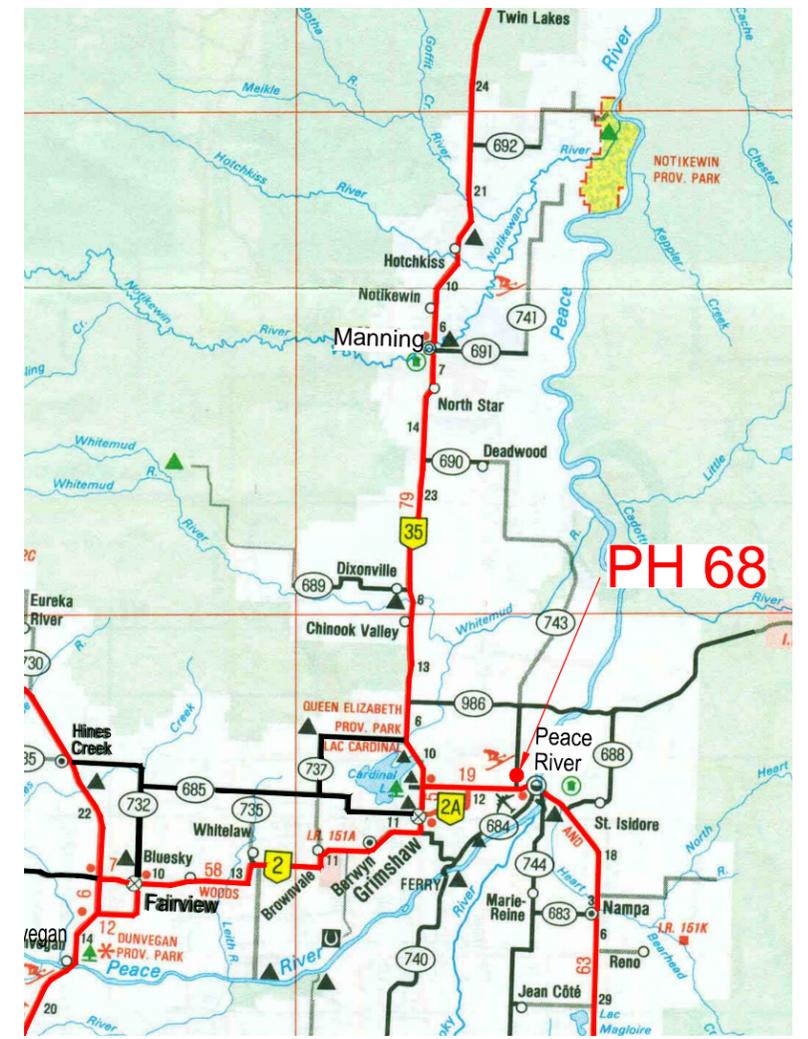
FIGURE PH68-1

NOTE:
JUNE 2014 OBSERVATIONS SHOWN IN RED

SITE PLAN
APPROX SCALE 1:1250

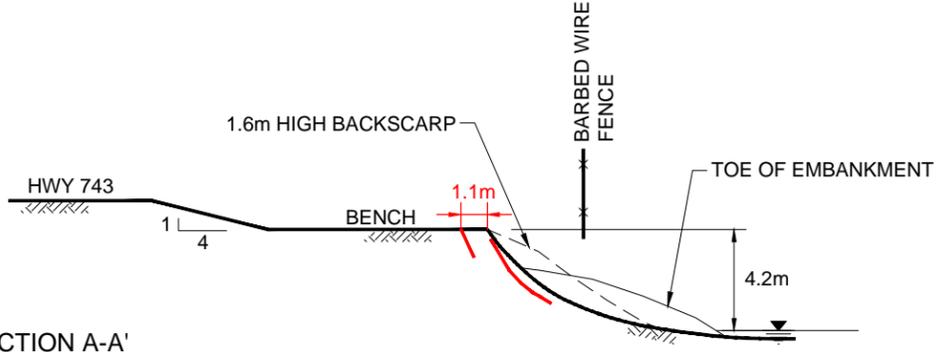
CROSS SECTION A-A'
APPROX SCALE 1:300

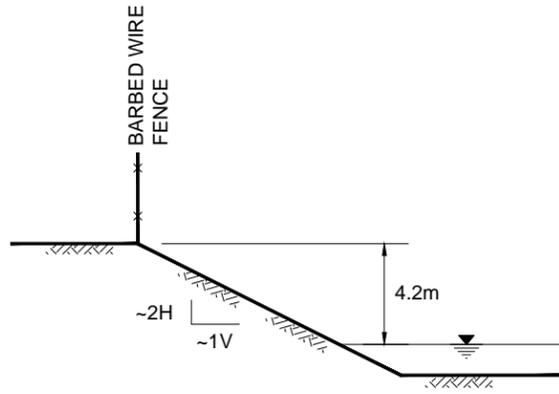
CROSS SECTION B-B'
APPROX SCALE 1:300

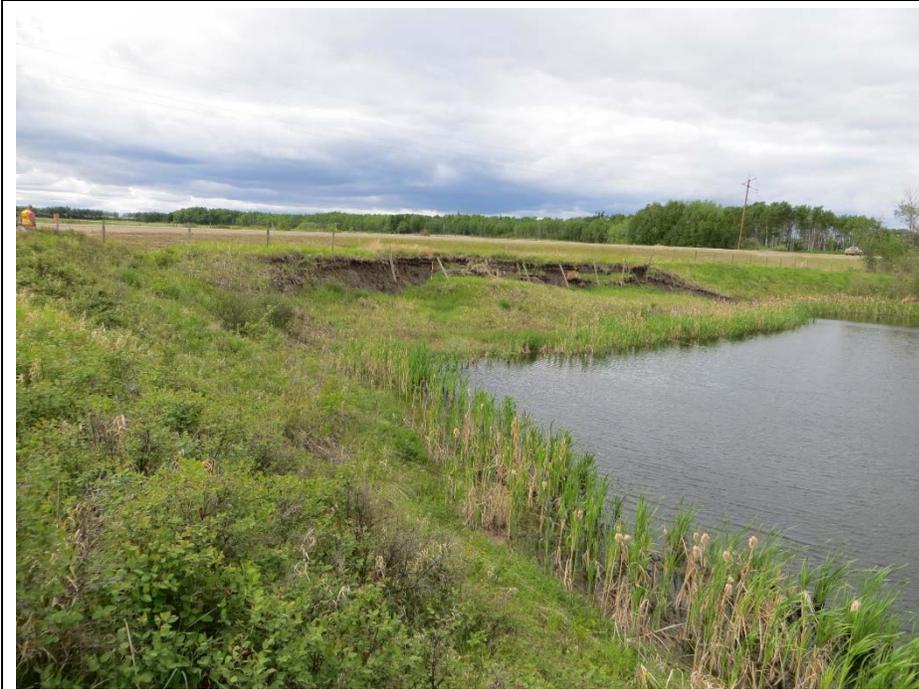
Photo 1.
Looking northwest at
Double Bogey
landslide dugout
scarp.

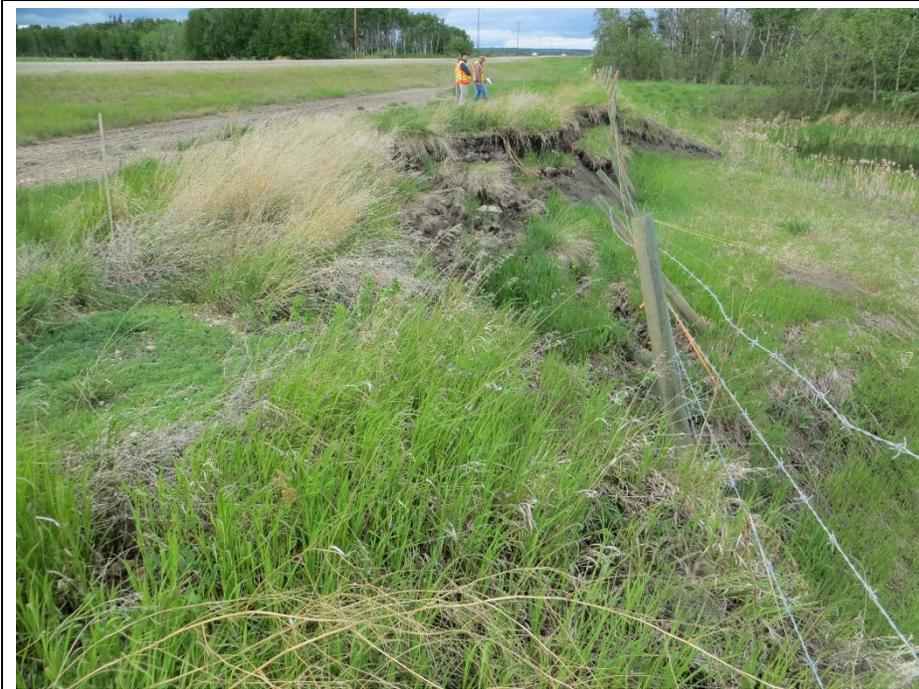
Photo 2.
Looking north at
Double Bogey
landslide dugout
scarp.

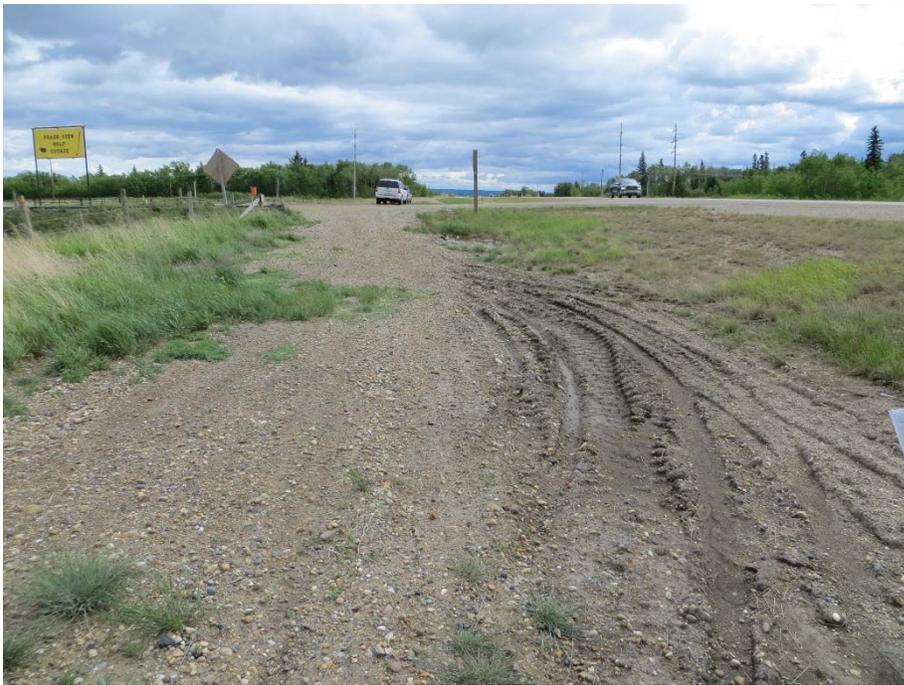
Photo 3.
Looking south at Double Bogey landslide golf course access road culvert inlet.

Golf course access road culvert located south of the Double Bogey Slide is obstructed. Culvert should be cleaned and outlet should be graded to reduce ponding.		
<input type="checkbox"/> Other		<input type="checkbox"/>	<input type="checkbox"/>
Instrumentation: None at this site.			
Assessment Bogey Slide The side slopes and the highway at the Bogey slide location were repaired in the fall of 2011, and no signs of movement were observed during the site visit of spring 2013 (Photos 6 to 10). Double Bogey Slide A landslide developed in the cutslope of the borrow pit pond. The back scarp was measured to be about 1.6 m deep. The scarp was about 15 m from the edge of the asphalt. The barb wire fence was observed leaning at the scarp location (Photos 1 to 5). The potential cause is cyclic filling and draining at the pond combined with a high groundwater table, and weathering and progressive loss of cohesion in the clay cut slopes. The cutslope angle of 2.2H:1V is steeper than usual for high plastic clay in this area.

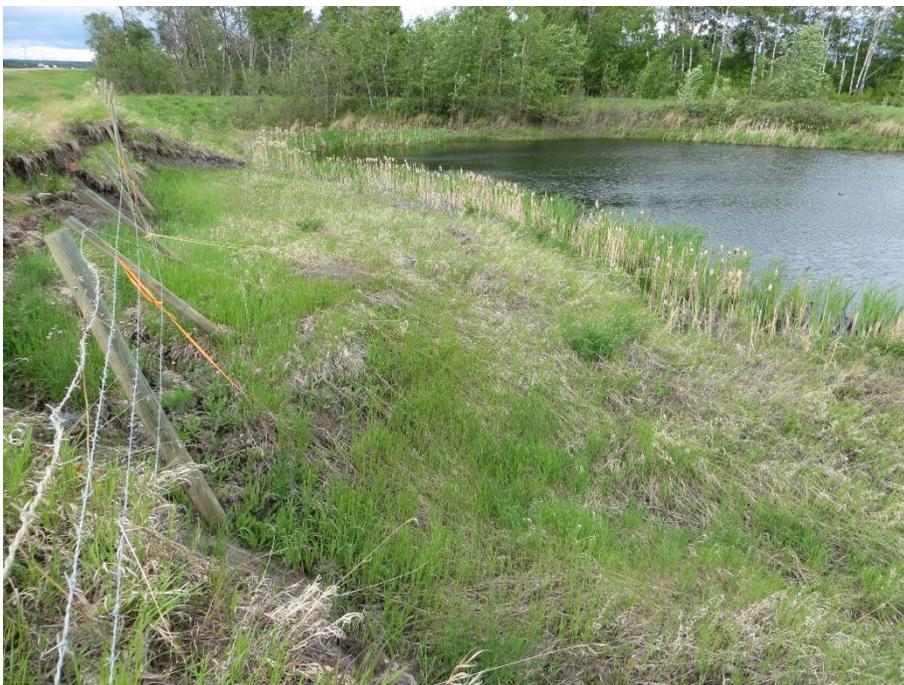
Photo 4.
Looking northeast at Double Bogey landslide dugout scarp.

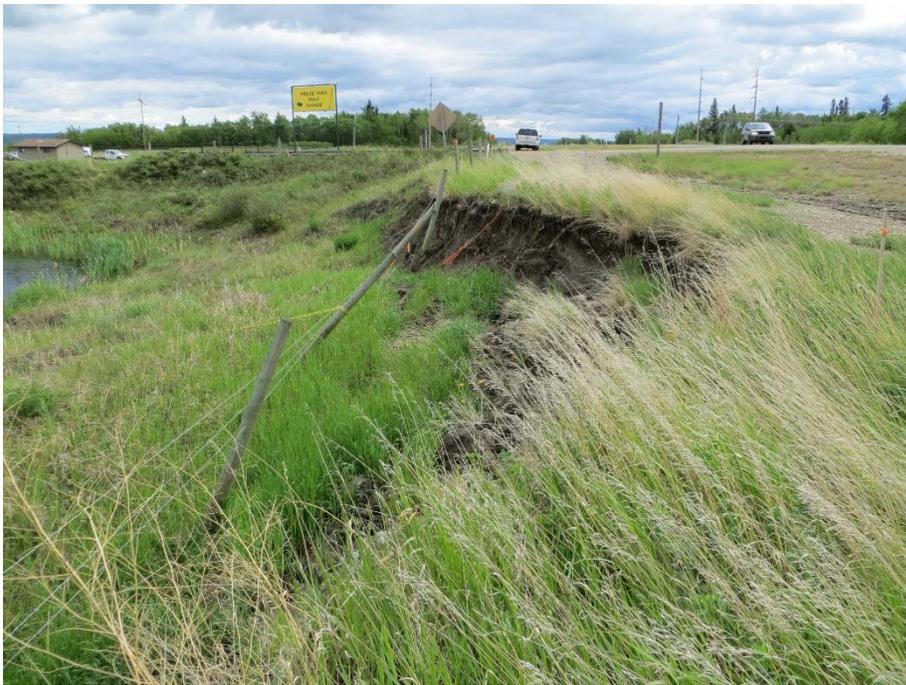
Photo 5.
Looking south at
Double Bogey
landslide dugout
scarp and leaning
fence.

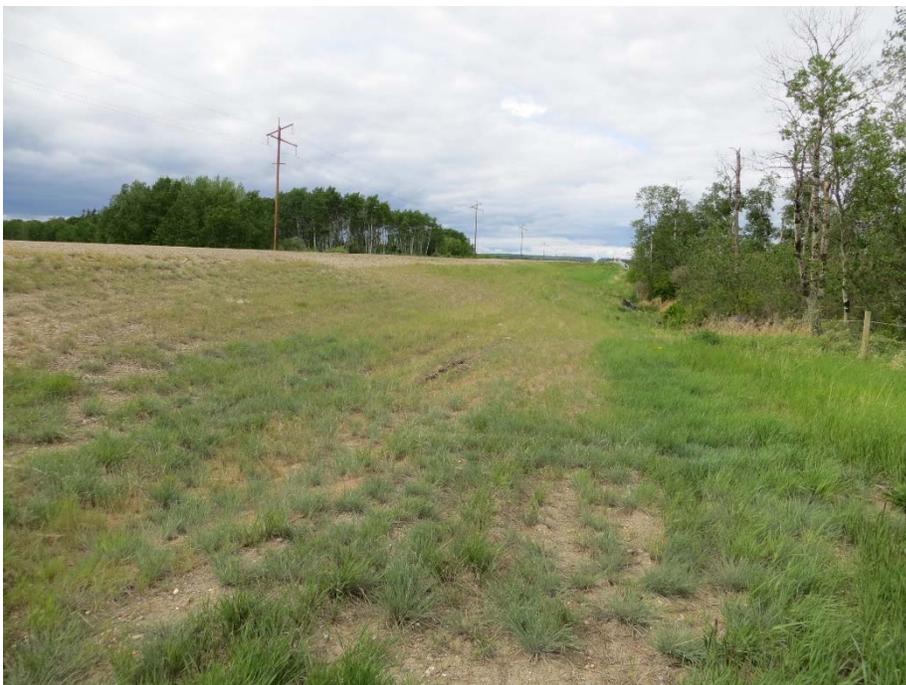
Photo 6.
Looking north at
Bogey landslide east
sideslope repair.

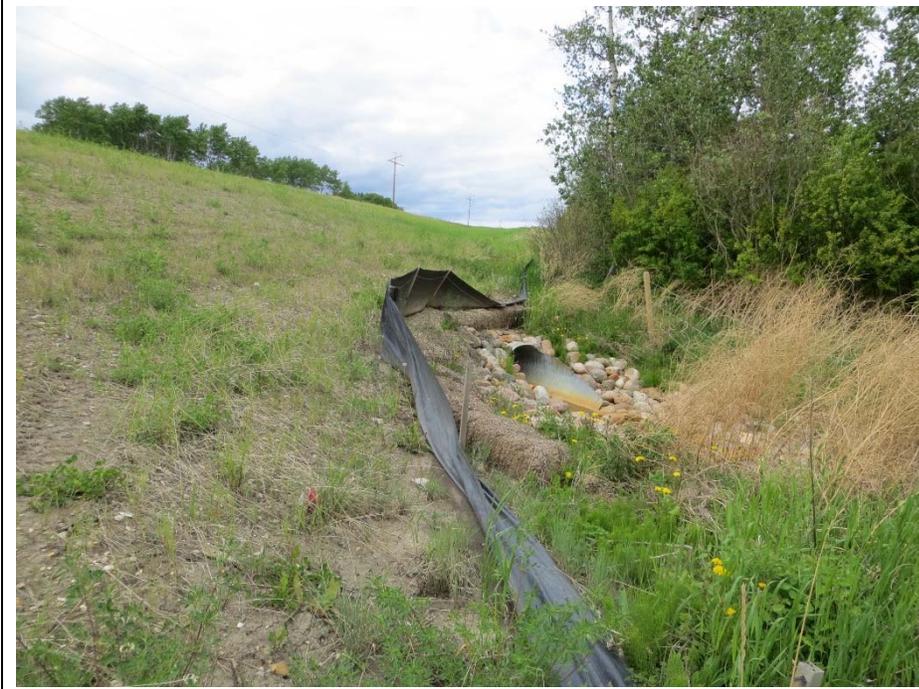
Photo 7.
Looking northeast at
Bogey landslide
centerline culvert
outlet.

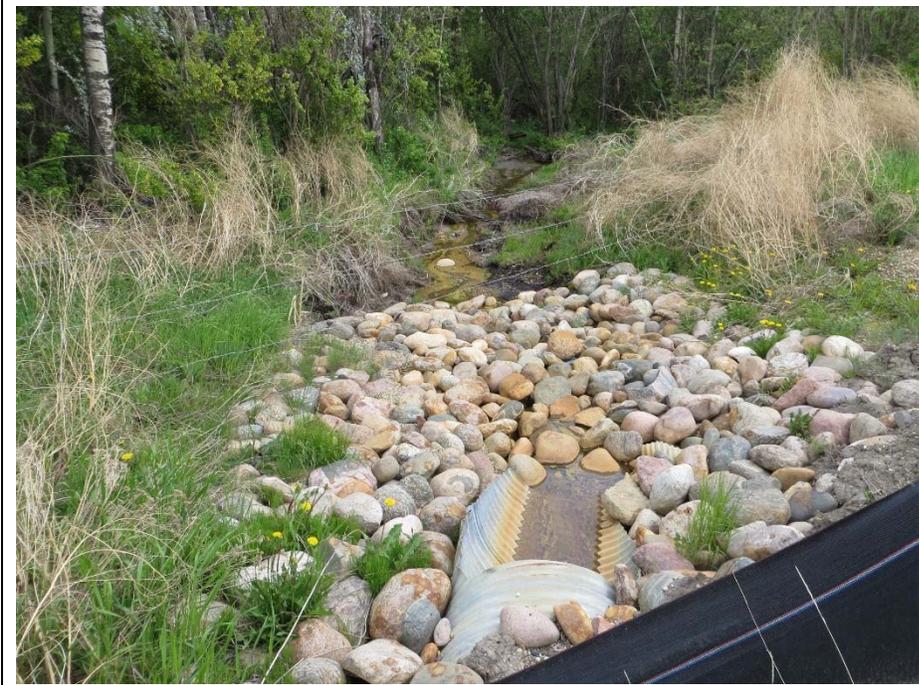
Photo 8.
Looking southeast at
Bogey landslide
culvert outlet rip rap.

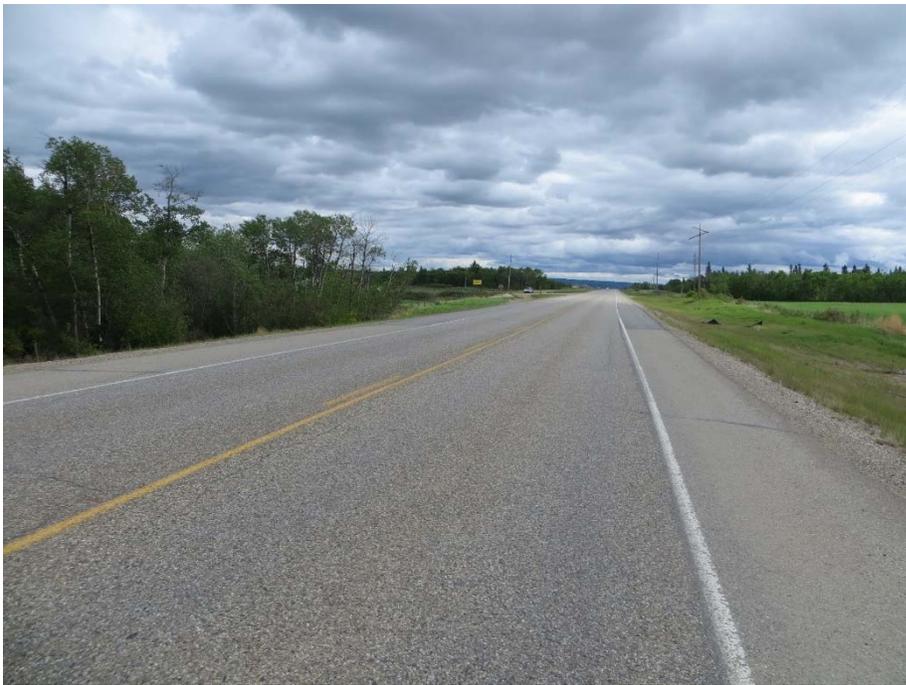
Photo 9.
Looking north at
Bogey landslide
highway
embankment repair.

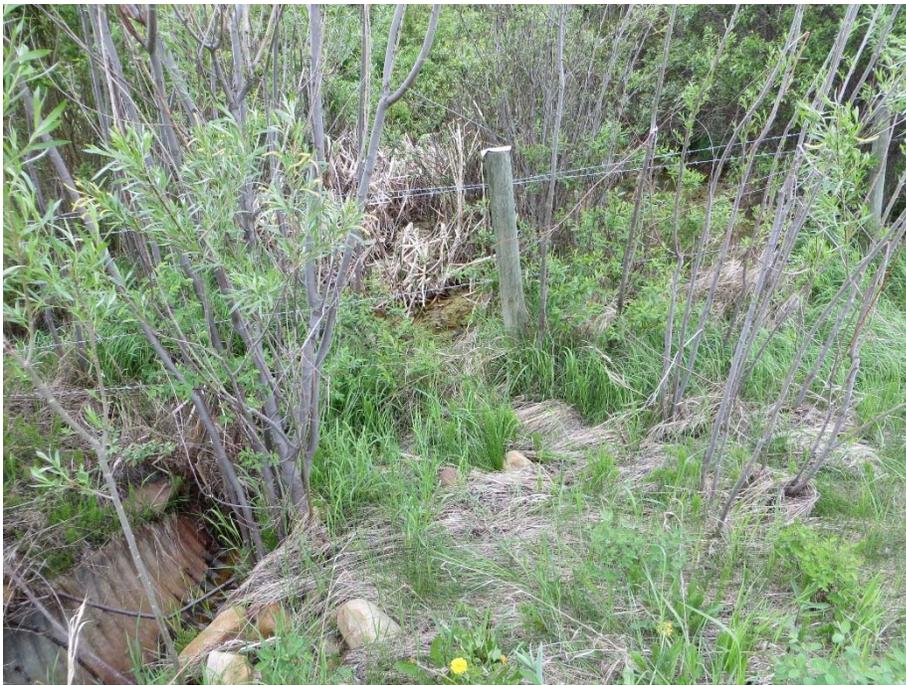
<input type="checkbox"/> Erosion		<input type="checkbox"/>	<input type="checkbox"/>
<input checked="" type="checkbox"/> Seepage	No seepage observed at both locations.	<input type="checkbox"/>	<input checked="" type="checkbox"/>
<input checked="" type="checkbox"/> Culvert Distress	Inlet of Centerline Culvert at Bogey Slide on west side of Hwy 743 is obstructed with Rush overgrowth and should be properly cleaned to allow better water flow.	<input type="checkbox"/>	<input checked="" type="checkbox"/>

Photo 10.
Looking northwest at
Bogey landslide
centerline culvert
inlet.

Recommendations: Bogey Slide The Bogey slide should be observed for stability and highway performance as part of the site visits for the Double Bogey Slide. Rushes and small shrubs are restricting the flow into the Hwy 743 centerline culvert inlet on the west side of the highway embankment, and should be periodically trimmed, (Photo 10). Double Bogey Slide Culvert should be cleaned and outlet should be graded to reduce ponding at the private entry culvert south of the slide area. In order to repair the back scarp of the borrow pit dugout one of the following recommendations may be considered: Option 1 <ul style="list-style-type: none"> ▪ Cut back the pond slope to about 6H: 1V. This involves further encroaching into the highway right of way. ▪ Install French drains at a spacing of 5 m centre to centre to drain the groundwater from the road into the pond. Option 2 <ul style="list-style-type: none"> ▪ Over-excavate the slump and reconstruct the cut slope with geogrid reinforced gravel, incorporating a gravel shear key at the base of the excavation. This would allow the repair to stay within the highway right of way. Either of the above remediation measures will need to be undertaken within the highway right of way. The ballpark cost for either option is \$175,000 to \$225,000.
