**ALBERTA TRANSPORTATION  
GEOHAZARD ASSESSMENT PROGRAM  
PEACE REGION (PEACE RIVER DISTRICT)  
2021 INSPECTION**

Site Number	Location	Name	Hwy	km
SH016-1	Little Smoky River	West Bridge Abutment	49:12	1.90
Legal Description		UTM Co-ordinates		
NE33-74-21-W5M		11U E 489,573	N 6,145,499

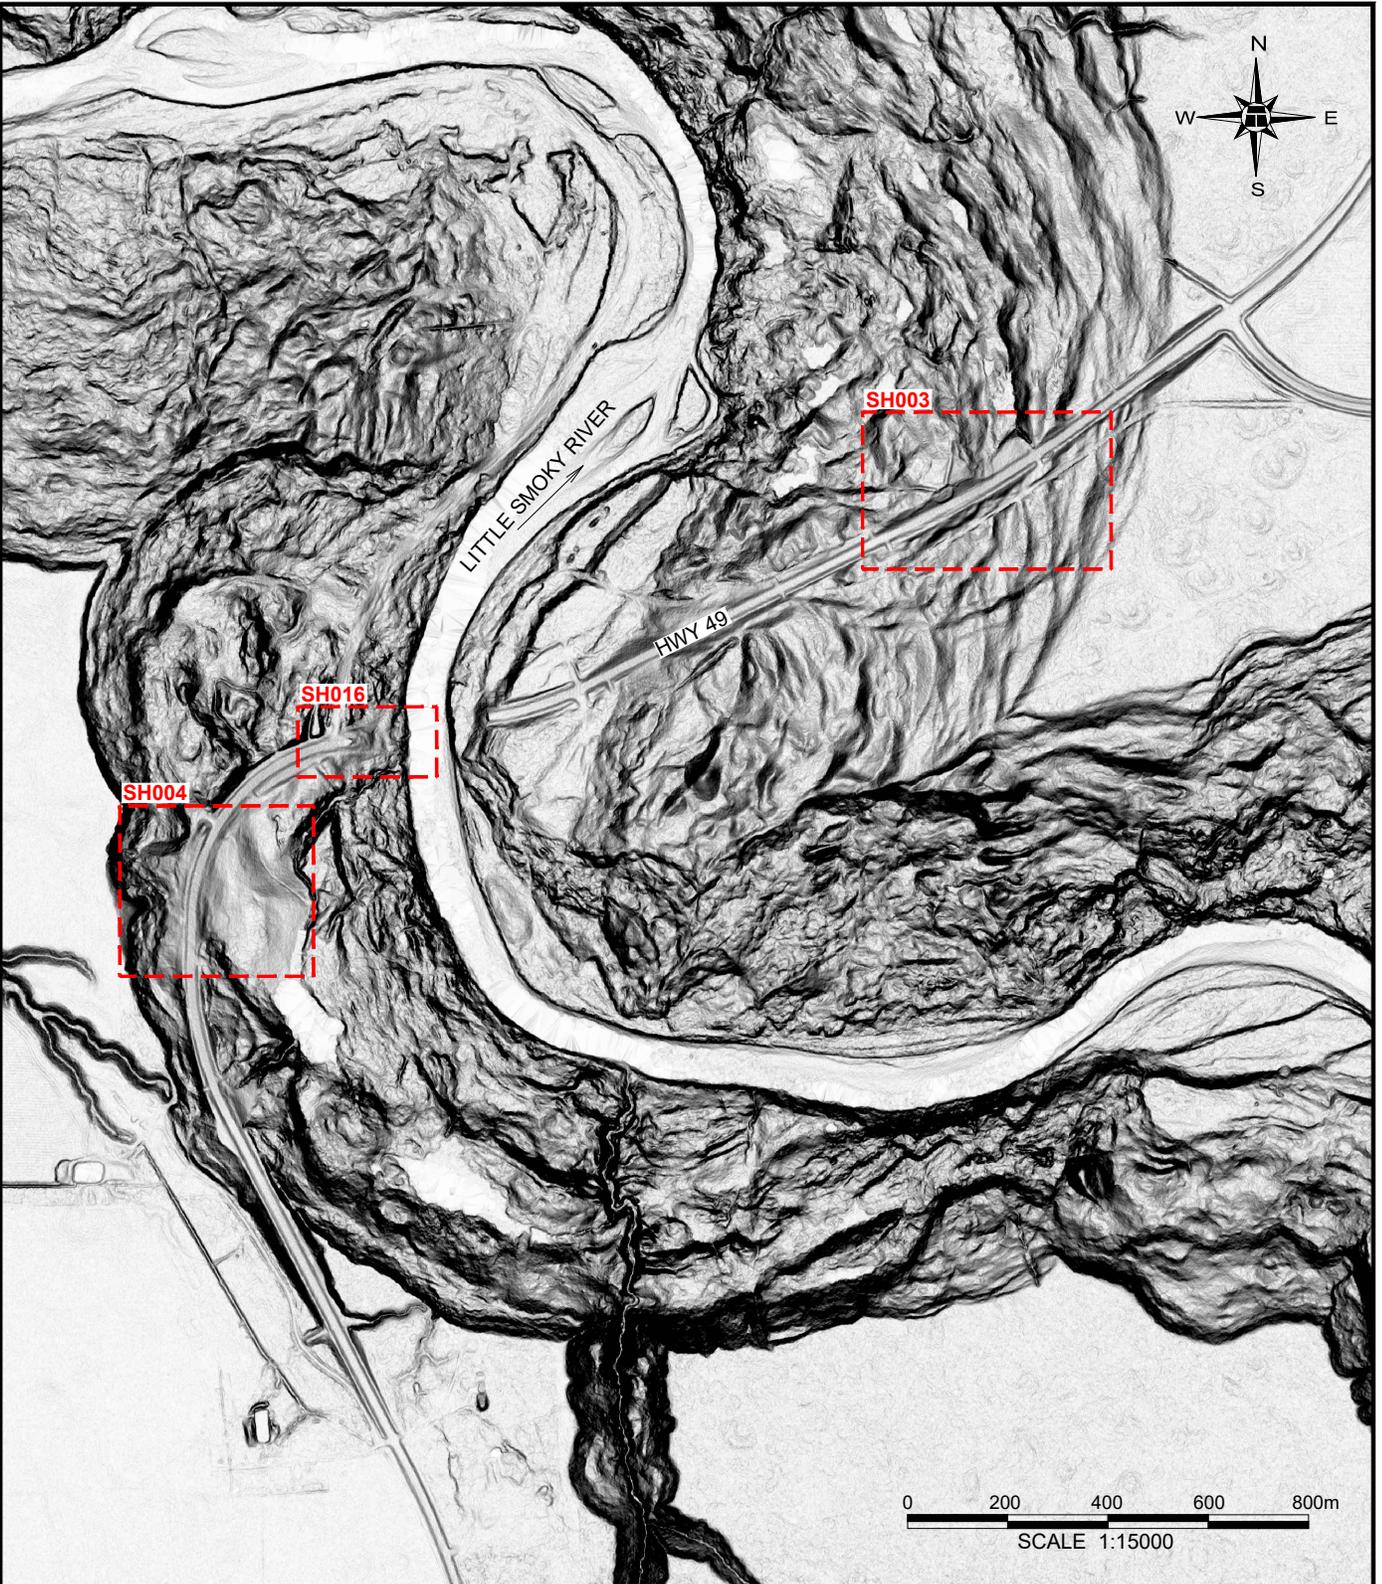
FIGURE 1

Based on GPS survey of the inSAR points conducted by Alberta Geological Survey (AGS Open Report 2013-14), the west abutment of the bridge is situated on a faster-moving block (greater than 90 mm per year) compared to the rest of the west slope which is moving at 5 mm to 40 mm per year. Figure 1 shows a high-level view of the LiDAR (flown in 2008 and provided by Alberta Transportation) for the overall west slope where slide scarps and sag pond features can be readily identified.

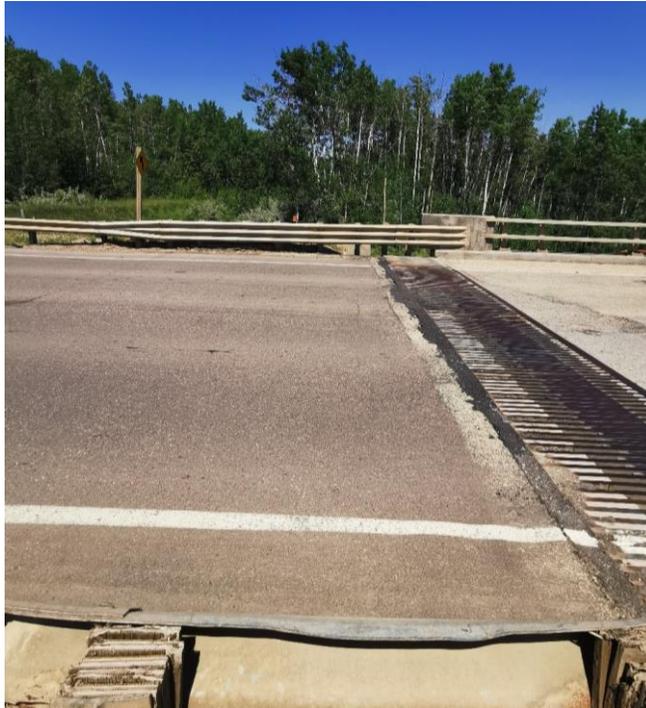
Photo 1 – Looking north at paved surface at the abutment expansion joint where cracks were previously observed

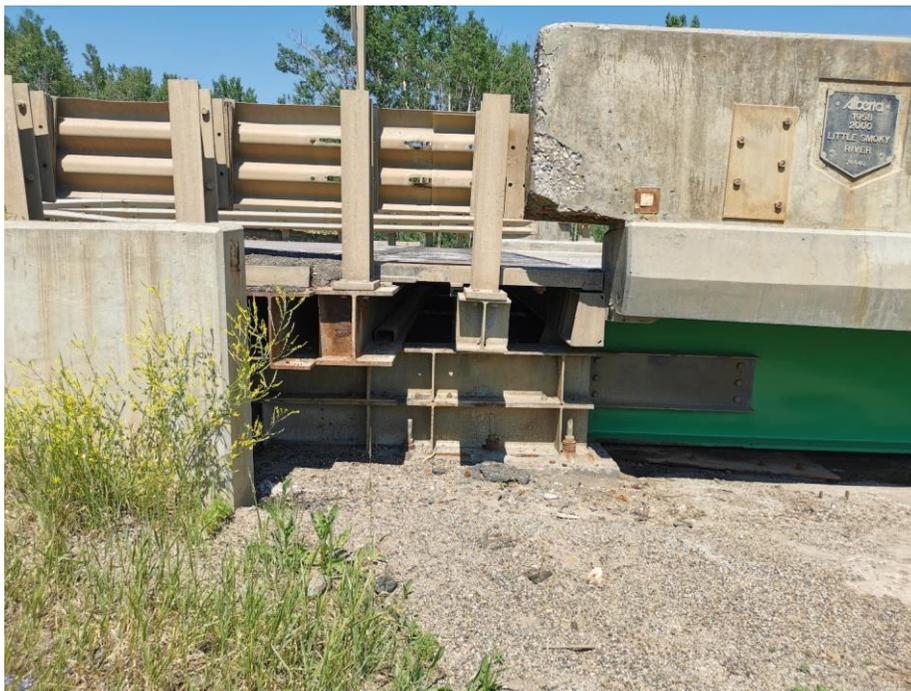
The West Abutment, Abutment 1, and Pier 1 were designed to compensate for movement of the landslide and foundation below the bridge. The West Abutment compensation is done by adjusting the location of the west half of the finger joints along with adjustment of the length of the approach slab by removing steel I-beams (see photos). Since 2000, three of the five beams have been removed with the fourth likely to be taking out in the next couple of years. As each beam is approximately 368 mm in width, there has been 1104 mm of horizontal displacement in 20 years for an annualized rate of 55 mm/year. Based on measurements between the bridge deck and wingwall, there has been 220 mm of displacement in the last three years which is 73 mm/year.

Photo 2 – Looking north at west bridge abutment. The two I-beams at the edge of the wingwall are the remainder of the 5 installed in 2000.

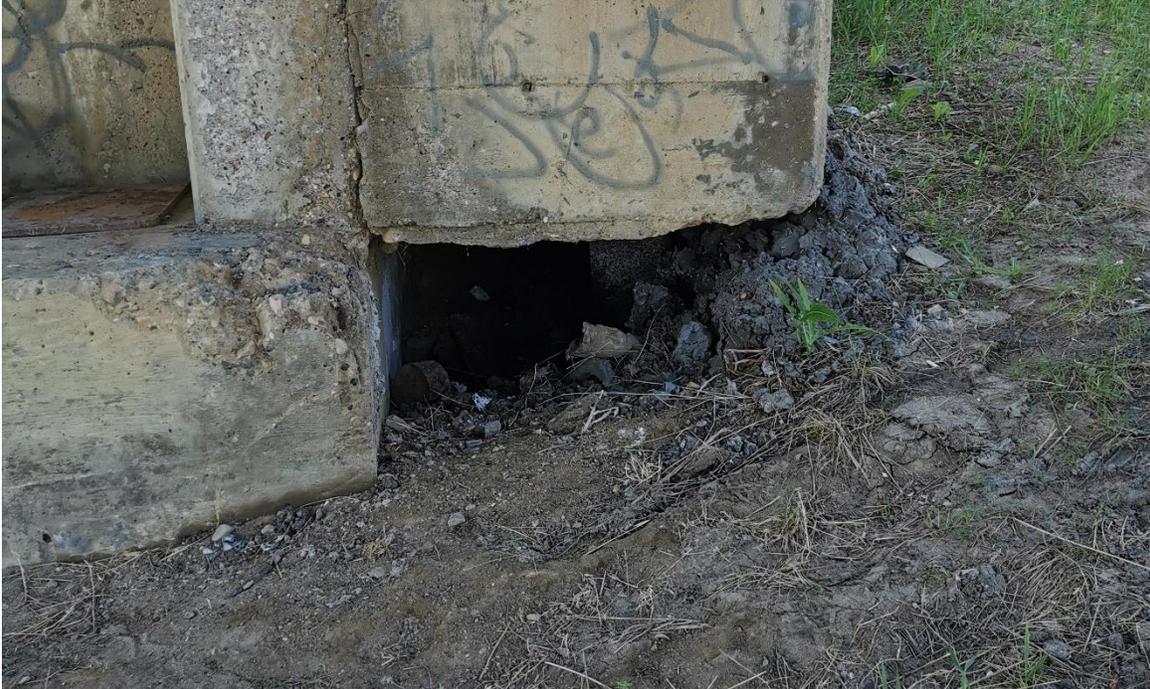
Photo 3 – Void on northeast corner of Abutment #1 exposing rusting H-pile.

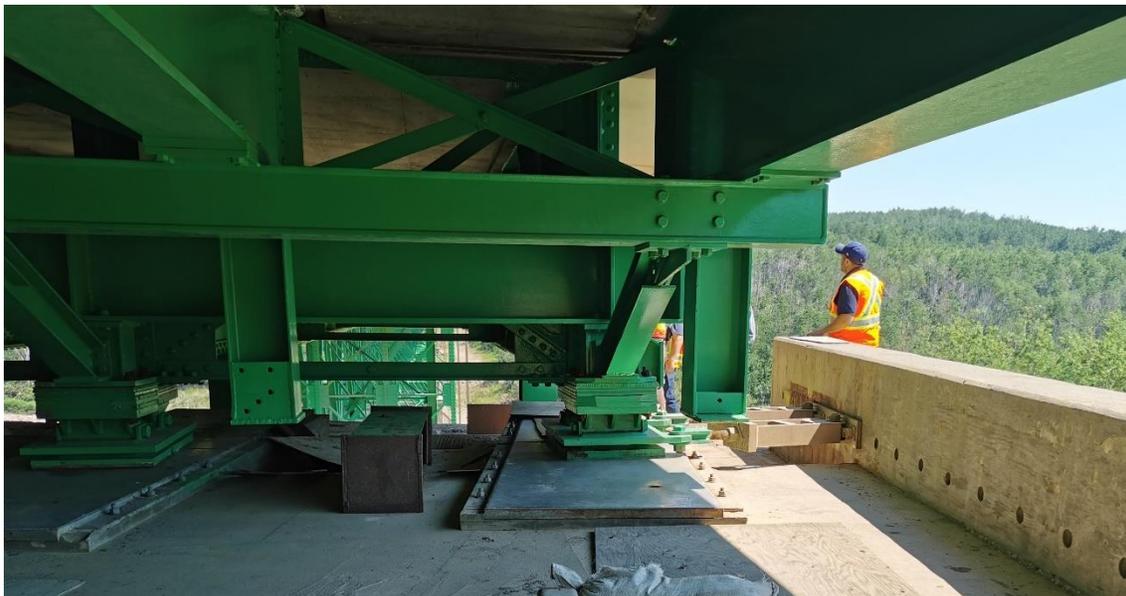
Abutment 1 teflon bearing pads move laterally over stainless-steel slide plates and are adjusted vertically using shim plates above the bearing pads, and like Pier 1, require frequent adjustment. When additional shim plates are added, the contractor also jacks the bridge transversely to correct the alignment. Measurements taken at the south-most bearing pad indicate 110 mm of movement between October 28, 2020, and May 29, 2021 for an annualized rate of 264 mm per year.

Photo 4: Sliding configuration at abutment.

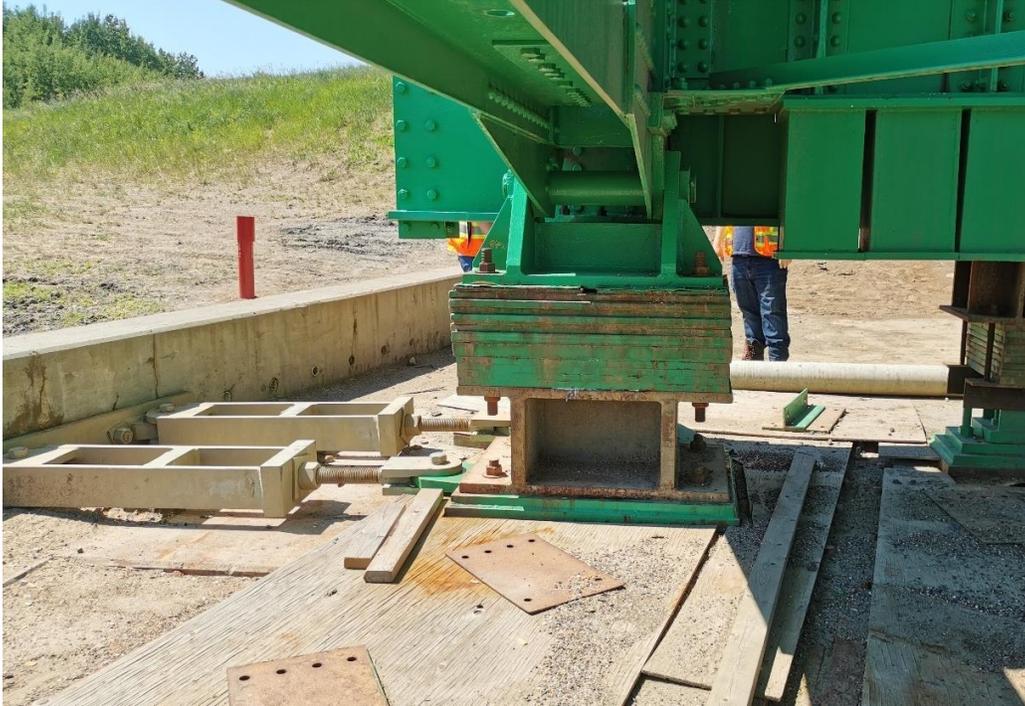
Pier 1 has a similar bearing pad and slide plate arrangements and, in June 2019, new shims and slider plates (to extend the distance the bearing pads can travel) were installed by Ardy Rigging. There is currently 0.84 m of shim between the foundation and the pier. The height of shims was 0.62 m in 2018 and 0.75 m in 2019 giving approximate annual settlements of 130 mm between 2018 and 2019 and 80 mm between 2019 and 2020. Since 1958, there has been 2.97 m of vertical settlement at this pier (approximately 48 mm/year average). Comparing current bolt holes in use on the wingwall with the ones that appear to have been used in the past, there has also been 1.18 m of horizontal movement since the wingwalls were installed in 2000 (74 mm per year). Previous measurements of marks on the slider plates estimated movement annual movement rates of 96 mm in 2016 and 89 mm in 2018. New slider plates were installed during the inspection in 2019. As of October 28, 2020, there had been 220 mm of displacement since June 16, 2019 (160 mm/year), 185 mm since May 29, 2020 (444 mm per year), and 110 mm since June 2, 2020 (271 mm per year). The Pier 1 foundation had a maximum cross-slope angle of 5°.

Photo 5 – Shims under rocker bearings at Pier 1.

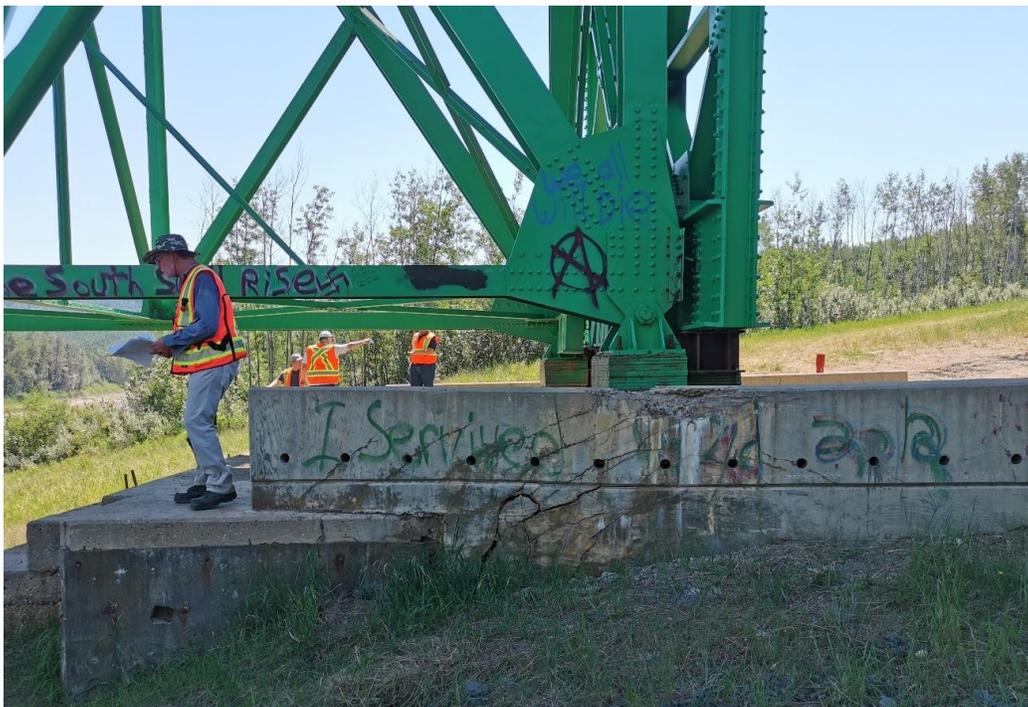
The cracking and accelerating movements and tilting observed in the concrete foundation at Pier 1 might be related to a change in foundation support conditions. The older downstream part of the foundation was supported on deep reaching steel piles; however, the landslide has moved the foundation to the transition point with the south part of the concrete slab which has no piles. The change in loading condition might be causing the slab to tilt and the side walls to crack.

Photo 6 – Looking south at Pier 1 wingwall at arc-shaped crack pattern in foundation. Left-hand portion of foundation is pile supported; right-hand is on-grade.

Carry out repairs to Pier 1 to deal with the accelerated movements and tilting that have been observed there in recent years.

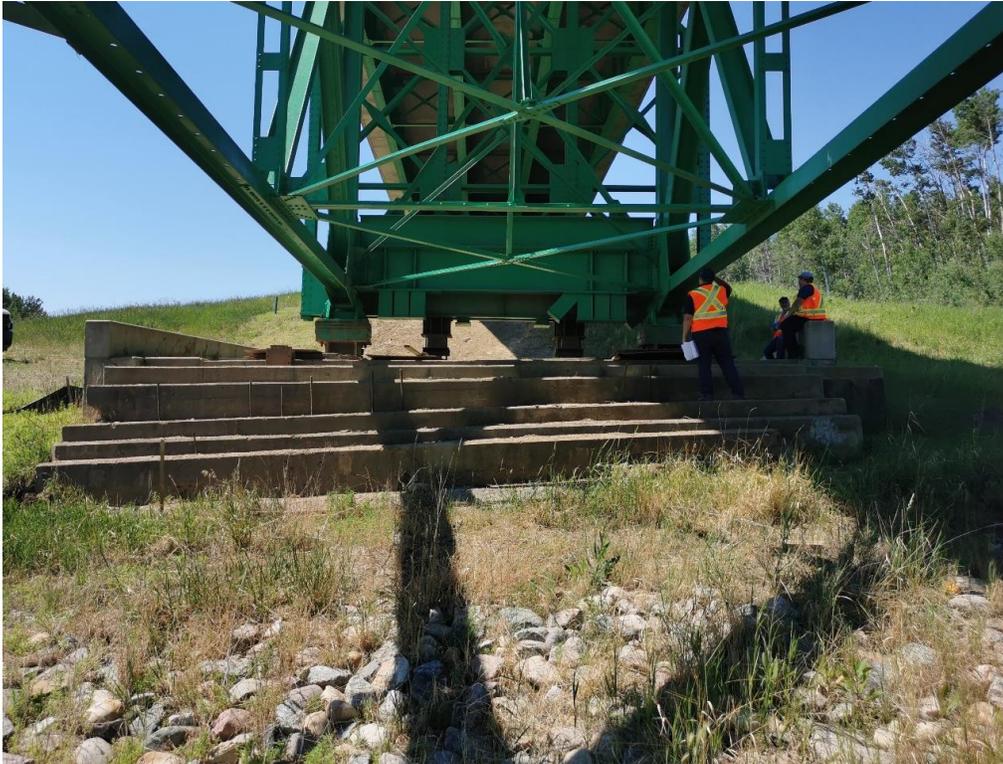
- The concrete foundation at Pier 1 tilts between 0.80° and 2.45° downward toward east (along the fall of the slope) which is an average increase in the dip angle of 0.15° from 2019 and 0.25° and 0.55° south.

Photo 7 – Looking west at Pier 1 foundation which is tilted downward to the south.

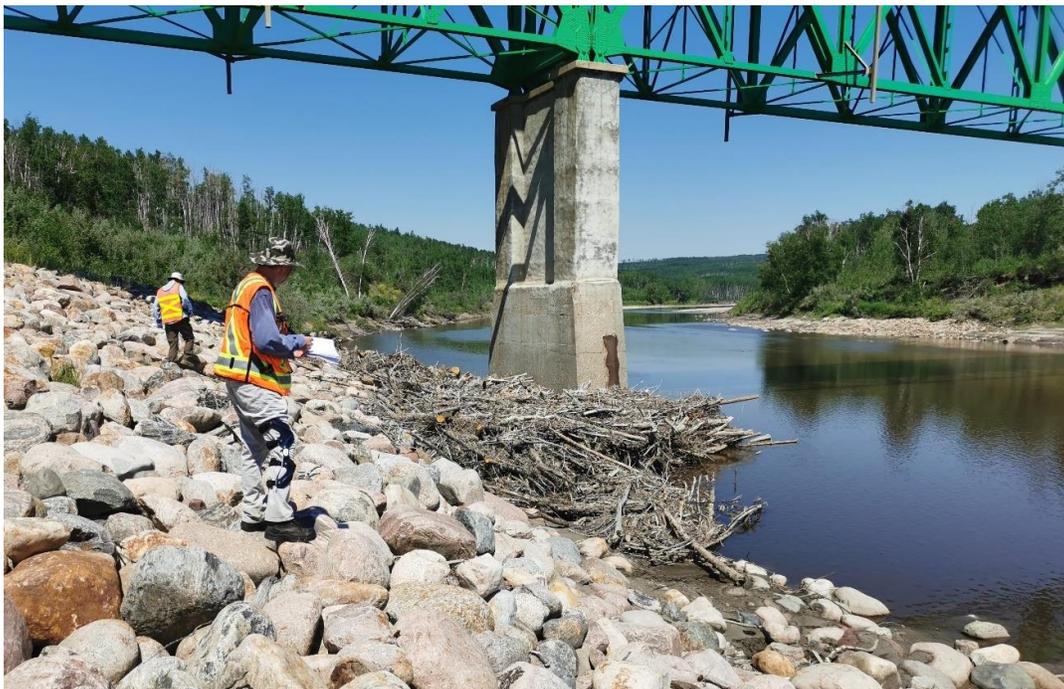
Photo 8 – Looking north at accumulated tree debris against Pier 2.

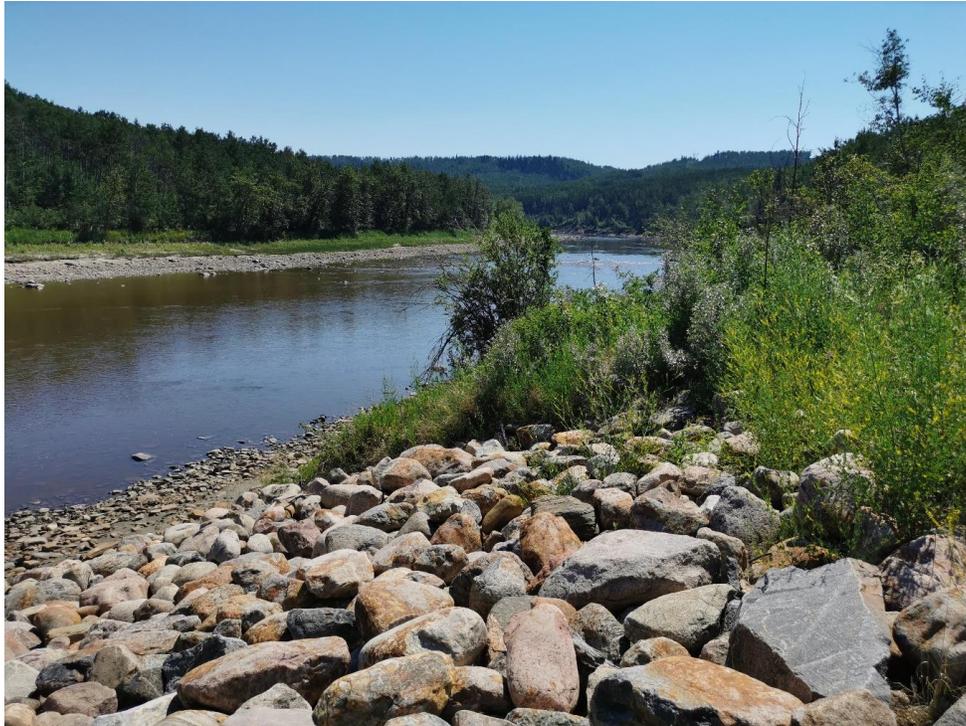
Ongoing river erosion had caused a localized slump between Piers 1 and 2. The slumped material was impacting against the west side of Pier 2 where ongoing river erosion kept the slide active. A repair of this slump was undertaken by AMEC in 2017 which involved the installation of stone columns, a subdrainage system, and riprap slope protection. The potted willows shown at the toe of the slope on the drawings have died. Future observations will be required to determine if the repair is effective; however, this will likely have only a limited effect on the overall valley movements. River erosion has over steepened the south section of the riprap apron resulting in the loss of some material which worsened in 2020. This was also observed in 2021. At the lower water levels in October 2020, it was also noted that there is some erosion and slumping cutting into the apron north (downstream) of the bridge.

Photo 9 – Looking south at erosion along toe of riprap and riverbank.

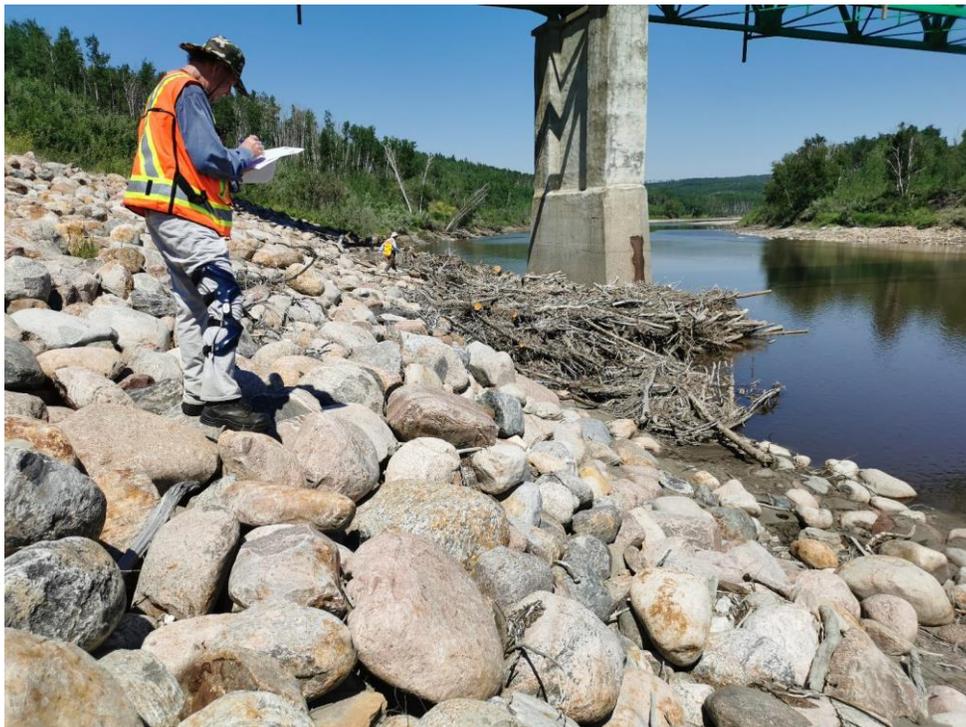
Photo 10: Oversteepening of riprap south of Pier 2.

- Routine assessment of the bridge should be undertaken such that adjustments can be made when required (it is understood that AT’s Bridge Branch is routinely inspecting this structure). Should cracking form on the highway to the west of the abutment, crack sealing should be undertaken to minimize water infiltration.
- Milling and patching of the pavement surface at the west end of the bridge should be carried out on a periodic basis as required to maintain a safe riding surface.
- Annual GeoHazard Inspection should observe the south end of the riprap apron as there is the potential for loss of further material.
