**THURBER** ENGINEERING LTD.

December 1, 2022

**ALBERTA TRANSPORTATION GRMP (CON0022164)  
PEACE REGION (PEACE RIVER DISTRICT)  
INSTRUMENTATION MONITORING RESULTS – FALL 2022**

**SITE SH016: HWY 49:12, LITTLE SMOKY RIVER BRIDGE**

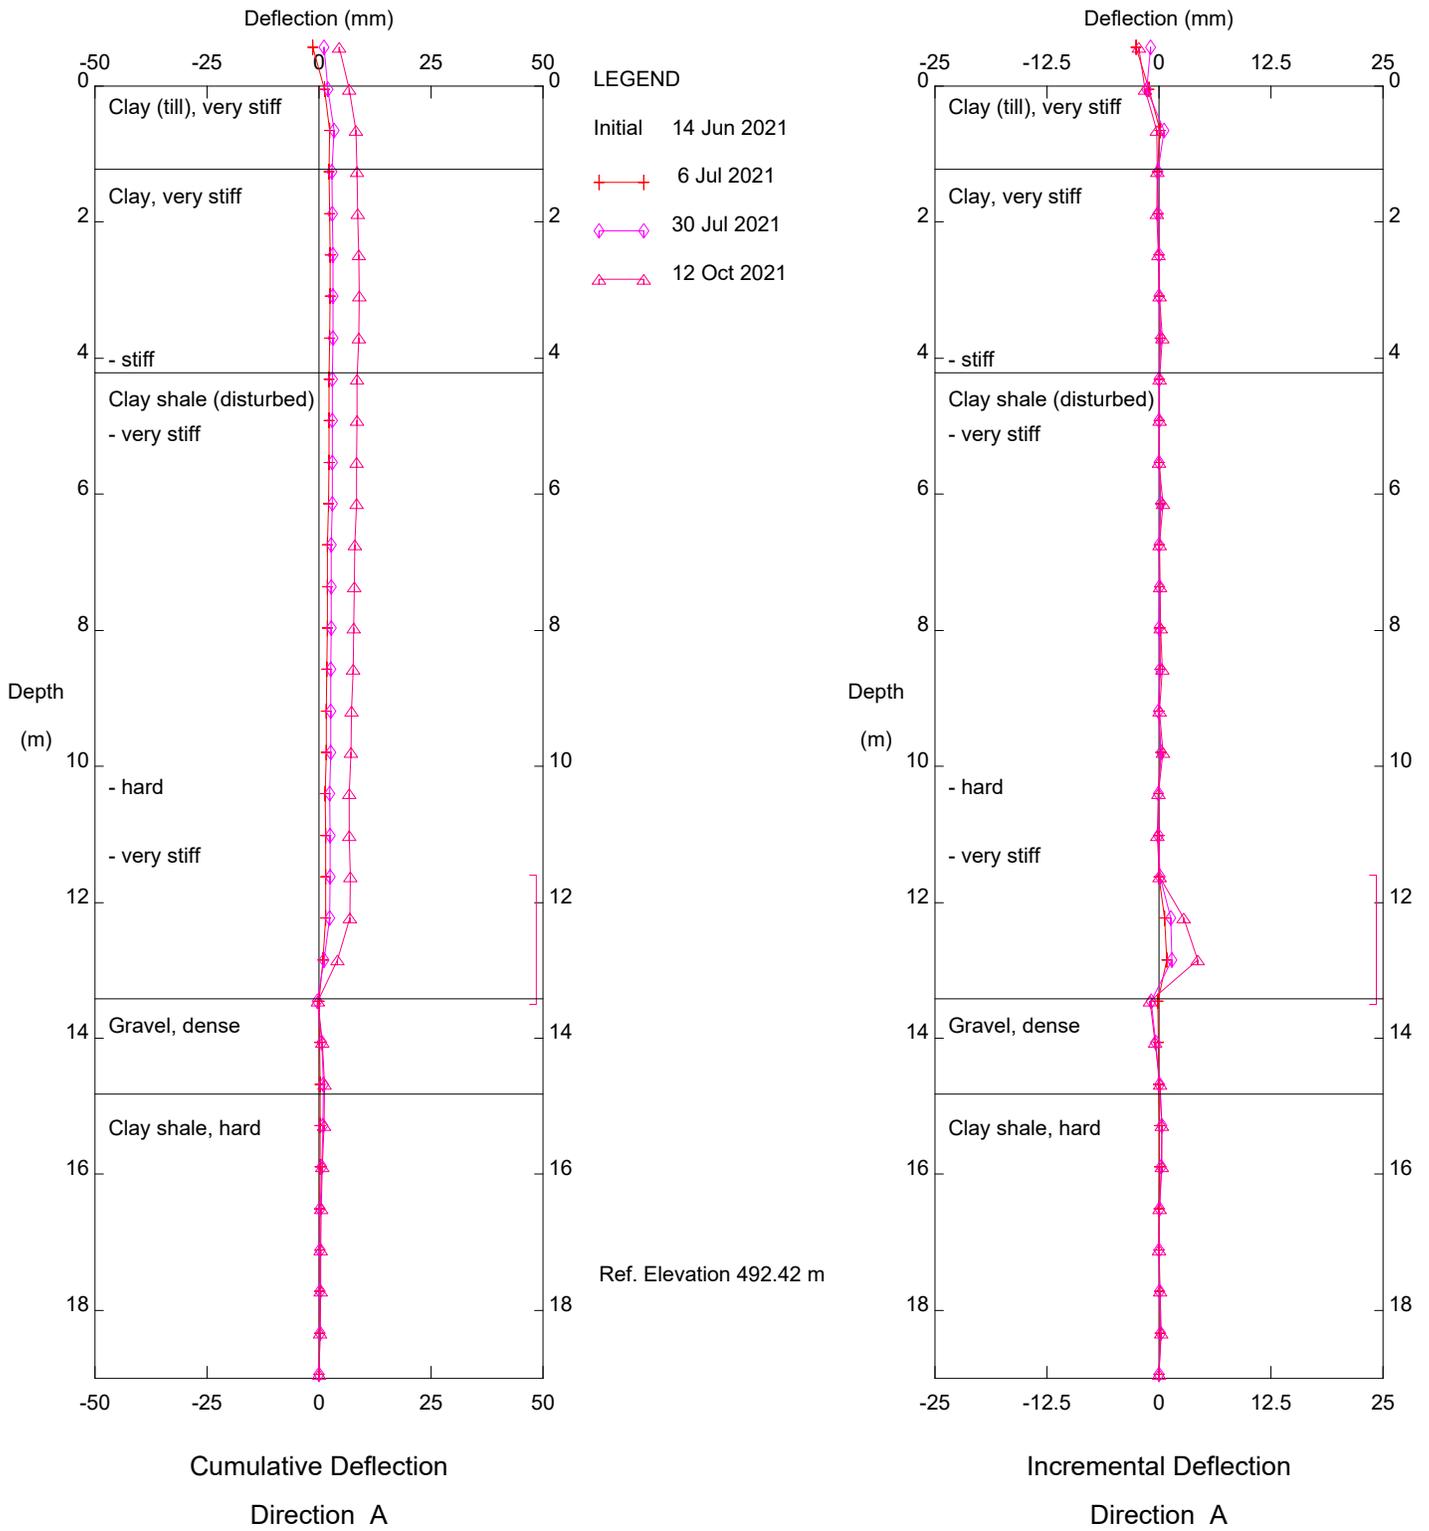
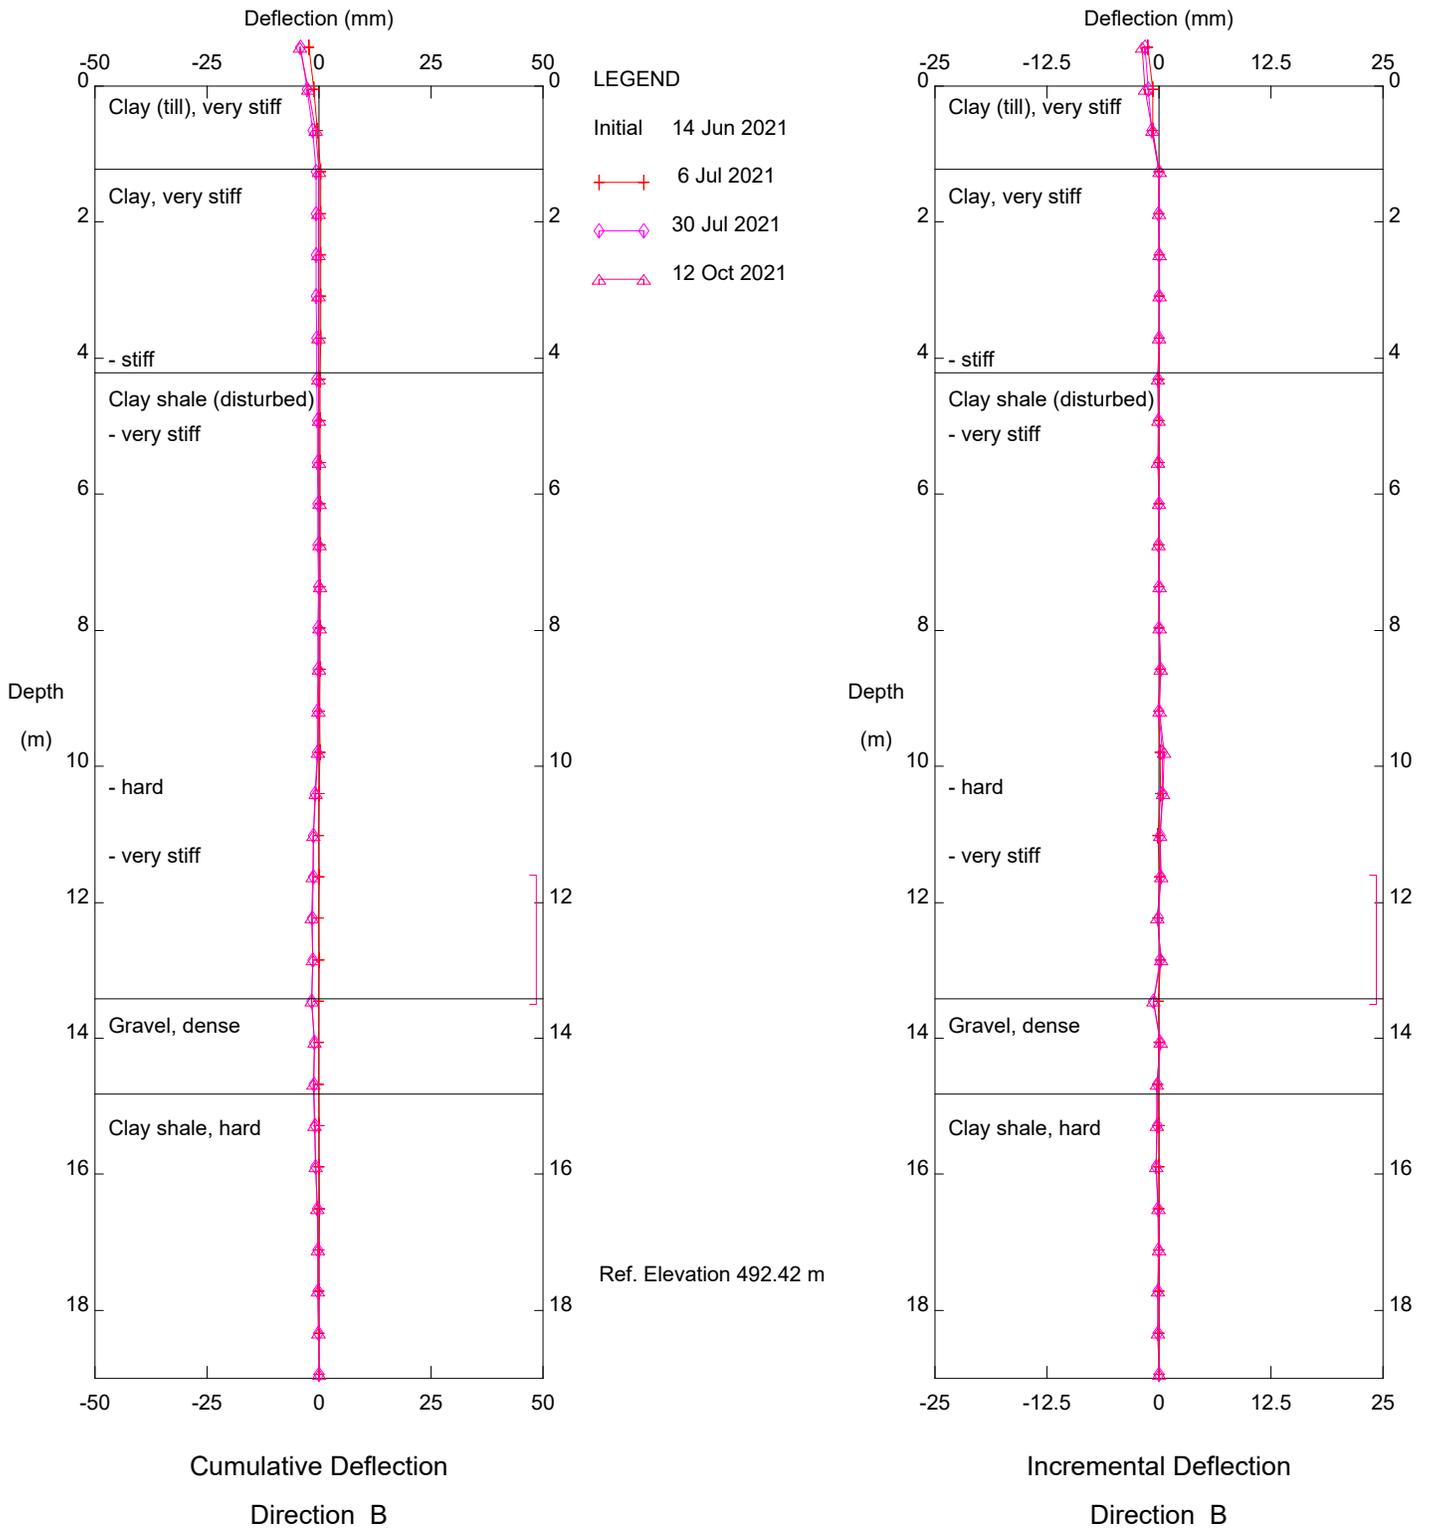
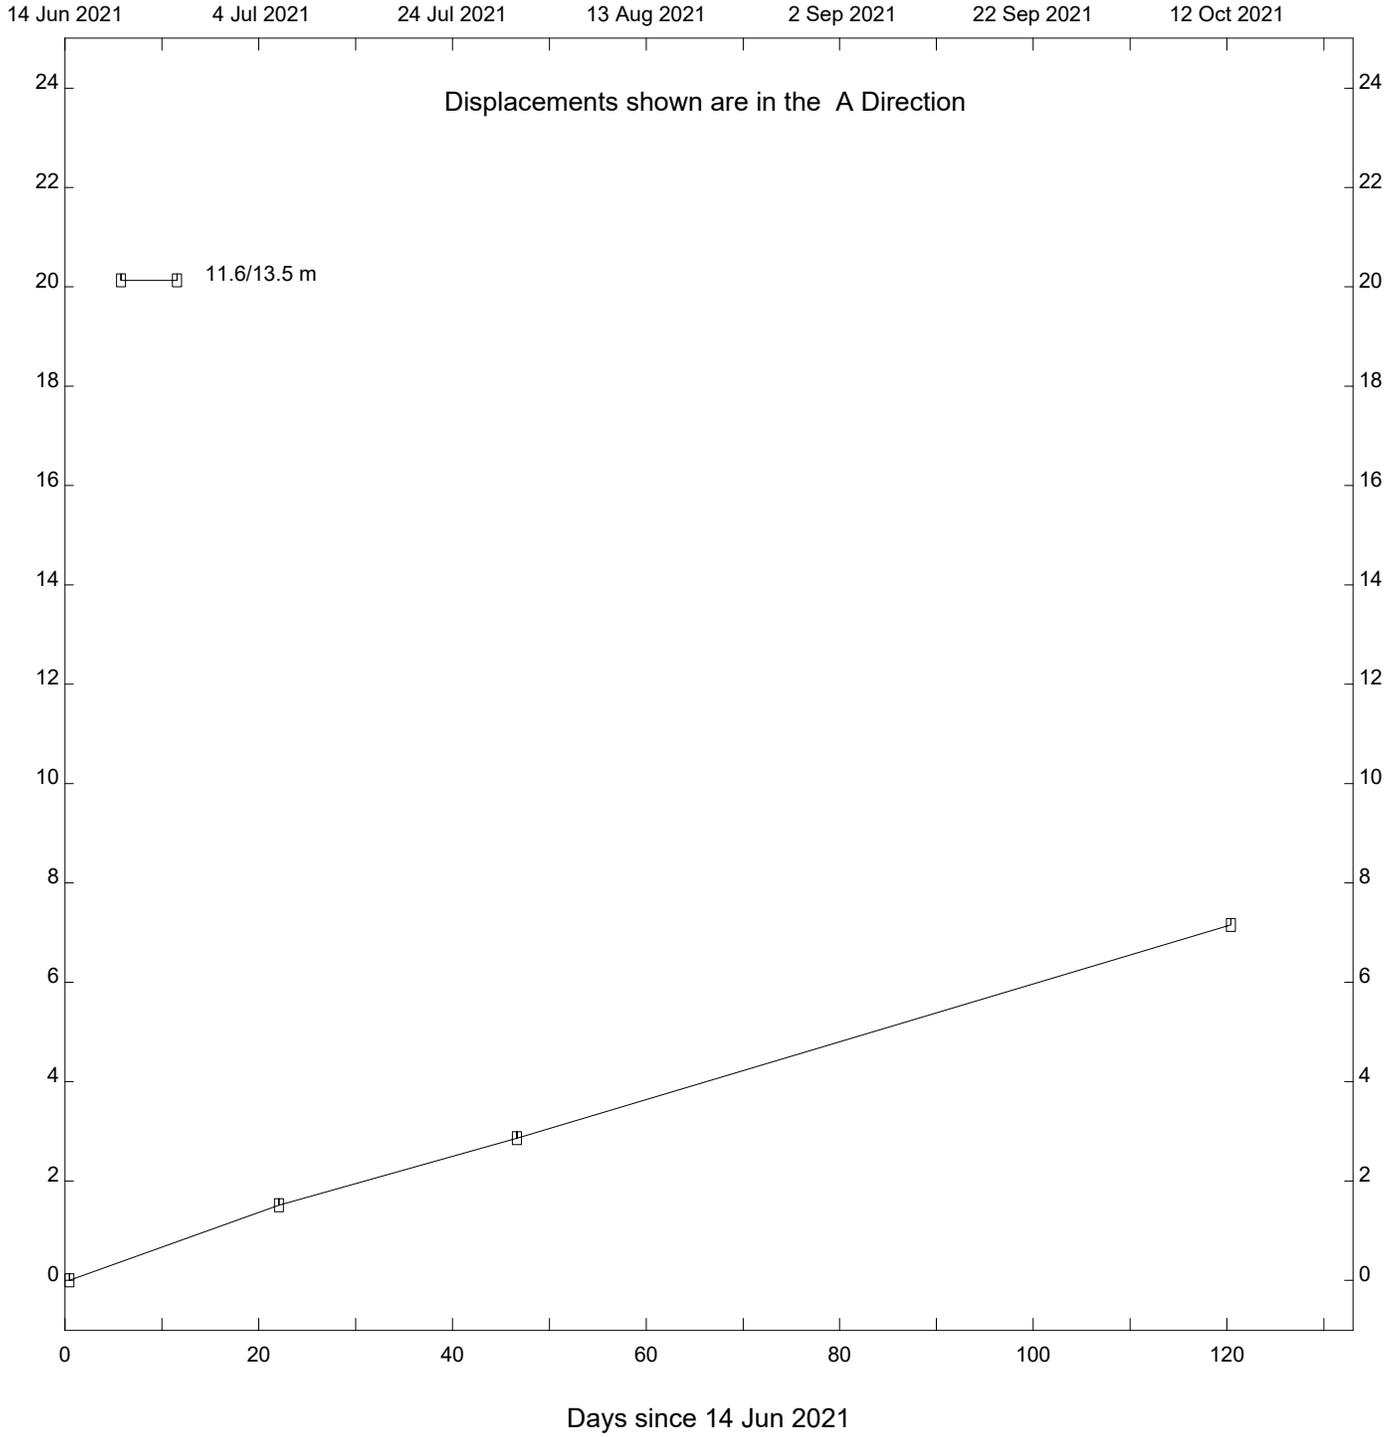
Hwy 49:12 Little Smoky River Bridge, Inclinometer SI21-07

The SIs and vibrating wire piezometers were read on October 6, 2022 by, by Mr. Niraj Regmi, G.I.T., and Mr. Kyle Crooymans, both of Thurber. SI21-7, SI21-8 and SI21-9 were found to be sheared off at 13.4 m, 11.0 m, and 16.5 m below the tops of their respective instrument casings. The vibrating wire piezometers were all still found to be functional, and were read using a GEOKON GK 404 vibrating wire readout.

Before shearing off, all of the SIs showed a distinct shear zone towards the bottom of a layer of disturbed clay shale underlying the upper clay fill. SI21-7, SI21-8 and SI21-9 showed average rates of movement over the monitoring period of June 14, 2021 to October 12, 2021 of 21.8 mm/yr, 22.7 mm/yr and 28.8 mm/yr, respectively.

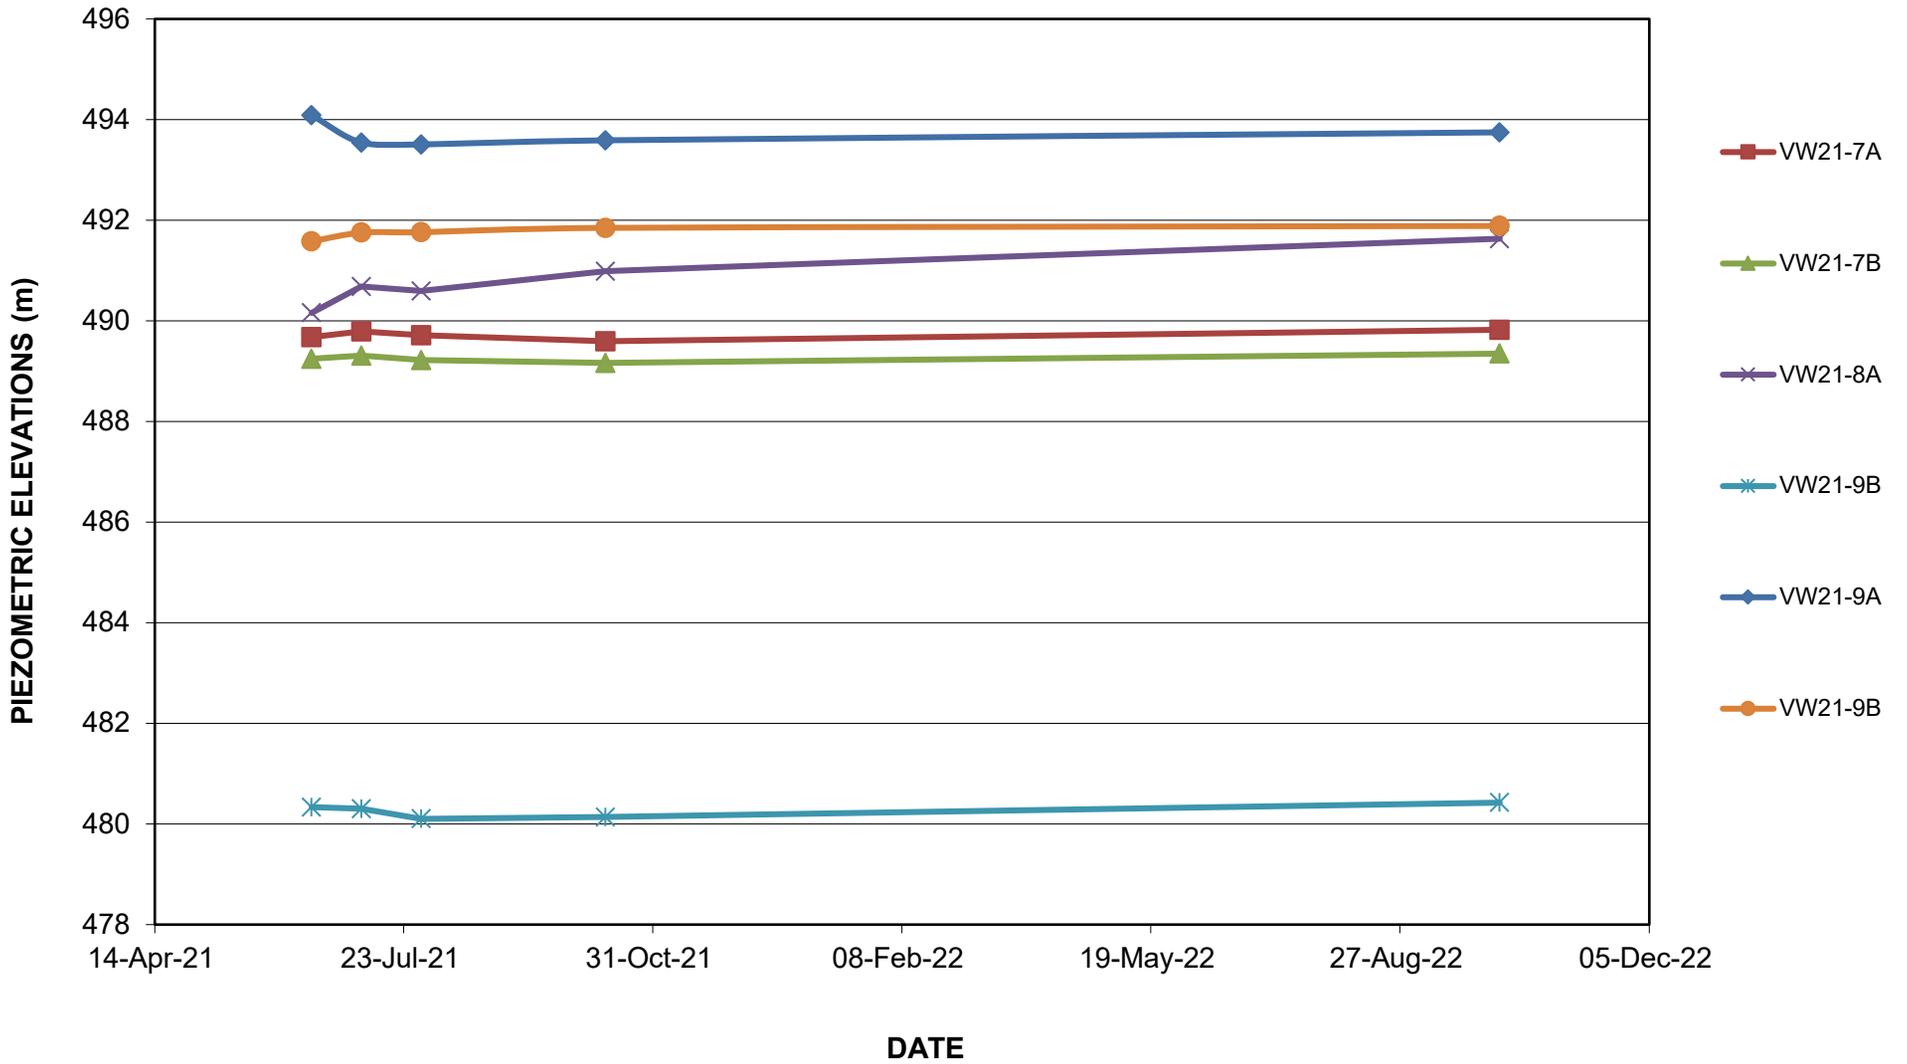
**FIGURE SH016-1**  
**HWY 49:12 LITTLE SMOKY RIVER PIEZOMETRIC ELEVATIONS**

The vibrating wire piezometers all showed increases in groundwater level compared to the previous readings on October 12, 2021, ranging from 0.04 m in VW21-9B to 0.65 m in VW21-8A. All of the piezometers, except for VW21-9A, recorded the highest groundwater levels measured since the initialization of their respective instruments during the current readings cycle. The vibrating wire piezometer readings are plotted on Figure SH016-1 (by elevation) and Figure SH016-2 (by depth) in Appendix A.
